Large N.G. explosion and fire involving several buried utility networks

N. Piccinini⁽¹⁾, R. Tommasini⁽²⁾, E. Pons⁽²⁾

Abstract

This paper describes an accident (explosion and natural gas fire) that occurred in Turin (Italy), in which power distribution cables, tramway network feeding cables and a gas pipe were involved.

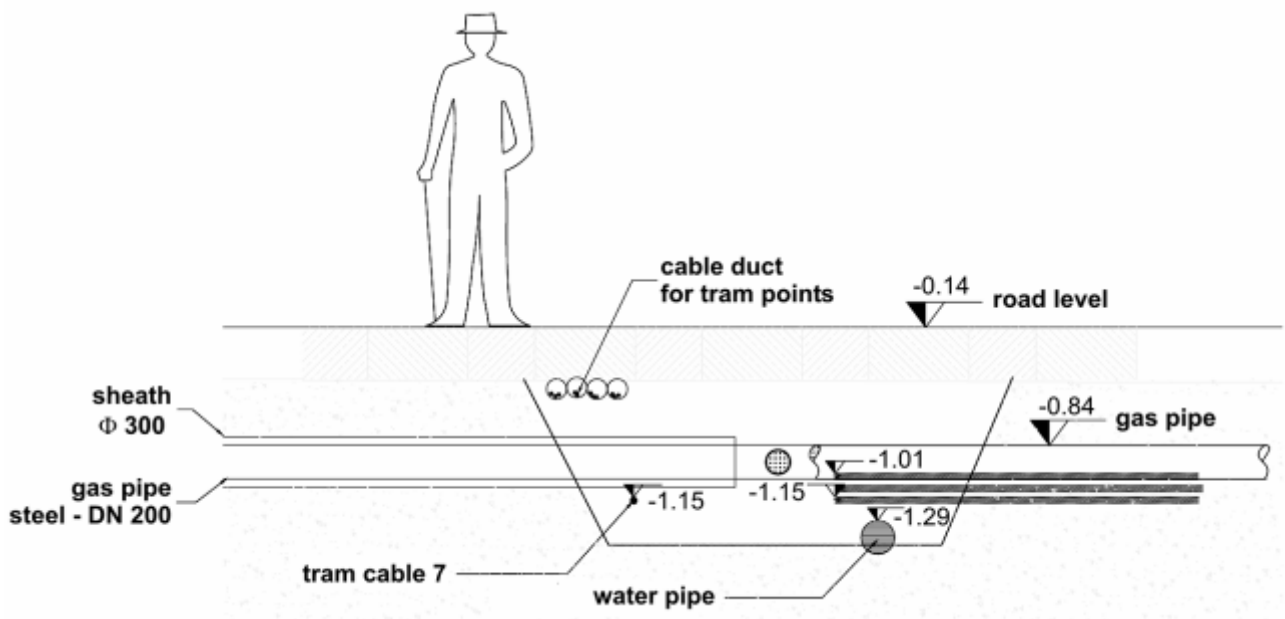
Fig. 1 – Depth survey

There were many buried utilities below the road where the accident took place; from the ground surface and going downwards (for a detailed depth survey see Fig. 1) there were: traffic lights, tram points, public lighting, power distribution and tram network power cables, gas pipes and water pipes. The layout of the lower installations is described in Fig. 3.

No trace of the gres pipe which protected tram cable n. 7 was found near the gas pipe. This was probably damaged and removed during previous works (perhaps when the old cast iron gas pipe was substituted by the steel pipe in 1980). Moreover, the space between the gas pipe, the water pipe and the tram cables 1-6 was not sufficient to allow the gres pipe to cross (see Fig. 1 for details).

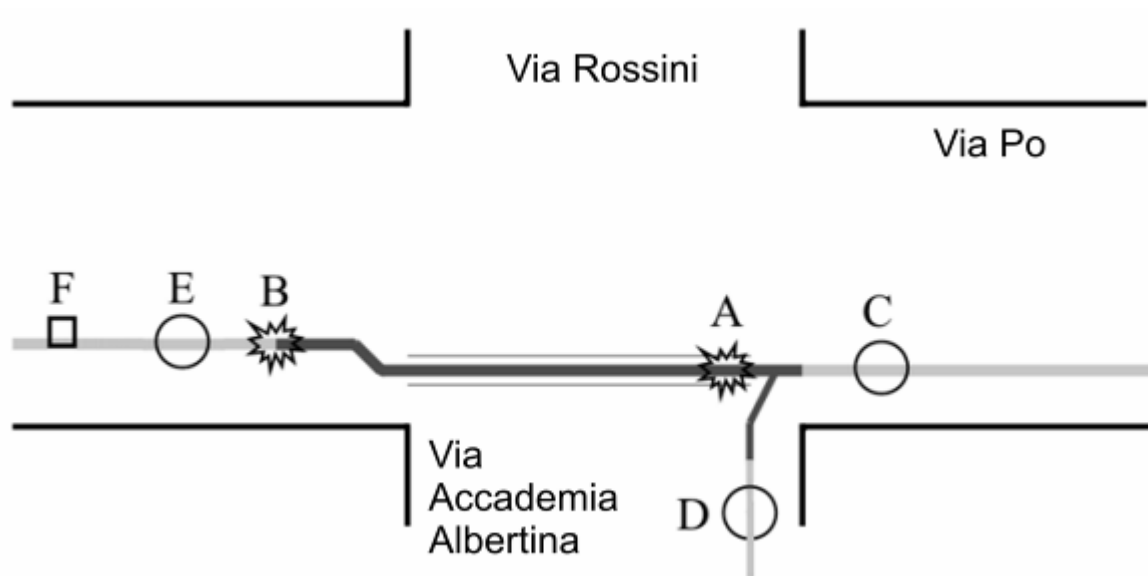
Fig. 2 – Gas pipe damage

Two damaged points, marked “A” and “B” in Fig. 2, were found along the gas pipe:

During the inspections after the accident, a water leak was found, at about 100 m from the crossroads where the accident happened; the water leak was caused by an old damaged lead pipe in the manhole marked with the letter "F" in Fig. 2. The street is slightly sloping, and the water therefore flowed through the PVC pipes of cables 1-6 and reached the accident area, where the terrain was flooded. This water flow accelerated the damage of cable 7, which started to leak current to the ground, through the gas and water pipes. In a vicious circle, the fault current produced heat, the heat accelerated the cable damage and the fault current increased.

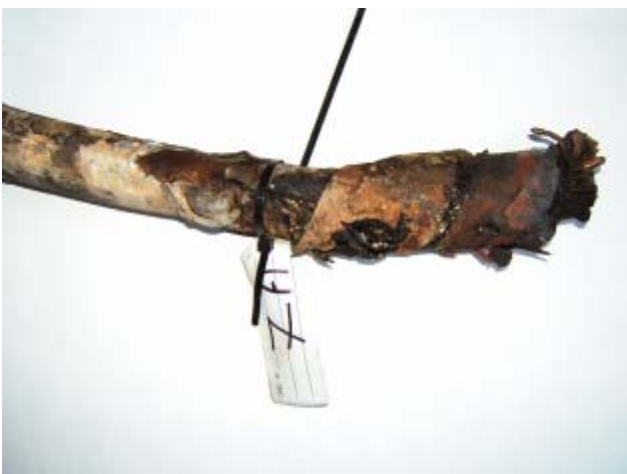
The gres protection, however, was not found in the zone in which cable 7 crossed the gas and water pipes. It had probably been broken or removed during previous maintenance works.

The damaged terminals of the cables are shown in Fig. 9 and Fig. 10.

Fig. 9 – Cable 7

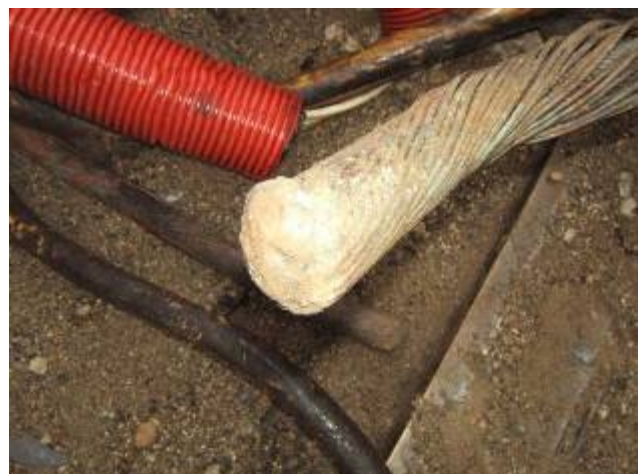
Fig. 10 – Cable 1

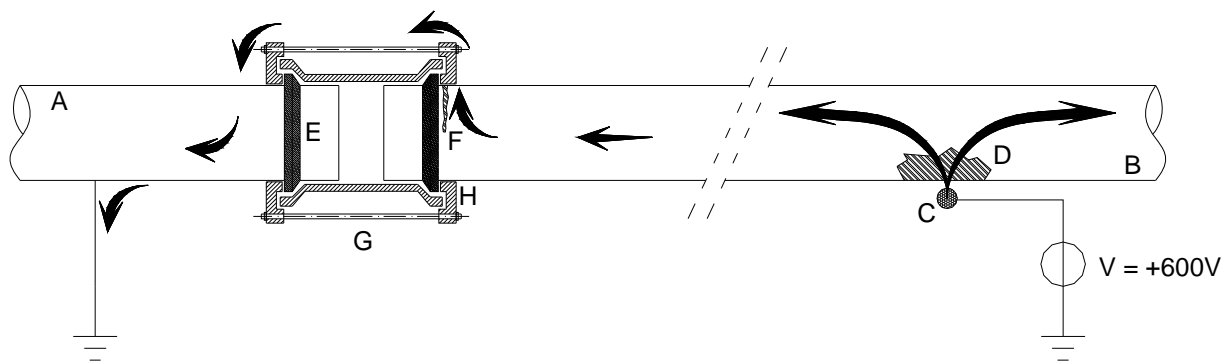
The damages to the gas and water pipes where GTT cable 7 was crossing are certainly not due to corrosion but to the high current flow because it was directed from the cable into the pipes. The path followed by the fault current is shown in Fig. 11, where:

A is the cast iron gas pipe;

B is the steel gas pipe;

C is GTT cable n. 7;

D is the gas pipe damage (letter A in Fig. 2);

E is the junction washer;

F is the gas pipe damage (letter B in Fig. 2);

G is the junction between the cast iron and the steel gas pipe;

H is the junction metal ring.

Fig. 11 – Path followed by the electric current

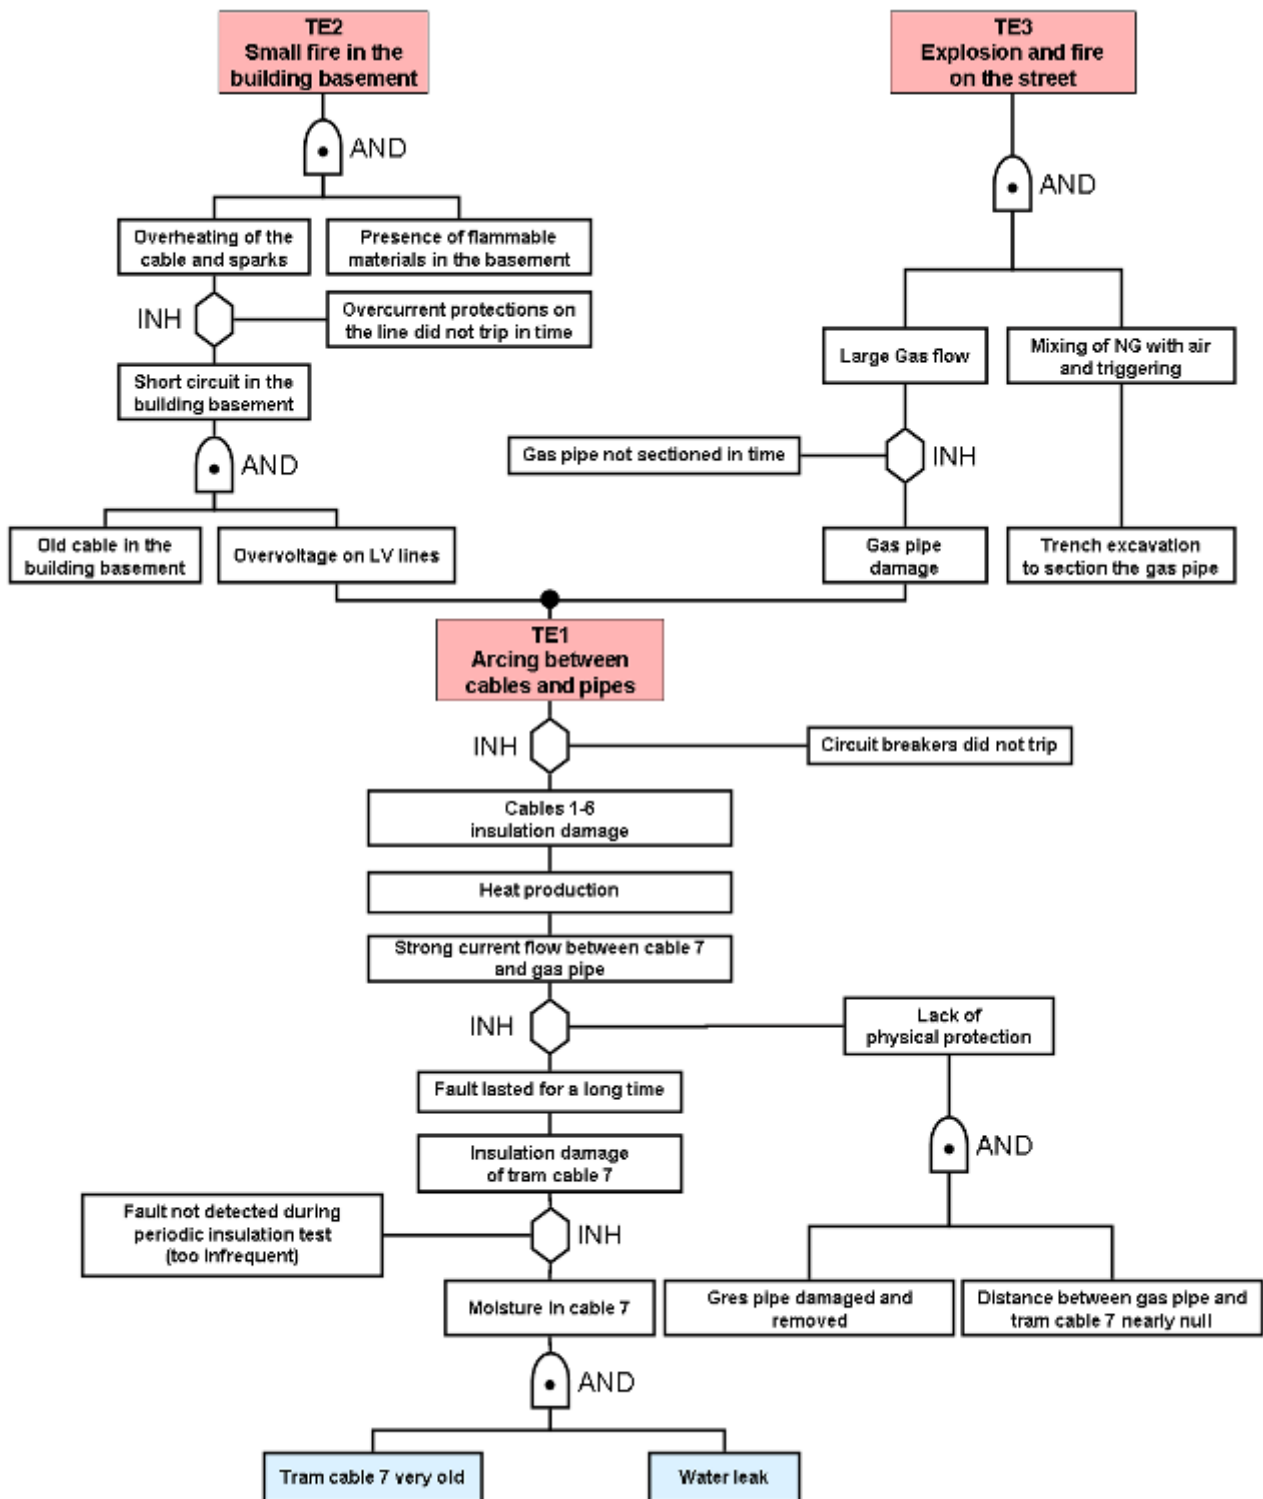
Fig. 12 – ISD presenting the domino effects and the failure of the protection systems

modest event (600 V electric cable loss of insulation), which most likely lasted for months, the aforementioned accident was reached in a crescendo of domino effects. This sequence has been represented by an Incidental Sequences Diagram (ISD) (Fig. 12) in which the failure of the different protection systems is highlighted (Piccinini and Ciarambino, 1997). These protection systems were mostly based upon the strict respect of procedures both in the installation and in the following maintenance of the different utilities. In general the development of an accident or any undesired event (Top Event) can be ascribed to a process malfunction AND to the failure of both the automatic and manual protection systems; these may be due to different initiating events OR human errors of different kind. The representation of Fig. 12, which is called Incidental Sequences Diagram (ISD), is a causes/consequences logical graph similar to the better known Fault Tree representation. The construction of these graphs proceeds downwards with small logic steps from the Top Events to the Initiating Events, while their reading, or their numerical solution, proceeds in the opposite way: upward from the Primary Events towards the Top Event.

The accident was caused by the fact that many cables and pipes were buried at a limited distance from each other, without any proper protection. With reference to Fig. 12, the electric fault, involving tram cable n. 7, a water pipe and a gas pipe occurred because:

- the gres protection pipe was not present where the power cable crossed the two pipes;
- the distance between the two pipes and the cable was nearly null;
- the tram cable was quite old (installed in 1956).

A periodical check of the cables insulation is probably not sufficient, and after a certain number of years (mean life) they should be substituted.
