Mobile Harbor Crane Wheel Hub Fatigue Failure

J. Shirokoff

Failure analysis of a mobile harbor crane wheel hub demonstrated that the mechanism of failure was fatigue. The wheel hub was a ductile cast iron component that had been subjected to cyclic loading during a ten-year service period. The fracture surface of the fatigue failure also contained corrosion deposit, suggesting that cracking occurred over a period of time sufficient to allow corrosion of the cracked surfaces. Replacement and alignment of the failed wheel hub is recommended along with inspection of the nonfailed wheel hubs that remain on the crane.

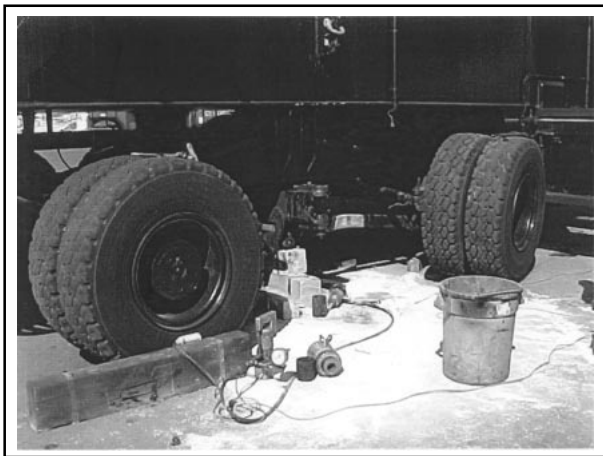
A general view of two of the six axles and their wheels along the side of the crane is shown in Fig. 1. In between the two axle/wheel assemblies is the failed axle with wheel assemblage removed. The photograph in Fig. 2 shows an axle, wheel hub, wheel, tire, and steering arm of an axle assemblage that is in good working order.

Fig. 1 General view of two crane wheel sets and one failed axle (middle) with wheel and wheel hub removed. The wheels are turned at different angles.

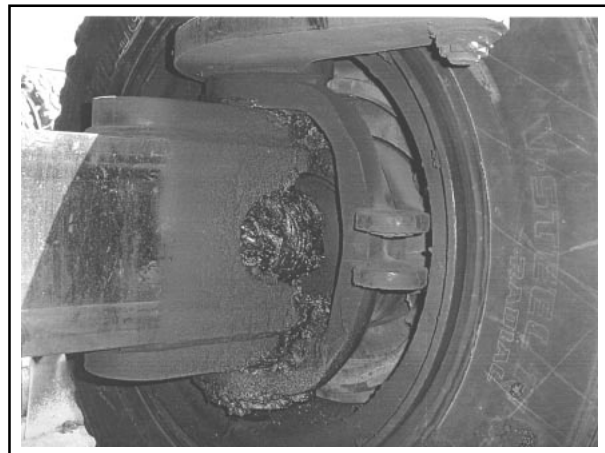
Fig. 2 View of a nonfailed axle, wheel hub, and steering arm (top)

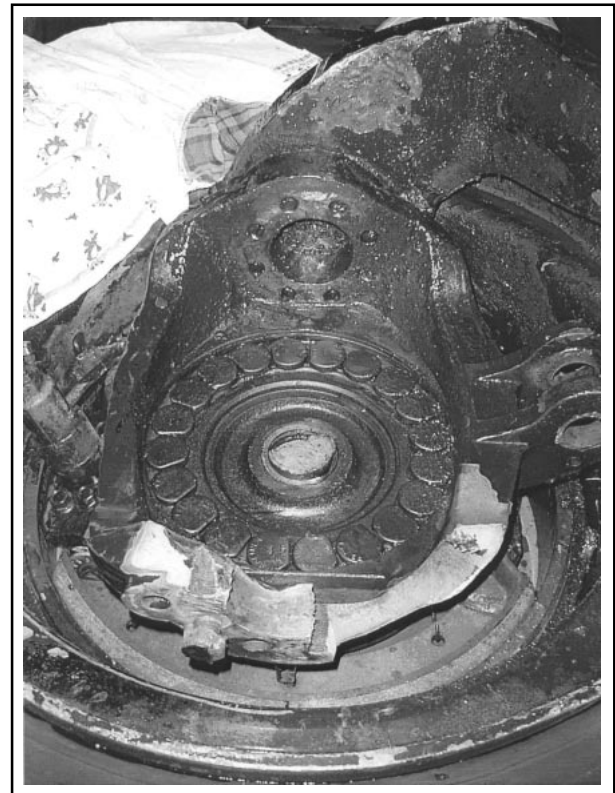
Fig. 5 Failed wheel hub (side view) showing fracture surface and area where material has broken away

The failed wheel hub and axle are shown in Fig. 5. Much of the fracture surface appears rough and granular, consistent with macroscopic appearance of overload fracture. Such fracture would occur after the load-carrying capabilities of the component had been reduced by the presence of fatigue cracks.^[2] Additional examples of overload fracture are presented in Fig. 6, where a side view of the fractured wheel hub components are shown. Another smoother, flatter, and less shiny region of the fracture surface is shown in Fig. 7. Regions on this portion of the fracture appear as brown stains (arrow). The brown area was chemically analyzed by EDS on the

1. A new nodular cast iron wheel hub and axle should be used to replace the failed component.
2. The installation process should assure that the new wheel hub and axle are properly aligned.
3. The nonfailed wheel hubs should be examined for cracks using traditional inspection methods such as liquid dye penetrant.
4. A more detailed analysis of wheel hub stresses may be beneficial, especially if any additional cracks are found in the nonfailed assemblies. This analysis would require data and engineering drawings of the wheel hub assemblage from the crane manufacturer and could incorporate stress measurement of the wheel hub using strain gages.

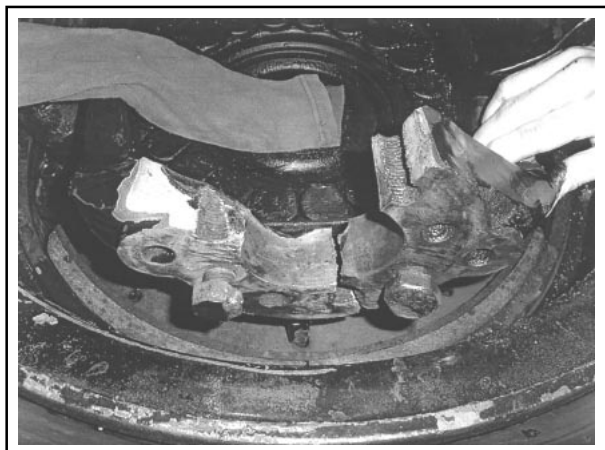
Fig. 6 Failed wheel hub (side view) incorporating the broken part held in place

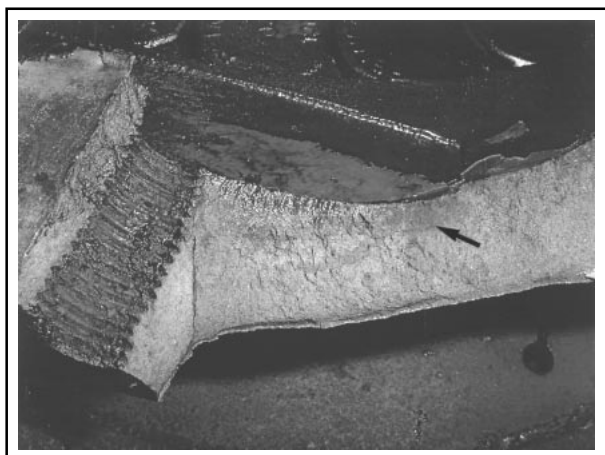
Fig. 7 Fracture surface of the failed wheel hub showing the brown discoloration or stain area (arrow)

SEM and found to be primarily iron with a minor presence of sodium, silicon, sulfur, chlorine, potassium, calcium, manganese, and zinc. The brown stain is assumed to be primarily iron oxide (the EDS system does not capture X-ray emissions from oxygen). Scanning electron microscopy fractograph and optical fractograph of the flat oxidized portions of the fracture surface (Fig. 9 and 10) are consistent with a ductile fatigue fracture failure without the presence of fatigue striations.^[3,4] These fracture features are also consistent with the lack of embrittlement in the nodular cast iron.^[5-7]

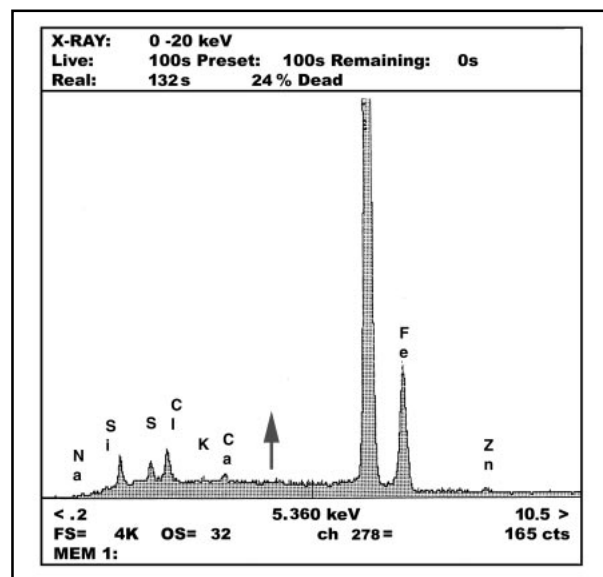
Fig. 8 Energy-dispersive spectroscopy of the discolored surface of Fig. 7

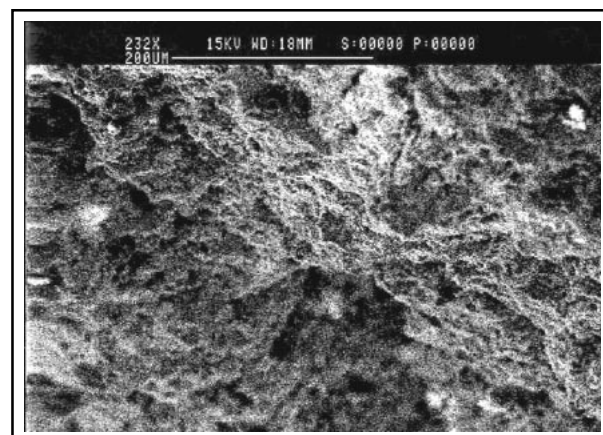
Fig. 9 Scanning electron microscopy micrograph of the fracture surface

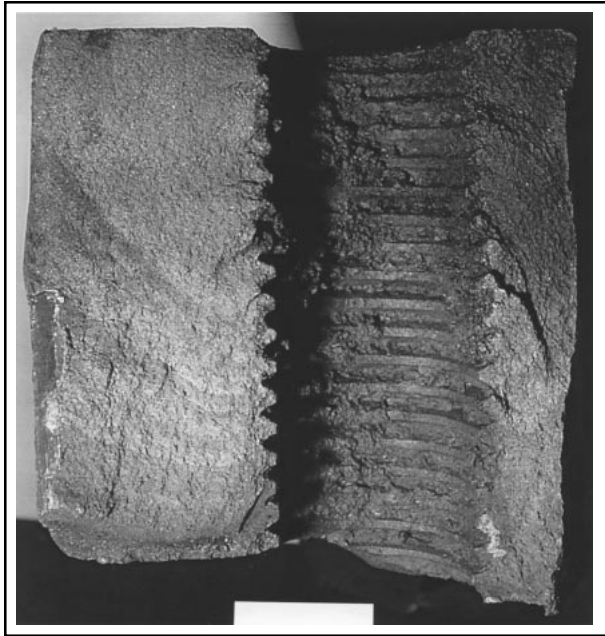
Fig. 10 Fractograph of the wheel hub fatigue failure

The wheel hub failure was due to the service-induced growth of a fatigue crack and stress-concentrating effects of that crack on motion-induced stresses. The cause(s) of fatigue crack initiation and growth was(were) not established, but misalignment of the hub is considered a likely candidate.
