Kržan, M. Bosiljkov, V., Gostič, S., Zupančič, P. 2012. Influence of Ageing and Deterioration of Masonry on Load Bearing Capacity of Historical Building In: 15th World Conference on Earthquake Engineering: 24 to 28 september 2012, Lisbon, Portugal. Lisbon : Sociedade Portuguesa do Engenharia Sísmica : International Association for Earthquake Engineering: p. 1-10.

Influence of Ageing and Deterioration of Masonry on Load Bearing Capacity of Historical Building

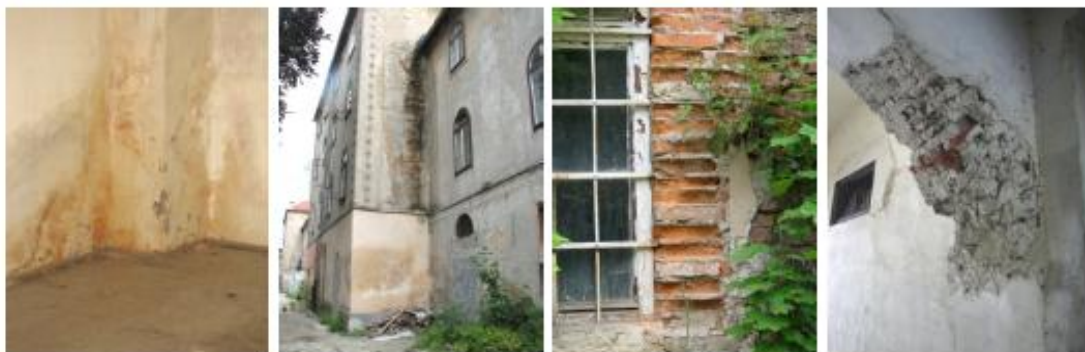
In-situ inspections in 2008 (Bosiljkov et al., 2008) revealed that the load bearing walls and columns were in some parts in very bad condition. Consequences of moisture due to capillary rise, unsuitable introduction of hydro isolation, damaged downpipes and damage due to overloading were obvious (Fig.2). Deterioration due to moisture was extensive throughout the basement and partially in the ground floor, while in the upper floors along drainage at some positions on outer walls. The building was abandoned for at least a decade; therefore neither structural repairs nor proper maintenance have been done recently.

Figure 2. Deterioration due to capillary rise, inadequate drainage, freezing-thawing and overloading

- Influence of deterioration and ageing of brickwork masonry has significant effects on mechanical properties of both masonry constituents and masonry as a composite material. For Kolizej Palace moistening, capillary rise and freezing-thawing cycling were probably the most powerful parameters that accelerated deterioration of the masonry.

Following the results of this analysis it may be concluded, that first major steps for the preservation of the state of built masonry are proper maintenance, preventive measures and monitoring. With this approach (in the long term) the influence of deterioration and ageing of masonry on the load bearing capacity of the structure might be significantly decreased. Following the results of comprehensive in-situ investigation of the Kolizej Palace in Ljubljana, main conclusions regarding mechanical parameters are:

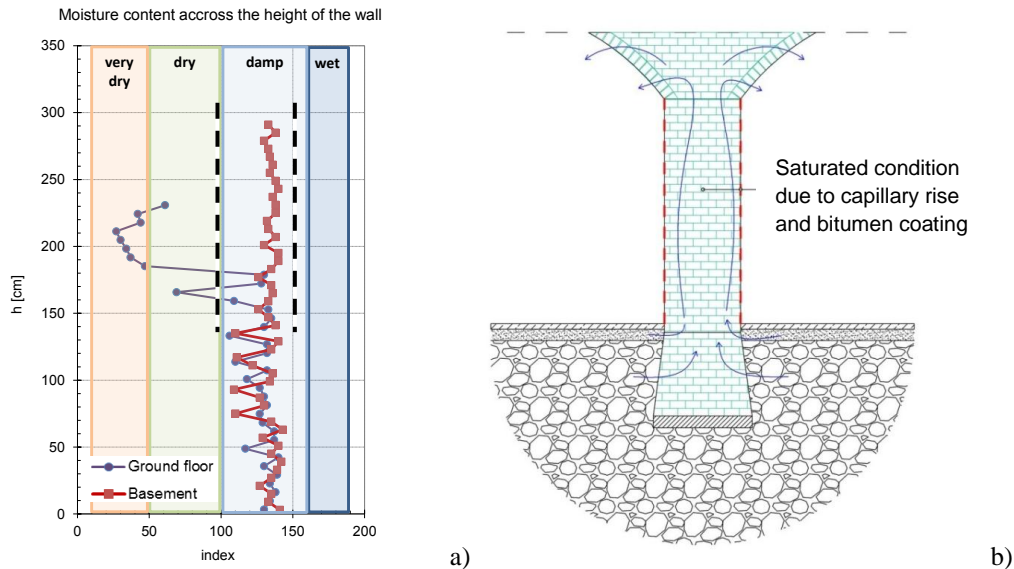
Moisture content of bricks was determined on the basis of drilled brick powder and brick specimens taken from the walls and drying them till constant mass. Moisture content of powder from the basement was 18.9 - 29.6% for exterior walls, and 1.4 - 14.3% for interior columns. In the upper floors the moisture was noticeable lower; 1.3 - 3.3%. Comparison of moisture and water absorption for

different classes of bricks confirms, that in the basement the bricks were in almost completely saturated state.

On site damp investigation was also done with surface electronic moisture meter. Moisture content was measured in the basement, ground level and the 1st floor. Along the height of the building where in-situ shear tests were done, across the entire basement floor wall and approximately half of the height of the ground floor the masonry was damp, but then in relatively short transition it became very dry as seen in Fig. 4-a. The reason for high level of moisture in the ground level was due to improper introduction of bitumen coating for almost all elements of the basement level (Fig.4-b).

Figure 4. Cross-section of basement column and moisture content measurements across the height of the walls

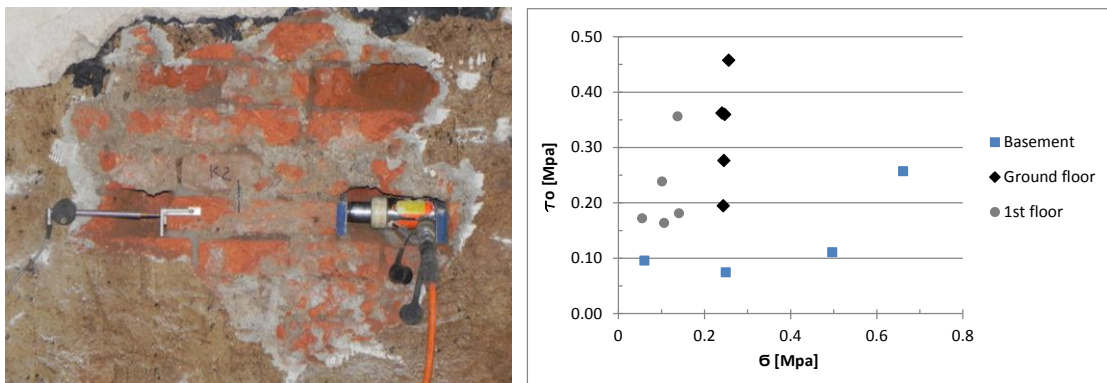
Figure 5. In-situ test setup for shove test and calculated initial shear strengths

Shove tests confirm the presumptions of strength decrease in the basement due to amplified

deterioration because of moisture. Ground and the 1st floor had substantially higher initial shear strength τ_0 . Average values were 0.33 MPa with corresponding average moisture content of 9.7% in ground floor and 0.22 MPa and 5.7% in the 1st floor, while the basement average initial shear strength reached only 0.16 MPa. Initial shear strength τ_0 was lower in the 1st floor probably due to lower vertical load and the change of coefficient of friction in dependence of vertical load and moisture content. The moisture content (measured at testing positions) was not significantly higher in the basement in comparison to other floors, which may imply that not moisture content itself but the long term exposure to moisture with freezing and thawing cycles contributes to amplified deterioration of the bond and mortar.

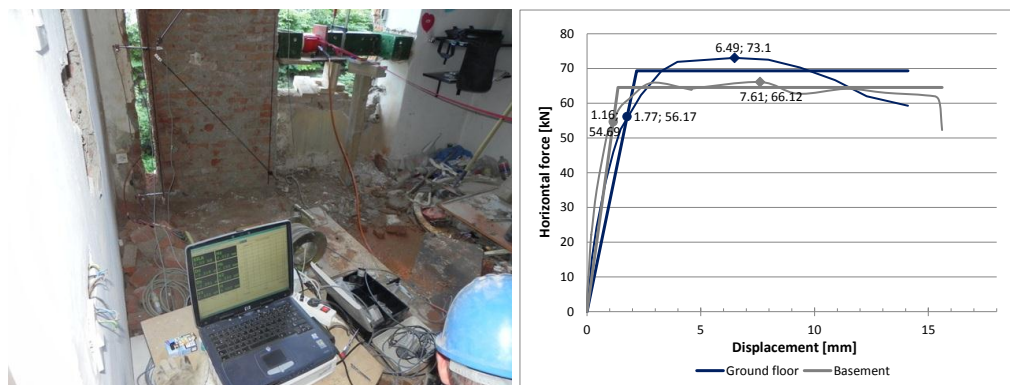
Figure 6. Shear test setup and hysteretic envelopes and idealized bilinear curves for both floors

Reference tensile strength f_t of both walls, calculated considering bilinear idealized curve, clearly shows better state of masonry in normal condition. For the ground level wall f_t was in average 0,072 MPa, while for more deteriorated wall in the basement it was 0.046 MPa, which is 36% less. Ductility and maximum displacements were higher for the specimens in the basement level.

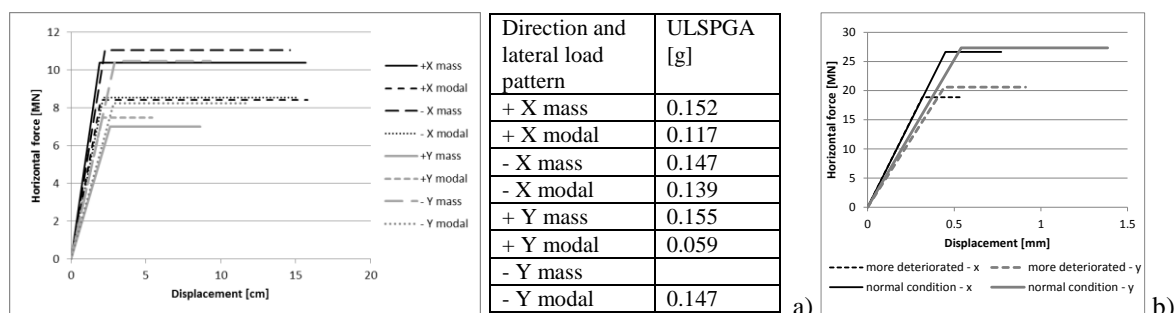
Results with 3Muri show, that in any of the supposed combination of parameters, the Kolizej does not withstand the code demands. Seismic resistance capacity curves for Kolizej with experimentally determined material characteristics for various direction and lateral load pattern combinations are presented in Fig. 9-a. Longitudinal direction is referred as X direction and transversal as Y. As it can be seen from Fig.9-a, the resistance is the lowest in Y direction of the building, furthermore critical is combination with modal lateral load pattern. Hence in all directions modal load pattern is more critical than mass. This indicates that in case of Kolizej the critical storey mechanism model is not the best solution for the assessment of the seismic resistance.

Figure 9. Pushover curves for transversal and longitudinal direction from 3Muri – a) and capacity curves resistance obtained considering normal condition and more deteriorated material with SREMB – b)
