THE REHABILITATION OF A VICTORIAN CLAY BRICK RAILWAY VIADUCT

Stephen W. Garrity
University of Leeds, England, UK

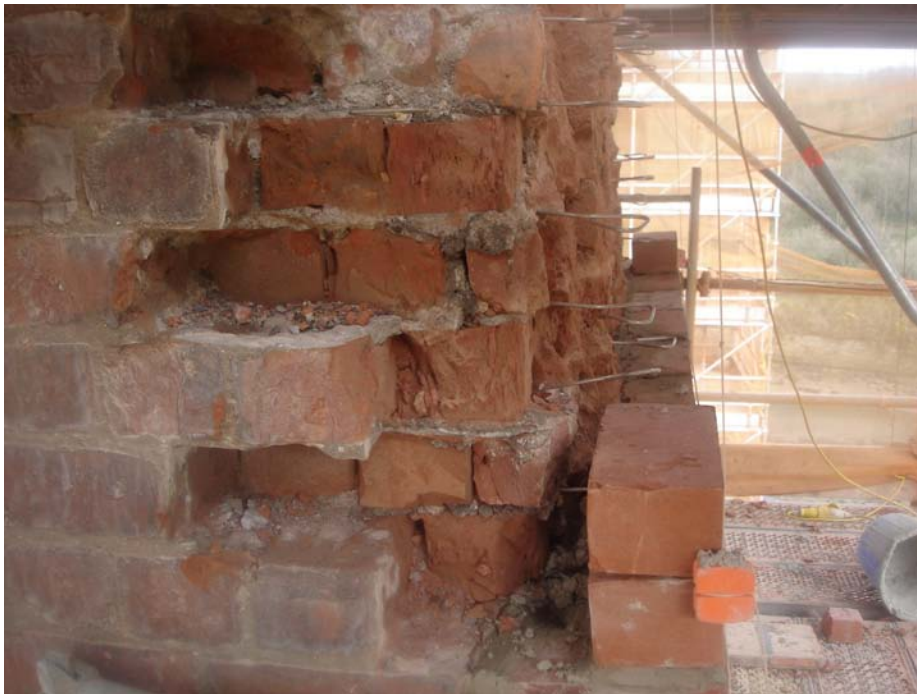
Figure 6. View of the pier rehabilitation works

- a). The contractor used a power saw with a circular blade to break up the damaged parts of the surface brickwork using a series of vertical cuts. This facilitated removal of the damaged brickwork using small hand tools and created a very rough texture to the existing substrate. This was considered to be good practice as it was not only an efficient means of removing the damaged material but it also helped to maximise the shear connection between the new and existing brickwork through improved bond.

- f). Even at the early stages of construction there was evidence of poor backfilling of some of the facing brickwork with, in some cases, large voids between the new facing brickwork and the existing substrate. These voids were subsequently filled with grout by the contractor when instructed to do so by the Client’s site representative.

- g). Many of the ties appeared to be well anchored into the existing brickwork substrate but the Client’s site representative confirmed that a small number could be pulled out from the existing brickwork by hand. These were subsequently replaced by new ties.

In summary, the materials selected for the new brickwork construction matched that of the existing viaduct as well as can be reasonably expected. Although some aspects of the contractor’s method of working helped to maximise bond between the new and existing materials, the standard of workmanship and quality control on site were in need of improvement. These issues were addressed by increasing the level of independent supervision on site and by carrying out a pull-out test on randomly selected ties at regular stages throughout construction.
