## Proceedings of 8<sup>th</sup> International Conference on Short and Medium Span Bridges

# THE REHABILITATION OF A VICTORIAN CLAY BRICK RAILWAY VIADUCT

Stephen W. Garrity  
University of Leeds, England, UK

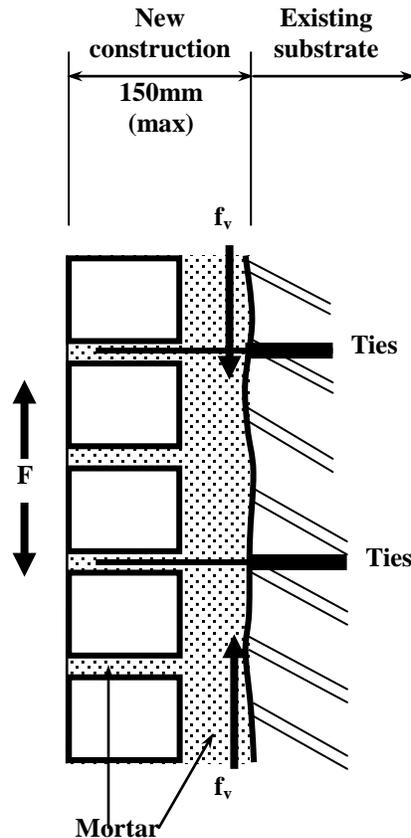
Figure 5. Typical detail of the pier rehabilitation works

- a). Red class B engineering clay bricks laid in a 1:½:4½ (Cement : lime : sand) mortar.
- b). New brickwork facing to consist of alternate stretcher and snap header courses.
- c). Snap headers to be cut from full bricks using a bolster to provide a rough end surface profile for maximum bond.
- d). Space between new facing brickwork and existing substrate to be carefully filled with 1:½:4½ mortar as bricklaying progresses.
- e). At the repair boundaries, new brickwork to be “toothed” into existing undamaged brickwork.

- i). Single triangle 3.3mm dia. grade 304 austenitic stainless steel remedial ties (tensile strength = 750 N/mm<sup>2</sup>).
- ii). Ties anchored into 10mm dia. pre-drilled hole using a water -tolerant polymer resin grout.
- iii). Min. anchorage length into existing substrate = 50mm.
- iv). Ties provided every alternate course vertically and at a maximum spacing of 500mm horizontally.
- v). At corners, ties are to be provided in every course vertically.

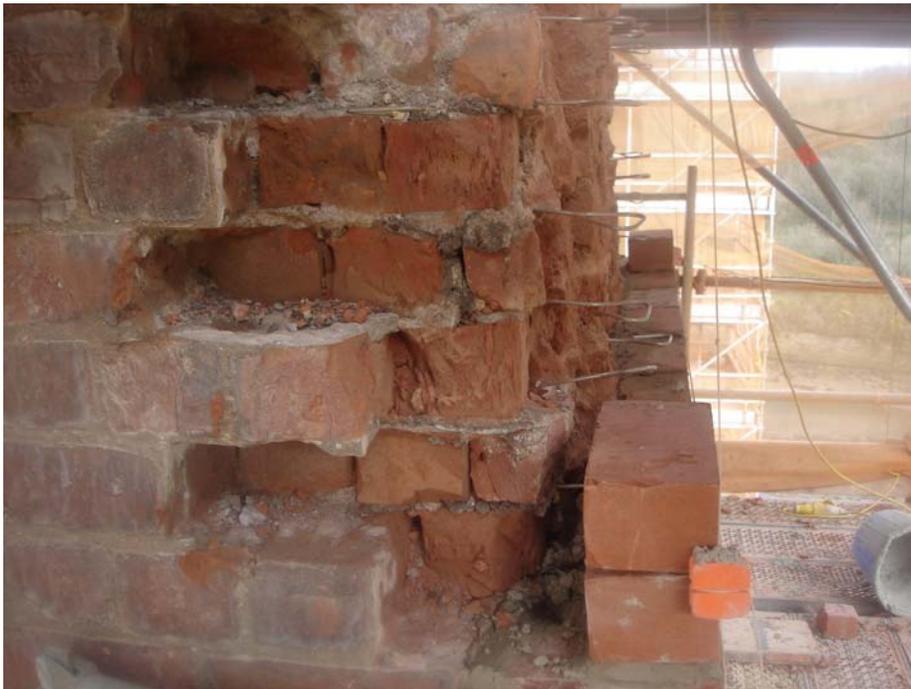
Figure 6. View of the pier rehabilitation works

- a). The contractor used a power saw with a circular blade to break up the damaged parts of the surface brickwork using a series of vertical cuts. This facilitated removal of the damaged brickwork using small hand tools and created a very rough texture to the existing substrate. This was considered to be good practice as it was not only an efficient means of removing the damaged material but it also helped to maximise the shear connection between the new and existing brickwork through improved bond.

- b). Following removal of the deteriorated brickwork, the existing substrate was found to be in good condition. Many of the original joints were completely filled with mortar which appeared to be in a sound condition. A high standard of workmanship appeared to have been achieved in the original construction.

- f). Even at the early stages of construction there was evidence of poor backfilling of some of the facing brickwork with, in some cases, large voids between the new facing brickwork and the existing substrate. These voids were subsequently filled with grout by the contractor when instructed to do so by the Client’s site representative.

- g). Many of the ties appeared to be well anchored into the existing brickwork substrate but the Client’s site representative confirmed that a small number could be pulled out from the existing brickwork by hand. These were subsequently replaced by new ties.

In summary, the materials selected for the new brickwork construction matched that of the existing viaduct as well as can be reasonably expected. Although some aspects of the contractor’s method of working helped to maximise bond between the new and existing materials, the standard of workmanship and quality control on site were in need of improvement. These issues were addressed by increasing the level of independent supervision on site and by carrying out a pull-out test on randomly selected ties at regular stages throughout construction.
