# Private Sector Participation in Low Cost Water Well Drilling

Knowledge and Research (KAR) Project R7126

## Contractor Drilling with Pounder II

Danert K and Carter R C  
December 2000 – June 2001

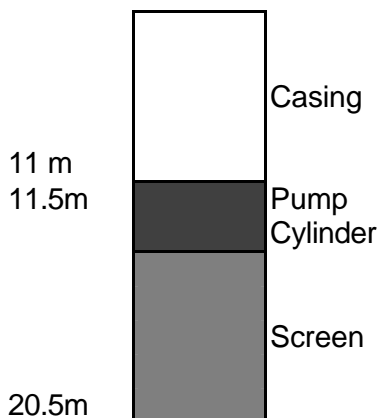
### ***Well Profile***

The RWL on day five was 2.2 and the hole had collapsed back to 16.5m. The reaming proceeded slowly due to the hard layers at the bottom. Installation of the screen, pump cylinder and casing along with 1 1/2 bags of gravel pack was undertaken followed by a rough pump test using the drill pipe pump test arrangement. The drawdown was rapid and considerable fine sand was pumped out.

The crew left the site unsure of the success of the well as a hand pump water source.

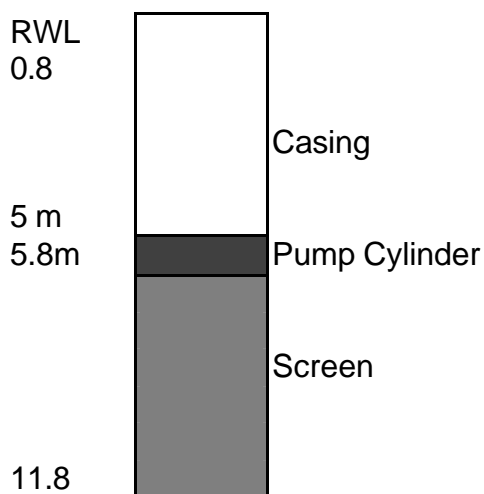
#### Well Profile

The community complains that the water is salty, although they say that is better than the water from another well constructed in the area earlier. The other well was vandalised by thieves who were interested in the pipes. As the Pounder well components plastic and are fixed in the ground, the pump is not likely to be vandalised.
