Investigation into boiler corrosion on the historic vessel SL Dolly

I. A. Turnbull and M. J. Robinson*

Keywords: Boiler corrosion, Wrought iron, SL Dolly

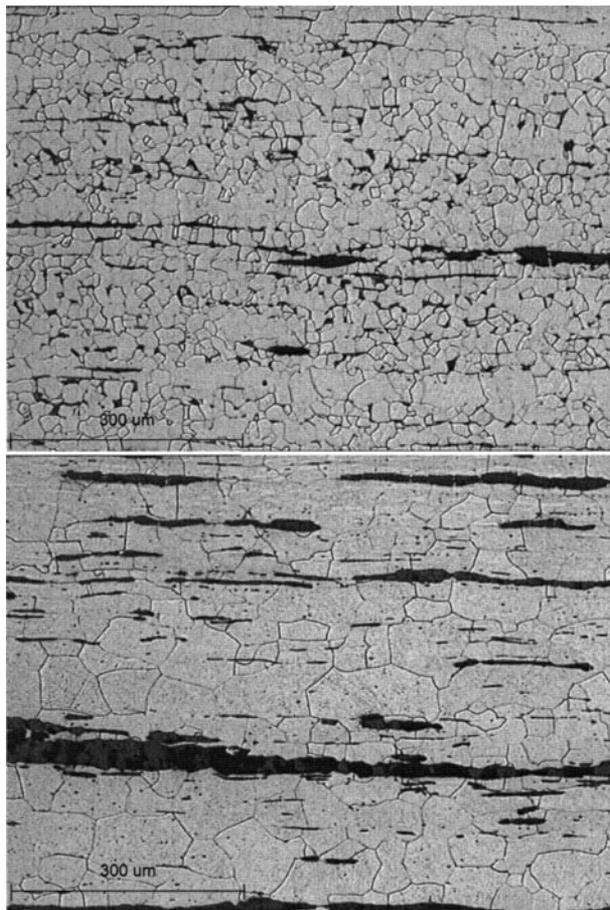
1 Typical longitudinal microstructures of W11 and W12 etched in 2% nital, showing equiaxed ferrite grain structures and elongated slag inclusions

The microstructures of the wrought iron samples were inhomogeneous and consisted of equiaxed ferrite grains with variable quantities of elongated slag inclusions, as shown in Fig. 1. In general, W12 had larger ferrite grains and more extensive slag inclusions than W11. The ferrite grains consisted of iron alone, with carbon and other elements being undetected; the slag inclusions were essentially iron oxide, with additional elements present in the case of W11. The chemical compositions of the slag inclusions are shown in Table 1 and the analysis of the ASTM A106 steel is given in Table 2.

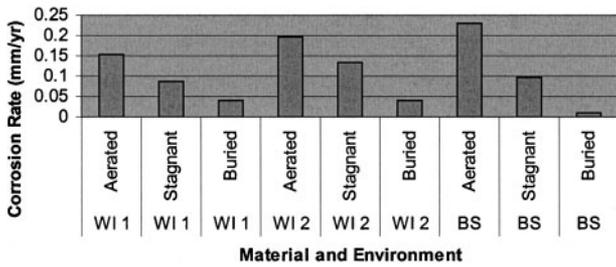
2 Mean corrosion rates of wrought iron (WI1 and WI2) and steel (BS) samples exposed to aerated and stagnant Cranfield tap water and buried in fine silica sand for 3 months

The results of the weight loss measurements are shown in Fig. 2. It is clear that the oxygen content of the water had a large effect on the corrosion of all three materials, the rate in aerated water being approximately twice that in stagnant conditions. The values ranged between 0.1 and 0.2 mm year⁻¹ for specimens in quiescent and aerated conditions, and these correspond well with corrosion rates usually reported for steels in water.⁹ The corrosion rates of specimens buried in sand were substantially lower than those in the aerated or stagnant water.

The corrosion rates of the two wrought iron samples were similar and they did not differ substantially from those of the steel. While the corrosion rate of the steel in aerated water was higher than that of the two wrought iron samples, the rate for the buried steel was lower than those of the other two. From these results, it appears that the low corrosion rate of Dolly's boiler cannot be explained by wrought iron having an inherently lower

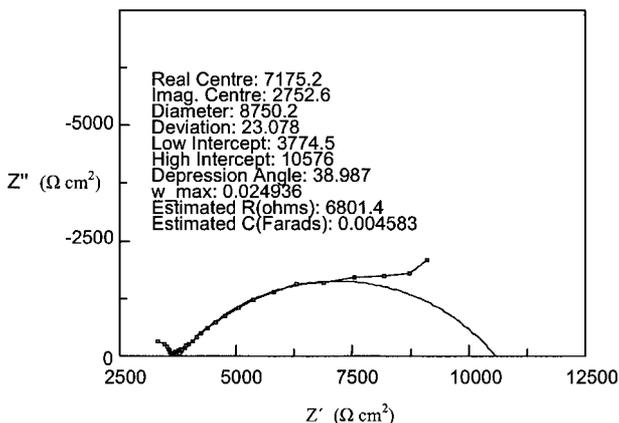
3 Impedance plot for WI1 in stagnant Cranfield tap water

The Nyquist plot¹⁰ for WI1 displaying the in-phase Z' and out of phase Z'' components of impedance in stagnant Cranfield tap water is shown in Fig. 3. A semicircular curve was fitted to the data and its diameter was used to establish the charge transfer resistance R_t , from which the corrosion rate was calculated using a corresponding relationship to that for the LPR method, given in equation (2). At the lowest measurement frequencies (approaching 1 mHz), the plot deviated from the semicircular form due to the controlling influence of oxygen transport to the metal surface. At the highest frequencies (20 kHz and below), there was some evidence of a surface film (small semicircle) and the intercept on the x -axis represents the resistance of the water between the two electrodes (solution resistance). In the case of the stagnant tap water, this resistance was in the order of 3800 Ω .

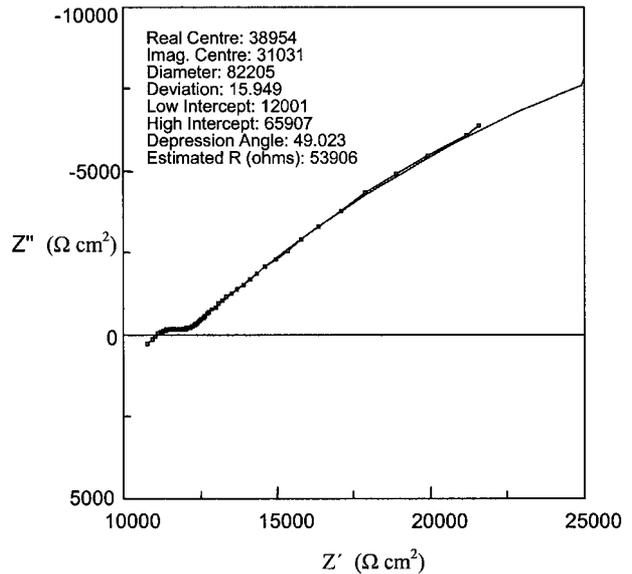
4 Impedance plot for WI1 exposed to Cranfield tap water and fine silica sand

Figure 4 shows the corresponding impedance plot in tap water when the WI1 sample was buried in silica sand. The form of the plot was essentially the same as that in tap water alone but the solution resistance increased to 12 000 Ω . This was caused by the sand acting as an incomplete non-conducting barrier such that the ionic path was limited to the water occupying the spaces between individual sand particles. Similarly, the charge transfer resistance increased from 6800 Ω to 54 000 Ω , indicating that there was a reduction in the corrosion rate of the wrought iron, approaching an order of magnitude. Again, this was the result of the sand acting as a partial barrier, restricting electrolyte access to the metal surface, together with the effects of dissolved oxygen depletion in the water.

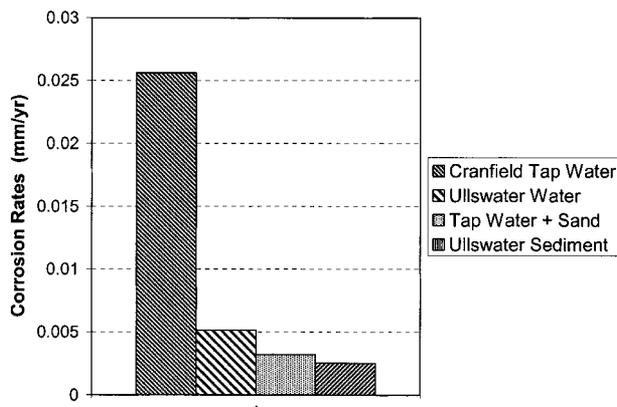
5 Comparison of corrosion rates of WI1 in tap water and Ullswater samples measured by EIS

The values of solution resistance, charge transfer resistance and corrosion rate for WI1 in tap water and water samples taken from Ullswater are summarised in Table 3 and Fig. 5. Important features of these results are the much higher values of solution resistance and charge transfer resistance measured in the water sample from Ullswater, the latter corresponding to a substantially lower corrosion rate than that in tap water. The high solution resistance was the consequence of the lower concentration of dissolved solids in the Ullswater sample, as shown in Table 4. Indeed, the conductivities of the tap water and Ullswater samples were 281 and 57 $\mu\text{S cm}^{-1}$, respectively, giving a ratio of 4.9:1. (The equivalent solution resistances of 3770 and 25 100 $\Omega \text{ cm}^2$ from EIS were in the ratio 1:6.6, indicating quite good agreement between the two measurement methods.) It is interesting to compare the conductivity of the Ullswater sample with that measured for deionised water (3 $\mu\text{S cm}^{-1}$). It is thought that the very low levels of dissolved solids in Ullswater made an important contribution to the low corrosion rate.¹¹

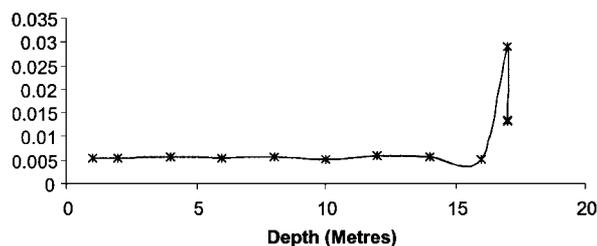
6 Effect of depth on corrosion rate of WI1 in Ullswater measured by the LPR technique

The corrosion rates of WI1 measured at different depths in Ullswater are shown in Fig. 6. The LPR readings indicate that the rate was fairly constant until the corrosion probe reached the lake bed at a depth of 17 m. The corrosion rate appeared to be higher in the sediment but this result needs further explanation, as it was influenced by the higher conductivity of the sediment, as discussed below.

A disadvantage of the LPR method is that the measured resistance includes the solution resistance of the electrolyte, which in the case of the lake water was very large. When the probe entered the sediment, the solution resistance fell, and this was interpreted as an increase in corrosion rate. A second disadvantage of the method is that the full charge transfer resistance is rarely measured, and for this reason the corrosion rate can be overestimated. In this work, the LPR measurements consisted of applying and then reversing a small dc signal to the electrodes over a total time of 4 min. Therefore, the LPR measurement was essentially equivalent to performing an EIS experiment at a single frequency of approximately 4 mHz. This is confirmed by the close agreement between the LPR results and the impedance values at 4 mHz, as shown in Table 6. It can also be seen that the LPR and EIS results were very similar in the two water samples but that in the sand and sediment tests the LPR method overestimated the corrosion rates.
