NASA/TM-2017-219497

Mission Success of U.S. Launch Vehicle Flights from a Propulsion Stage-based Perspective: 1980-2015

April 2017

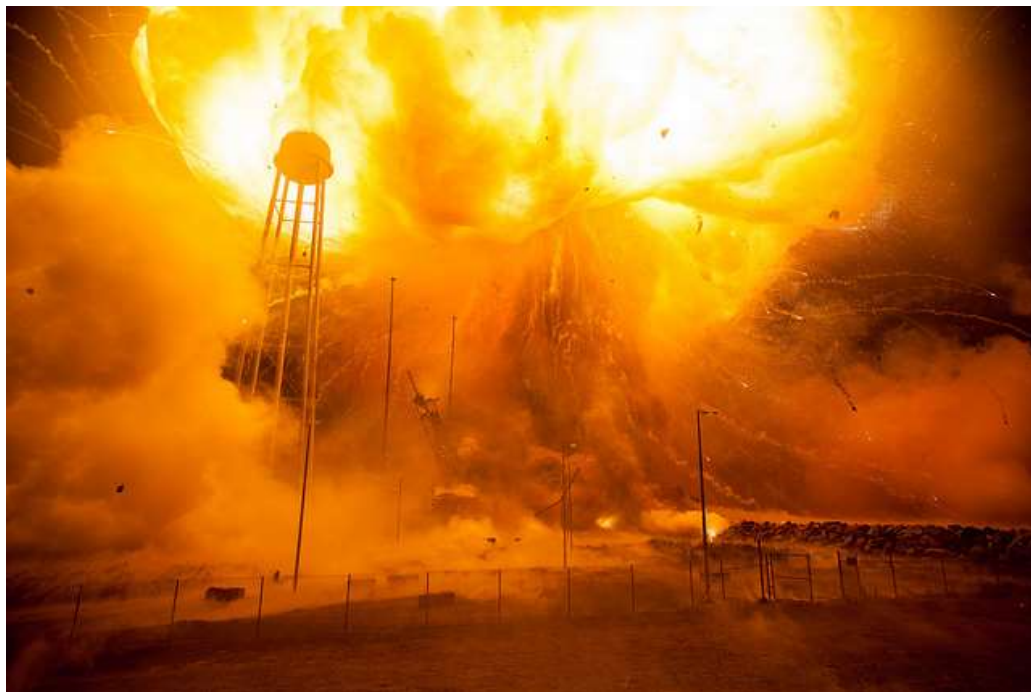
Figure C-2. Antares explodes just before hitting the launch pad. Credit: NASA
