Experimental behaviour of a steel structure under natural fire

This paper reports on the results of a collaborative research project (Tensile membrane action and robustness of structural steel joints under natural fire, European Community FP5 project HPRI—CV 5535) involving the following institutions: Czech Technical University (Czech Republic), University of Coimbra (Portugal), Slovak Technical University (Slovak Republic) and Building Research Establishment (United Kingdom). It consists of an experimental programme to investigate the global structural behaviour of a compartment on the 8-storey steel–concrete composite frame building at the Cardington laboratory during a BRE large-scale fire test, aimed at the examination of the temperature development within the various structural elements, the corresponding (dynamic) distribution of internal forces and the behaviour of the composite slab, beams, columns and connections.

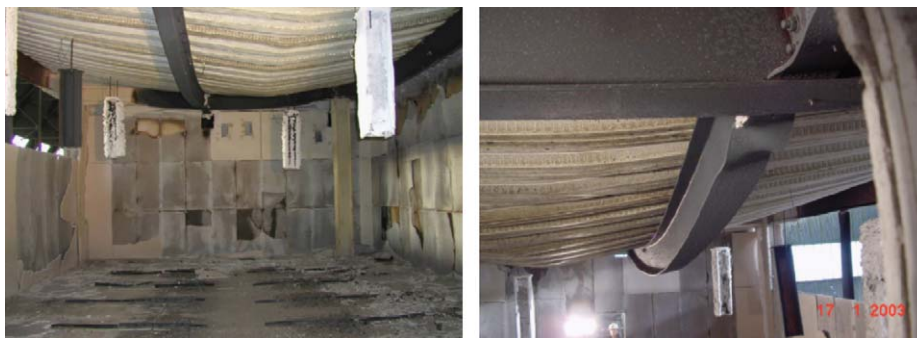
Fig. 9. Compartment after fire, residual deformation 925 mm, no local collapse of structure.

During the test the predicted local collapse of the structure was not reached, see Fig. 9. Fig. 10 compares

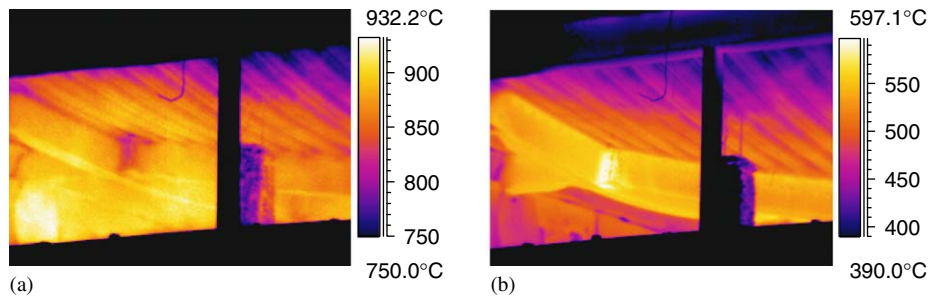
Fig. 15. Fin plate connection D1–2 recorded by thermo imaging camera (a) during heating after 58 min of fire; (b) during cooling after 92 min.

in the joints was slower. Using the thermal cameras it was possible to observe this effect, see Fig. 15.

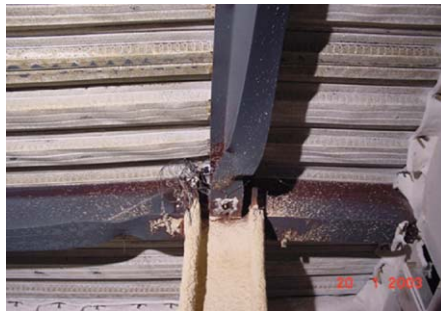
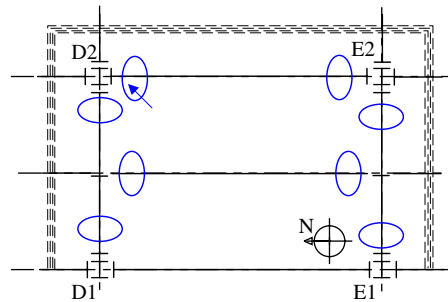
Local buckling of the beam lower flange was one of the main failure mechanisms. It is observed in the lower beam

flange and web adjacent to the joints, see Fig. 18, the concrete slab having restrained the upper flange. This local buckling occurs during the heating phase after about 23 min of fire (observed by thermo imaging camera), due to the restraint to thermal elongation provided by the adjacent cooler structure and the structural continuity of the test frame. The heated lower flange of the beam is unable to transmit the high normal forces generated in the lower flange of the beam to the adjacent beams/columns after closure of the gap in the lower part of the connections. The beam could be assumed to behave as ‘simply supported’, allowing larger mid-span deflections to develop. This phenomenon was numerically predicted by Lamont and Usmani [21].

Fig. 18. Local buckling of beam lower flange.

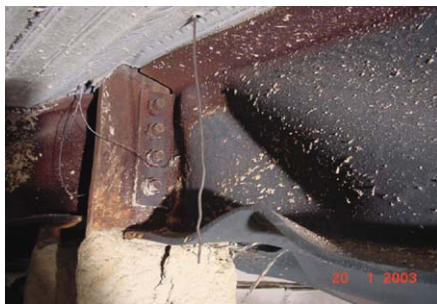
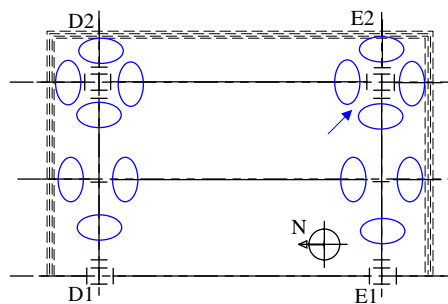
As temperature and the associated deformations increase, shear buckling of the beam web was observed, see Fig. 19.

Fig. 19. Beam web in shear.

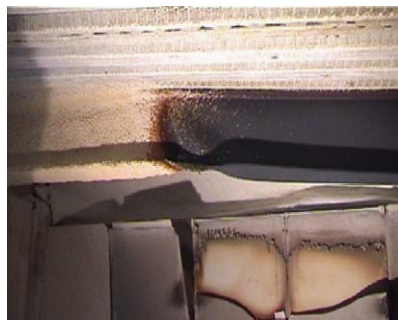
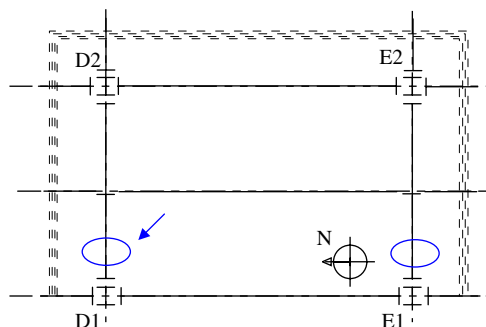
Fig. 20. Plastic hinge in the unprotected beam cross-section close to the end of the fire protection.

The formation of a plastic hinge in the beam cross-section next to the protected zone was one of the main observed mechanisms in the main beam D1/2, see Fig. 20. This hinge is induced by distortional buckling during the first stage of the heating phase, due to the restraint to

thermal elongation provided by the adjacent protected section. This behaviour is associated with the local loss of stability in the bottom flange. Subsequently, during the second stage of the heating phase, the beam rotates around this point due to the large mid-span deflection.

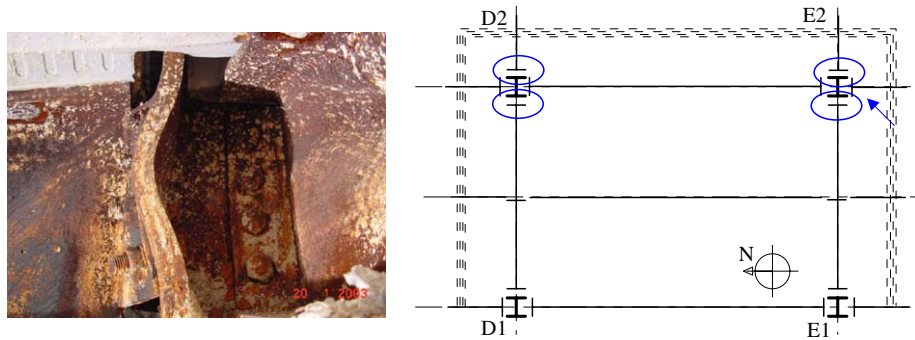
Fig. 21. Buckling of column flange in compression, column E2.

Due to the end-plate loading, bending in the column flange was observed in one of the major axis beam-to-column joints, see Fig. 21. This behaviour results from the small column flange thickness ($t = 21.4$ mm) and the small distance between the bolts, the bolted end-plate behaving as a welded joint. This behaviour was observed in both columns flanges of the two beam-to-column joints (D2; E2).

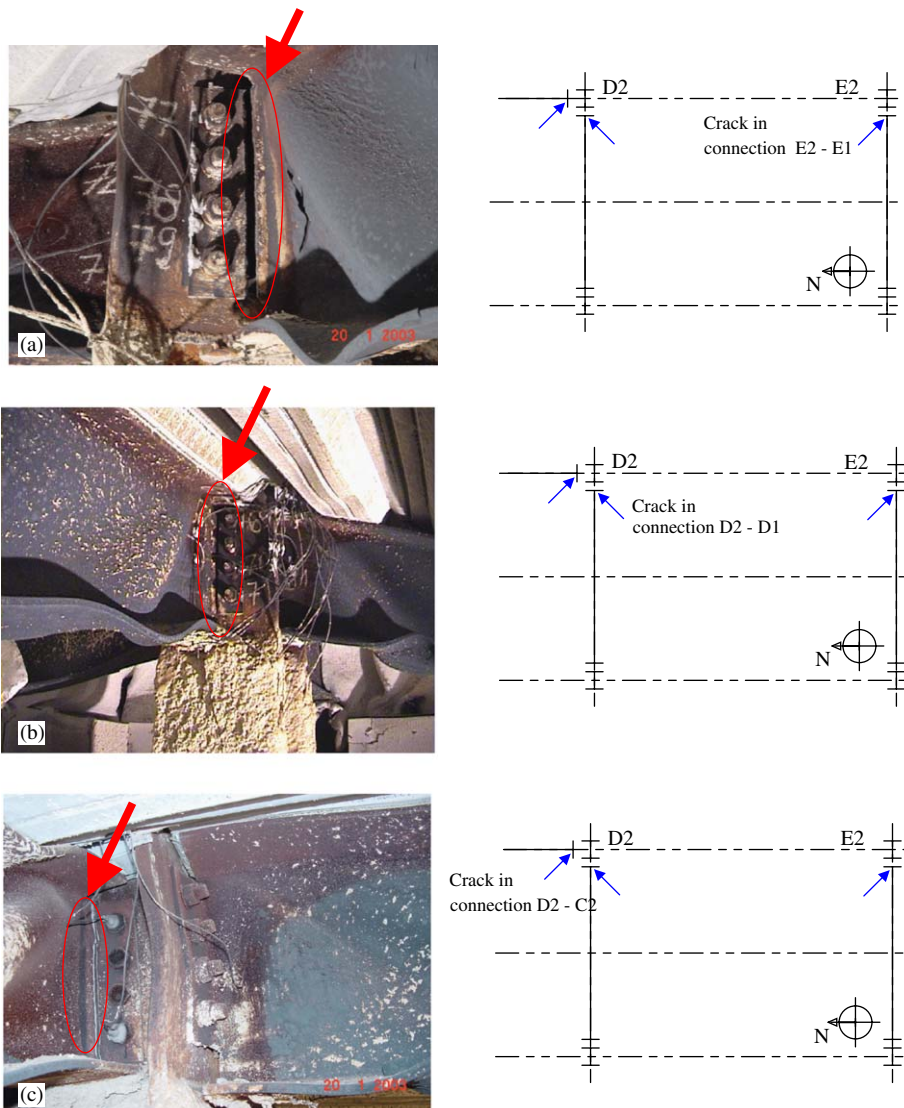
Fig. 22. Fracture of the end-plate along the welds, connections D2–D1; E2–E1, D2–C2.

Fracture of the end-plate along the welds was observed, caused by the horizontal tensile forces during cooling of the connected beam under large rotations associated with flexible end-plate joints, see Fig. 22. The fracture occurred along one side of the connection only, while the other side remained intact. After one side has fractured, the increased flexibility allowed larger deformations without further fracture. This behaviour was observed in both the major axis beam-to-column joints (D2–D1; E2–E1) and the minor axis beam-to-column joints (D2–C2).

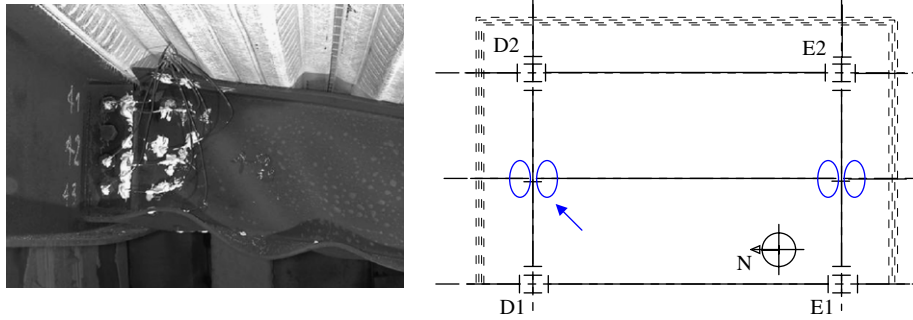
Fig. 23. Elongation of holes in the beam web in fin plate connection.

The elongation of the holes in the beam web in the tension/compression part of the fin plate connection is due to the associated large rotations, see Fig. 23. The elongation of the holes occurred on the web of connected beam, while the fin-plate remained intact: the beam web thickness (6 mm) is smaller than the fin-plate (10 mm); again, the elongation of the holes of the beam web leads to increased joint flexibility, allowing larger deformations without further fracture.

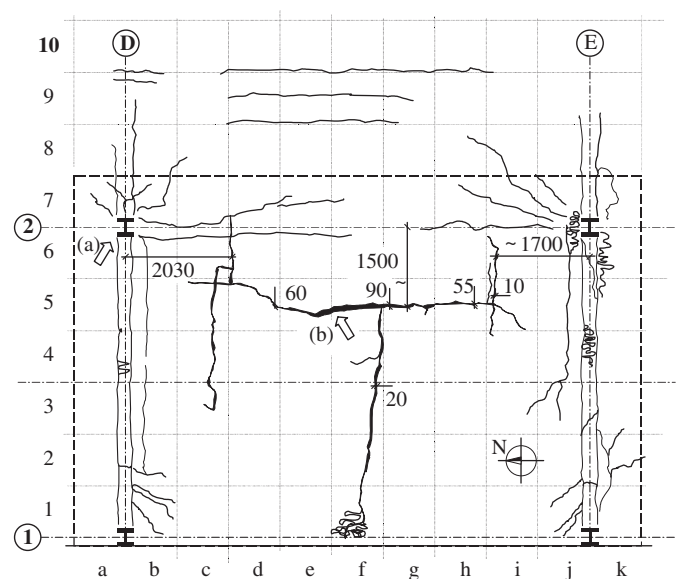
Fracture in the concrete slab was observed, a large crack propagating from the face of the column flange parallel to the beam (D2–E2), see Fig. 24. This crack developed due to the tension in the concrete slab, along the weak zone in the composite beam–flange extremity. After the concrete cracked, the joint stiffness gradually decreased. Secondary cracks occurred perpendicular to, and continuous across, the connections on both sides of the slab, see Fig. 25. The maximum vertical displacement occurred along a line of mesh reinforcement overlap (without adequate attachment). This led to slippage of the mesh and the

Fig. 24. Mesh of cracks in concrete slab.

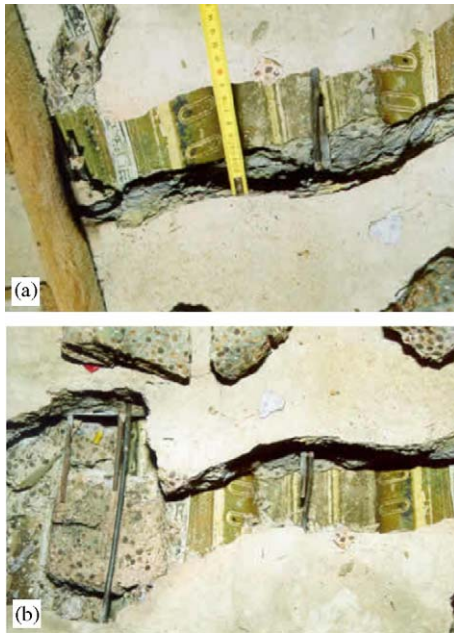
corresponding behaviour of the slab was “de facto” without reinforcement.

The cameras above the fire compartment recorded loss of the integrity limit state of the concrete slab after 54 min. The opening of the composite slab took place around column E2 by a punching mechanism due to the tension in the concrete slab in the edge compartment. Furthermore, many tiny cracks were observed in different areas of the concrete slab.

Fig. 25. Reinforcement mesh (a) slippage and cracking near to the column D2, (b) largest crack/opening in the mid-span.
