## ASSESSMENT OF DEBRIS FLOW DISASTER IN A RESERVE FOREST AREA, KERALA

A. K. Manoj\* & S. Sreekumar\*\*

**Cite This Article:** A. K. Manoj & S. Sreekumar, "Assessment of Debris Flow Disaster in a Reserve Forest Area, Kerala", *International Journal of Applied and Advanced Scientific Research*, Volume 2, Issue 2, Page Number 315-322, 2017.

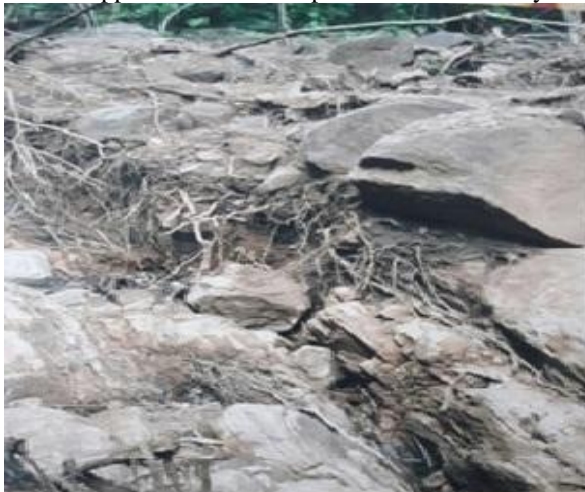
The landslide in the reserve forest area which occurred on 5<sup>th</sup> June 2004 (Fig 3a and 3b) belongs to debris flow category. The debris flowed very close to the settlement without devastating the houses. There were no casualties. The debris flow had its origin in a degraded forest patch. A streamlet was resulted when the failure happened and in later period it is marked by a small spring which appears only at the onset of monsoon.

Fig 3a: The initiation of debris flow by the wedge failure at the crown of the scar

The stereo plot of 5 major joints, hill slope and angle of internal friction of the weathered rock are presented in Fig.6. In this profile wedge failure occurred along the intersection of joints J3 and J4 within the crescent shaded area. The debris flow initiated with the wedge failure at the top. Consequent to the impact of slided rock and high water pressure activated planar failure down slope. J4 acted as the potential slide surface.

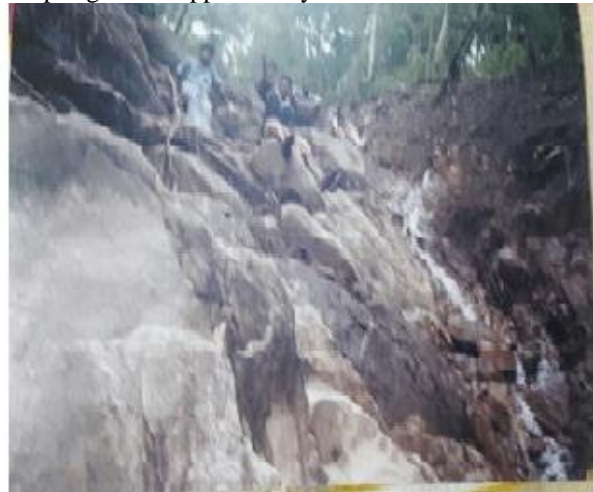
Fig 3b: joints dipping towards the hill slope favouring plane failure (middle portion)

The field study indicates that chances of plane failure along joint J4 still exist in the location. During monsoon period the factor safety of the slope get reduced as the angle of internal friction decreases.

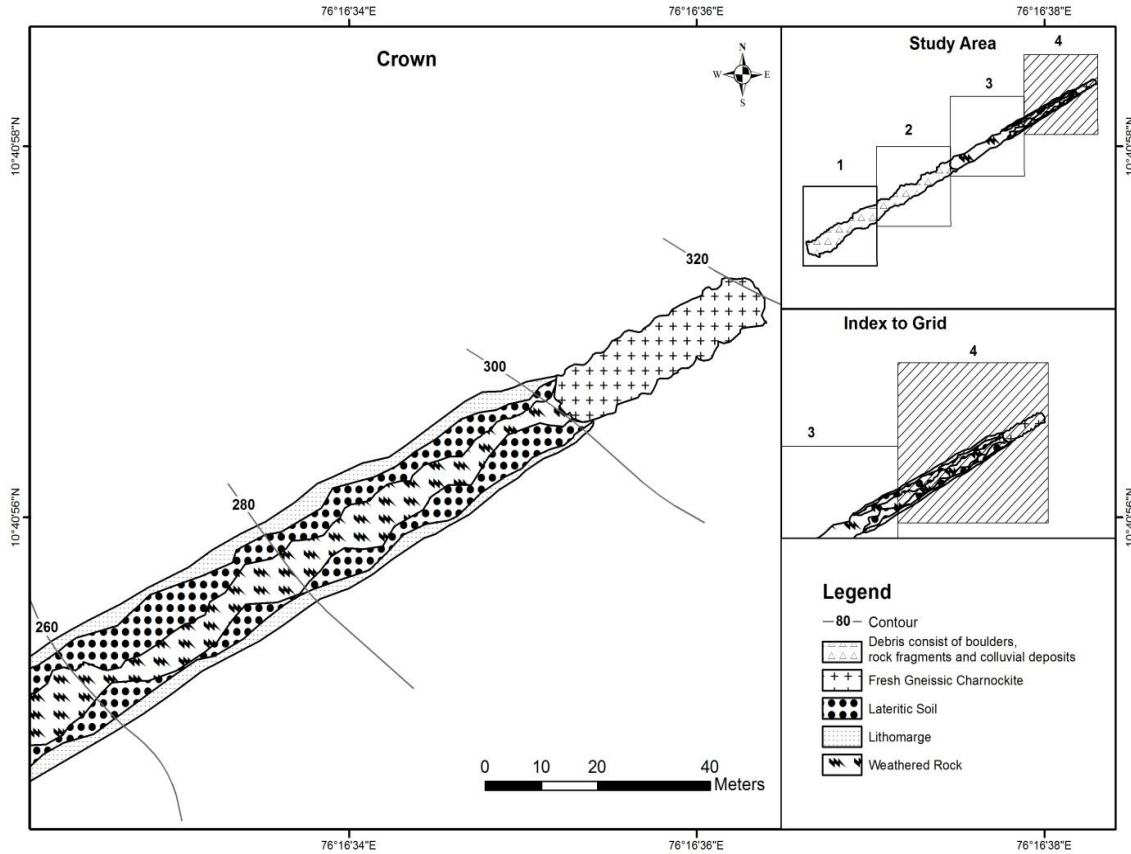
Figure 4a-d: Detailed geologic map of paleoscar

The detailed geological map of the failed slope from crown to the toe of paleoscar is presented in Fig 4a-d. The debris consisting of boulders of weathered rock, lithomarge, sand - clay mixture spread out to a wider area at the toe, where families live. As a consequence of this debris flow a deep crack has been developed in the upper and adjacent part of the slide scar, and making the slope vulnerable to further slope failures. The debris flow is left behind by numerous precariously perched boulders too.

The top part of the crown (Fig 4a) is composed of fresh charnockites which are traversed by joints. The scar is bordered by lithomarge clay and laterite soil and its central part is occupied by weathered rock and angular boulders. In the middle part (Fig 4b and Fig 4c) the width of the scar increases but that of weathered rock narrows down. The flank consists of angular boulders laterite soil and lithomarge. Further down only weathered rock is exposed. In the toe part of the scar (Fig 4d) a heap of very coarse angular debris are observed.

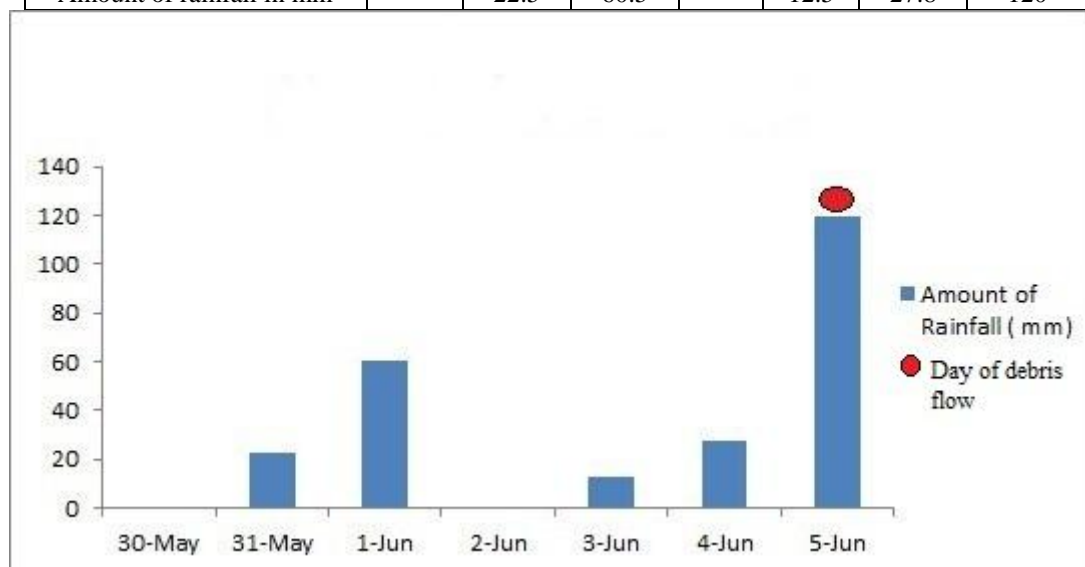
Figure 5: Rainfall (mm) received in the station prior to the debris flow

Successful relationship between rainfall and landslides in Western Ghats has been brought out by several researchers (Sekhar et al 2008, Thampi 1998, Sankar 1991, Sreekumar 1998, Sajinkumar et al 2011). One hundred and eighty millimetre rainfall for couple of days can be considered as a threshold value to alert the civic administration to get set for disaster management measures in (Sreekumar 1998). Thampi et al. (1998) suggested a minimum rainfall of 300 mm in 2 days as needed to initiate landslides in Western Ghats regions. Sekhar et al (2008) found that on day of mass wasting events in Aruvikkal catchment area, the region received about 200 mm rainfall and the 2-day cumulative rainfall was 278.4 mm. The 2-day cumulative rainfall coinciding with landslides was 315 mm. Monsoon was very active during the period of slope failure in the study area. The rain fall received for a period of seven days including the day of occurrence prior to the incidence of slide is presented in table 2 and Fig 5. Analysis of rainfall data for seven days including the day of incidence indicate that Akamala region received 243.4 mm rain prior to the slide.

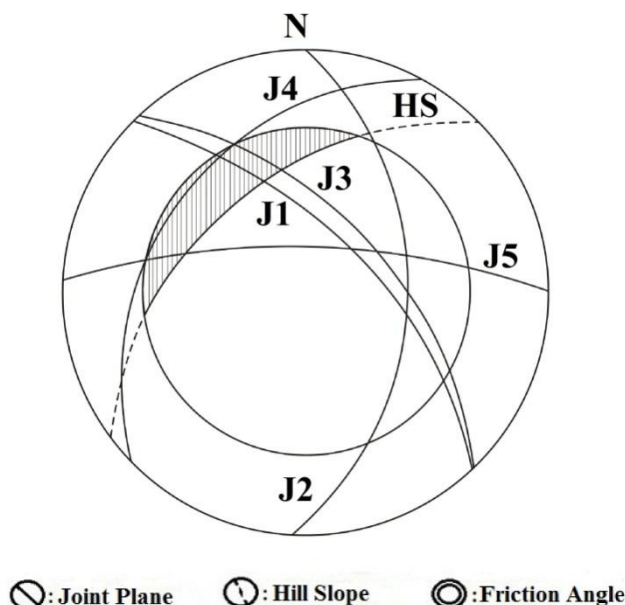
Figure 6: Stereographic Projection of Joints and their relationship with the material properties and hill slope. HS – Hill Slope, J1, J2, J3, J4 and J5 are the joints

From the results it is obvious that the debris flow was resulted due to combined effect of the presence of potential joint planes and water ingress that reduces the normal stress to a level that accelerate failure. The vulnerability of slope failures would have been scaled down, if healthy wild trees were there. It is found that this debris flow occurred in a degraded reserve forest area.
