RECENT CASE HISTORIES WITH COUPLING ENCLOSURES

Michael M. Calistrat

THE DESIGN OF A LEAK-PROOF ENCLOSURE

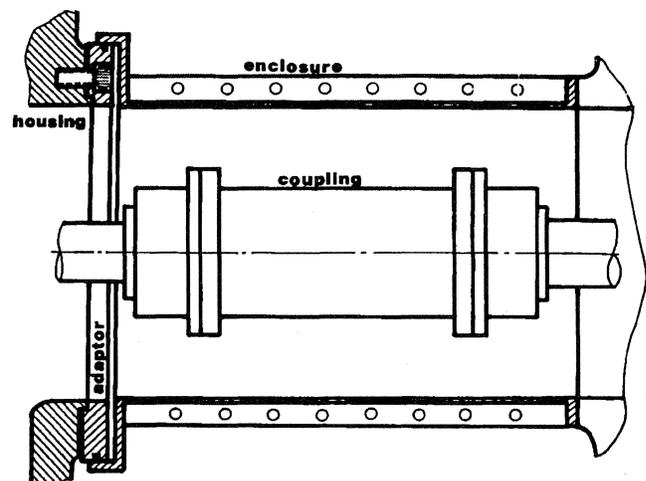
Figure 1. Rigid Enclosure, OEM Design.

ures resist offset movement between the two machines. Evidently, the enclosure is too weak to prevent the machine movements, and the end result is the distortion of the enclosure, and inevitable oil leaks.

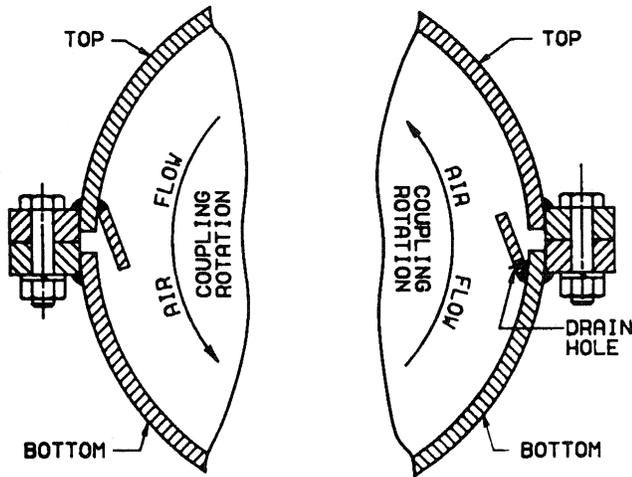
Figure 2. Dynamic Sealing for Flange Joints.

- The split lines incorporate dynamic seals, based on the design proposed in the first paper, and reproduced now in Figure 2.
- The enclosure was made to "float" at both ends, rather than being rigidly attached to the turbine. *Rigidly attached enclou-*

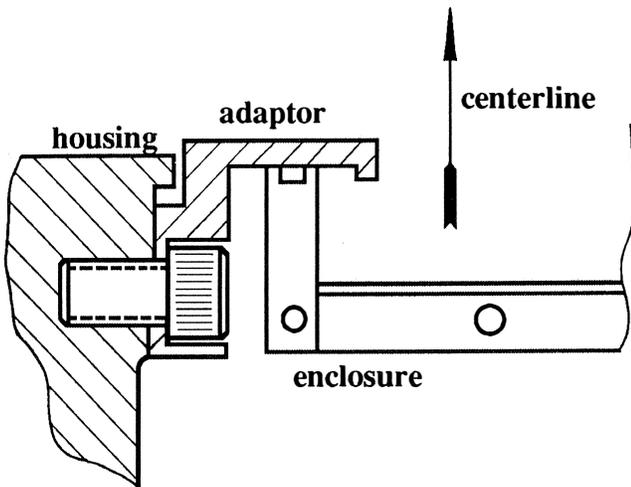
Figure 3. Redesigned Enclosure-to-Compressor Seal.

- The side seal was moved to a radius that is smaller than the enclosure drain point, as shown in Figure 3. The enclosure-to-compressor connections of the original design generated pools of oil that could not be drained, and which contributed to the continuous leaks.

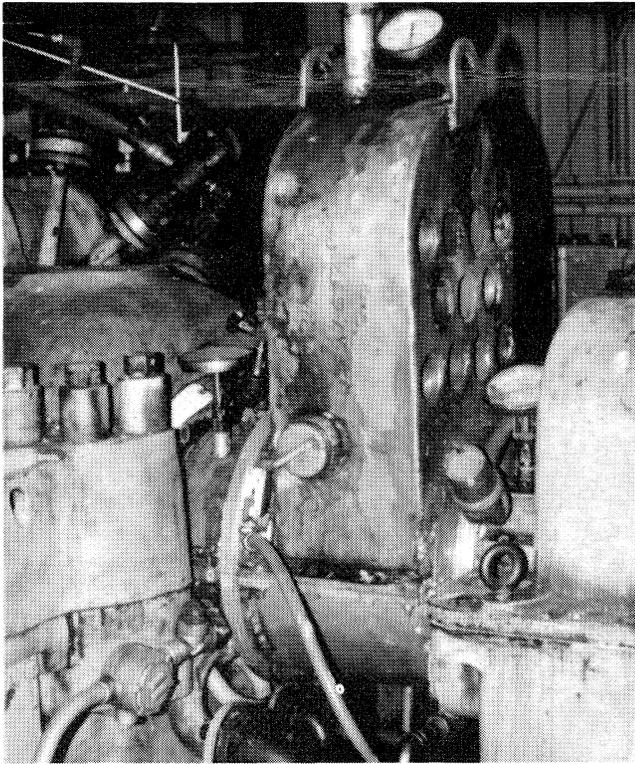
In an attempt to reduce this high temperature, which could have caused the deterioration of the oil leaking from the compressor seals into the enclosure (at the rate of 150 gal/day!), a new enclosure was fabricated. The idea behind the new design was to significantly increase the enclosure's surface area in order to improve the heat radiation. The new enclosure design is shown in Figure 4. In hindsight, it is easy to see that the odd-looking birdhouse design could not have worked. The boiler type tubes intended to increase the heat transfer were at the same time impeding the smooth air flow inside the enclosure, aggravating the turbulence. The end result was a slight drop in enclosure temperature, which still ranged between 250 and 300°F. The oil that continued to leak from the machines was exiting the enclosure at the same temperatures, and was not allowed to go back to the reservoir because of possible degradation.

Figure 4. Increased Surface Area Enclosure Design.

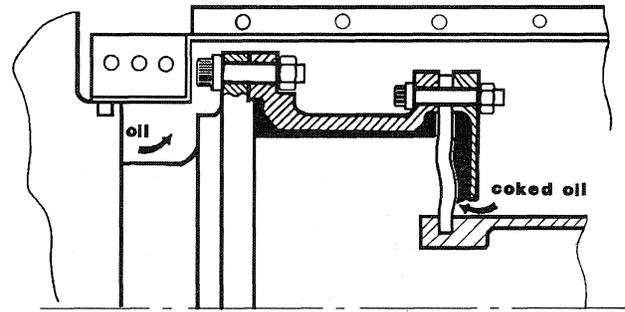
- The enclosure side wall was very close to the coupling bolts. This configuration made the coupling operate as a blower, causing a large negative pressure at the steam turbine oil seal. Oil flowed into the enclosure from that bearing.

Figure 5. Fabricated Enclosure and Locked Coupling.

- The drain line was fabricated from a 3/4 in electrical conduit, in the belief that a *dry* coupling enclosure would operate *dry*. In addition, the drain line was perpendicular to the enclosure wall, and no baffle was added.

- No breather was provided. The enclosure was intentionally made air tight as, at the time of the retrofit, a vacuum (5.0 in of water) pump was installed at the oil tank, in order to improve the flow of the oil returning from the bearings.

The condition of the coupling immediately before the failure is sketched in Figure 5. The dark area represents coked oil. The density of this substance was amazingly high. The author had to use a screwdriver and a hammer to break it into pieces (Figure 7). This high density was caused by the large centrifugal acceleration (4,500 g) in the coupling, which tightly packed every particle of coked oil as it entered the coupling. Eventually, the space between the first diaphragm and the guard disk was completely filled with rock-solid coke.

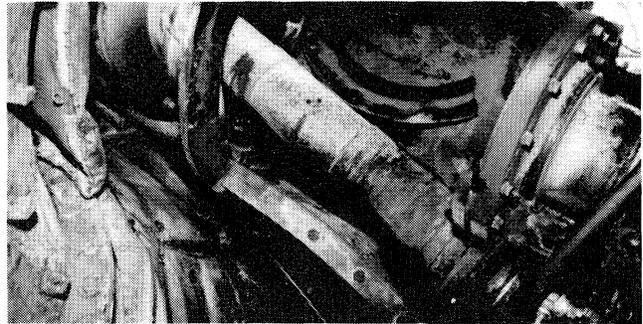
This is a very difficult application for any dry coupling, which connects the discharge ends of both turbines. In addition to the operation at high temperatures, the coupling has to accommodate a significant axial shaft movement. Because the OEM was late in delivering a new enclosure, the maintenance department fabricated a new one *onsite*. A partial sketch of the fabricated enclosure is shown in Figure 5. It incorporated a few significant mistakes, which eventually caused the diaphragms at the steam turbine end to rupture, the failed coupling to rip the enclosure, and the steam turbine shaft to bend. The appearance of the coupling after failure is shown in Figure 6.

Figure 6. Equipment Failure Caused by an Improperly Designed Enclosure.

The temperature of the enclosure must have been *very high*. After the accident, coked oil was found inside the enclosure, as well as inside *and outside* the coupling. Lubrication experts estimated the coupling temperature at about 700°F! It is amazing that the coupling continued to operate for three years. Eventually, it failed during a cold December.

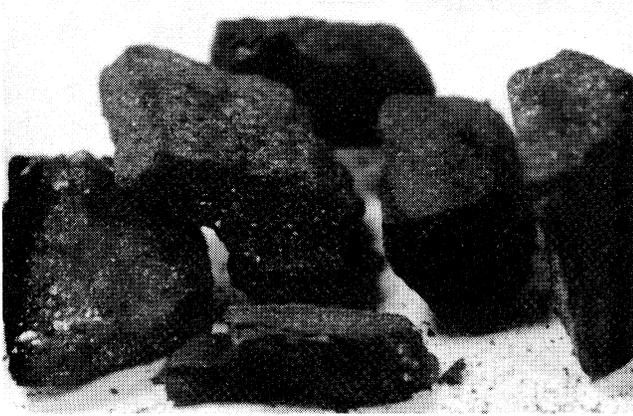
Figure 7. Coked Oil that Blocked Coupling Movements.

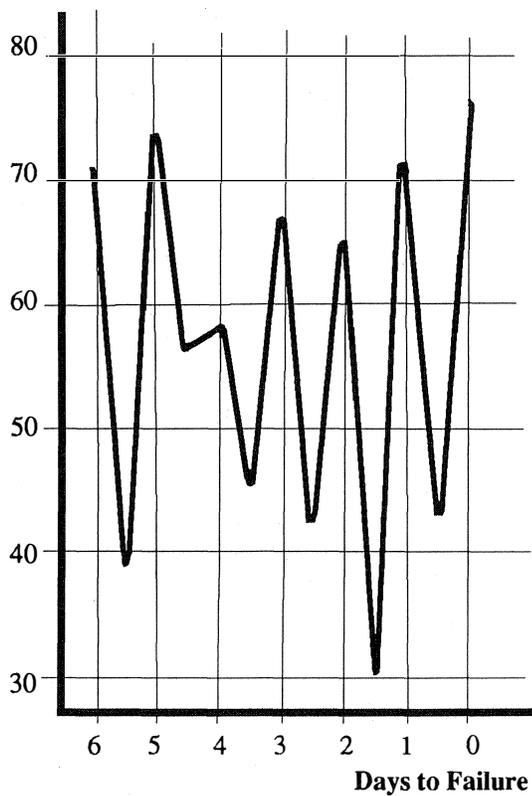
The failure was triggered by large axial shaft movements, which demanded from the coupling a flexibility it no longer had. The axial movements were caused by freak winter conditions in South Texas. The temperature variations during the six days before the failure is shown in Figure 8. Adding to the 45° temperature variations in the air, the machines and the skid were also heated by the sun during the day. The resulting thermal movements caused the breaking of one diaphragm after another.

Figure 8. Ambient Temperature Variations before the Failure.

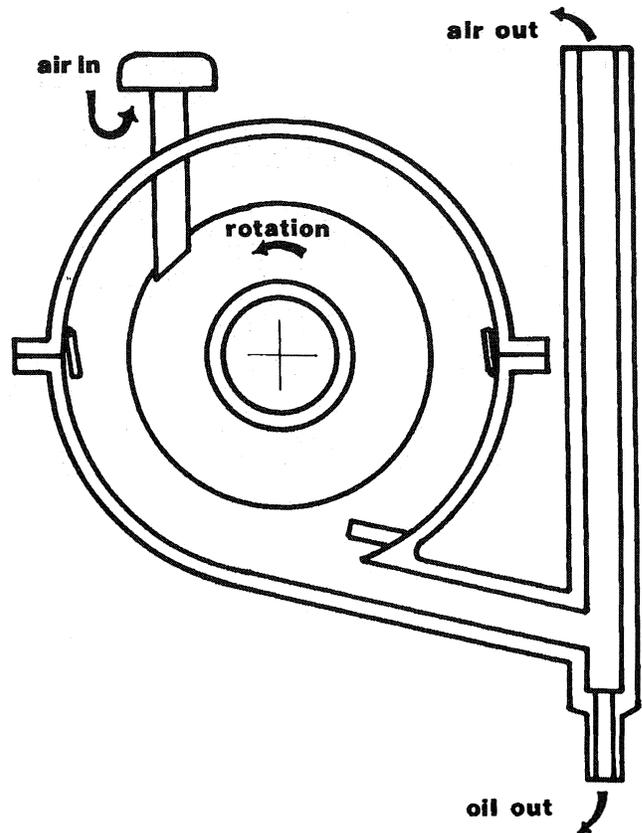
Figure 9. Enclosure with Air Cooling.

- Two drains and two breathers were incorporated. The drains were provided with air escape piping (Figure 9), and provisions were made to increase the air flow, if necessary, by connecting the breathers to the plant air supply.

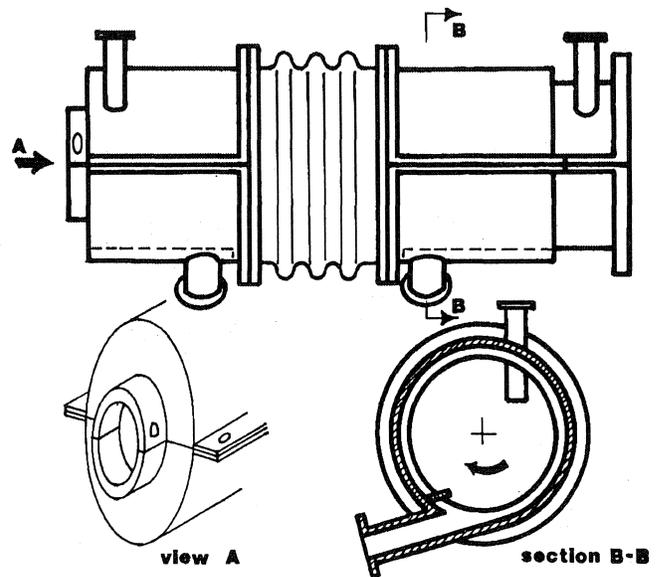
Figure 10. Redesigned Enclosure.

- The side walls were moved as far as possible from the coupling bolts.

A drawing of the new enclosure is shown in Figure 10, and a piping diagram is shown in Figure 11. With all these improvements, the enclosure still operated hot because of heat radiated toward it. An air blower was added to move the hot air that surrounds the enclosure, which has now operated satisfactorily for close to two years.

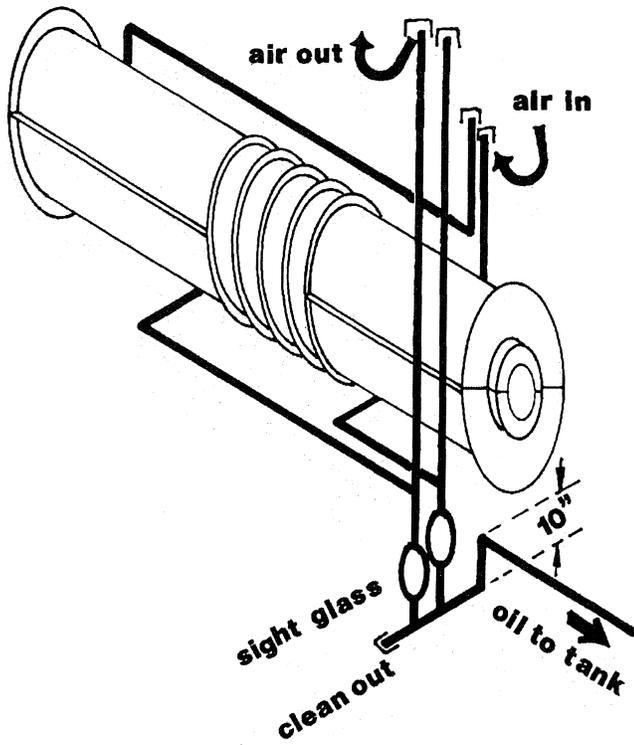
Figure 11. New Enclosure Piping Diagram.

- A 10 in trap was built in the drain line, ensuring the oil return *without* breaking the vacuum in the oil reservoir.

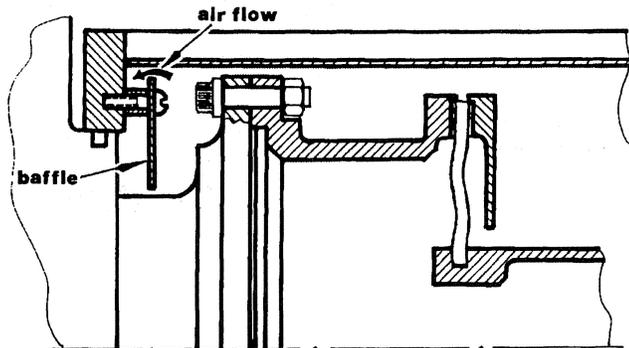
Figure 12. Vacuum-Breaking Baffle.

• The method recommended in Figure 7 of the 1985 paper for the reduction of oil being sucked out of the machine seals proved ineffective at high speeds or when couplings with abrupt diametral changes are used. A more effective method to break the vacuum present in the vicinity of the bearing seals is shown in Figure 12. The baffle must have a small clearance at the shaft, and about one inch clearance at the enclosure.

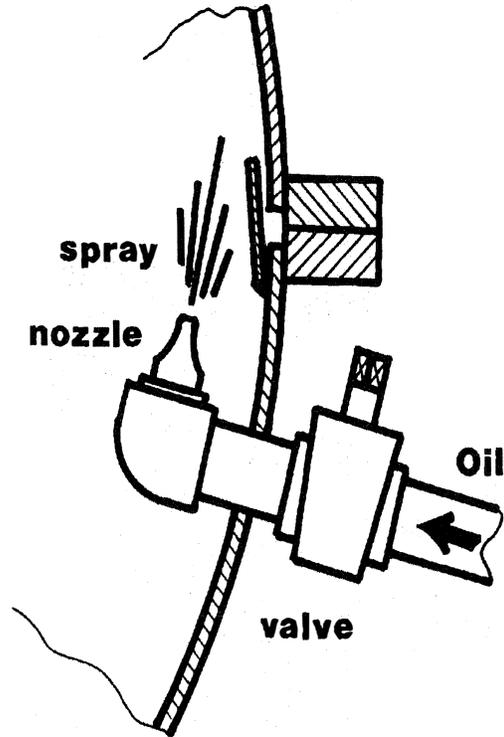
Figure 13. Enclosure Cooling with Oil Spray.

closure, and only in the direction of the coupling's rotation. Rather than performing oil flow calculations, the author recommends the installation of an oil valve in the circuit, as shown in Figure 13, and the adjustment of the flow until an acceptable temperature is achieved. Two nozzles must be used, at the ends of the enclosure, with one drain at the center.
