Fractography of clinically fractured, implant-supported dental computer-aided design and computer-aided manufacturing crowns

Lohbauer, Ulrich; Belli, Renan; Cune, Marco; Schepke, Ulf

Published in:
SAGE open medical case reports

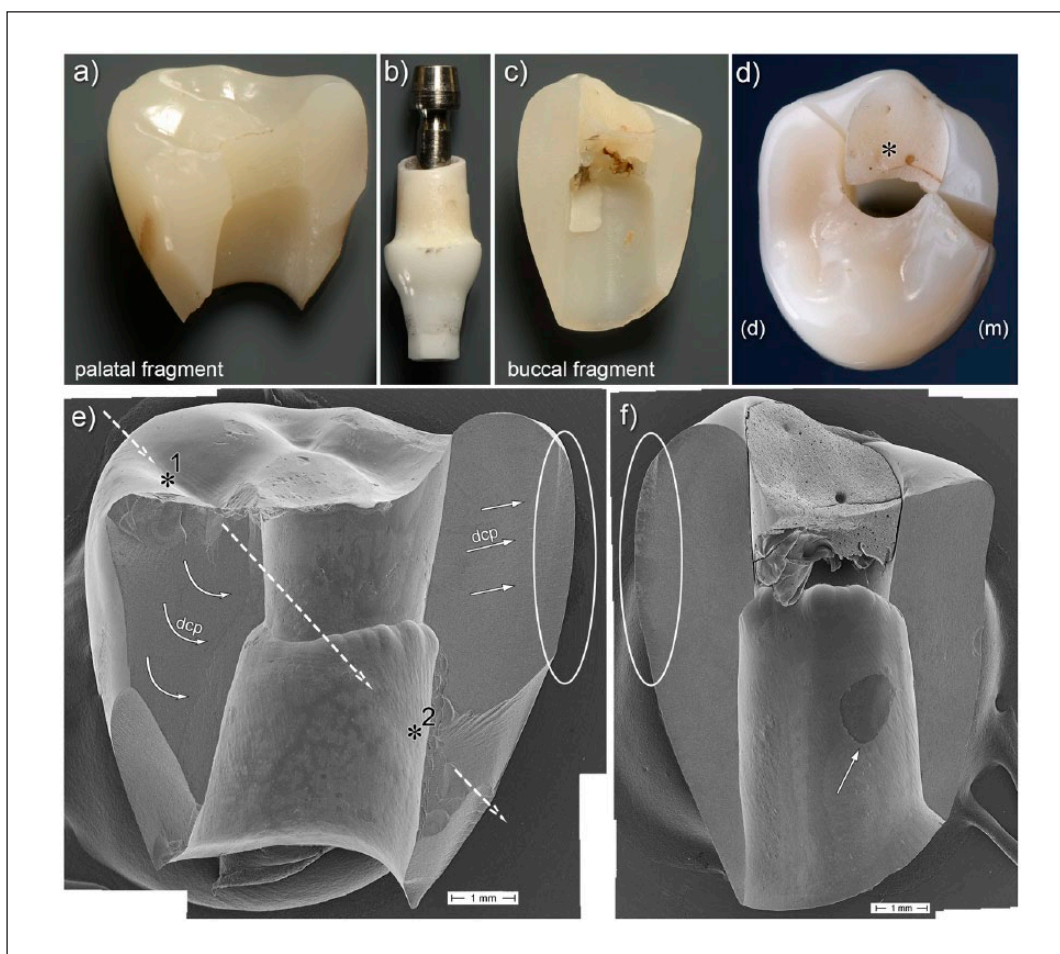
Figure 1. (a–d) Photographs of the crown and the abutment of case 1. The crown fractured mesio (m)- distally (d) in two fragments, while some minor fragments on the mesial side went missing, most likely during intraoral fracture. (b) Luting remnants can be found on the implant abutment surface. (d) The screw hole clinically filled with glass ionomer cement (*). (e and f) Higher resolution SEM images (mapped from individual SEM images) from the fracture surfaces of the fragments shown in (a) and (c). Both fragments exhibit the corresponding compression curl (circle), indicating the termination of the fracture event. (e) The palatal fragment shows clear fracture patterns on the cusp of the mesial proximal ridge (*1) and on the intaglio side of the disto-buccal margin (*2). The buccal fragment shows only minor luting remnants on the intaglio side (arrow). Most of the yellowish luting remnants are found on the zirconia abutment (b), indicating the crown–adhesive interface as the weakest link. In consequence, it seems very likely that the crown fracture was preceded by a debonding event, most likely leading to wedging of the crown and subsequent inclined shear loading in the direction assigned in (e) (dotted arrows). The fracture origin on the distal intaglio surface (*2) is thus termed a secondary event leading to abfraction of the missing marginal fragment. (e) The general direction of crack propagation (dcp) is indicated with arrows. The fracture started on the mesial side and ended on the disto-buccal side.

This crown was retrieved from tooth #14 of a 60-year-old male patient and fractured after 2 months in situ without any complications or reported malfunction. The fractographic examination is presented in Figures 1 and 2.

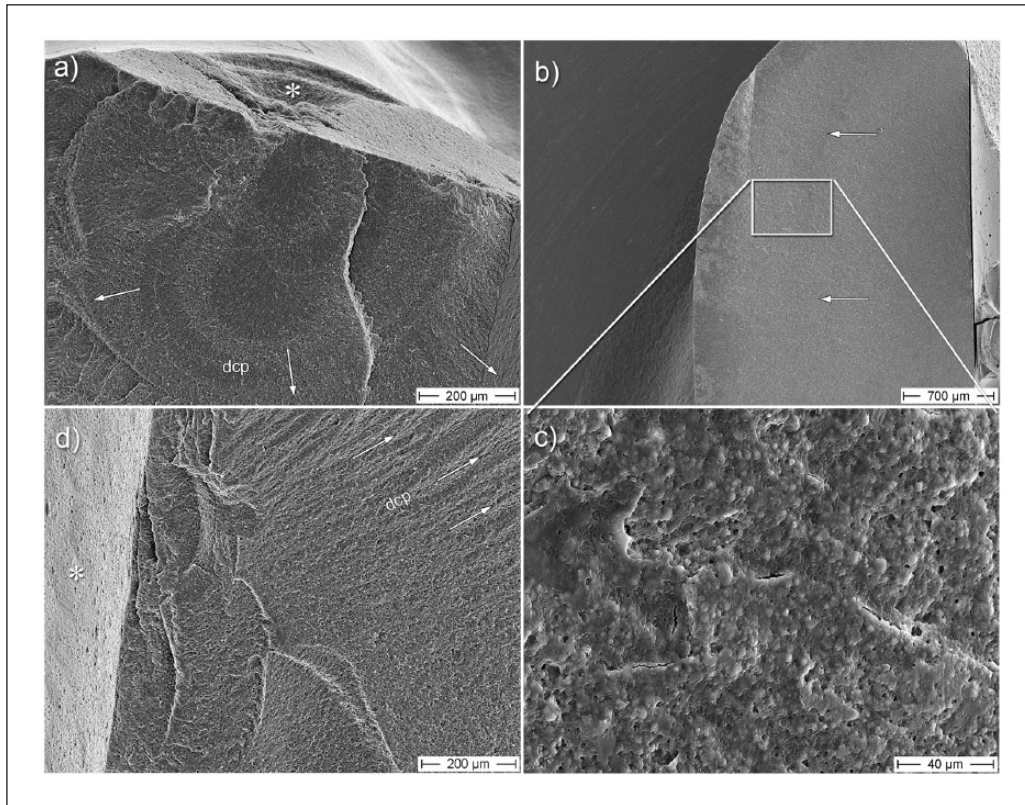
Figure 2. (a) The fracture origin on the palatal fragment of Figure 1 (e) (see *1). A large wear facet and damage accumulation zone can be seen on the surface (*) as well as multiple and overlaying mist and hackle regions and radial crack extension (arrows). (b) A magnification of the compression curl of Figure 1 (e) and (f), the endpoint of the fracture event on the disto-buccal side of the crown. (c) A high magnification of a fracture region close to the compression curl in (b). Small cracks are observable hypothesizing a degradation artifact in the microstructure of the resin composite crown material. (d) The secondary fracture event. Hackle indicates the dcp (arrows) radial from the fracture origin. (d) A clean intaglio surface (*) without any remnants of the luting agents, indicating an adhesive failure at the crown–adhesive interface.

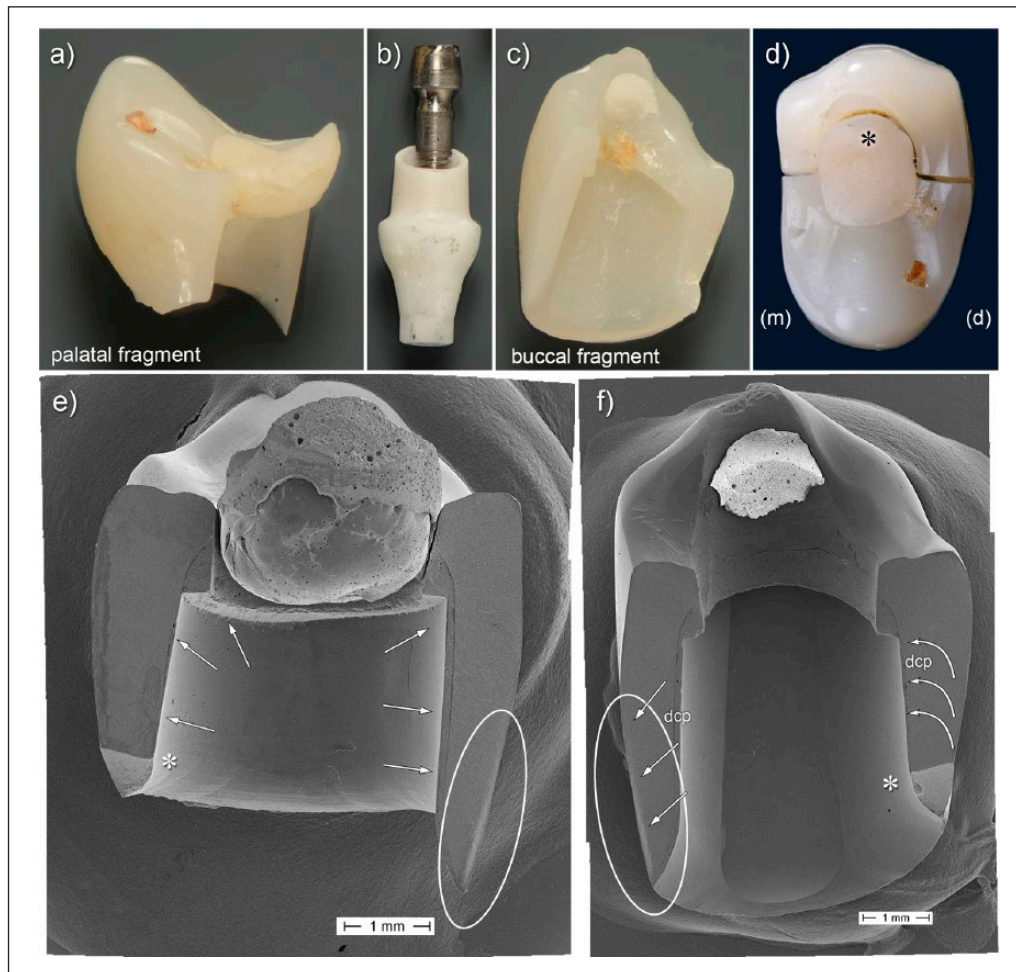
This crown was retrieved from tooth #25 of a 39-year-old female patient and fractured after 5 months in situ without any signs of malfunction. The fractographic examination is presented in Figures 3 and 4.

Figure 3. (a–d) Photographs of the crown and the implant abutment of case 2. The crown fractured mesio (m)-distally (d) in two fragments. (b) The zirconia abutment was found free of luting remnants. (d) The screw hole clinically filled with glass ionomer cement (*). (e) and (f) Higher resolution SEM images (mapped from individual SEM images) from the fracture surfaces of the fragments shown in (a) and (c). Both fragments exhibit the corresponding compression curl on the mesial margins (circles), indicating the termination of the fracture event. On the opposite (distal) margins, (e) and (f) shows a sharp and tilted fracture plane, suggesting the fracture initiation site at the marginal ridge (*). A clear fracture origin cannot be located, but fine hackle lines trace back to the marginal ridge, as shown in Figure 4(d). Luting remnants can be found only on the crown intaglio surface as indicated by the arrows in (e), indicating the zirconia–adhesive interface as the weakest link. It is likely that the fracture was preceded by a debonding event, resulting in tilting of the crown and shear fracture originating from the crown margins. (f) The general direction of crack propagation (dcp) is indicated by arrows. The fracture started on the distal side and terminated on the cervical mesial margin.

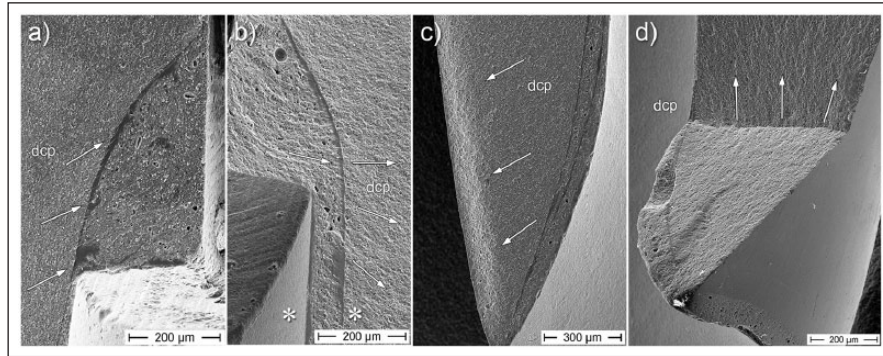
Figure 4. (a–d) High-resolution SEM images from the luting layer (Figure 3(a, b)), the compression curl (Figure 3(c)) and the fracture initiation site (Figure 3(d)). While Figure 3(a) and (b) is taken from the palatal fragment, Figure 3(c) and (d) is taken from the buccal fragment. Figure 3(a) and (b) clearly show the adhesive layer on the zirconia–adhesive side as well as on the crown–adhesive side with the sandwich luting agent in between (see * in (b)). The dcp can be seen from fine hackle lines, especially in the smooth and flat adhesive layer, indicated by arrows in Figure 3(a) and (b). Figure 3(c) and (d) also shows the luting layer and the dcp, indicated by arrows. An overview of the general dcp is shown in Figure 3(f).

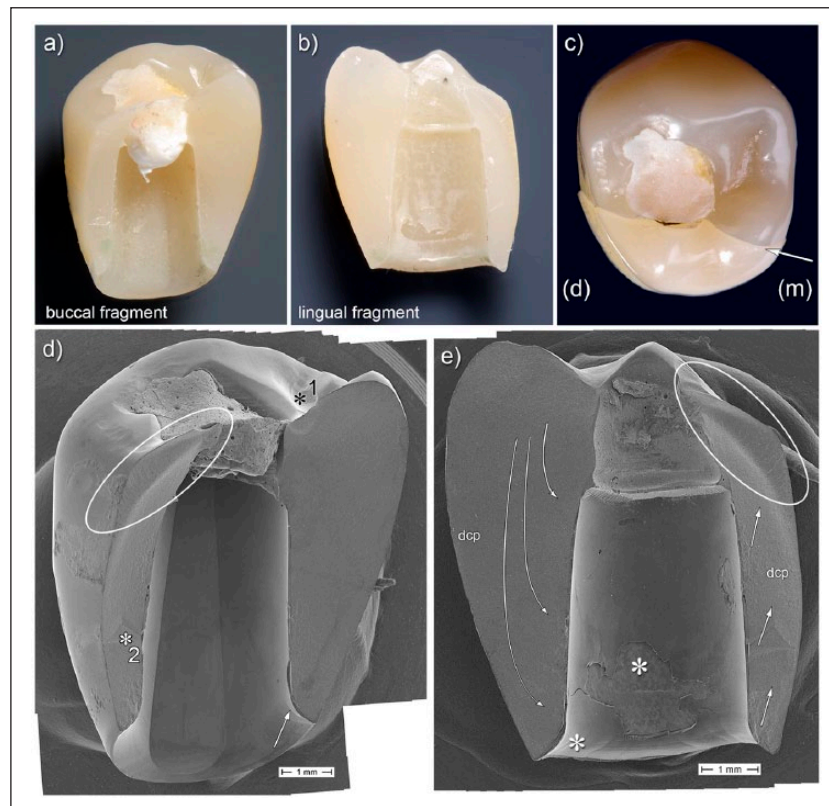
This crown was retrieved from tooth #35 of a 24-year-old male patient and fractured after 4 months in situ. The patient reported that he felt loosening of the crown before mastication fracture. The fractographic examination is presented in Figures 5 and 6.

Figure 5. (a and b) Photographs of the retrieved fragments of case 3. The crown fractured mesio (m)–distally (d) in two fragments. The corresponding abutment was not available for fractographic analysis due to further patient treatment. (c) The occlusal view on the crown with the screw hole filled with glass ionomer cement (*) and the fracture plane eccentrically located on the lingual side, separating the lingual cusp (arrow). Interestingly, the fracture started on the massive and bulky lingual cusp which indicates an unbalanced masticatory loading. (d and e) Higher resolution SEM images (mapped from individual SEM images) from the fracture surfaces of the fragments shown in (a) and (b). Both fragments exhibit the corresponding compression curl on the distal side (circles), indicating the termination of the fracture event. On the opposite (mesio-lingual) side, (d) clearly shows the fracture origin (*1). A secondary fracture event is further located on the inner plane on the gingival third of the distal margin (*2). Fine hackle lines, especially in the adhesive layer (see further analysis in Figure 6), trace the general dcp as indicated in (e). The fracture started on the mesio-lingual cusp and terminated on the distal side. Luting remnants can be found on the crown intaglio surface. Some remnants broke off, as shown in (d) (arrow) and (e) (*). The luting layer tends to delaminate from either the crown or the zirconia abutment. In principle, both adhesive interfaces (but predominantly the adhesive–zirconia interface) represent the weak link leading to crown debonding.

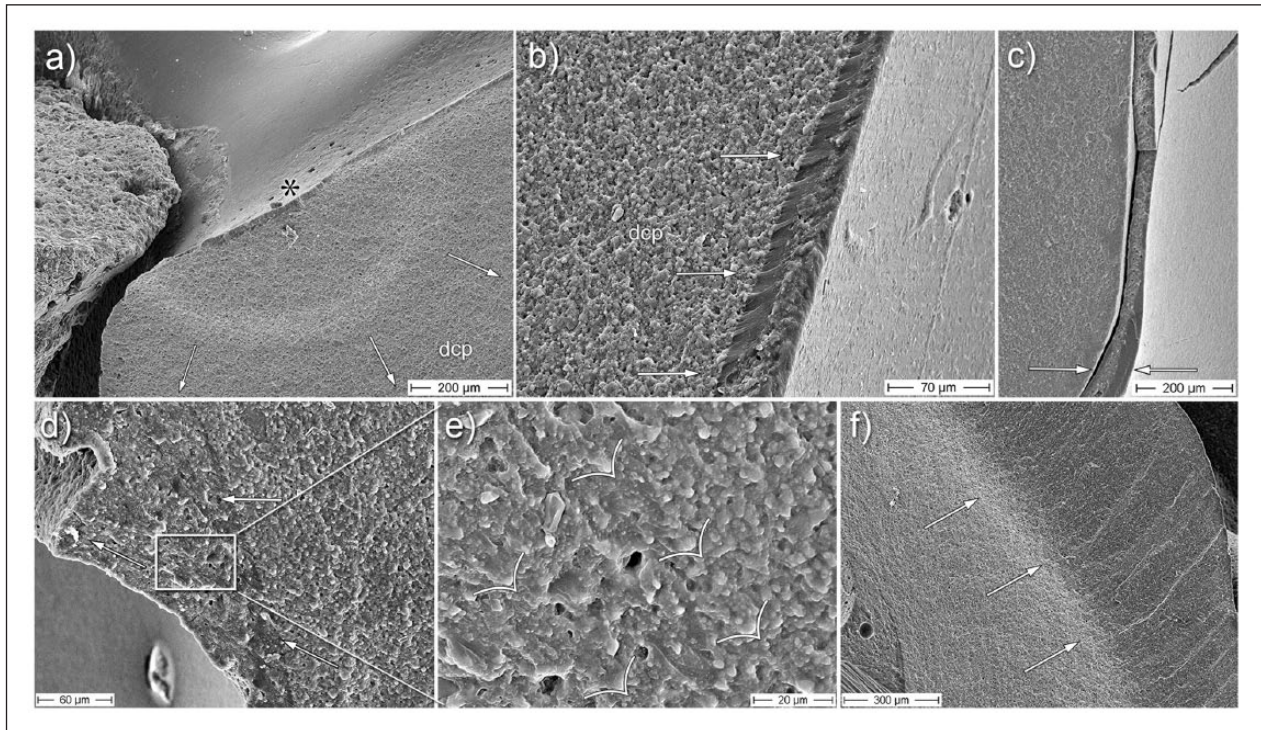
Figure 6. (a–e) High-resolution SEM images from the (a) fracture origin (b–e) luting layer, (f) the compression curl. While (a) is taken from the buccal fragment, (b–f) show magnifications of the lingal fragment. (a, b, d, f) Arrows indicate the dcp. (a) The fracture origin with a fracture releasing subsurface defect (*) and the radial fracture mirror and hackle region. The microstructure of the resin-based crown material did not elucidate distinct fractographic patterns. (b) The smooth adhesive layer, on the other hand, clearly indicates the dcp. Parallel, crazing-like hackle lines are found. (c) Delamination of the luting layer occurred mainly from the zirconia abutment, but also from the crown surface (arrows). (d and e) Also, the microstructure of the luting agent indicates the dcp. A magnification of the microstructure in (e) exhibits gull-wing-like microstructural features indicating the dcp. (f) The compression curl as the endpoint of the fracture event.

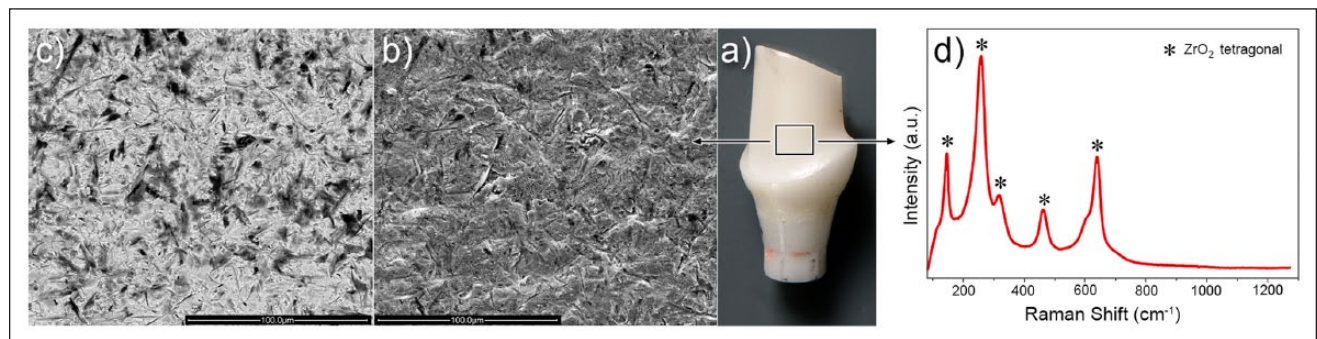
should conclude that adhesion is compromised. Sandblasting of tetragonal stabilized zirconia (TZP) is known to transform and degrade the microstructural cohesion of the zirconia (sub-) surface.^{22,23} Such degradation could have an effect on adhesion as well. However, the Raman spectrum in Figure 7 confirms the sole existence of the tetragonal zirconia on the buccal side of the implant abutment and no signs of the monoclinic polymorph. Apparently, no substantial tetragonal-to-monoclinic phase transformation was induced during sandblasting, which suggests that the applied sandblasting procedure (< 50 μm , 2 bar, 2–10 mm distance) was too soft. This would explain the absence of silica on the zirconia surface, as silica on

the silicatized alumina particles need impact energy to tribochemically adhere onto the zirconia surface.

Figure 7. (a) Analytical investigations on the buccal side of one debonded zirconia implant abutment. (b) SEM surface reveals rough patterns due to sandblasting. (c) EDS analysis did not show signs of silicon in the region of interest. (d) The Raman spectrum did only indicate tetragonal zirconia and no signs of silica.

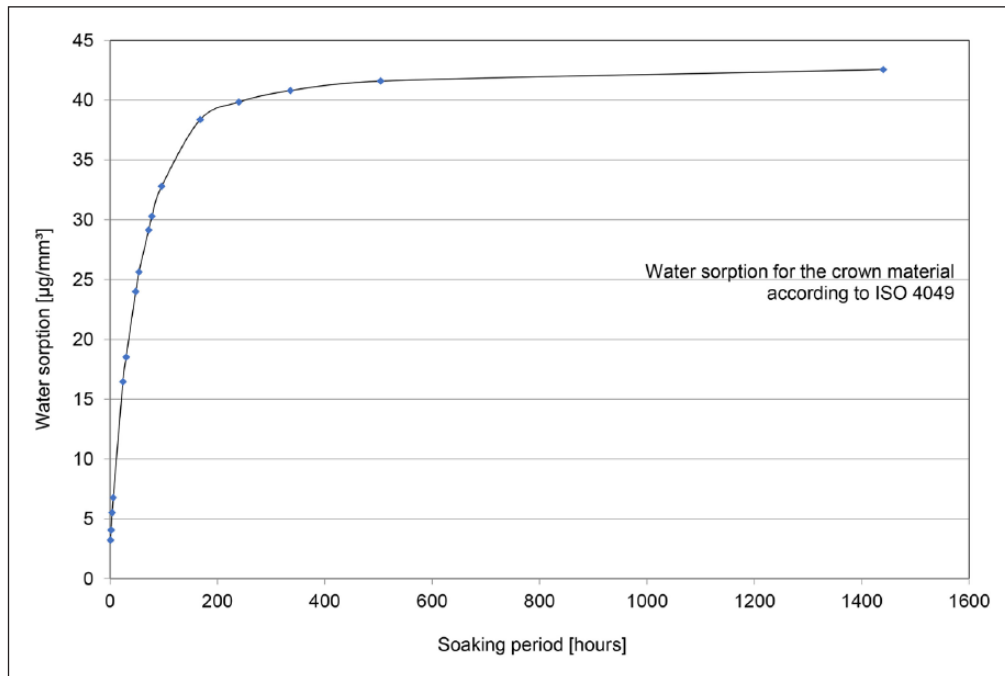
and to suffer from hydrolytic degradation and dimensional swelling to a certain extent.²⁵ Figure 8 shows a water saturation plot of the crown composite Lava Ultimate. The material takes up a maximum of $43 \mu\text{g}/\text{mm}^3$ water over 2-month saturation period. The 95% water saturation level is already reached after 14 days of water storage. The maximum of $43 \mu\text{g}/\text{mm}^3$ actually exceeds the maximum threshold value (40

$\mu\text{g}/\text{mm}^3$) in ISO 4049:2009 for polymer-based filling, restorative, and luting materials.¹² Although not measured, a relative dimensional change of a clinically placed crown can be assumed, based on the high amount of absorbed water, in turn increasing the stress state at the interface between crown and the zirconia abutment. Dental literature has not paid much attention to the swelling of resin luting agent, but indications

Figure 8. Water saturation curve for the resin-based composite Lava Ultimate over 2-month water storage period according to ISO 4049:2009. The material absorbed 43 $\mu\text{g}/\text{mm}^3$ water.
