# The restoration of San Paolo Church in Pisa: geotechnical aspects

Nunziante Squeglia,\* Stefano Stacul,\* Elena Diddi\*\*

## Summary

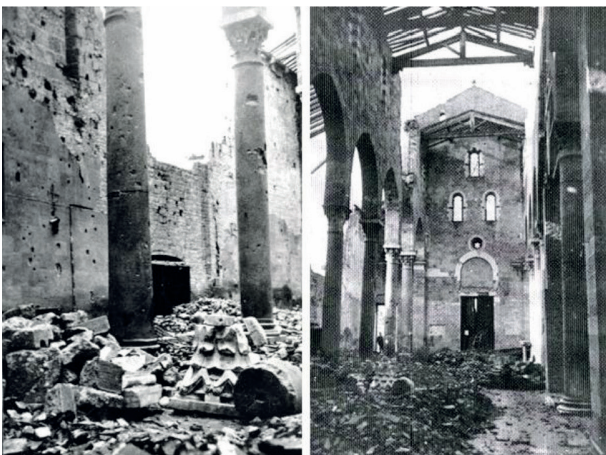
On August 31<sup>st</sup>, 1943 the southern side of Pisa was intensely bombed and the Church was heavily damaged (Fig. 2), with the destruction of the wooden roof and the partial collapse of the southern wall. The reconstruction, which lasted 16 years, took place between 1944 and 1960.

Fig. 2 – Damages due to bombing of 1943.

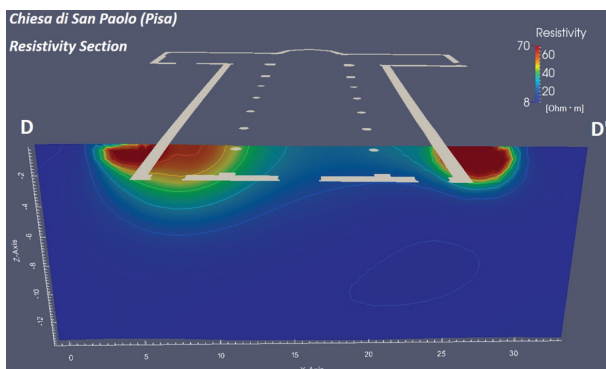
sent case an increment of resistivity has been associated to the occurrence of masonry; in figure 16 the foundation seems 2.5 m deep and some meters wide. As reported in figure 15, information about foundation of columns is not available. Such lack of information is due to presence of a metallic grid below internal pavement, discovered after ERT execution.

An accurate analysis of electric tomography and a comparison with direct inspection (say excavation) revealed that the information deduced by means of ERT is not reliable. The reasons of such unreliability are probably connected to the small difference in resistivity between the foundation walls and the ground, rather than the presence of the metallic grid. In fact, similar results have been obtained at the Baptistry in Piazza dei Miracoli, in which the metallic grid below the internal pavement is not present, while the material of foundation masonry is similar (Fig. 17). Further investigation revealed that the foundation were deeper than 2.5 m and the ERT tests have been discarded since the technique was evidently unable to discriminate the masonry from the ground.

Fig. 16 – Results of electrical tomography.  
Fig. 16 – Risultati delle tomografie elettriche per le fondazioni della Chiesa di San Paolo.

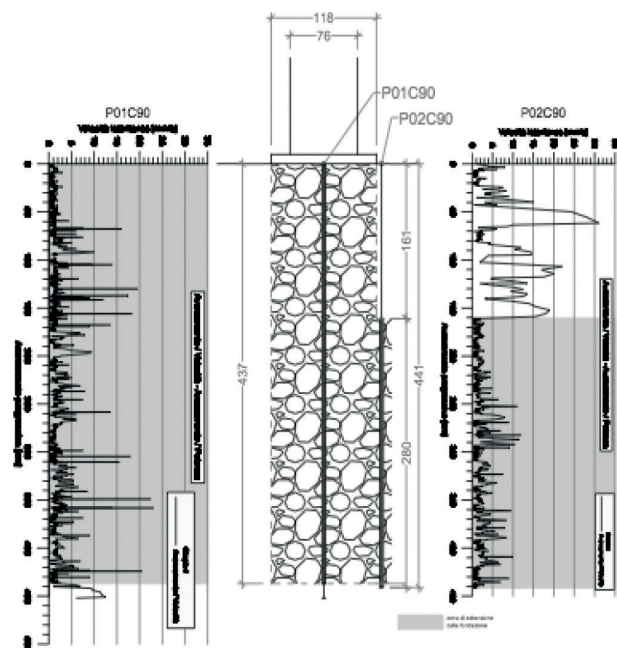
samples from masonry is connected to the quality of masonry itself and the diameter of borehole. In the case of very small diameter, say 35 ÷ 40 mm, only a very good masonry or large stones allow the retrieval of intact cores. The recorded parameters, therefore, are the only data available to judge the quality of masonry and to deduce its geometry. At present, it is not yet possible to directly relate the recorded parameters to the masonry characteristics; as a consequence, the identification of masonry is deduced by comparison. Figure 20 shows an example of the results in terms of rate of penetration versus depth. In the figure is evident the role of rate of penetration in defining the geometry of the foundation.

Fig. 20 – Results of instrumented coring.

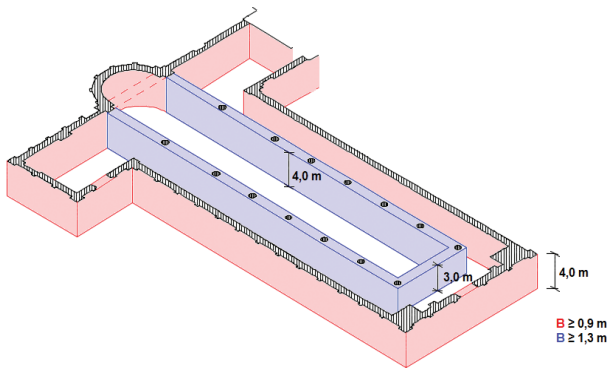
- columns rest on a masonry wall 4 m deep with a base at least 1 m wide. This wall connects all columns in E-W direction. The columns are not connected in N-S direction with the exception of western columns, where a masonry wall based at 3m depth has been found. This system probably coincides with the foundation of the smaller church built at the beginning of X century;
- all walls foundations are 4 m deep, with a base no more than one meter wide.

This information, summarised in figure 21, is somewhat unexpected. There is about a century between the two part of the construction, but the depth of the foundations of the different portion is quite the same and rather large.

A hand excavation down to 4 m depth and under water does not appear credible. In an alternati-

Fig. 21 – Scheme of foundation system deduced by the whole investigations.

ve hypothesis, the original foundations were shallower, and then the ground level has been risen by natural sedimentation or artificial infill to protect the church by the Arno river floods.
