NASA/TM—2018-219400

Advanced Stirling Radioisotope Generator Engineering Unit 2 Anomaly Investigation

Edward J. Lewandowski
Glenn Research Center, Cleveland, Ohio

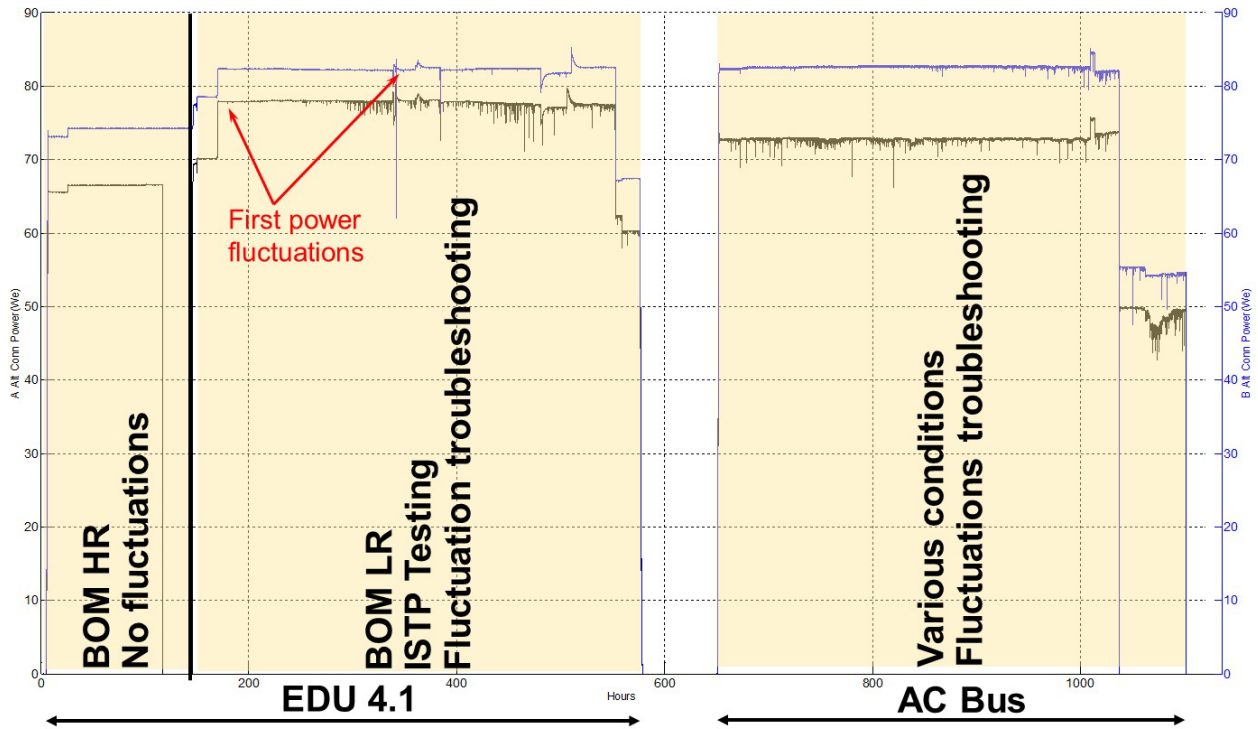
Test engineers first noticed small power fluctuations on ASC-E3 #1 as the first indication of a problem with the EU2. After just 179 hr of EU2 generator operation, the first power fluctuation occurred on ASC-E3 #1 (0.4 W drop) on December 2, 2014. This corresponded to 3,435 total hr of operation for ASC-E3 #1 since delivery, 328 hr of operation in the GHA under either AC bus or ACU control, and 225 hr of operation under ACU control (Figure 3). Then 175 hr later, the first power fluctuation occurred on ASC-E3 #2 (0.2 W drop). Figure 4 shows the power fluctuations observed on ASC-E3 #1 and #2 during EU2 operation, which appear as short-duration decreases in power. Some power fluctuations were as small as 0.2 to 0.4 W and lasted less than 2 sec. Over time they became more frequent and greater in magnitude, with some power fluctuations becoming as large as 9 W and lasting for many minutes, if not hours.

Figure 4.—ASC-E3 #1 and #2 output power during Advanced Stirling Radioisotope Generator Engineering Unit 2 and generator housing assembly (GHA) testing from November 25, 2014, through January 1, 2015, showing power fluctuations.

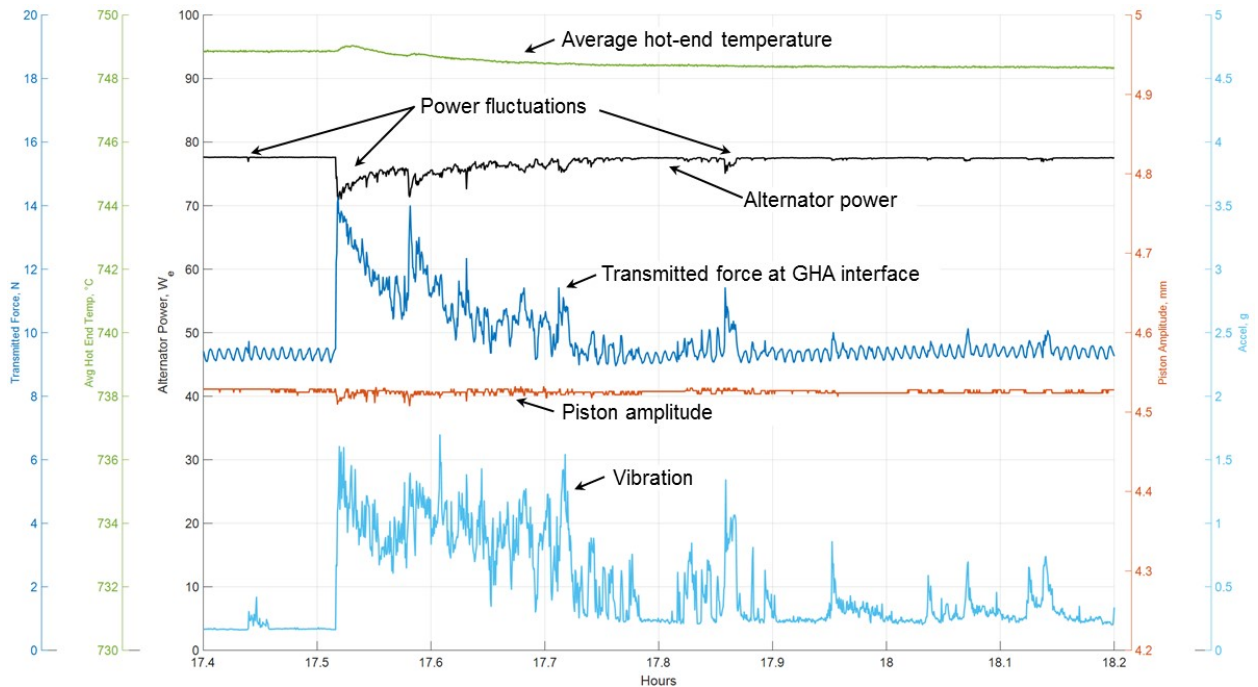
Figure 5.—Example of power fluctuations that occurred on ASC-E3 #1 on December 14, 2014.

The next power fluctuation started at 17.52 hr and persisted for at least 0.25 hr (15 min). The power initially dropped by 6.62 W, then slowly recovered, with fluctuations in power during that process. This time, the piston amplitude clearly dropped (by 0.019 mm), then recovered. Because the transmitted force and vibration levels remain high even when piston amplitude returns to near nominal values, this suggests that the relative phasing between ASC-E3 #1 and #2 is increased.

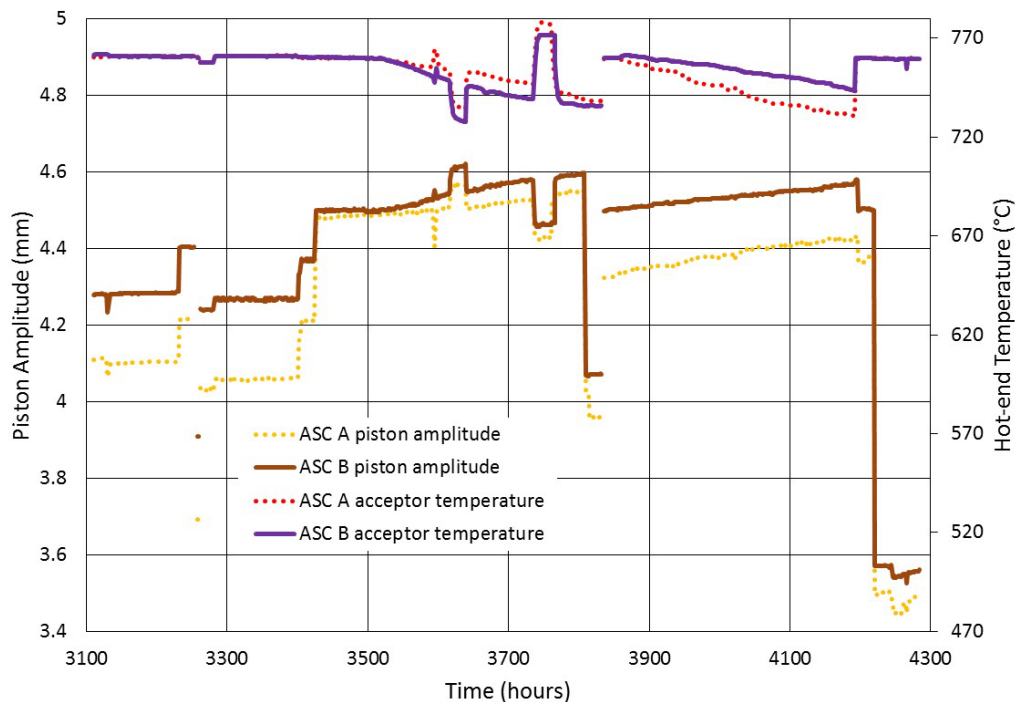
The fourth observation was a slow downward drift in hot-end temperature and upward piston amplitude over many hours. The drift began about when the EU2 began operation under fixed heat input at 3,495 hr of ASC operation. Previously, the hot-end temperature was fixed, and the test system adjusted heat input to maintain temperature. In Figure 6, the downward drift in hot-end temperature and upward drift in piston amplitude is clearly seen, superimposed on step changes in hot-end temperature and amplitude when the operating point was adjusted. This drift occurred under both ACU control and AC bus control, which began at 3,833 hr. The ASRG was designed to maintain hot-end temperature and piston amplitude open loop by controlling the ASC voltage setpoint, and this amount of drift was abnormal. This drift can also be seen in figures published previously. The downward drift in hot-end temperature is apparent in Figures 7 and 8 in Reference 2 and the upward drift in piston amplitude is seen in Figure 8 in Reference 2.

Figure 6.—Slow drift in hot-end temperature and piston amplitude during Engineering Unit 2 operation.

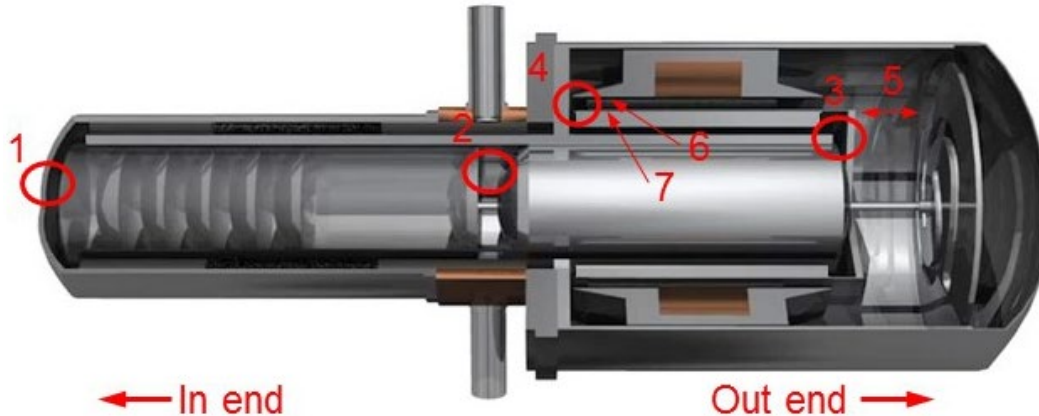
1. Between the displacer dome and the heater head dome
2. Between the displacer body and the piston nose
3. Between the magnet can beams and the out end of the cylinder
4. Between the in end of the magnet can and the fasteners on the cylinder clamp ring
5. Between the ASC Position Sensor's (APS's) sensor core and the spring standoff (The APS sensor core and spring standoff are not shown in Figure 8, but their location is indicated by arrows.)

The geometry of ASC-E3 #1 and #2 indicated that collision scenario #3 would occur before collision scenario #4, and no evidence of contact at location #4 was found, so that collision scenario was not considered a possible initiating event.

Figure 8.—Cross section of the ASC convertor with possible internal collision locations identified. Numbers described in Section 5.1.

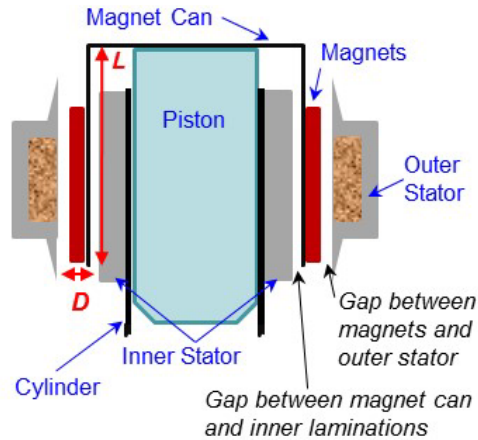
Figure 9.—Cross section of ASC alternator showing location of airgaps.

The magnet can clearance theory postulates that insufficient running clearance, possibly in combination with imperfect alignment of the magnet can within the airgap between the inner stator and the outer stator (Figure 9), could not accommodate all thermal and dynamic effects encountered during operation. This would result in rubbing contact between the magnets and outer stator and/or between the magnet can and the inner stator, initiating damage and eventual failure.

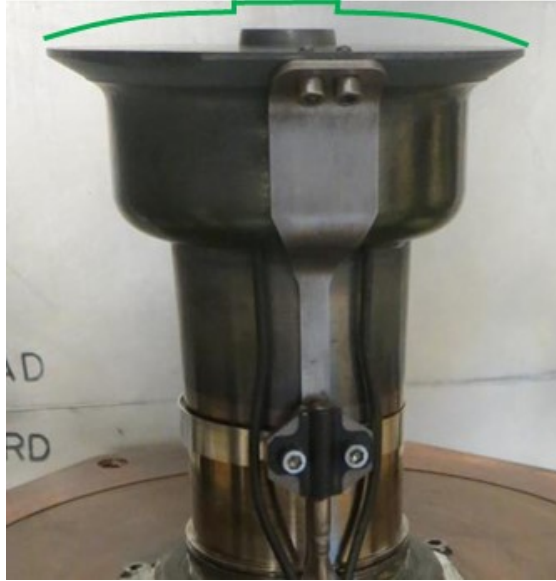
During GHA disassembly it was discovered that the ASC heat collectors were slightly crowned, shown exaggerated in Figure 10. The surface around the button in the middle of the heat collector was higher than the surface at the outer diameter (O.D.) by about 0.06 mm (0.0024 in.).

Heat collector crowning did not appear to play a role in the EU2 anomalous observations. Thermal simulations showed that when operating in an argon atmosphere, as was the case with EU2, the gap created by the crowning would not have significantly affected the heat transfer due to the presence of argon in the gap. Further, the change in heat transfer would not have caused the anomalous observations seen in the EU2. However, because 0.06 mm crowning could adversely affect heat transfer between the heat source and the heat collector in vacuum, the team did investigate further to better understand the cause of the crowning.

Figure 10.—Exaggerated illustration of crowning of ASC-E3 #1 and #2 across the heat collector face.

One plausible explanation for heat collector crowning is that it may be caused by creep due to thermal stresses from thermal gradients within the heat collector. Creep occurs at stresses that are less than the high-temperature yield strength of the material. An FEA creep analysis of the ASC-E3 heater head at temperature and pressure did suggest that crowning could occur due to creep.

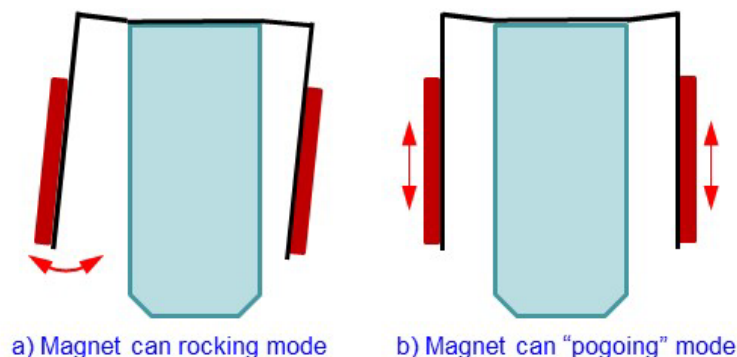
The EU2 anomaly investigation team identified two aspects of the ASC alternator design that need to be addressed. The first aspect is associated with the mechanical dynamics of the piston–magnet can assembly. The piston assembly consists of two relatively large masses (piston and magnets) connected by compliant beams and a thin titanium can. Significant inertial, pressure, and electromagnetic forces act on this assembly during nominal operation. During off-nominal operation and unintended collision events, the ASC magnet can may undergo significant dimensional deflection relative to clearances. The magnets on the O.D. of the magnet can rock relative to the piston and can undergo “pogoing” motion relative to the piston, as illustrated in Figure 11. The ASC magnet can should be designed to acceptable levels of maximum dimensional deflection, even under off-nominal conditions.

The second aspect is associated with the relatively tight alternator airgaps in the ASC alternator. The ASC alternator airgap in combination with the magnet can’s high length-to-diameter (L/D) ratio (see Figure 9) is challenging to manufacture and creates potential failure modes that reduce robustness to unacceptable levels for a critical component in a nuclear power system.

Figure 11.—Illustration of two magnet can modes of oscillation.

Further redesign of the ASC alternator tooling and manufacturing processes to address this aspect is recommended.
