Geoscience Laser Altimetry System (GLAS) Loop Heat Pipe Anomaly and On Orbit Testing

Charles Baker¹, Dan Butler², Eric Grob³
NASA/Goddard Spaceflight Center, Greenbelt, MD 20771

The Geoscience Laser Altimetry System (GLAS) is the sole instrument on the ICESat Satellite. On day 230 of 2003, the GLAS Component Loop Heat Pipe (CLHP) entered a slow circulation mode that resulted in the main electronics box reaching its hot safing temperature, after which the entire instrument was turned off. The CLHP had a propylene working fluid and was actively temperature controlled via a heater on the compensation chamber. The slow circulation mode happened right after a planned propulsive yaw maneuver with the spacecraft. It took several days to recover the CLHP and ensure that it was still operational. The recovery occurred after the entire instrument was cooled to survival temperatures and the CLHP compensation chamber cycled on a survival heater. There are several theories as to why this slow circulation mode exhibited itself, including: accumulation of Non-Condensable Gas (NCG), the secondary wick being under designed or improperly implemented, or an expanded (post-launch) leak across the pr

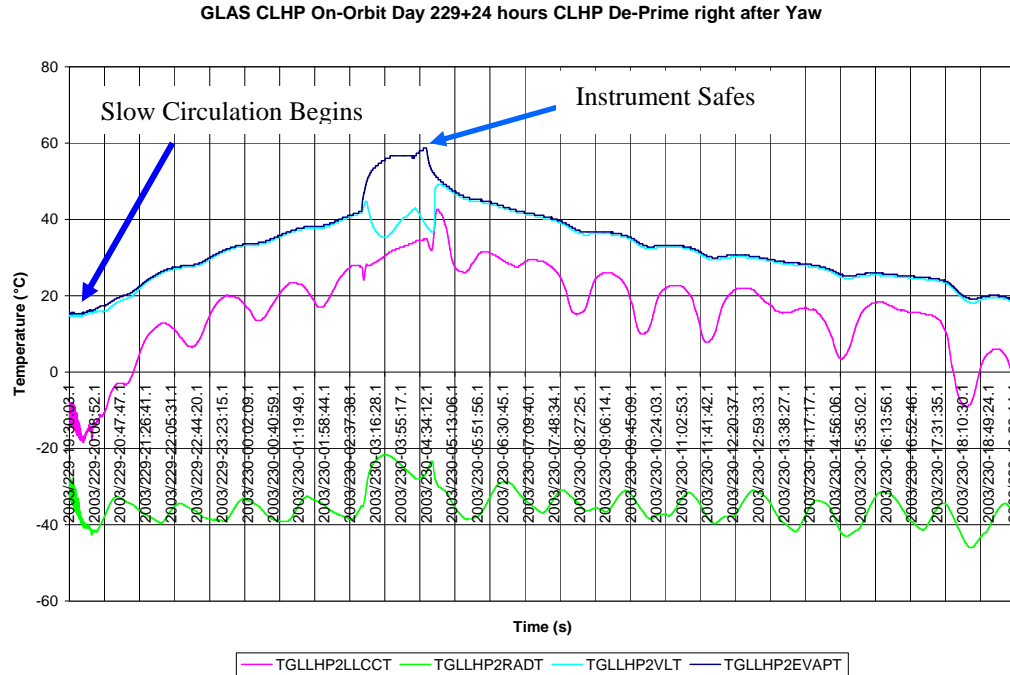
During the 6 year mission, only one significant thermal performance issue occurred. This happened in the fall of 2003 (the year ICESAT launched) when the GLAS Component Loop Heat Pipe (CLHP) did not provide adequate cooling to the Component thermal system (and therefore the GLAS electronics) following the Yaw maneuver at Beta 32° (which has the hottest and most transient sink.) The yaw maneuver produced around $5 \times 10^{-5} \text{ m/s}^2$ of acceleration. Though the CLHP appeared to continue to circulate fluid, the active control of the setpoint was lost. The week before the yaw maneuver, similar temperature excursions were observed, after which the CLHP recovered (or appeared to). Fig 2 shows the overall rise of the temperature, due to the slow circulation mode directly after an orbit maneuver of the ICESat Spacecraft. The increase continued until the instrument safed itself when the temperature limit on the MEB was reached. In the last several months before GLAS was decommissioned, tests were conducted with the instrument to try to reproduce the observed CLHP slow circulation from 2003. The test were unsuccessful with the exception of the last test, which included the yaw maneuver that was similar to the one linked to the original anomaly and followed by a setpoint increase which resulted in some precursor blips that will

Figure 2. Temperature rise due to slow circulation mode following Yaw Maneuver

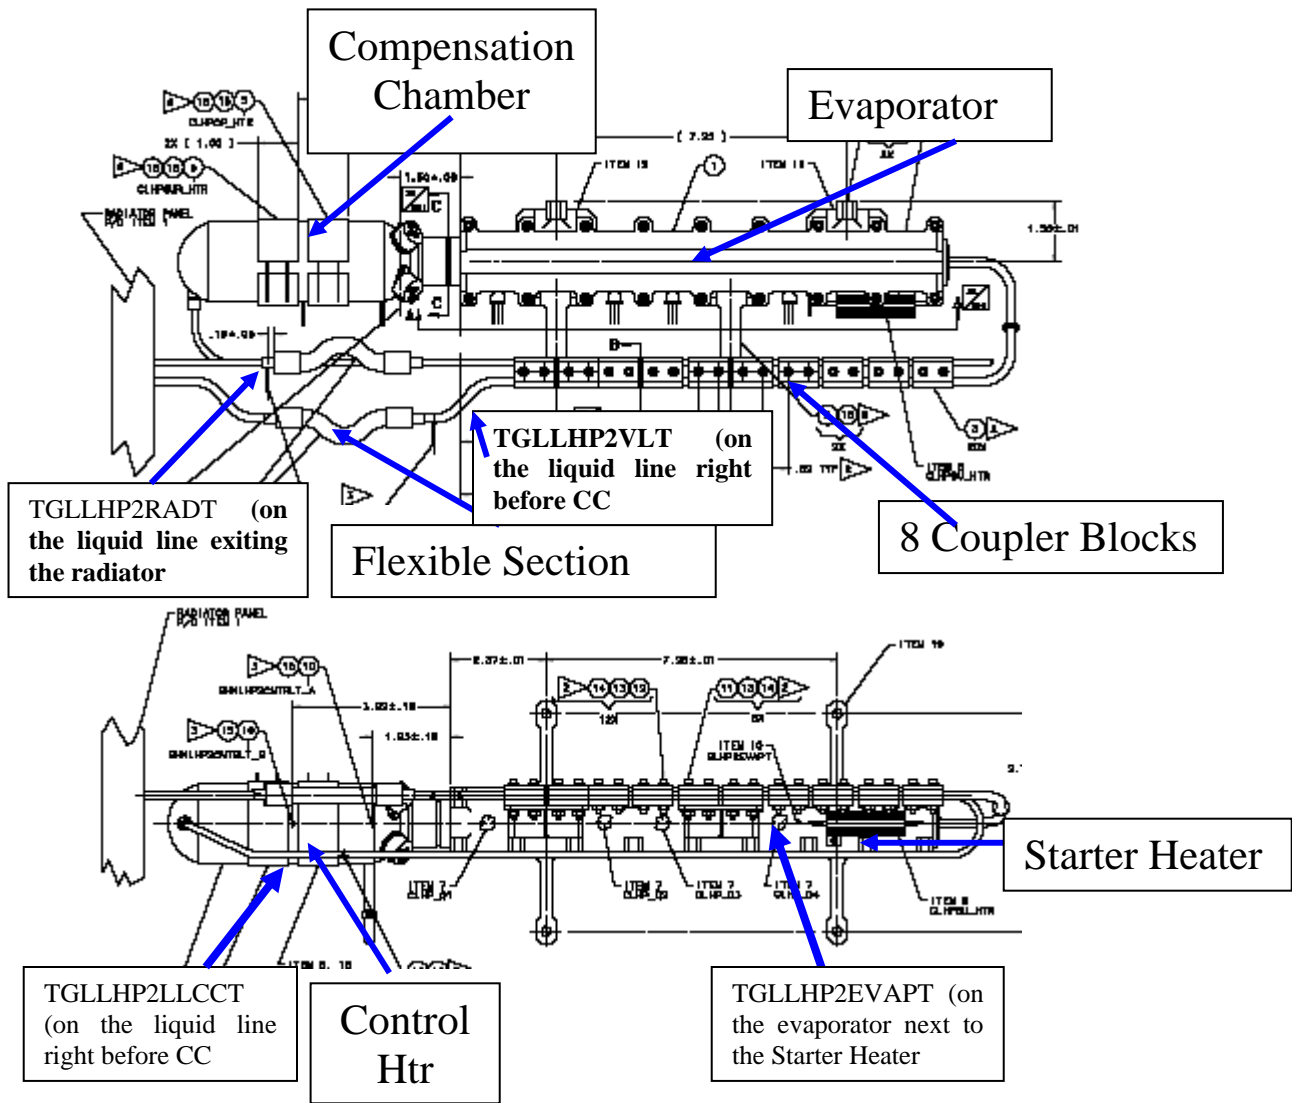
The available flight telemetry on the CLHP consists of 4 telemetry points: TGLLHP2EVAPT (Evaporator), TGLLHP2VLT (Vapor Line), TGLLHP2LLCCT (Liquid Line at CC entrance), TGLLHP2RADT (liquid line exit from condenser); respectively located on the LHP Evaporator near the starter heater, the vapor line after exiting the coupling blocks (which is the saturation vapor), the liquid line after the coupling blocks but before the compensation chamber, and the liquid line exit directly from the radiator (see Fig 3). The TGLLHP2EVAPT is used to measure the relative temperature of the component system (as the electronic components are coupled to the evaporator via constant conductance heat pipes (see Fig 1).

Figure 3. Component LHP Telemetry, Starter Heater and Operational Heater.

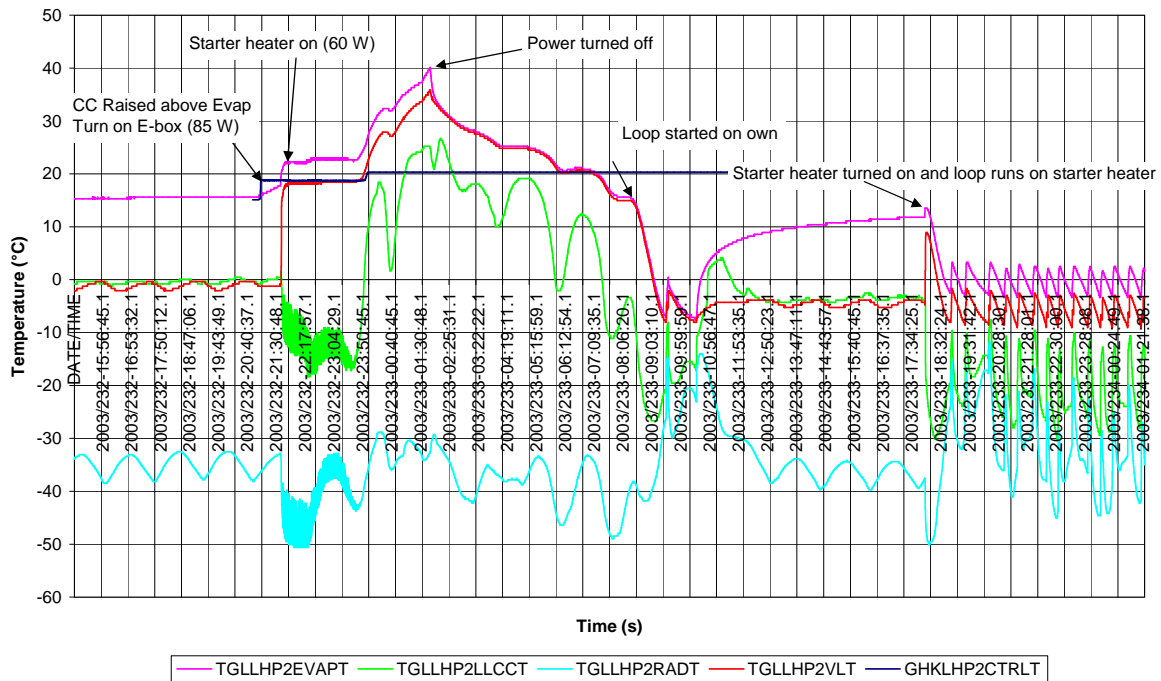
An attempt to quickly re-prime and pre-condition the LHP two days later resulted in the LHP starting quickly but failing soon after, as shown in Fig 4. After the LHP was operated cold on the survival heater for many hours, the LHP was slowly (decreasing the setpoint increase rate to 1/36 of the previous rate) raised back to operating range and operated with a full load plus a 60 W starter heater without entering the slow circulation mode for the remainder of the mission.

GLAS CLHP On-Orbit Day 232+30 hours 2nd attempt to reprime and restart (not successful)
Note: CC was raised 2°C above Evap for 15 minutes before restart

Figure 4. CLHP Second Start-up attempt pre-conditioning, failure, and recovery

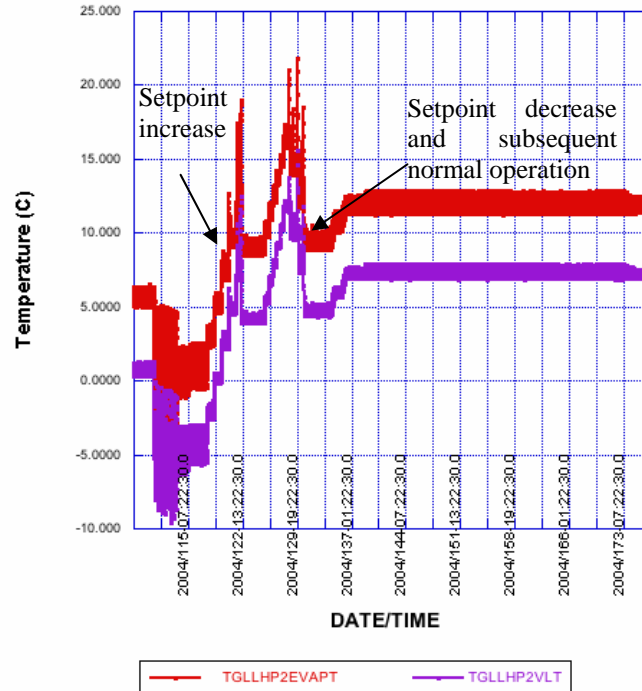
operating temperature by a few degrees, which flushed the evaporator core with liquid. It was important to flush the evaporator after observing the blips on subsequent blip precursors. There had been blip precursors before the Fig 2 slow circulation run away 3 days prior to the Yaw maneuver. Whatever was affecting the LHP at that time must have remained and the perturbation of the Yaw maneuver must have exacerbated the problem to cause the slow circulation. In Fig 5, the temperature setpoint decrease is observable and then the precursor blips ceased.

Figure 5. Further observations of slow circulation precursors on-orbit

Nominal operations of the LHP resumed after flushing of the CLHP with the survival heater. After this slow circulation mode was experienced, there were observations of the slow circulation precursors during later flight operations, as shown below in Fig 5, however the slow circulation mode was averted by lowering the CLHP

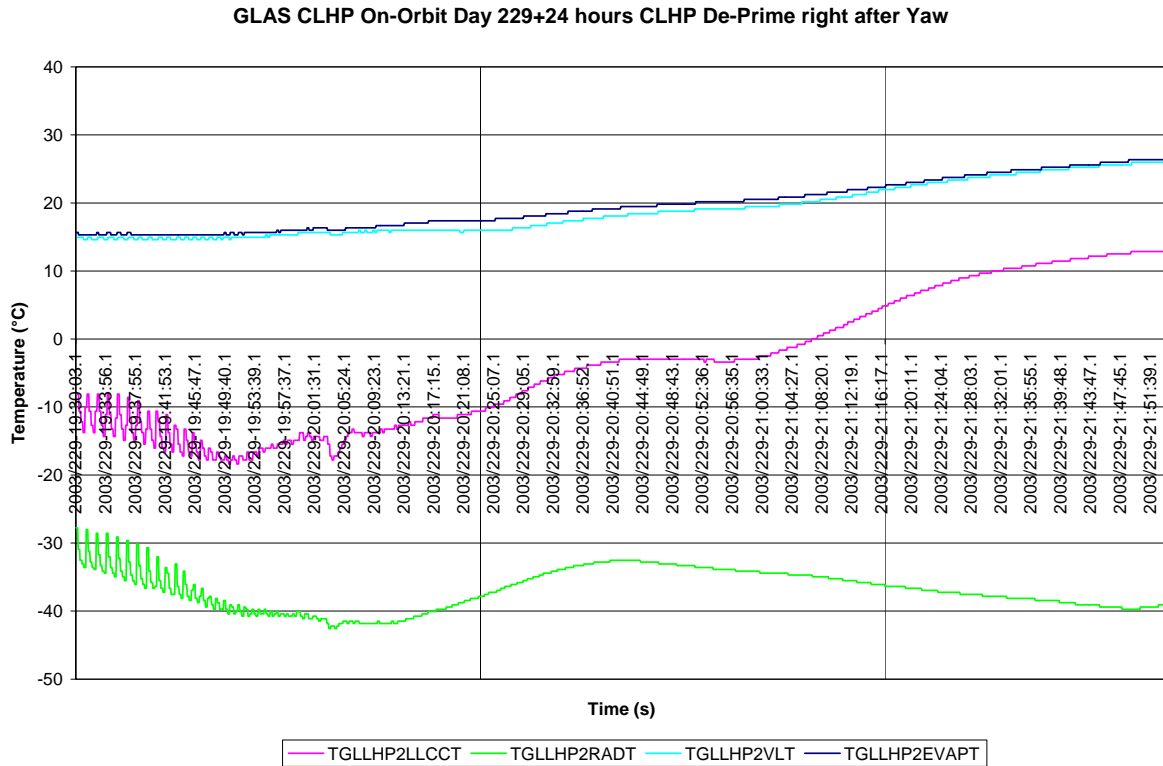
- Temperature excursions were seen on cold portion of orbit when the condenser cooling (due to a colder sink) results in a liquid transfer from the Compensation Chamber and Evaporator Core to the Condenser see Fig 6
- LHP Runs better at colder temperatures – more liquid fill in the compensation chamber due to density changes

Figure 6. Blow up of the original CLHP De-Prime showing the Liquid Line temperature drop and then slow circulation mode commence

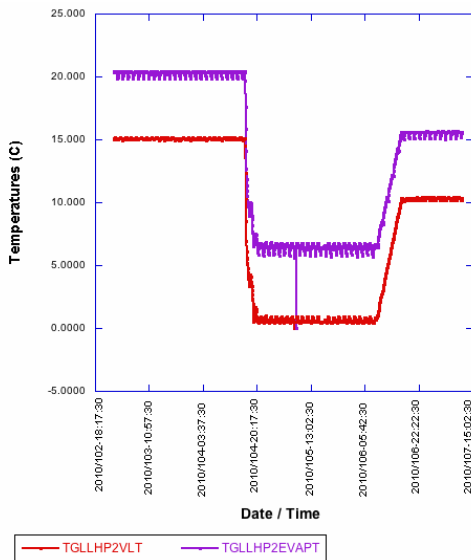
Following the end of the GLAS science campaign, a series of instrument tests were initiated to explore the causes of the slow circulation mode. The intention of the test was to reproduce the flight failure. The Test program is shown in Table 1. A sink change test is shown in Fig 7 and a setpoint change test. This test did not result in any precursor blips.

Figure 7. Sink Change Test (at 0°C) and Setpoint Change Test.

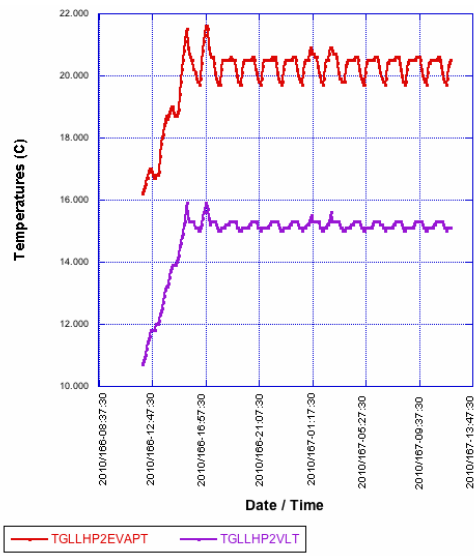
Figure 8. EVAPT Blips (slow circulation precursors) resulting from combination of setpoint changes and high control points

As is seen, neither sink transients (rotating the CLHP radiator to face the Earth versus deep space), nor setpoint changes were successful in forcing the CLHP to start to show precursors for slow circulation mode. Only by combining setpoint changes and high control points after the yaw maneuver, were the precursor blips observed (Fig 8). As was noted earlier, these pre-cursor blips may be indications of a susceptibility to future sustained slow circulation mode. Fig 8 shows the only precursors for slow circulation that occurred during the testing a few days after the Yaw maneuver and when the LHP setpoint was well above its nominal setting (this graph has a setpoint of 20 C.) The previous precursor blips during the baseline mission occurred when the CLHP was set at 15 C in the original slow circulation runaway and at 7.5 C during the Fig 5 blips. Note also that after the setpoint was dropped 5°C that the precursor blips stopped (which Fig 5 shows.) The effect of dropping the setpoint transfers fluid from the condenser into the evaporator core rapidly potentially re-wetting the dried out wick section.
