# Seismic Behavior of Local Soil and Foundations in Bam City During the 2003 Bam Earthquake in Iran

## Abstract

## 2. Ground conditions in Bam city

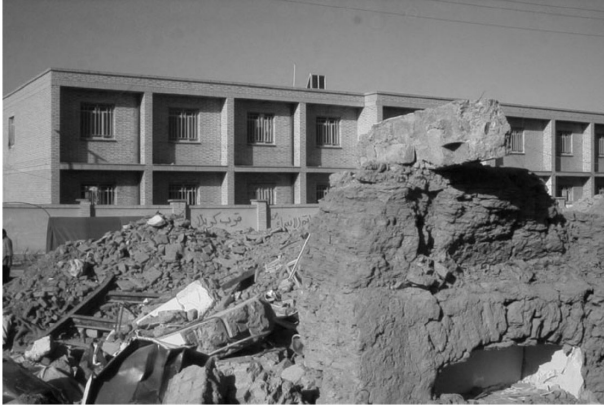
The IIEES array 5 is the first of 4 sites where Swedish soundings were conducted. This site is located in the northern part of the city (Fig. 3) and the extent of damage to buildings was significant. It is, however, noteworthy that a few buildings survived the quake without suffering damage among many other damaged neighboring buildings (Photo 3).

Photo 3. Damaged and undamaged buildings around the site of IIEES array 5.

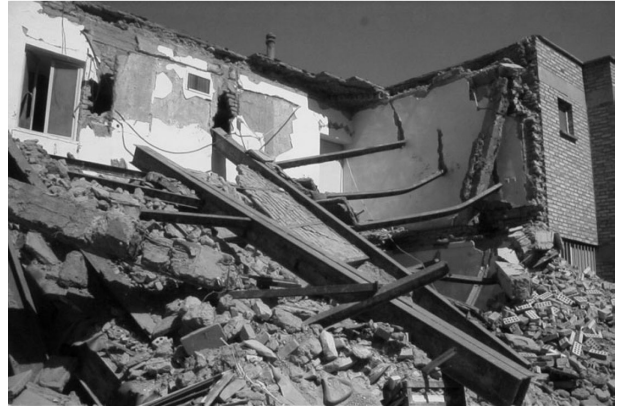
Photo 4. Damaged masonry building near site of IIEES array 6.

This site is located at the center of the city and many buildings were destroyed by the earthquake (Photo 4). It is again noteworthy that there was 1 house that suffered little damage in this area (Photo

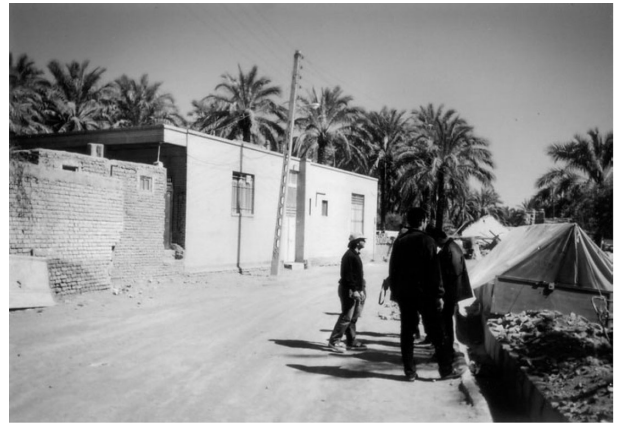
Photo 5. Undamaged house near the site of array 6.

5). Upon visiting this house, its owner said that it had been built by a local contractor who was renowned for the good quality of construction. Fig. 7 compares

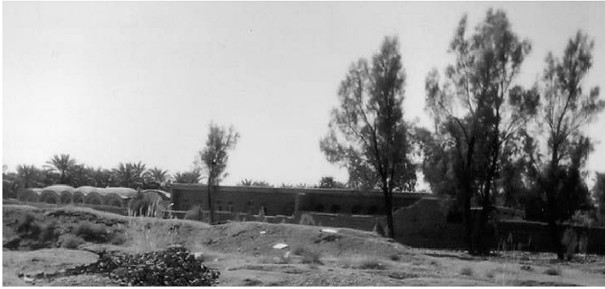
Photo 6. Relatively light damage around site of IIEES array 7.

less significant (Photo 6) than in the north and central parts of the city, as demonstrated above. Swedish sounding at this site was conducted in a large excavated pit (Photo 7 a), which was approximately 3 meters deep. It was expected that this decision would save time needed to penetrate the top hard soil and more efficiently study subsoil conditions.

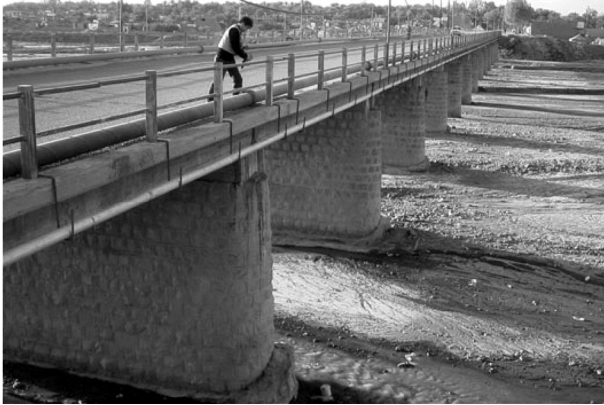
There are 2 major bridges in the Bam City area. They are the Esfikan and Khaje-Askar Bridges crossing the Posht-e-Rud (Posht River). The Esfikan Bridge is located at the north end of the city (Fig. 3), while the Khaje-Askar Bridge is to the west. Photos 9 and 10 show the appearance of the bridges during the investigation. There is evidently no significant damage to or deformation of these bridges, and road traffic was not suspended. In more detail, Photo 11 shows the situation of the Esfikan Bridge at the top of the pier. Noteworthy is the fact that the lateral displacement is only a few centimeters, and that the function of the bridge was maintained, in spite of the lack of any aseismic measures, during the earthquake. The good performance of the bridges during the quake is in contrast with the complete destruc-

Photo 9. Appearance of Esfikan bridge after the earthquake.

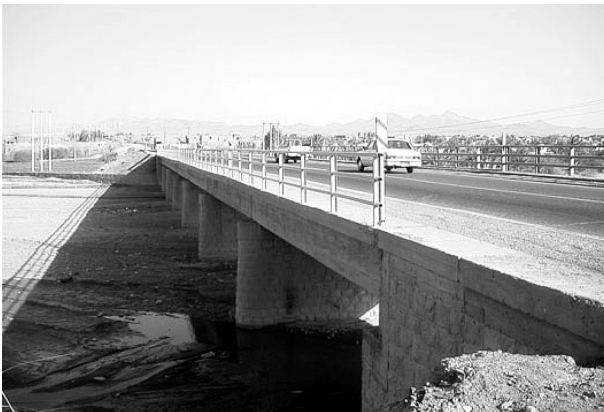
Photo 10. Appearance of Khaje-Askar bridge after the earthquake.

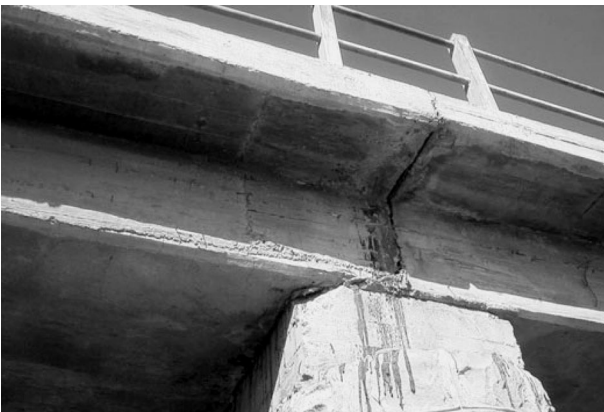
Photo 11. Minor displacement of Esfikan bridge at the top of pier.

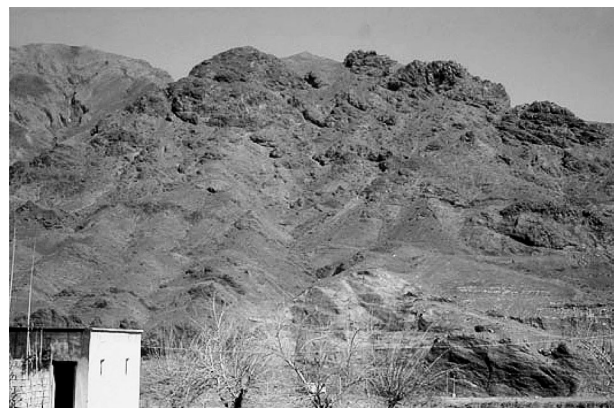
A visit was made to the site of Narmoshir Dam, whose construction was to start 25 km south east of Bam city. Located in a mountainous area, the dam site experienced “strong and long earthquake tremors” according to the chief engineer of dam construction. No seismometer was installed there. The present investigation did not find seismic slope instability in this area, with the exception of a minor rock fall (Photo 13) from the excavation site of the rockfill dam. This situation is again in clear contrast with

Photo 13. Rock fall near Narmoshir Dam under construction.

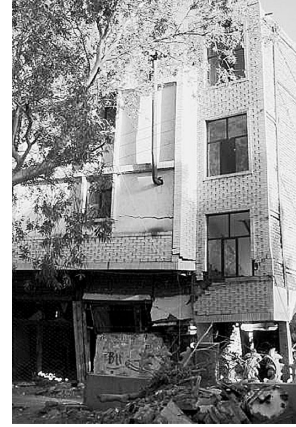
First, the bank building in Photo 14 had no appearance of damage. On the opposite side of the street, there was a building in Photo 15 whose first floor was severely distorted. As has been pointed out, thus, there are buildings in all parts of the city which survived the quake. Conversely, many nearby buildings and houses were severely affected by the same earthquake motion. Because the distance between damaged and undamaged buildings was small, the globally inclined geology in the city (Fig. 10) cannot account for the difference in damage. A more detailed inspection of Photo 15 reveals that the foundation did not deform. This may imply that the foundation and the subsoil had sufficient resistance to the seismically-induced inertia force, while the first floor did not.

Photo 15. Damaged building in front of bank in Photo 13.

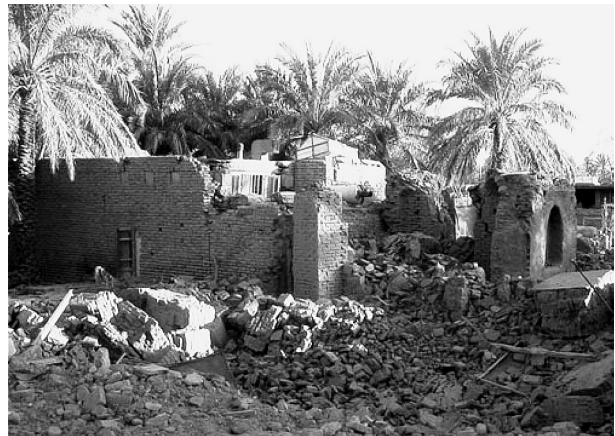
Second, Photo 16 shows a completely destroyed adobe house. Adobe is a form of masonry made from local soil, which is mixed with water and sun-baked. Because it is easily available without any special raw material or manufacturing process required, adobe is widely used in Central Asia, which has an arid cli-

mate, and in South America. It is important that the base of the wall of this house did not distort, although the upper part totally collapsed. This again suggests that the damage was caused not by weak

Photo 16. Foundation of destroyed adobe house.

foundation and soil, but the low strength of the superstructure.

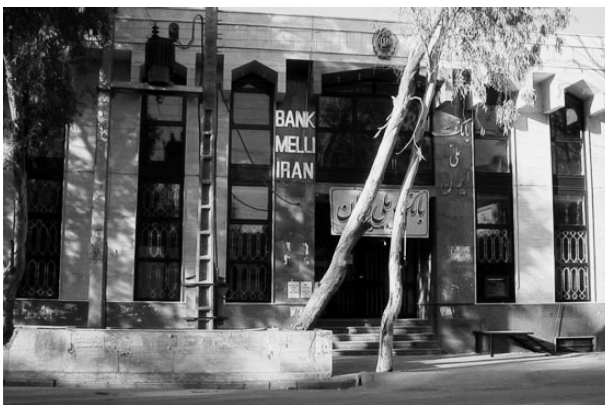
Photo 14. Undamaged bank building in western Bam.

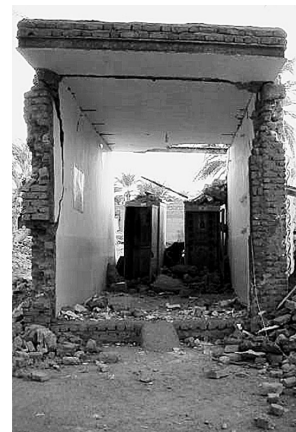
Photo 17. Damage of to masonry structure.

Photo 17 further indicates the form of damage to the masonry structure in which the front wall was lost. It can be seen that the base of the side walls did not deform, showing that the foundation was not responsible for this damage.

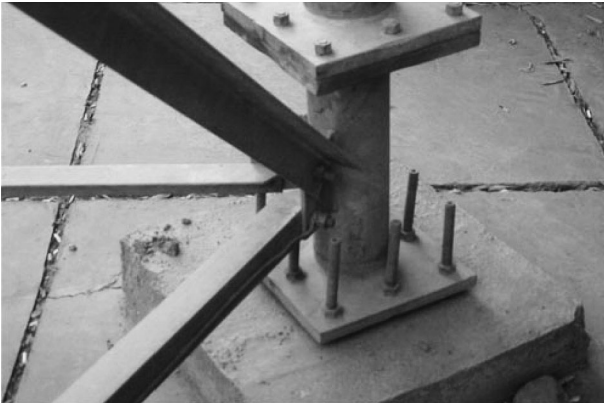
Photo 18. Foundation of communication transmission tower.

Finally, Photo 18 shows the footing of a microwave transmission tower. Apparently, there is no distortion. This is in strong contrast with the substantial damage to masonry houses and buildings in the same part of the city.

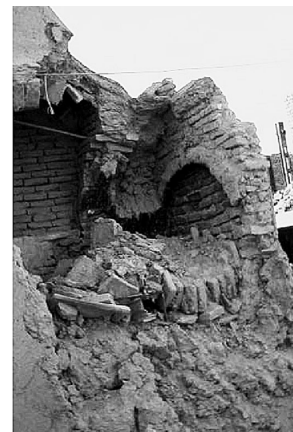
Photo 19. Exceptional seismic damage to adobe house in Kerman City.

Iran. Due to the 150 km distance from Bam city, the magnitude of tremors in Kerman was much weaker than in the Bam city. Therefore, most adobe houses in this city received no seismic damage. There was, however, an exceptional case, as shown in Photo 19, in which a wall of an adobe house fell down due to

the Bam earthquake. This example suggests that some adobe and local masonry houses might have extremely low seismic resistance.

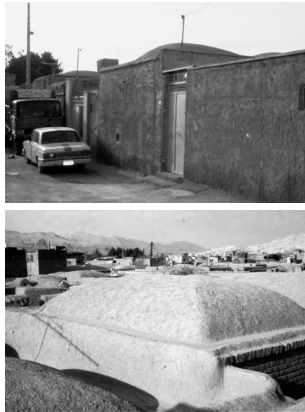
Photo 20. Intact adobe house in Kerman City.

Photo 20 shows an adobe house visited by the authors. Although the surface is covered with beautiful tiles, the internal structure is made of adobe. This visit was intended to examine any possibility of structurally improving the seismic resistance of existing houses. The improvement measure in mind was replacing heavy top roofs with lighter materials. The owner of this house stated during the visit that his family was scared now by earthquakes and slept under a table, which could provide good shelter. He also mentioned that the top roof had new mud added once every 4 years, and its present thickness was about 40 cm.

As shown in Photo 20 (b), the top roof is massive and replacement with a lighter material seemed to be very difficult, if not impossible, for ordinary families. Consequently, it is suggested by the authors that public support should be introduced for retrofitting existing houses, or that furniture that could provide shelter during strong tremors should be made available at reasonable costs.
