Building Damage around Bam Seismological Observatory Following the Bam, Iran Earthquake of Dec. 26, 2003

Yasushi Sanada^{1)*}, Ali Niousha²⁾, Masaki Maeda³⁾, Toshimi Kabeyasawa¹⁾ and Mohammad Reza Ghayamghamian⁴⁾

Abstract

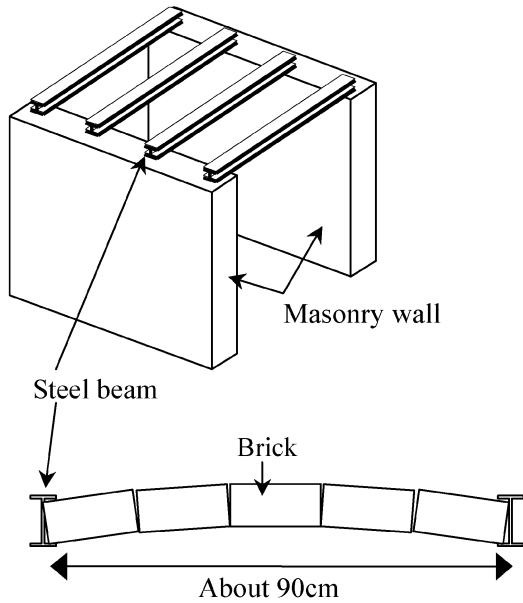
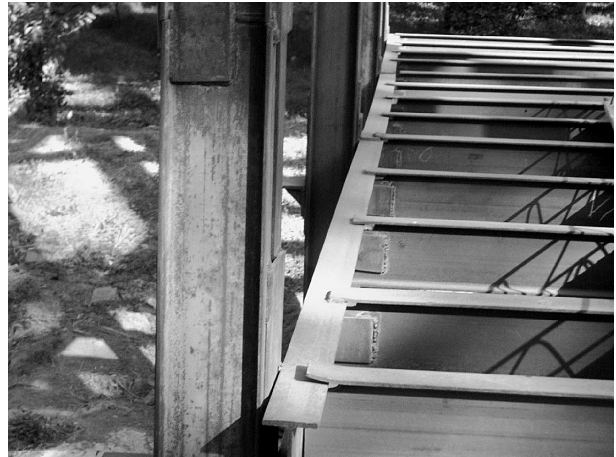
The common slab in the buildings was of the brick jack arch type (Fig. 1). The system consists of parallel I-shape steel beams at intervals of about 90 cm. These beams support the brick arches, which are covered and leveled off with gypsum plaster at the bottom and mortar and tiling at the top.

These slabs are heavy and behave like a flexible diaphragm unless detailing is considered. Slabs constructed in this way are usually not tied together or to supporting walls or girders. Therefore, these kinds of slabs have caused many building failures and an unusually high death toll in many recent earthquakes in Iran.

Fig. 1. Commonly used jack arch slab (left: wall supporting; right: girder supporting).

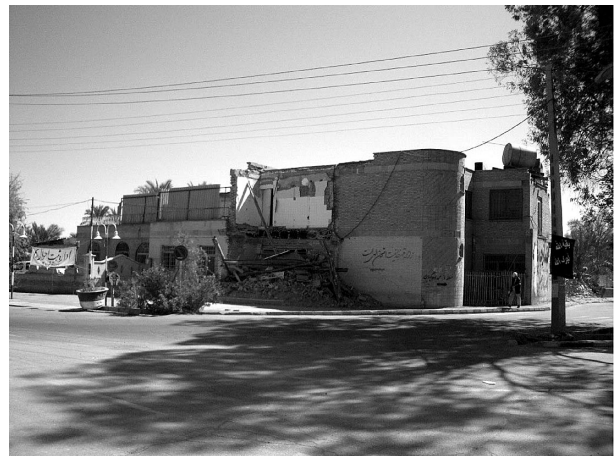
The Governor’s Building is a 2-story SM building with reinforced concrete horizontal ties, as shown in Photo 1. This building has an irregular plan. The wall arrangement is illustrated in Fig. 9. The damage level, classified by EMS-98, was Grade 4 due to the partially collapses of NW- and SW-sections as shown in Photo 2. The location of the seismograph is

Photo 1. North view of Governor’s Building.

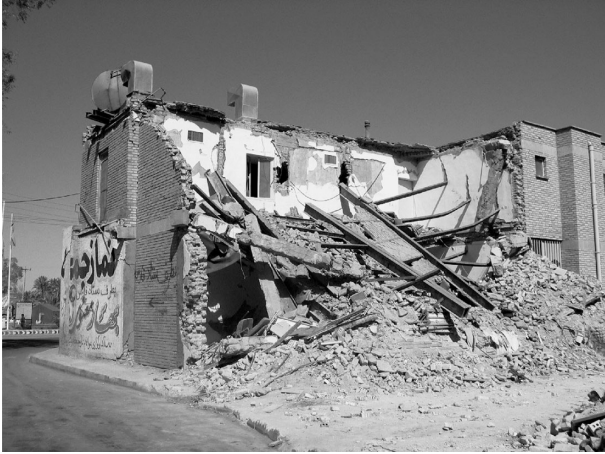
Photo 2. Collapse at the south west section.

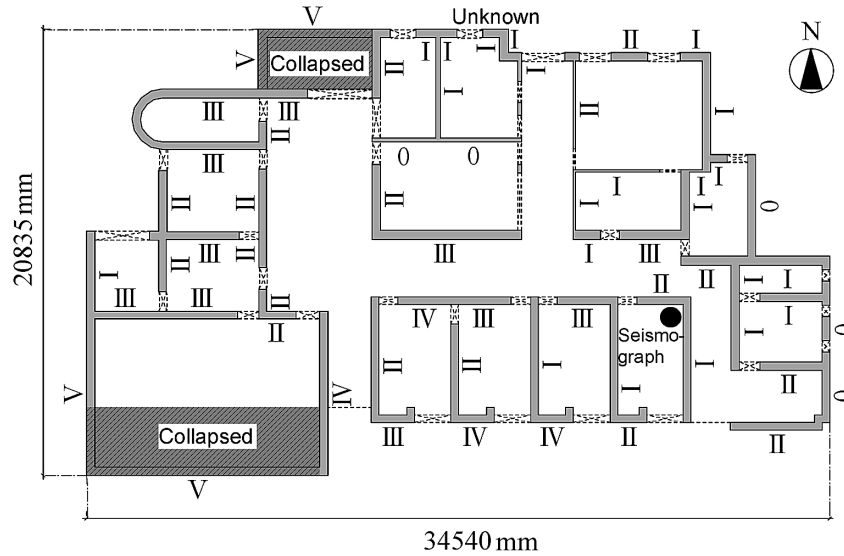
also illustrated in Fig. 9, which shows that the seismograph was placed far from both collapsed areas. The wall ratios (=the sum of the first floor wall sectional area/the first floor area) were 6.4% to 6.8% in the NS direction and 5.8% to 6.7% in the EW direction, considering those with and without the collapsed area.

Moreover, the damage levels and the maximum crack widths of all masonry walls in the first story, except an inaccessible one, were measured in the Governor's Building according to the criteria shown in Table 2. The damage levels of walls are also shown in Fig. 9 and the distribution of wall damage level in each direction is shown in Fig. 10. The

Fig. 9. First floor plan and damage levels of masonry walls of Governor's Building.

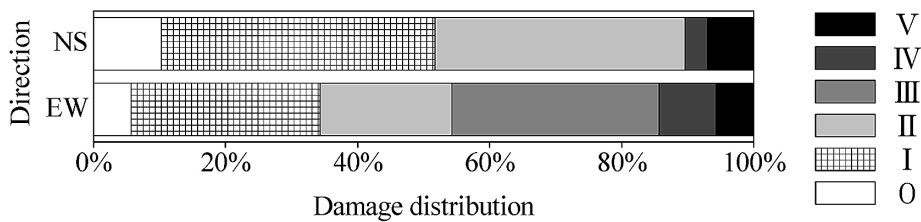
Fig. 10. Distributions of the wall damage level in Governor's Building.

average damage level of all walls in the EW direction of 2.3 is larger than that in the NS direction of 1.7, which means the directivity of the input motions, estimated by the wall ratios (NS \approx EW) and damage levels (NS<EW), corresponds to that of actually recorded data (NS<EW).

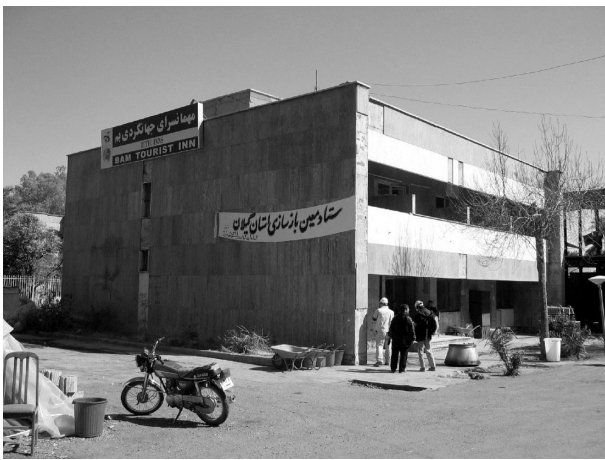
Bam Tourist Inn, used as hotel and restaurant, is a 2-story SM building as shown in Photo 3. The plan of this building is relatively regular (Fig. 11). The damage level, classified by EMS-98, was as low as

Grade 2 as estimated from Photo 3, however, the roof of the penthouse collapsed as shown in Photo 4. The wall ratio in the NS direction was 9.4%, which was much larger than that of the Governor's Building, and that in the EW direction was 5.5%. The damage levels of walls except inaccessible ones, which were evaluated from the definition in Table 2, are illustrated in Fig. 11. Fig. 12 shows the distribution of wall damage level in each direction. The average damage level of walls in the NS direction of 1.3 was a little smaller than that in the EW direction of 2.3,

Photo 3. South west view of Bam Tourist Inn.

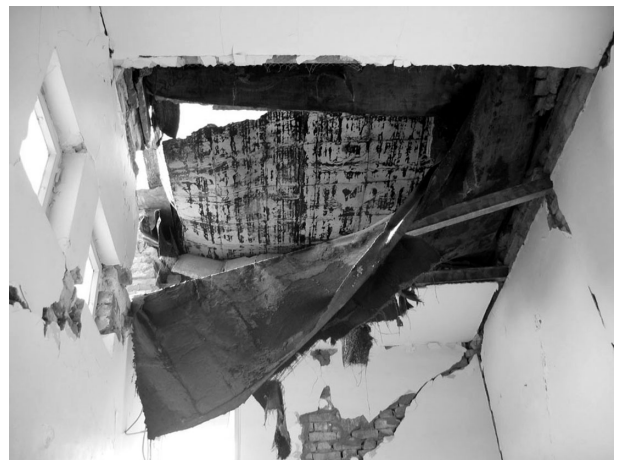
Photo 4. Falling down of the roof of penthouse.

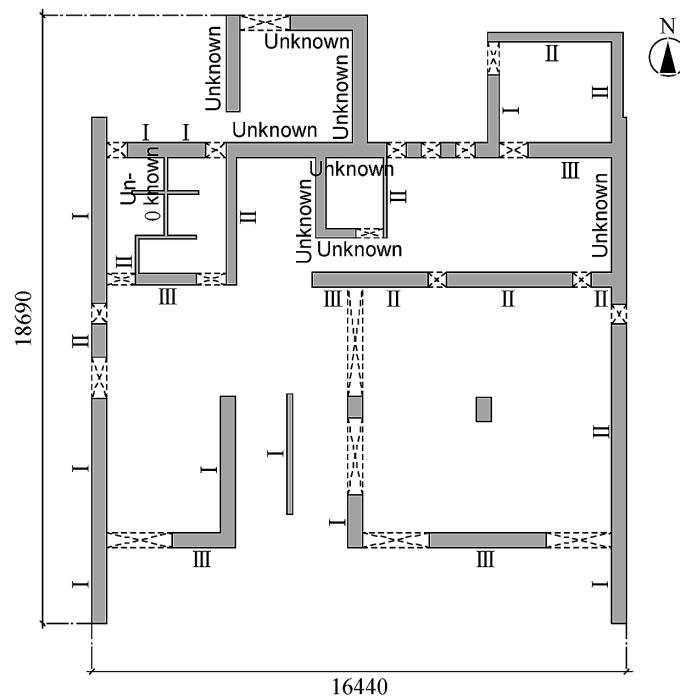
Fig. 11. First floor plan and damage levels of masonry walls of Bam Tourist Inn.

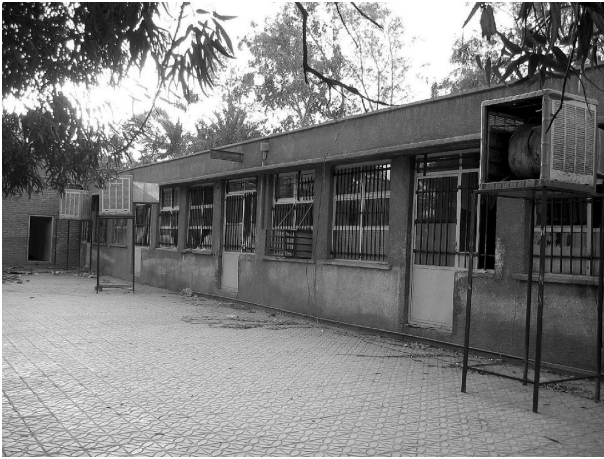
17 Shariwar High-School is located a few hundred meters west of the Governor’s Building and consists of 3 SM buildings. The 2 single-story buildings escaped severe damage, as shown in Photo 5, although minor cracks were found in brick walls. On the other hand, the 2-story building had partially collapsed (Photo 6). This building consists of intermediate steel frame and exterior brick walls. The floor slab system is a jack arch type, mentioned earlier. The floor plan of the collapsed part is shown

Photo 5. Single-story school building (slight damage).

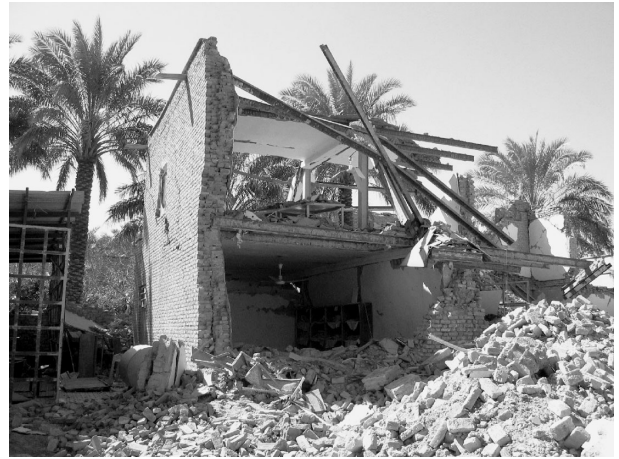
Photo 6. Collapsed two-story school building.

The wall area ratio of the first story obtained is 4.1% in the NS direction and 11.0% in the EW direction. Note that the value in NS was calculated assuming that the area of collapsed east exterior wall is 0, not only because thickness and length of the collapsed wall could not be identified, but also because a very short wall length may be expected due to the existence of windows and doors. The wall area ratio in the NS direction of 4.1%, in which severe damage occurred, is less than values of the 2 buildings mentioned before.

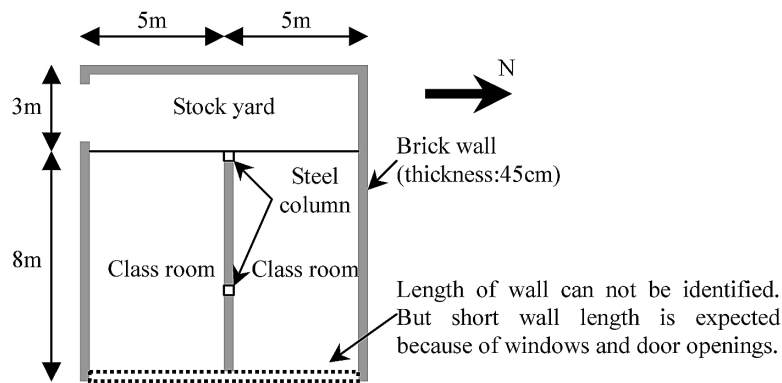
Fig. 14. Floor plan of collapsed part of two-story school building.

in Fig. 14. The roof and floor slab fell off due to the collapse of an east exterior brick wall.

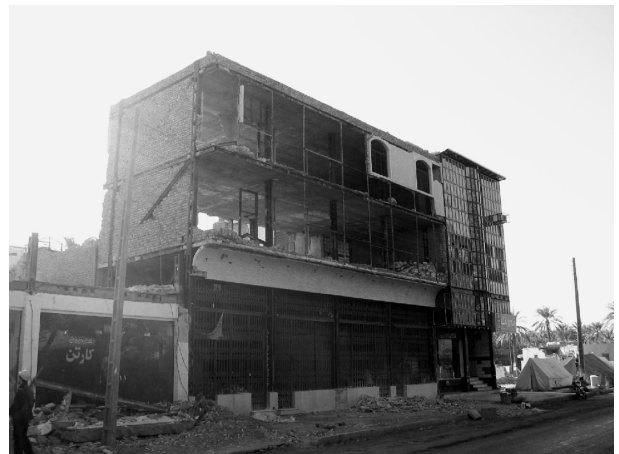
The building under construction (Photo 7) is located a few hundred meters south of the Governor's Building. The structural system of this building is quite typical of the buildings along the main streets

Photo 7. Residence and store building under construction.

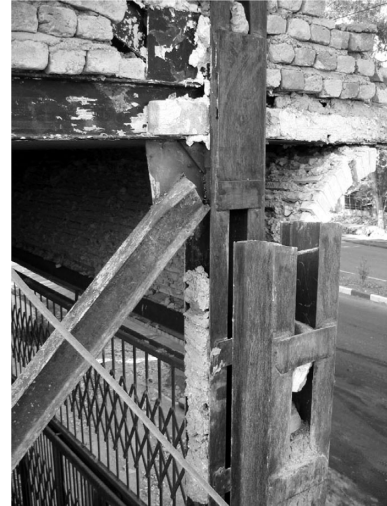
In the first story, fractures of welding joints and buckling of steel braces were observed (Photo 8 and 9). As a result, the brick walls had collapsed. Damage to the brick wall on the second story (Photo 10) was also observed. No remarkable structural damage to the steel columns in NS direction was found, although bricks had fallen off the facade of the building.

Photo 8. Fracture of welded joint of a steel brace.

cm², (2) angle of steel brace is 45 degrees, (3) unit weight of the building for each floor is 800 kgf/m², and (4) floor area is 5.7 m × 16 m = 91.2 m². These assumptions give a base shear coefficient, *C*, of 0.33. This base shear coefficient is lower than the approximated values for both the Governor's building and Bam Tourist Inn, in spite a higher than minimum requirement of 0.19. This may be one reason why this building suffered severe damage. Other reasons may be poor quality of welding (Fig. 8 and 9) and unconfined brick walls.

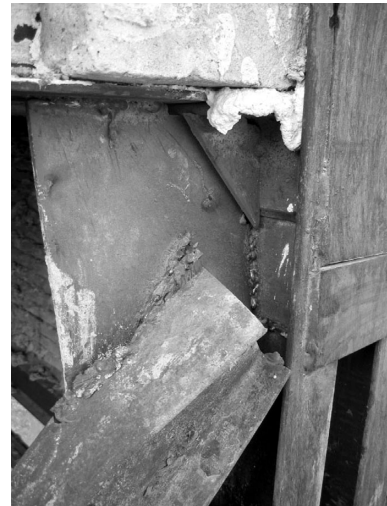
Photo 9. Close-up of Photo 8.

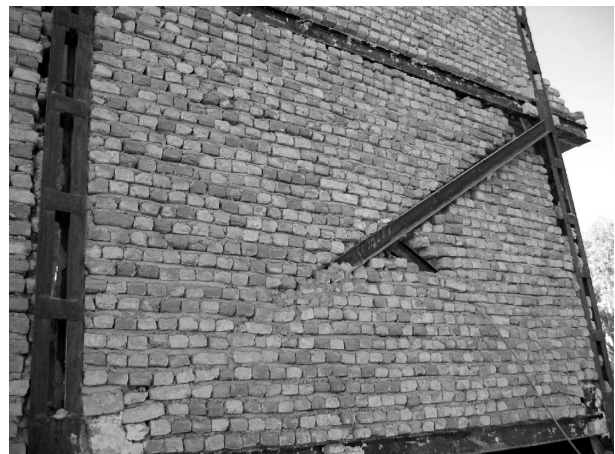
Photo 10. Buckling of steel brace and damage to brick wall.
