NASA AERONAUTICS BOOK SERIES

Lessons Learned from  
Accidents Involving  
Remotely Piloted and  
Autonomous Aircraft

# Crash Course

Peter W. Merlin

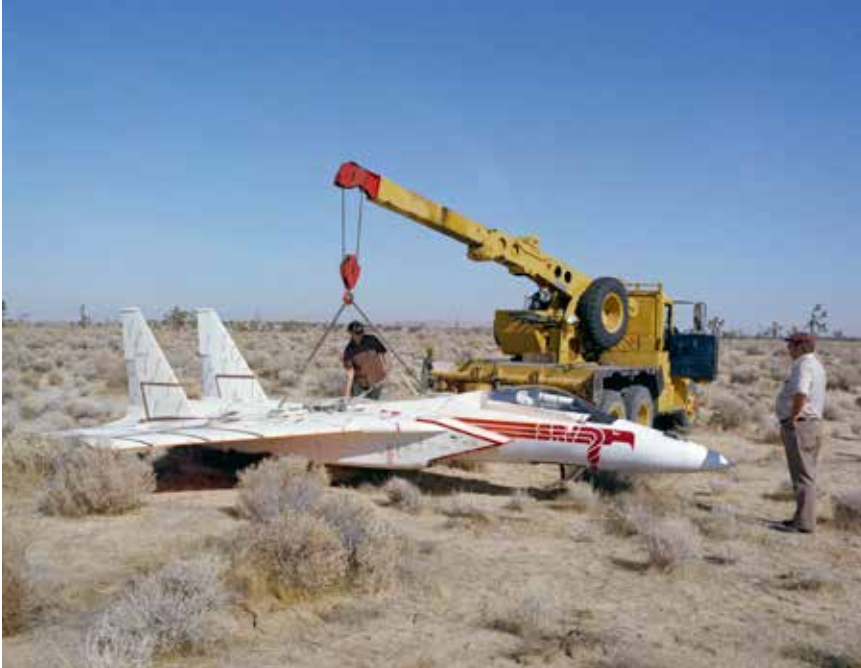
Recovery personnel prepare to lift the F-15 SRV off the Edwards Air Force Base PIRA after the vehicle's spin chute became entangled with the pitot tube. NASA

When flights resumed on February 18, 1981, the new nose parachute caught on the airplane's pitot tube after deployment. Einar Enevoldson guided the vehicle to a landing on the Edwards PIRA with only minor damage. No further problems were encountered during the remaining flights.<sup>25</sup>

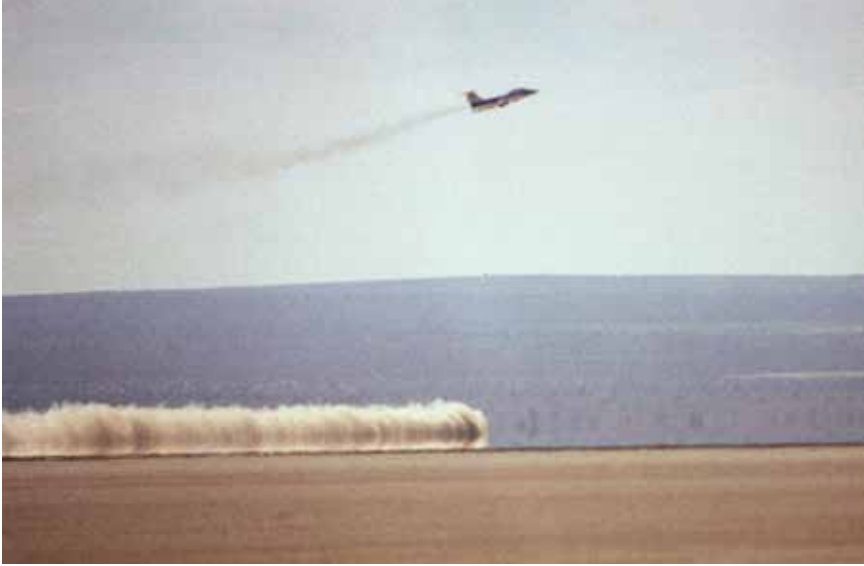
Observers aboard the TF-104G chase plane watch as the HiMAT slides across the dry lakebed on its belly. NASA

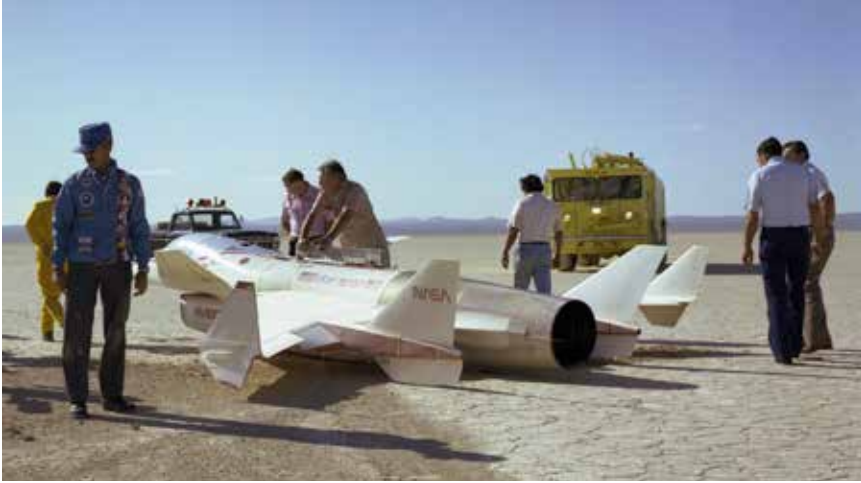
Investigators examine the HiMAT following its belly landing. Fortunately, damage was not extensive. NASA

The HiMAT PCS failure was caused by a mechanical malfunction. The landing gear malfunction stemmed from a software issue.

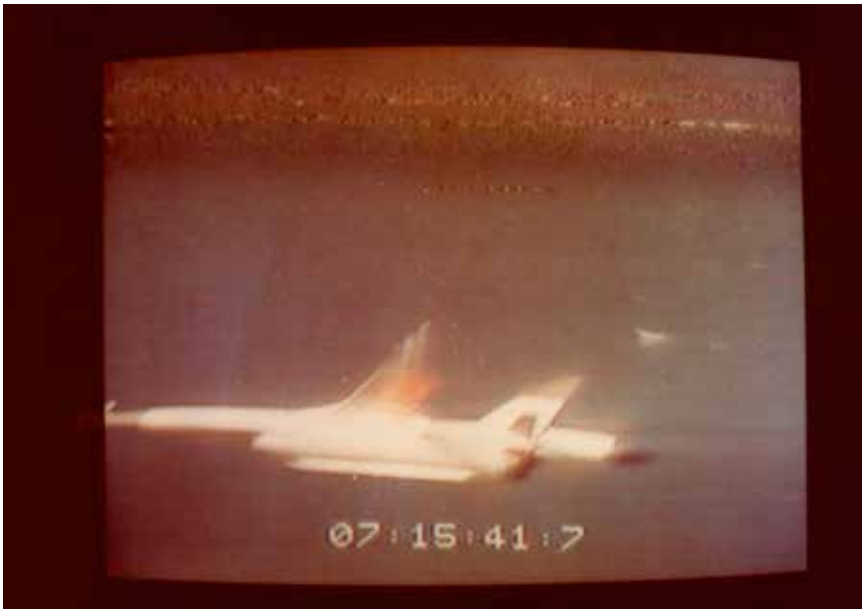
The DAST-1 experienced explosive flutter at Mach 0.825, leading to catastrophic failure of the right wing. NASA

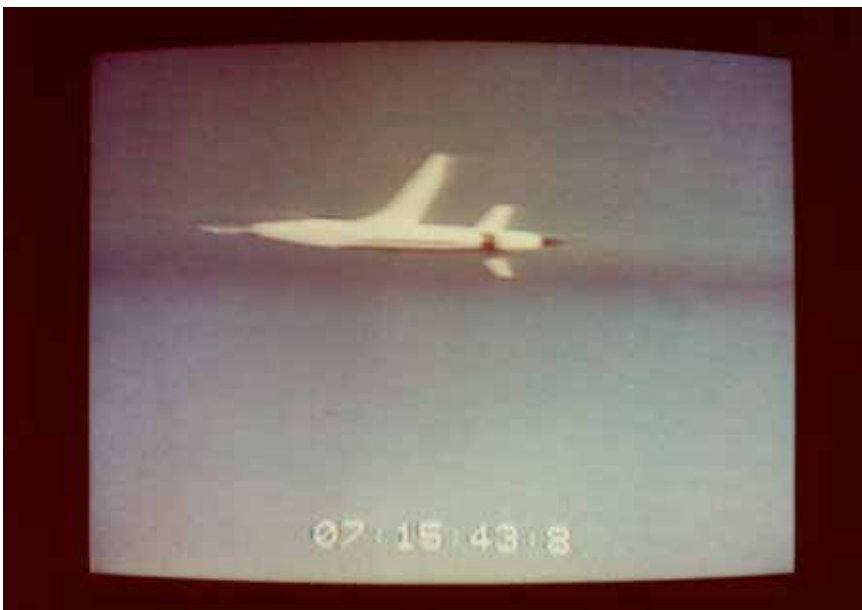
With only one remaining wing, the DAST-1 plummeted toward the ground. NASA

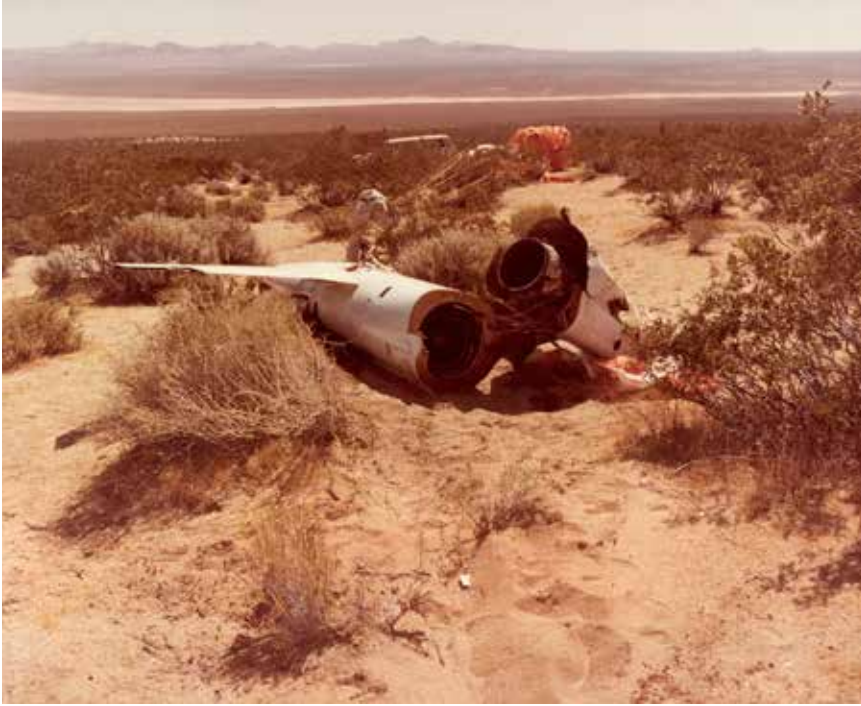
Because high-speed deployment conditions prevented full inflation of the main-parachute canopy, the DAST-1 was badly damaged when it struck the ground. NASA

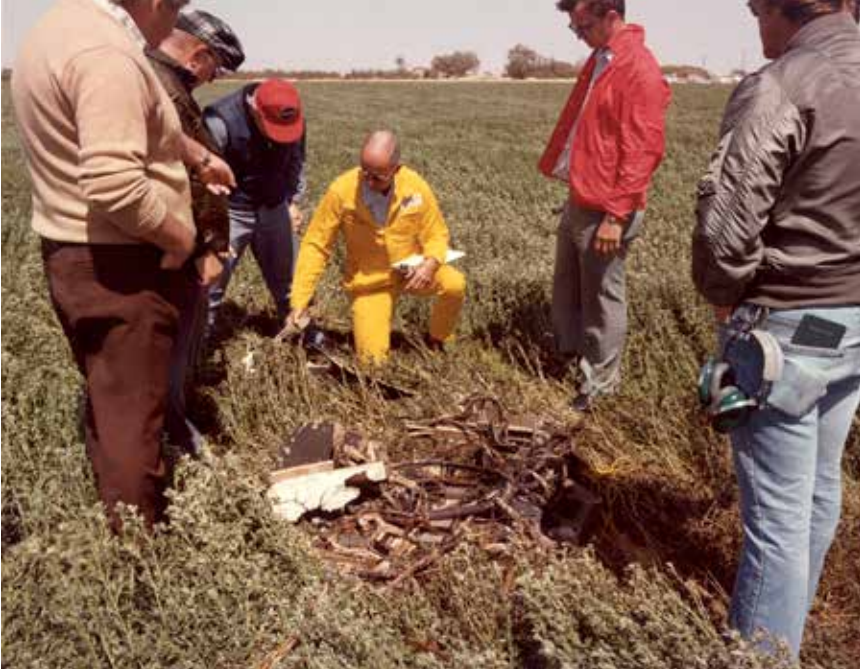
Investigators examine the DAST-2 wreckage at the crash site. The primary cause was traced to an electrical problem. NASA

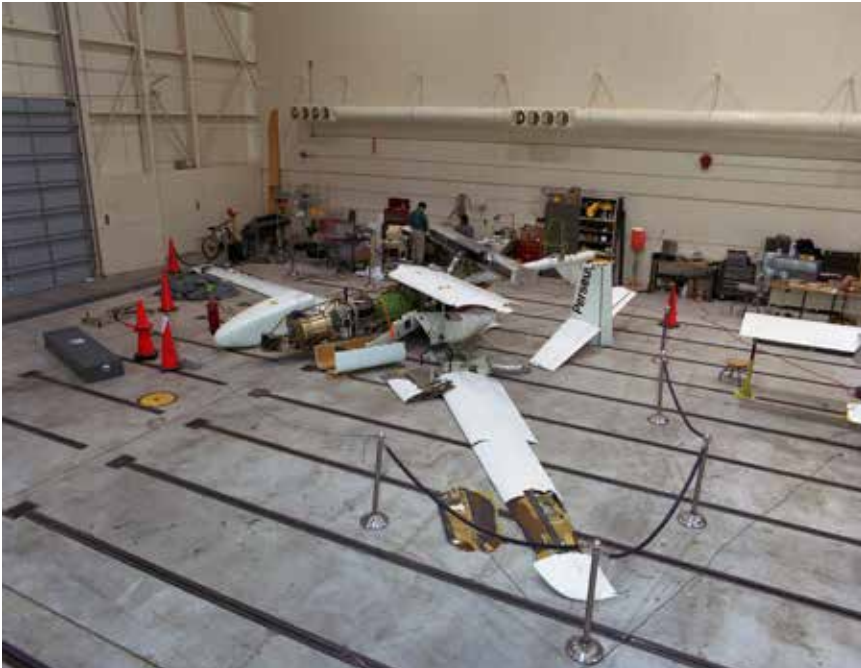
Investigators recommended that the Perseus vehicles not be flown again until the vertical gyro failure was resolved. NASA

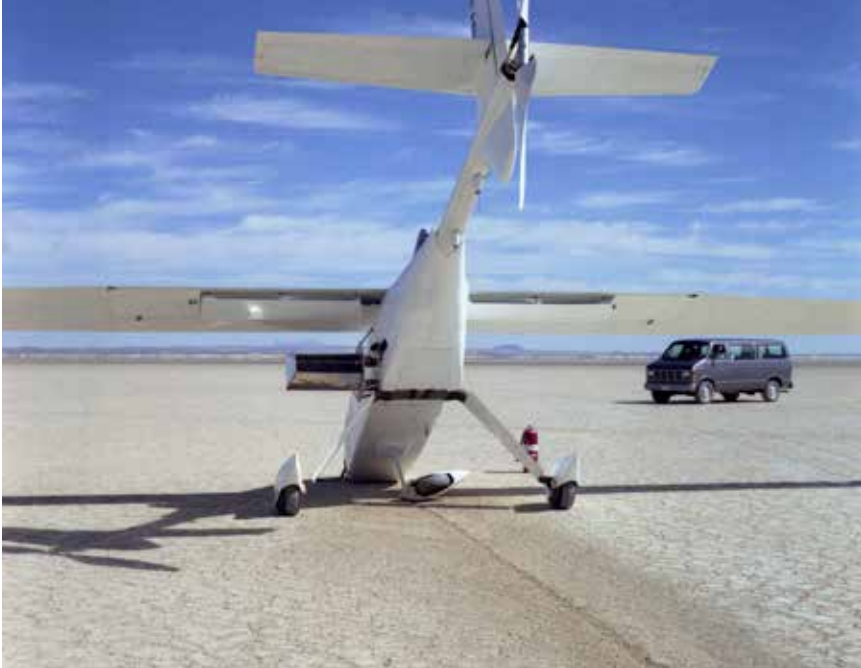
Nose-gear collapse following the maiden flight of Perseus-B damaged the vehicle's composite nose assembly. NASA

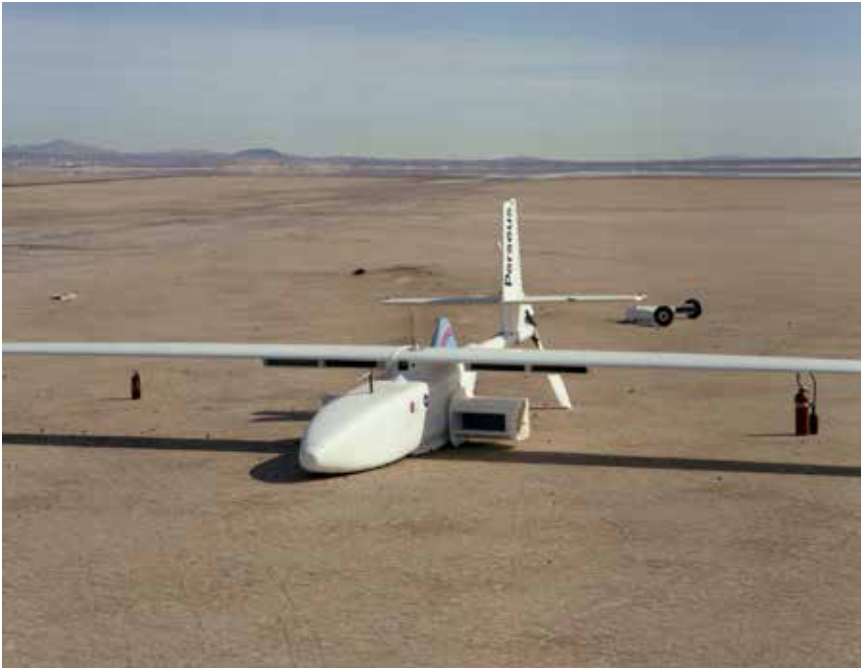
During a 1996 flight, a hard touchdown on the lakebed resulted in major damage to the landing gear, nose, and propeller tips. NASA

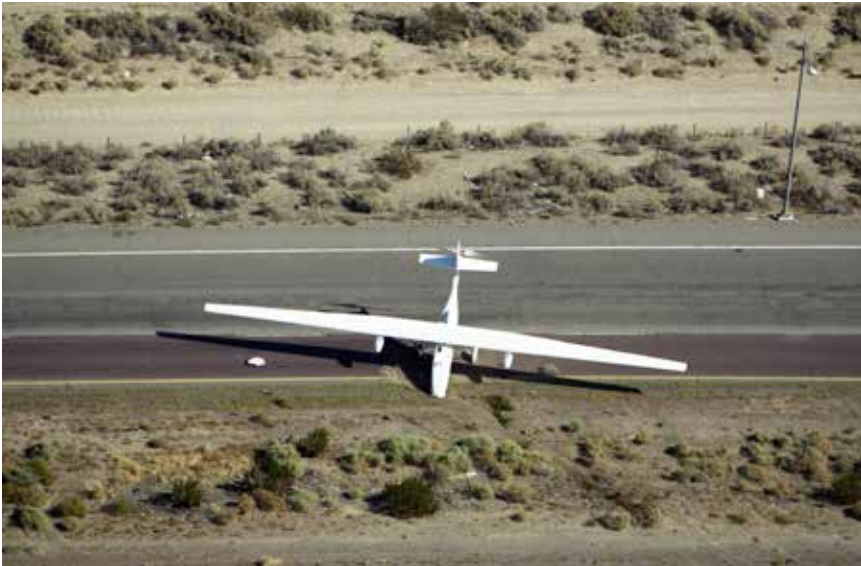
Failure of the flight-termination system led to an unplanned landing of Perseus-B on a major highway. NASA

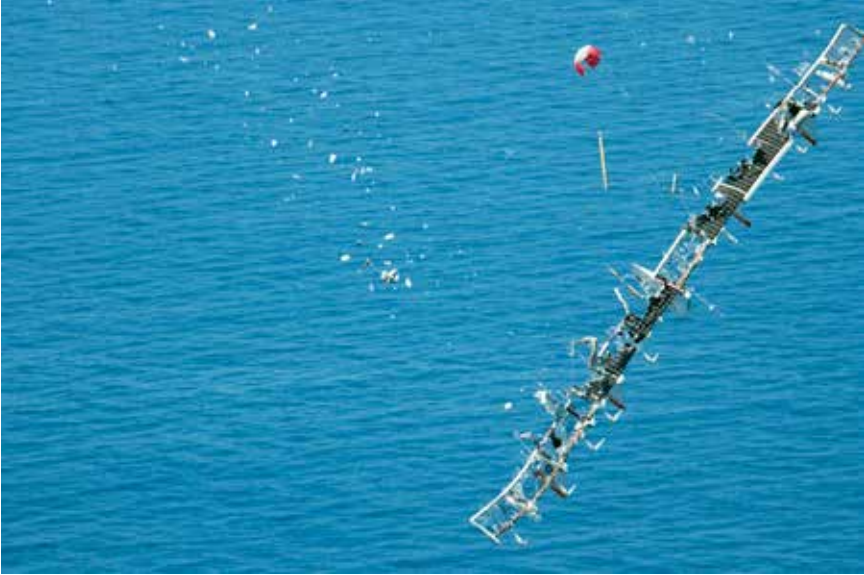
The Helios Prototype sheds parts as it plummets toward the ocean. The FTS worked exactly as designed. NASA

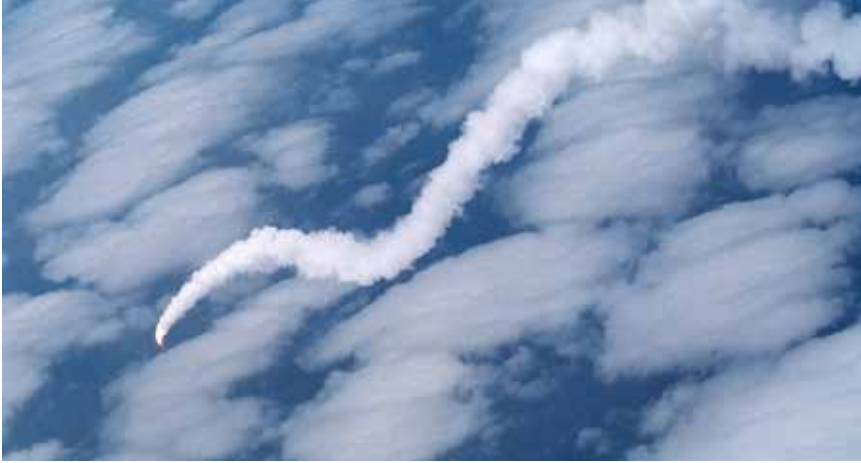
Divergent roll oscillatory motion caused by excessive control-system gain resulted from inadequate analytical modeling that allowed engineers to overestimate system safety margins. NASA

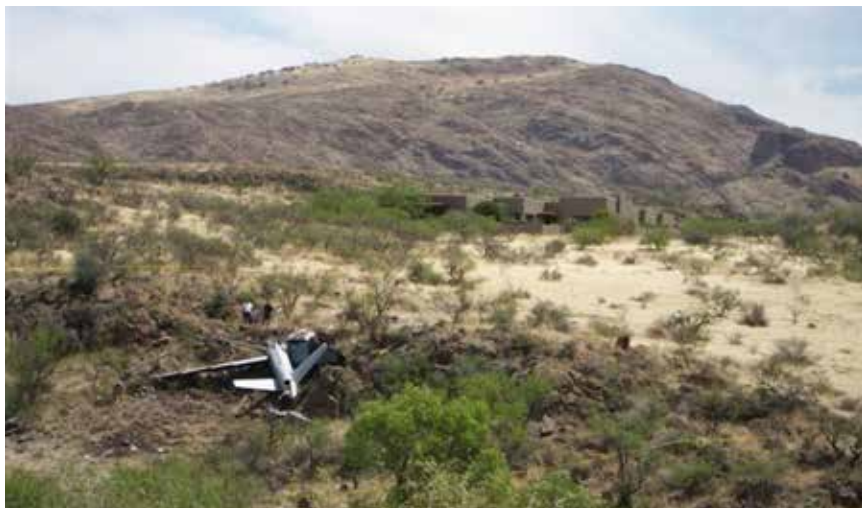
The MQ-9 crashed in a sparsely populated residential area, but there were no injuries or damage to private property. Mae Duggin
