# A Screening Method Using Pulsed-Power Combined with Infrared Imaging to Detect Pattern Defects in Bulk Metal Foil or Thin Film Resistors

Jay Brusse<sup>(1)</sup>, Lyudmyla Panashchenko<sup>(2)</sup>

To be published in the conference proceedings of the Space Passive Component Days (SPCD) international Symposium, Noordwijk, The Netherlands, October 9-12, 2018.

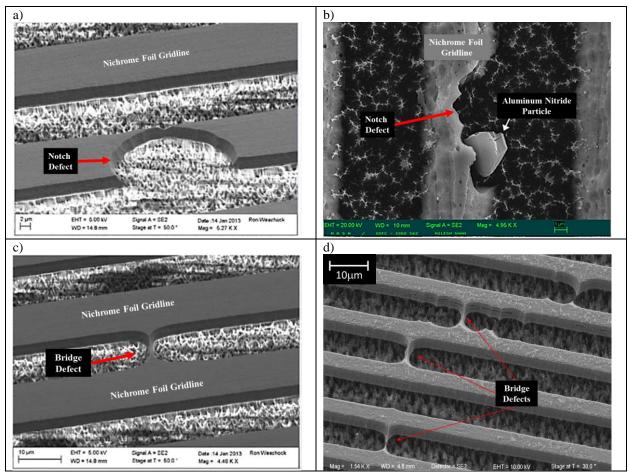
Notch defects are localized holes in the resistor gridline that reduce the gridline cross sectional area below the original design intent. Notches that take away >75% of the nominal resistor line width are considered to be unacceptable by some workmanship inspection criteria [3, 11] when the pattern is inspected at 30x magnification. The causes of notch defects include pre-existing pin holes in the foil sheet prior to etching, photolithography/etching-related anomalies and non-conductive particles (e.g., aluminum nitride) embedded in the foil [5]. If a notch defect breaks, then the electrical continuity of the gridline pattern is interrupted usually resulting in an open circuit failure mode. If the disrupted section of the resistor pattern has an associated parallel pathway, then a positive resistance shift occurs.

Bridge defects, as the name suggests, are sections of foil resistor material that interconnect two or more adjacent gridlines. Bridges whose narrowest width is <10% of the nominal resistor line width are considered to be unacceptable [3, 11]. The primary causes of bridge defects are related to photolithography/etching anomalies that result in a failure to completely remove foil material from the spaces between adjacent lines as intended. Bridges form unintentional parallel resistor pathways within the serpentine pattern. If during the trimming operation the manufacturer cuts a shorting tab associated with a section of the pattern containing bridge defects, then these bridges and the parallel resistance pathways they produce become essential features of the overall resistance value. Any disruption of the bridge would result in removal of the parallel path and an associated increase in resistance value.

Fig 3. Destructive Physical Analysis (DPA) Examples of Constriction Defects in Foil Resistors

- a) Large Notch Defect in Gridline,
- b) Notch Defect Associated with an Aluminum Nitride Particle Embedded in the Foil,
- c) and d) Bridge Defects Between Adjacent Gridlines

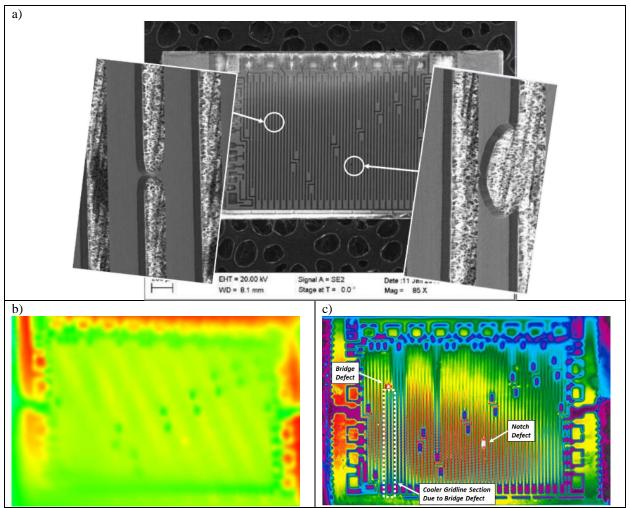
In our previous work [12] we first used the pulsed-power infrared inspection technique to examine a resistor that had failed the DPA workmanship criteria. During DPA both the polymer and epoxy coatings over the resistor element were removed. After coating removal, scanning electron microscopy (SEM) inspection identified both a notch and a bridge defect in the active region of the pattern each of which failed the established workmanship criteria in [3, 11] (i.e., notch > 75% of gridline width and bridge < 10% gridline width).

Fig 6. Inspection of a Single DPA Sample Foil Resistor Having 1 Notch and 1 Bridge Defect a) SEM Images, b) Low Resolution Infrared FLIR SC660, and c) High Resolution Infrared FLIR SC8300

The difference in resolution of the images acquired by the two infrared cameras was remarkable. Hot spots associated with both the notch and bridge defects (seen as white in this color palette) were readily identified by the FLIR SC8300 whereas the same defects were not discernable with the SC660. Even without a-priori knowledge from high-magnification SEM inspection, the high-resolution infrared image can be used to identify the constriction defect type. For example, the notch defect shown in Fig. 6 is revealed as a hot spot contained within a single gridline run. The notch is also identifiable by noting that the temperatures of the gridline runs entering and exiting the notch are approximately the same magnitude since the current flowing in each is the same and therefore, so too is the Joule heating. The bridge defect in Fig. 6 appears as a hot spot between two adjacent gridlines. The bridge can also be recognized by the much cooler temperature of the gridline section beyond the bridge defect where less current is flowing due to the bypass provided by the bridge. These initial results provided the motivation to pursue the use of the FLIR SC8300 as a non-destructive, post-procurement screening inspection tool.

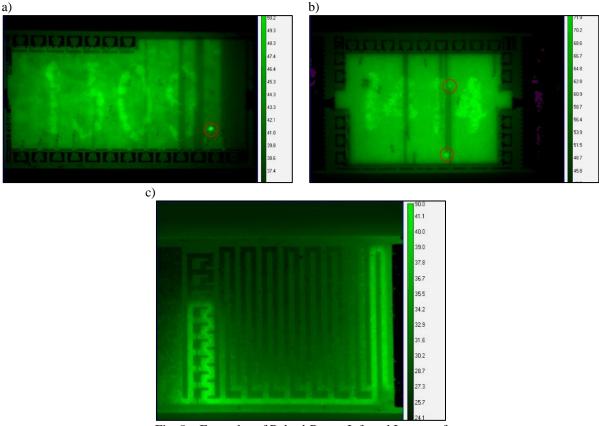
Next, infrared inspection was performed on several surface mount foil resistors and some surface mount thin film resistors while applying brief power pulses as described in Fig. 4. Fig. 8 provides a few examples of the kinds of pulsed-power infrared images obtained at this stage of development. The infrared camera's software allows selection of a variety of color palettes to represent different temperatures within the field of view. For these images the green palette was chosen where darker colors are cooler and lighter colors are hotter. Note: Due to differences in the emissivity of the marking ink compared to the other materials, the part markings give a false impression of hotter temperatures at their location.

Fig. 8 – Examples of Pulsed-Power Infrared Images of
a) Foil Resistor with a Notch Type Defect, b) Foil Resistor with 2 Bridge Type Defects and
c) Thin Film Resistor with No Defects

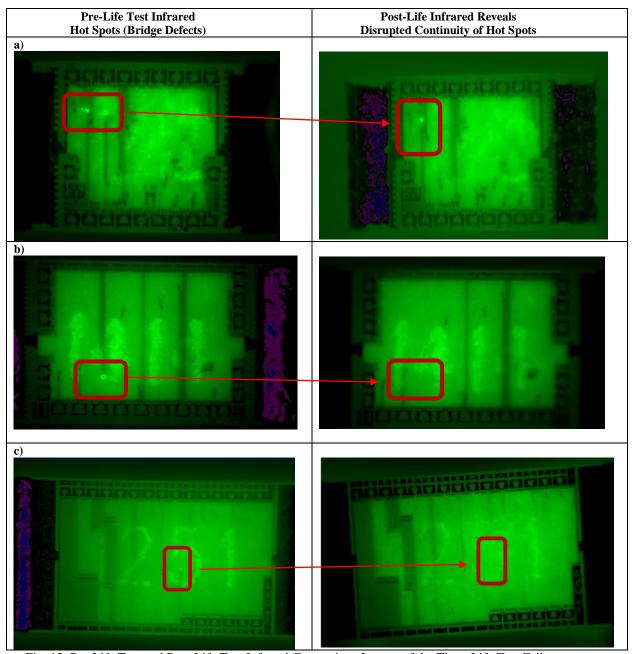
The pre-life test and post-life test infrared images for each of the three life test failures are shown in Fig. 12. These comparison images show that each of these three resistors had 'significant' hot spots identified prior to life test and by the conclusion of life test either 1 or 2 bridge defects per resistor had lost electrical conductivity as evidenced by the disappearance of the hot spots in the post-life test infrared images.

Since S/N 12 (0805 -  $5.1k\Omega$ ) exhibited two distinct and large positive resistance shifts (see Table 5), it is a good example to discuss the correlation between the resistance shifts and the infrared signature changes during life test. Fig. 12a shows that prior to life test S/N 12 contained 4 distinct hot spots each consisting of a bridge defect between adjacent gridlines. After life test, only 2 of the original 4 hot spots remained indicating that the other 2 bridge defects had become electrically open (i.e., non-conducting) during life test. As described earlier, the disruption of a bridge defect results in a positive resistance shift due to the removal of the parallel resistance pathway created by the bridge.

Fig. 12. Pre-Life Test and Post-Life Test Infrared Comparison Images of the Three Life Test Failures

- a) Size 0805, 5.1kΩ, S/N12, Type C,
- b) Size 1206, 20kΩ, S/N 28, Type A,
- c) Size 2010, 50kΩ, S/N 48, Type B

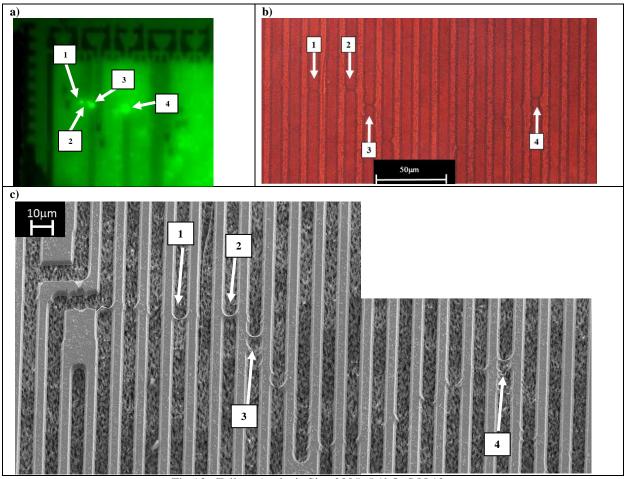
Fig 13. Failure Analysis Size 0805, 5.1kΩ, S/N 12

The results of these inspections are shown in Figs. 13 and 14. Fig. 13a shows the pre-life test infrared image of a resistor that had 4 significant hot spots each associated with a bridge defect. Fig. 13b is an optical microscopy image of the same resistor after removal of the opaque epoxy coating. Optical inspection through the translucent polymer coating that protects the resistor element shows certain aspects of these 4 bridge defects. However, especially at higher magnifications, factors such as focal range and optical reflections from the complicated shapes of the constrictions make it exceedingly difficult to quantify the dimensions of such defects. Fig. 13c shows a SEM view of the same region from Fig. 13b after complete removal of the polymer coating. The SEM, with its superior focal depth and magnification capabilities, reveals enhanced details of constriction defects not possible with optical microscopy.

- a) Infrared Image Showing 4 Hot Spots Associated with Bridge Defects
- b) Transmitted Light Microscopy Montage Image Highlighting Bridge Defects in a),
- c) SEM Image of Region Shown in b)

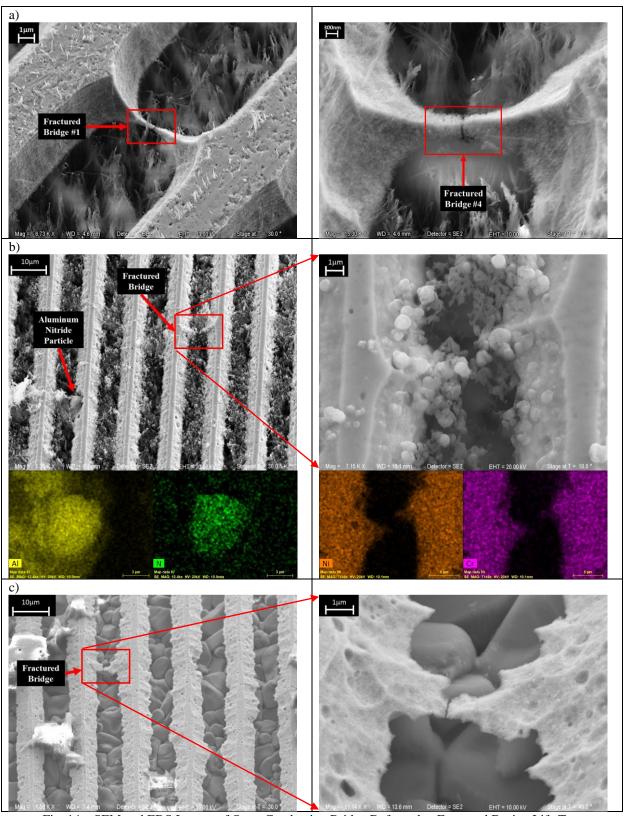
Fig. 14 shows that the failure sites for all 3 life test failures were identified and confirmed to be fractured bridge defects consistent with the locations of the pre-life test hot spots that had disappeared at discrete time intervals during life test. Each of these previously-conducting bridge defects fractured at the approximate mid-point in their span producing an open circuit condition in the bridge. The fractured bridges resulted in the removal of parallel resistance pathways in each resistor pattern thus producing the observed positive resistance shift failure modes. Detailed inspection of the fractured bridges shows no evidence of melting nor tensile stretch-to-break failure. Instead, the fractures are all consistent with cyclical fatigue fracture. The source of cycling was thermomechanically-induced by the on/off power cycling that resulted in hot spot expansion and contraction during the life test.

Fig. 14 – SEM and EDS Images of Once-Conducting Bridge Defects that Fractured During Life Test a) Size 0805, 5.1k $\Omega$ , S/N12, Type C, Showing the Fractured Bridges Labeled "1" and "4" in Fig. 13, b) Size 1206, 20k $\Omega$ , S/N 28, Type A Fractured Bridge and EDS of an Embedded Aluminum Nitride Particle c) Size 2010, 50k $\Omega$ , S/N 48, Type B, Fractured Bridge Defect

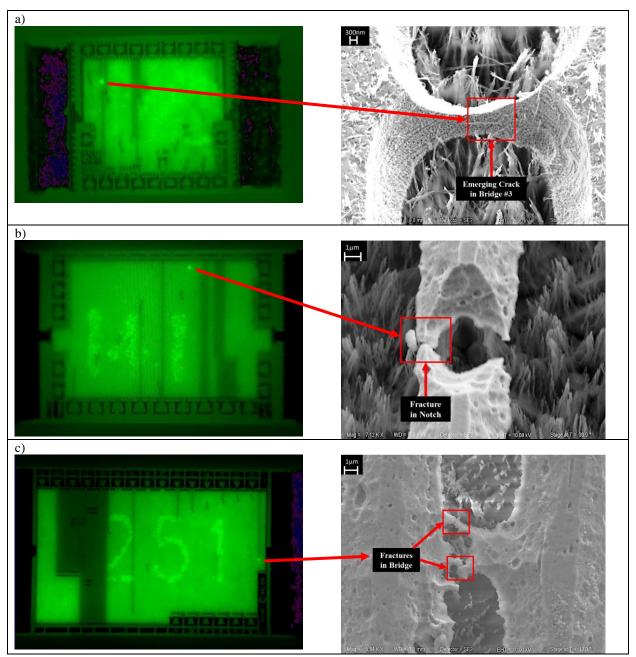
Three resistors with significant hot spots that persisted after life test were also deprocessed as described above to enable detailed SEM inspection (see fig. 15). High magnification SEM inspection of these three resistors showed evidence of emerging (fig. 15a) and/or near-complete fracture of the constrictions associated with these hot spots. In particular figs. 15b and 15c show evidence of near-complete fracture of the constriction. It is possible resistors in this condition will exhibit intermittent resistance changes caused by small displacements of the fractured ends that make and break pressure contact between the ends of the constriction. Such displacements may be produced by changes in ambient temperature leading to expansion and contraction of the resistor materials. Intermittent behavior like this would be very difficult to detect during life test since continuous resistance monitoring is not used.

Fig. 15. Infrared and Corresponding SEM Images of Constriction Defects that Remained Intact Through Life Test a) Size 0805, 5.1kΩ, S/N12, Type C, Bridge Defect (see Fig. 13 bridge #3) with Emerging Fracture

- b) Size 1206, 20kΩ, S/N 25, Type A, Notch Defect with Near-Complete Fracture
- c) Size 2010, 50kΩ, S/N 33, Type B, Bridge Defect with Two Near-Complete Fractures
