Image Analysis Overview

Multilateral Imagery Working Group Technical Interchange Meeting

NASA Johnson Space Center
Image Science and Analysis Group (ISAG) (XI4)

May 2018

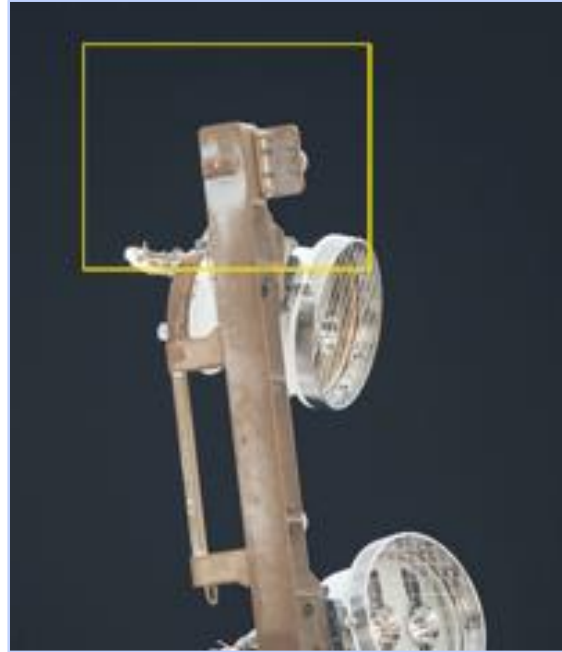
S1 CETA Light Stanchion

Possible MMOD Strikes

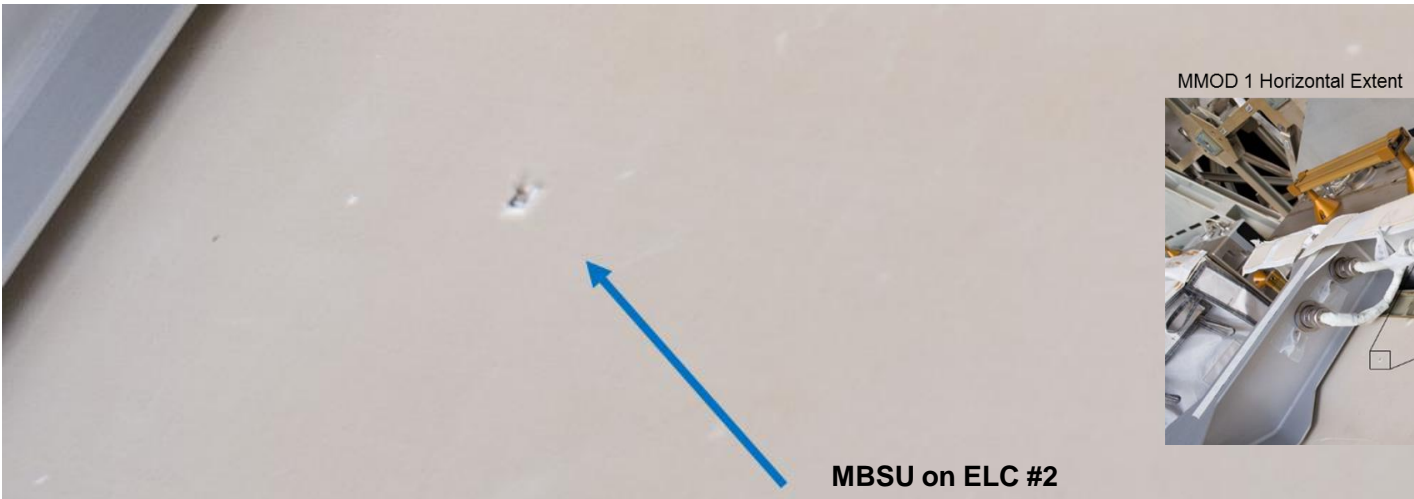
MBSU on ELC #2

MMOD 1 Horizontal Extent

0.21 inches +/- 0.01

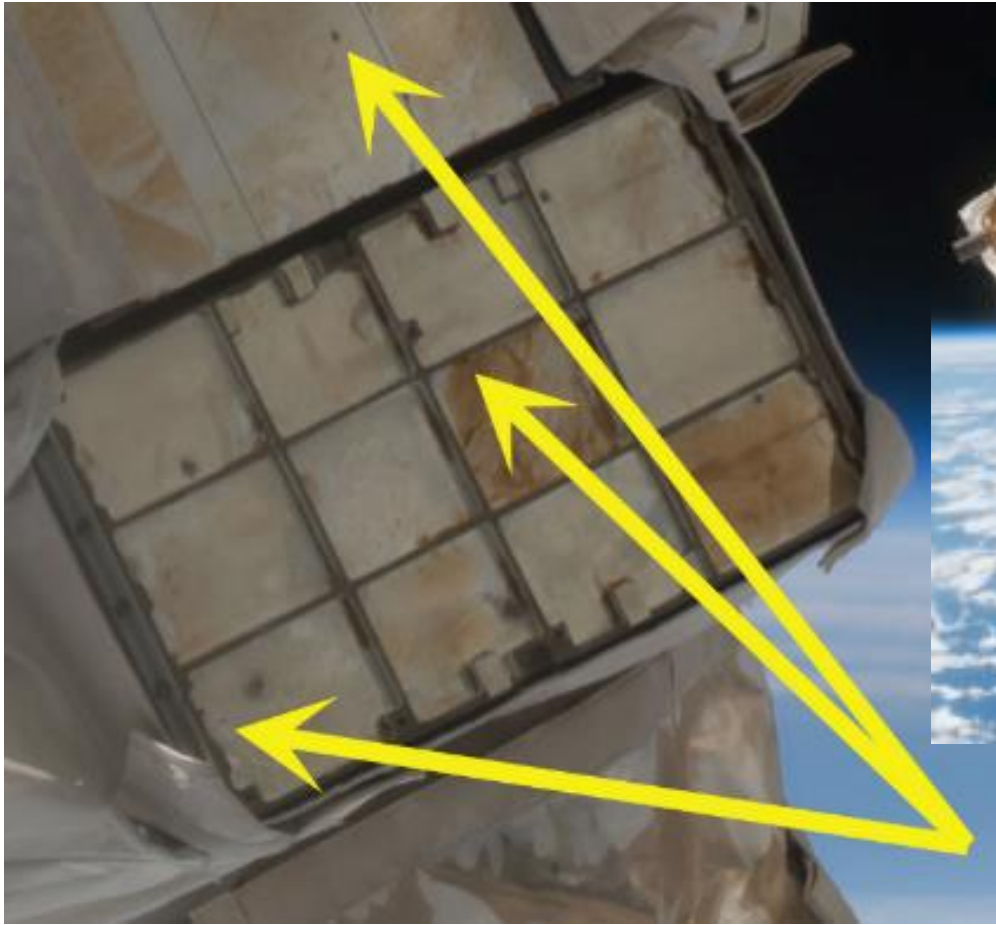
SSRMS LEE B

Possible MMOD Strikes

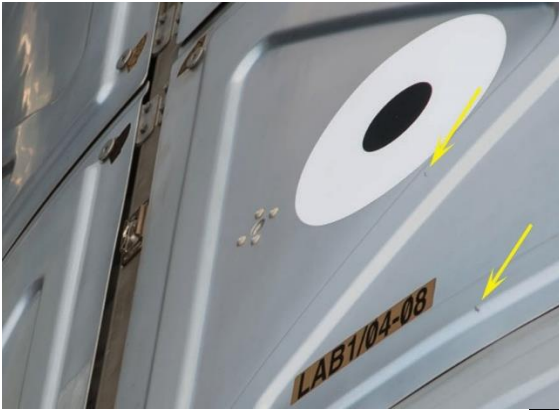
US Lab Module Nadir Side

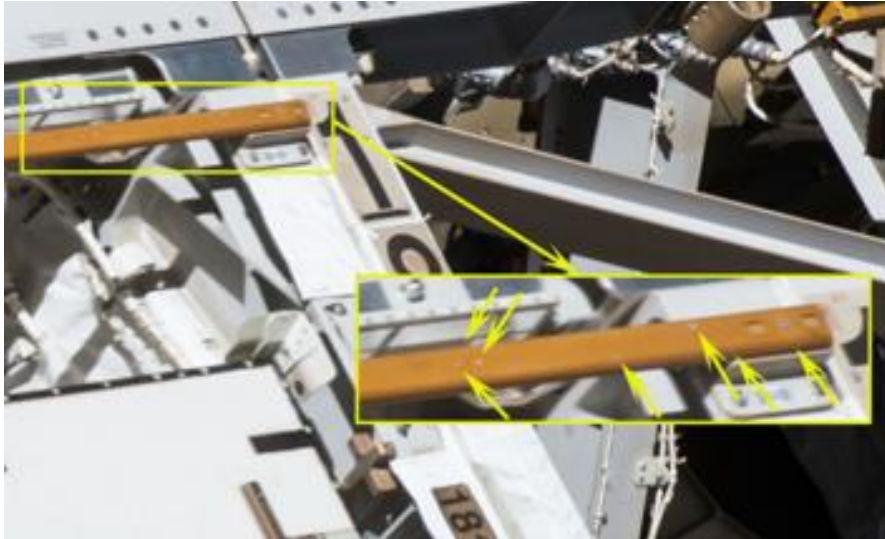
EVA Handrail Sharp Edge Risk

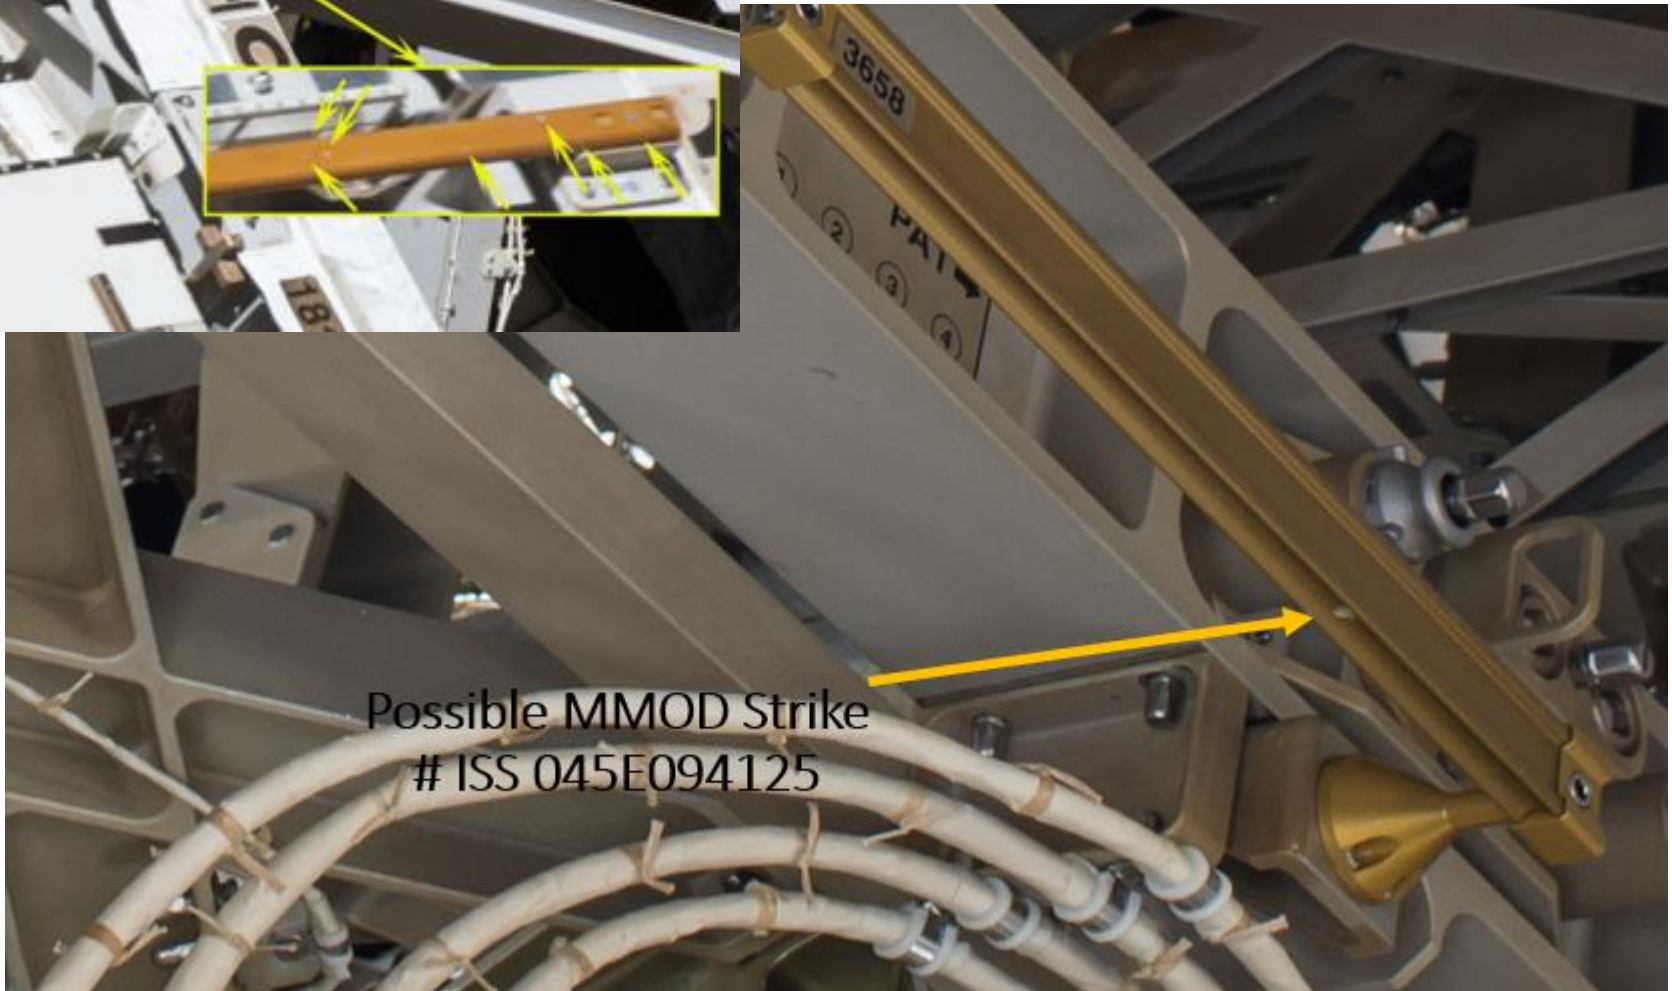
Trailing Thermal Control Radiator (TTCR)

MMOD Strike

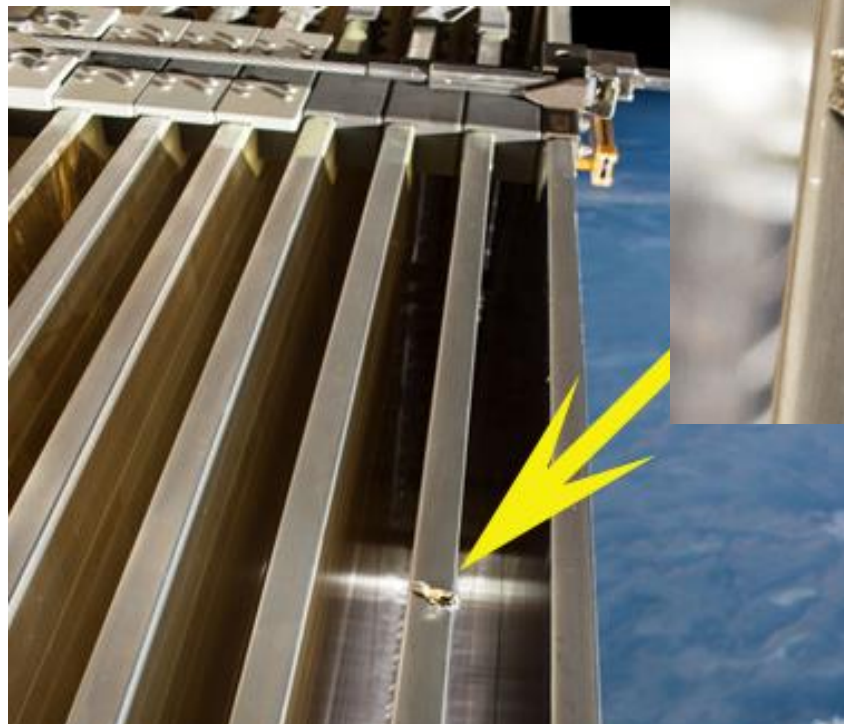
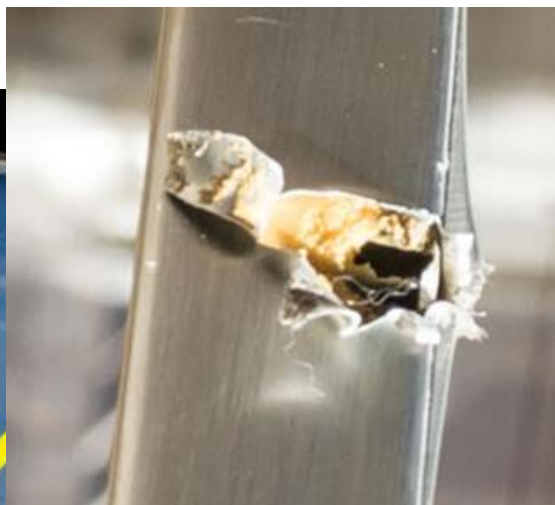
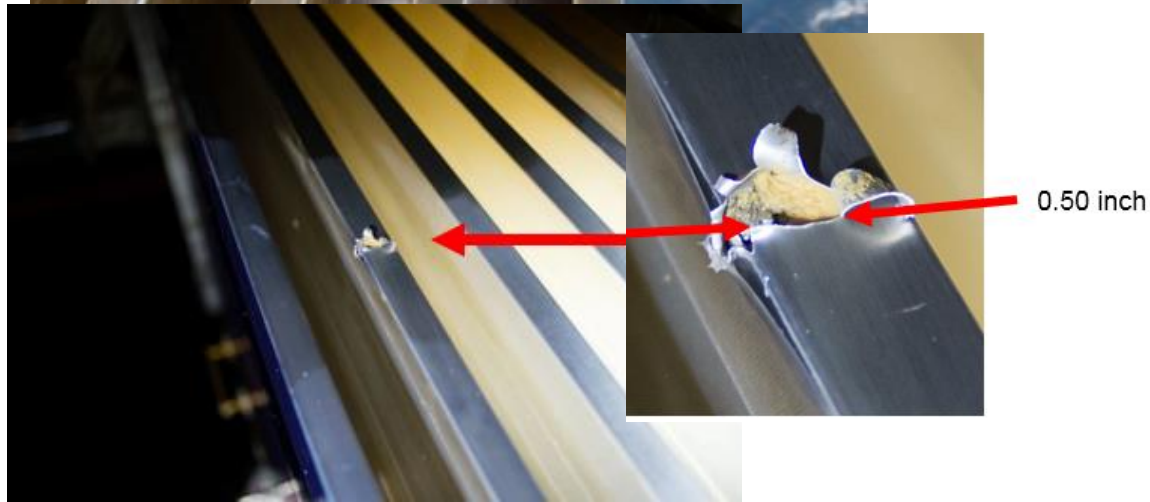
Deterioration Observed on SM LIRA Antenna

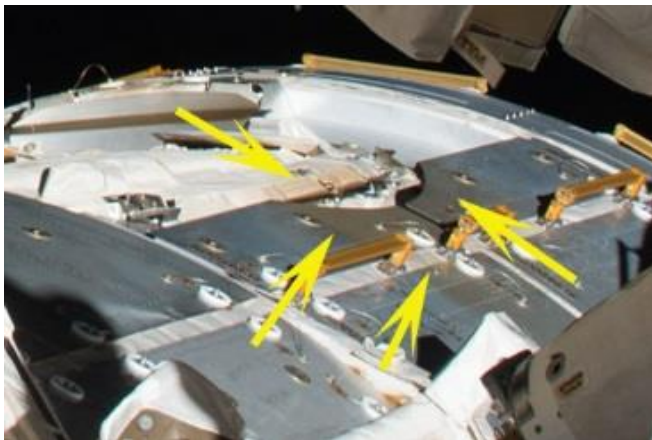
Discoloration on Node 2 Nadir CBM

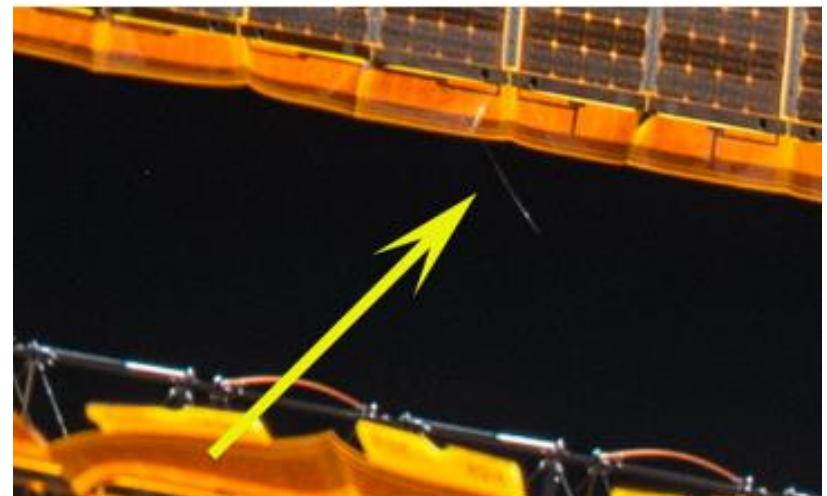
Part of P6 SAW Blanket Material or Wire Hanging From Blanket

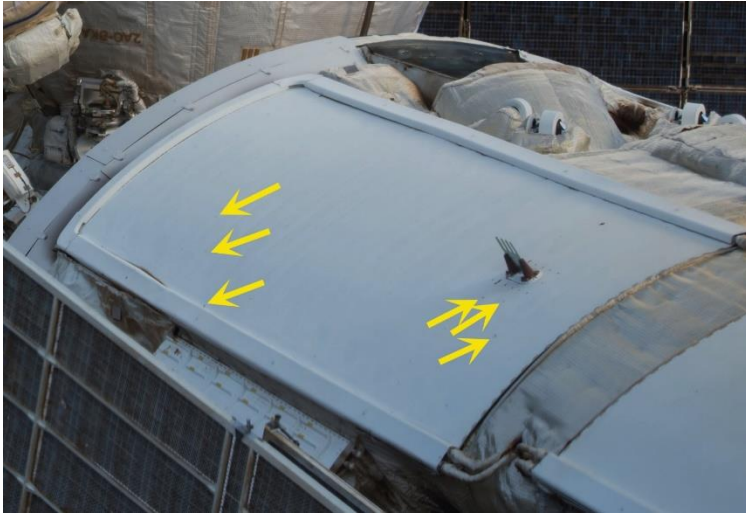
Possible MMOD Strikes or Paint Chips on FGB; Nadir

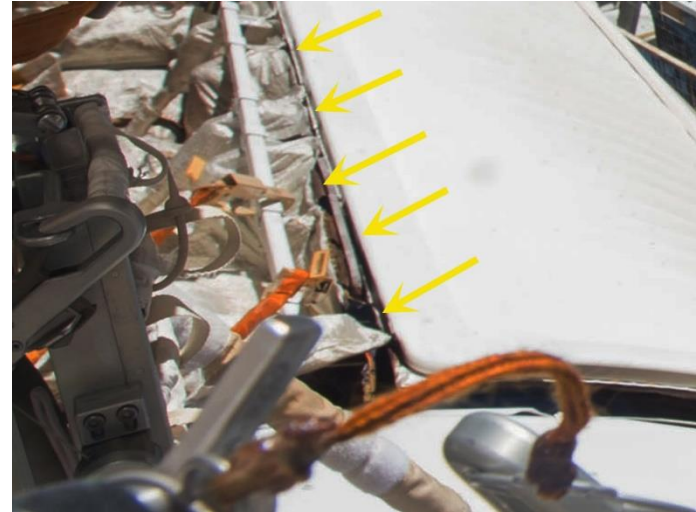
Possible MLI Lifted on FGB; Plane 3 /Zenith

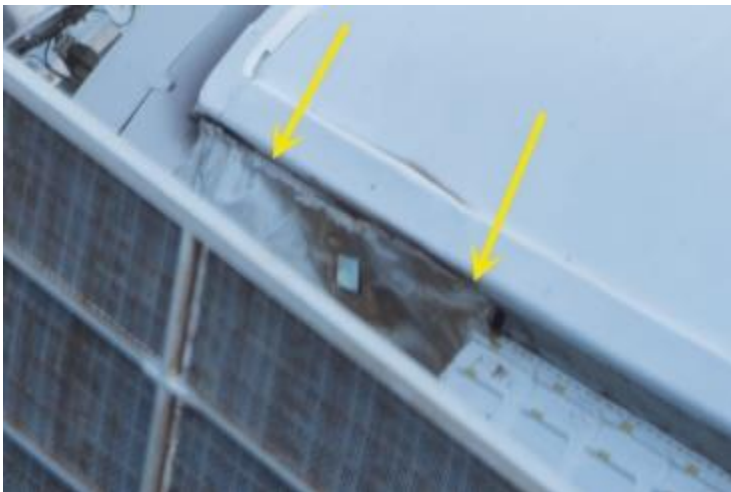
Discoloration Observed on FGB MLI Next to Radiator; Plane 1 /Nadir

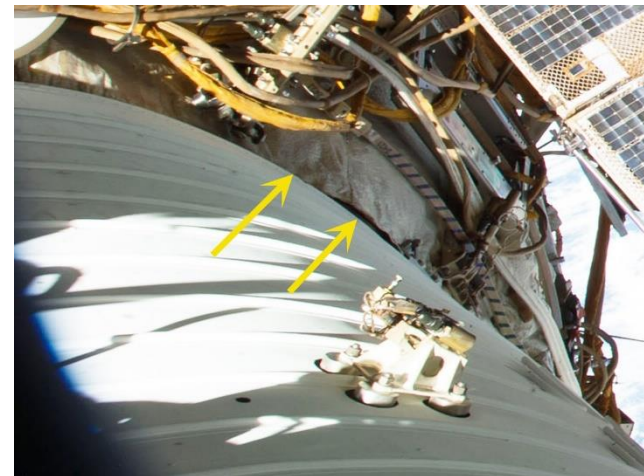
Lifted MLI on Service Module; Plane 3 /Zenith

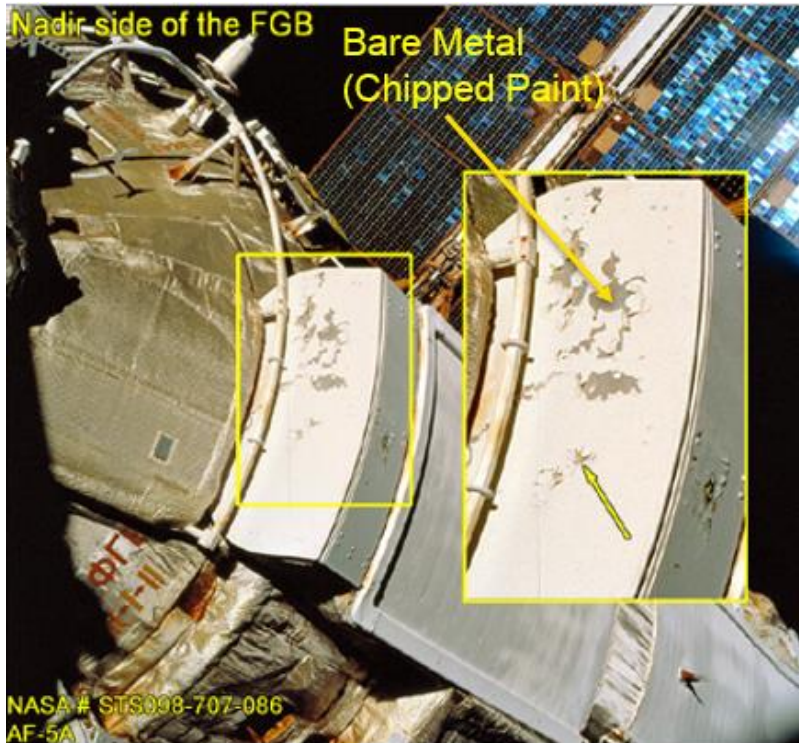
STS-098/AF-5A Chipped Paint on FGB MMOD Shielding Panel

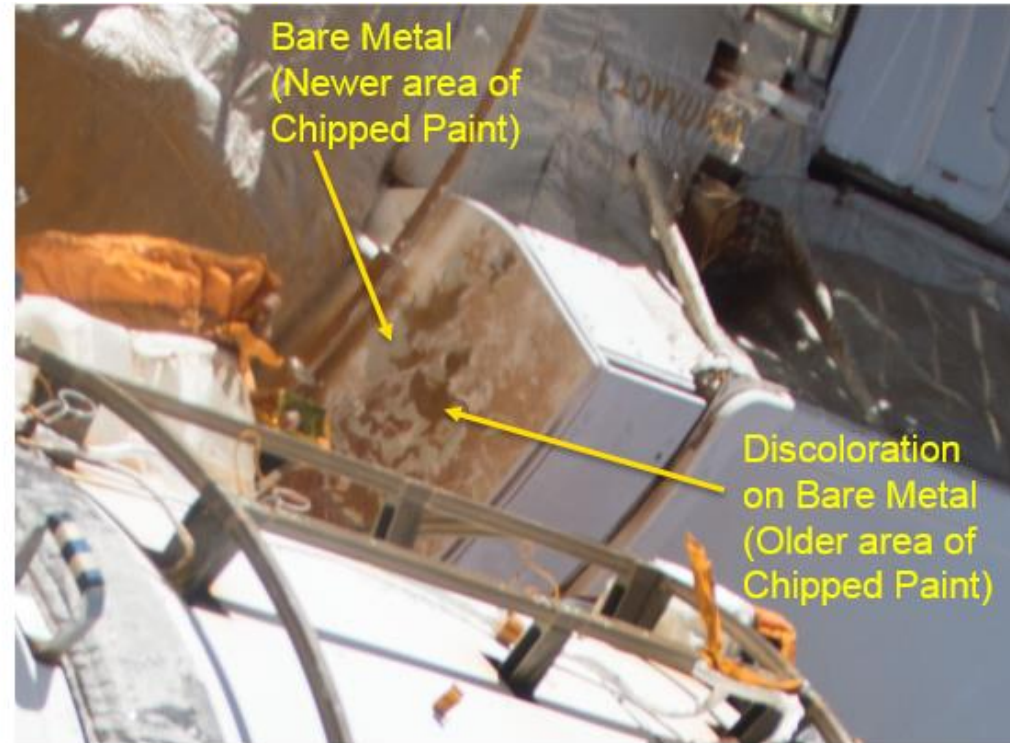
Increment 47 Chipped Paint and Discoloration on same FGB MMOD Shielding Panel

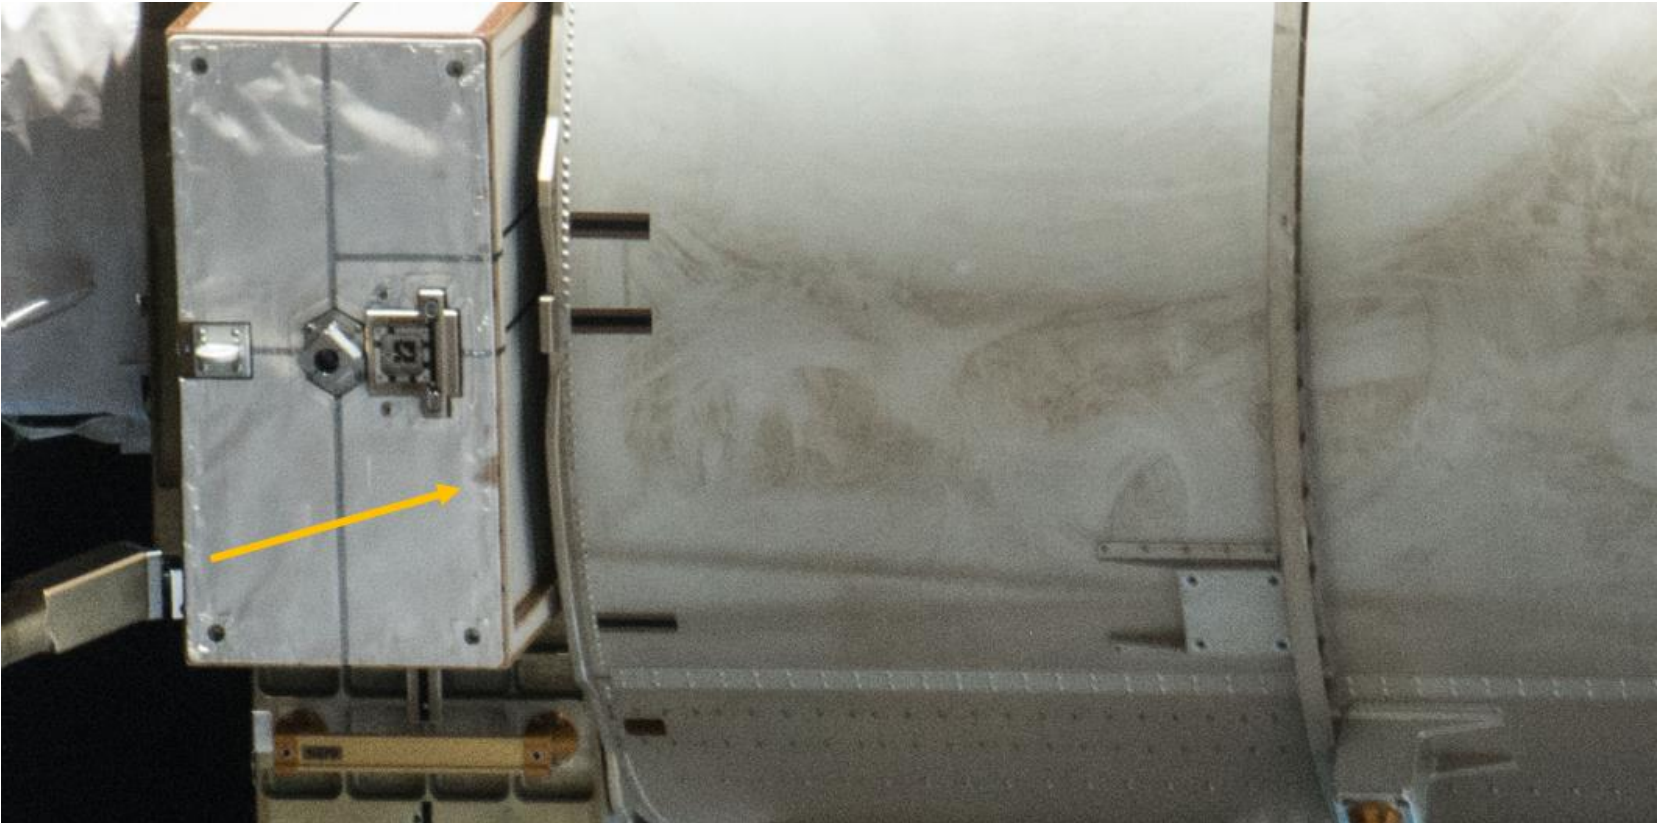
MLI Damage and Discoloration on S6 Mast Canister

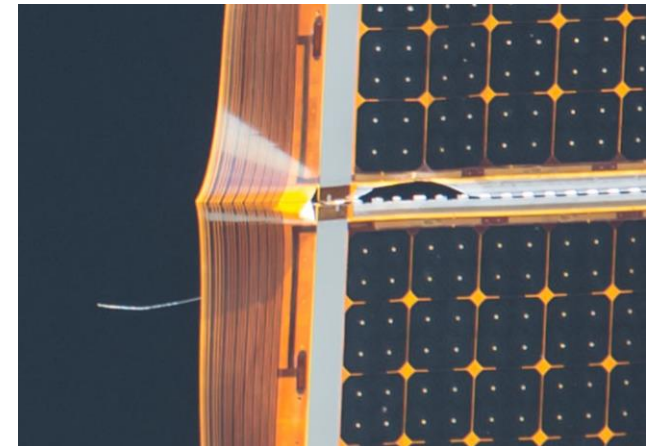
“New” 7 inch tear is visible on Solar Array 3B.

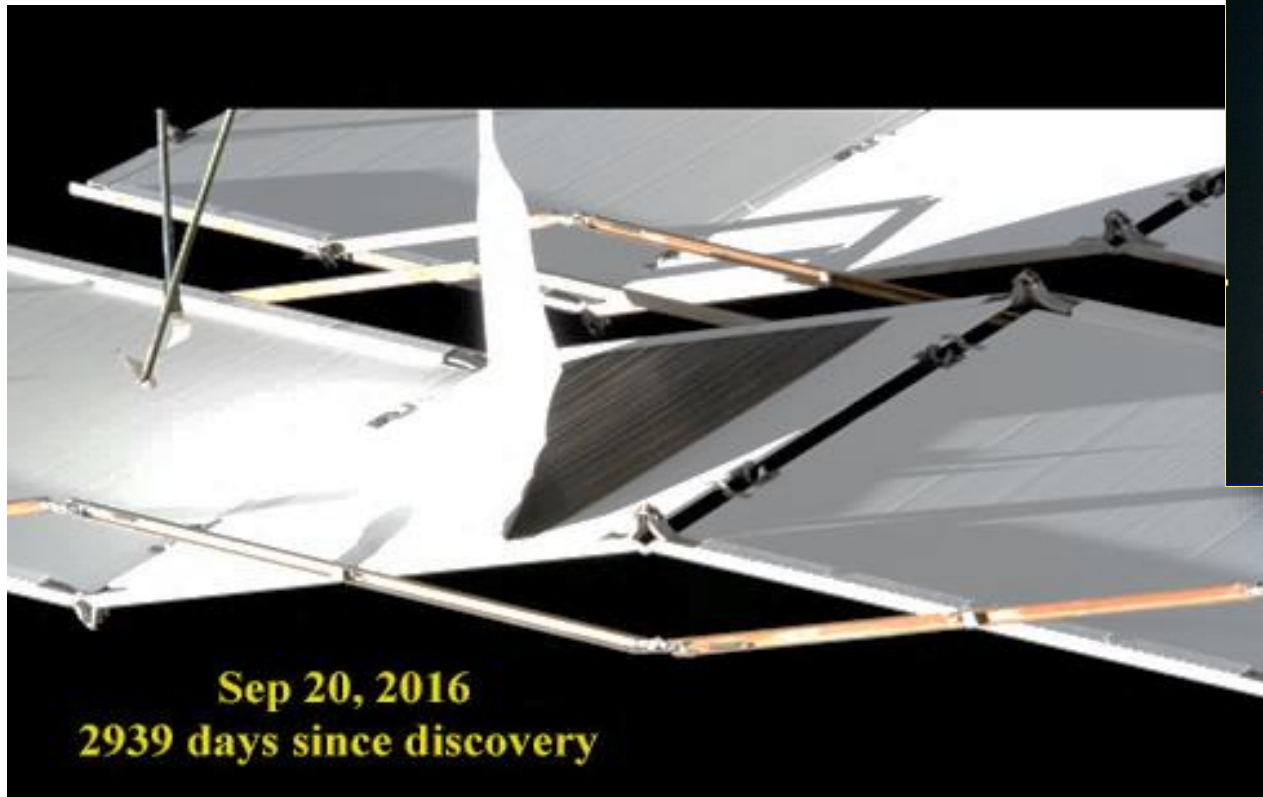
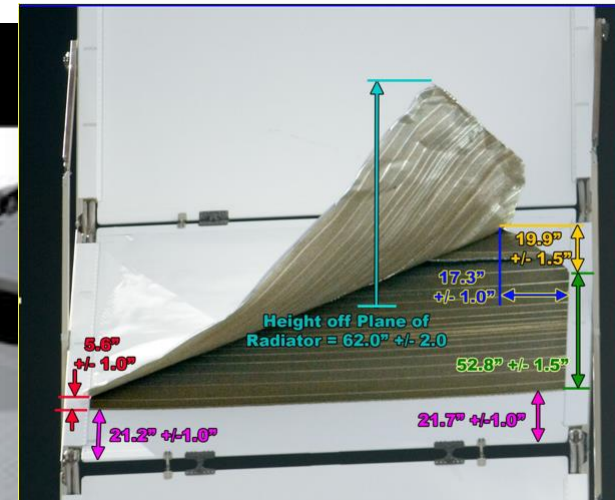
Bi-monthly Inspection of S1-3 Radiator Panel 7

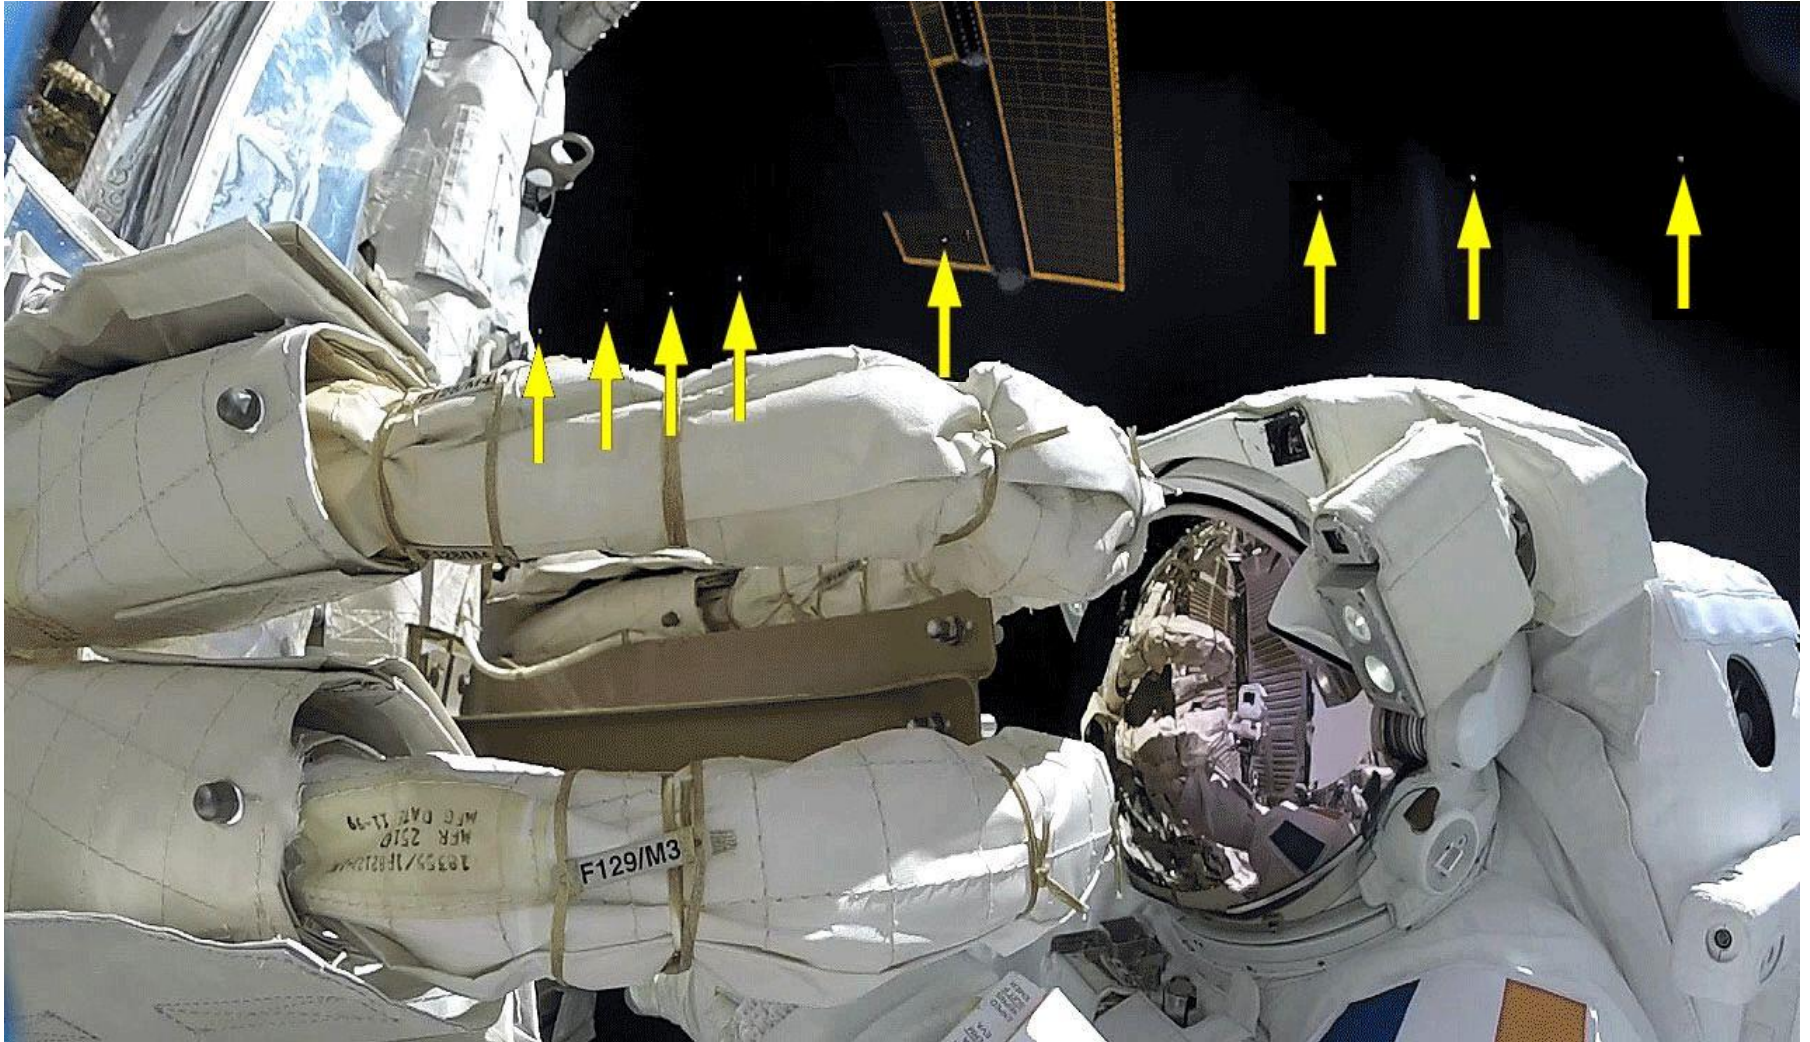
Ammonia Flakes Observed in EVA 40 GoPro Video

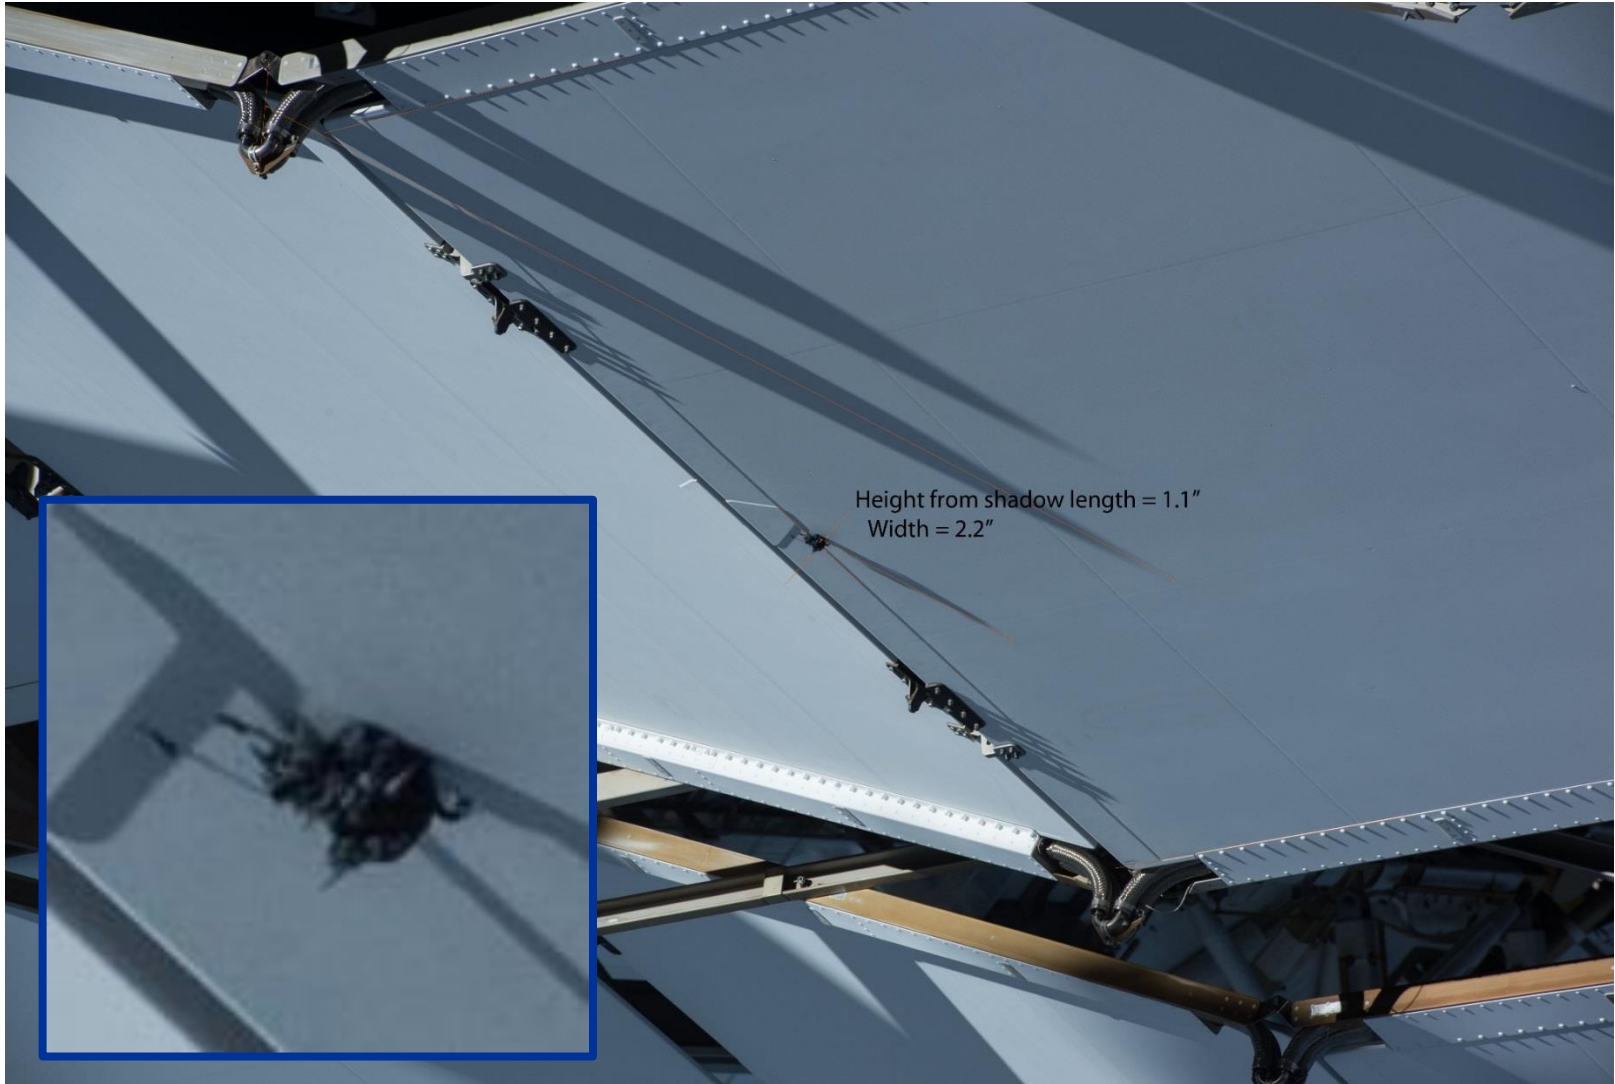
Possible EVA Grease Ball on Thermal Radiator

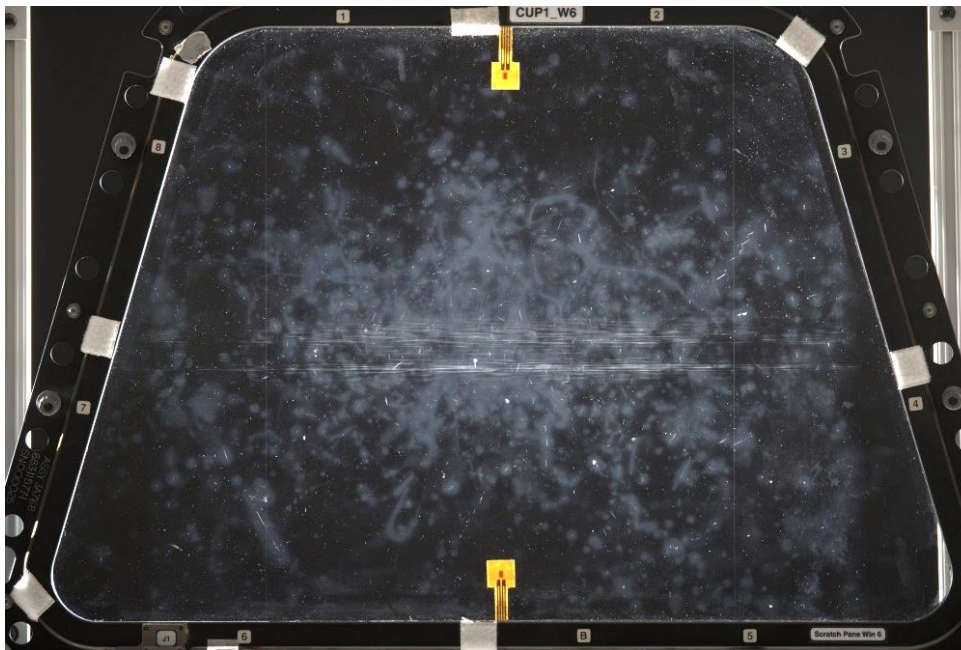
Haze and Nicks on Returned Pane
