Capture Latch Assembly for the NASA Docking System

Brandon N. Dick*, Nathan Mauch* and Timothy Rupp**

Abstract

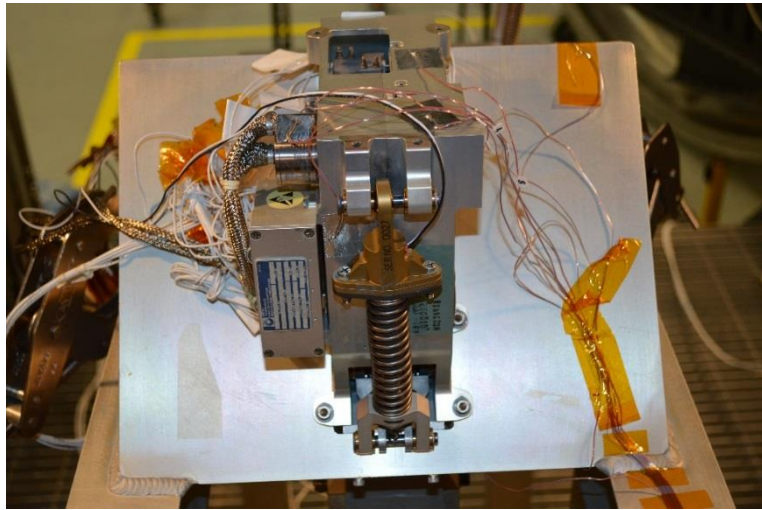
Figure 7. Qualification Capture Latch in CCLR Test Setup

The second CCLR failure occurred during qualification testing of the capture latch assembly. Similar to the development test, the qualification secondary release test occurred toward the end of the qualification program, to be followed only by the ultimate load test. However, for the qualification testing, the mechanism was tested under the thermal vacuum (cold) conditions. Like the development test, the unit had already been subjected to all other environmental tests, including random vibration. Additionally, the test load was lowered based on updated structural analysis of the worst case undocking conditions. The test setup for the qualification test was identical to flight except that a camera was added inside the thermal vacuum chamber to allow direct viewing of the NEA, and an oscilloscope was used to obtain high speed current data for the performance of the NEA. The test setup is shown in Figure 7.

During the secondary release test when current was applied there was no evidence the release mechanism moved. Additionally the position sensor and the camera showed no discernable movement.

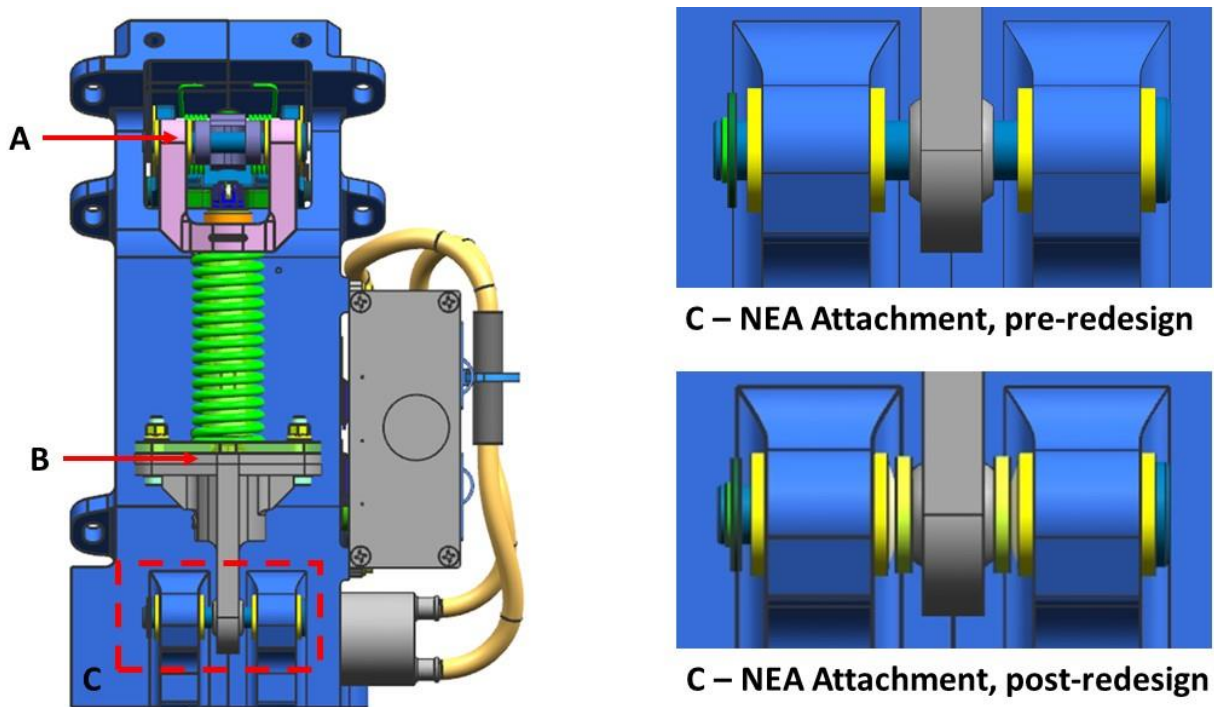
Figure 11. CCLR Detail

This test was informative, showing that the motion of the mechanism was extremely violent, subjecting it to nearly continuous shock loads as the mechanism shifted between the hard stops on either side of the free play. This motion was especially evident during testing in the axis parallel to the pins. Following the completion of the vibration testing, the unit was subjected to a Secondary Release Test, which it passed. The NEA was disassembled and similar wear was observed. Although the failure could not be duplicated, the excessive wear was duplicated and the test was considered successful.

Based on these results it was determined that the mechanism should be redesigned to remove free play. The design improvement was implemented by installing flat washers and Belleville washers on the pins to remove all gaps, with a slight preload, as shown in Figure 11. Additionally, the NEA was given a small preload. The development capture latch was rebuilt with the redesigned configuration and subject to the same set of tests. The redesigned configuration showed no signs of the galling/excess wear. The Qualification Capture Latch was then rebuilt per the new configuration and subjected to random vibration testing and a secondary release test. The unit passed and was shown to have no excessive wear during a post-test inspection.
