Analysis of the failure of a PPS polymer cycling support: Microscopy and Finite Element studies

J. Marsh, R.P. Turner*, M. Wang and M.J. Jenkins

School of Metallurgy & Materials, University of Birmingham, Edgbaston, Birmingham, United Kingdom B15 2TT

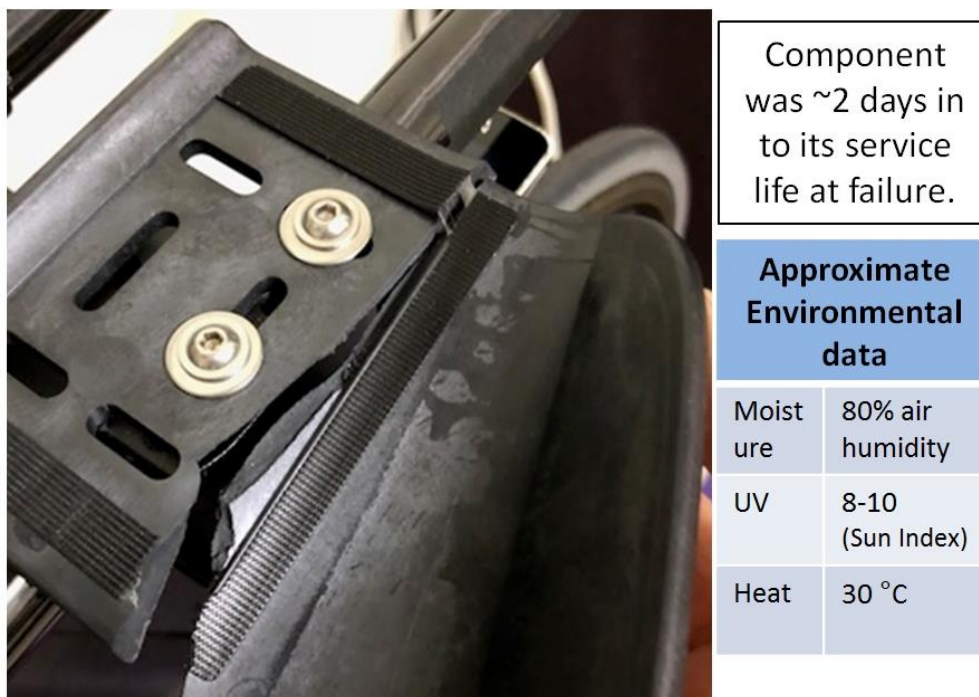
A cycling arm-rest component fabricated from the reinforced PPS using injection moulding methods was used for its intended application by a cyclist. The component was brand new, and fitted to the bicycle in its as-received condition. However the component suffered a sudden failure within days of being first attached and used, with a crack propagating through the component and causing the arm-rest to break in two (see **Figure 2**). Due to the component failing so shortly after first being attached to the bicycle, the failure was not considered to be caused in any way by PPS material surface degradation caused by environmental (UV or moisture) exposure.

Figure 2: Fractured component mounted on the handlebars

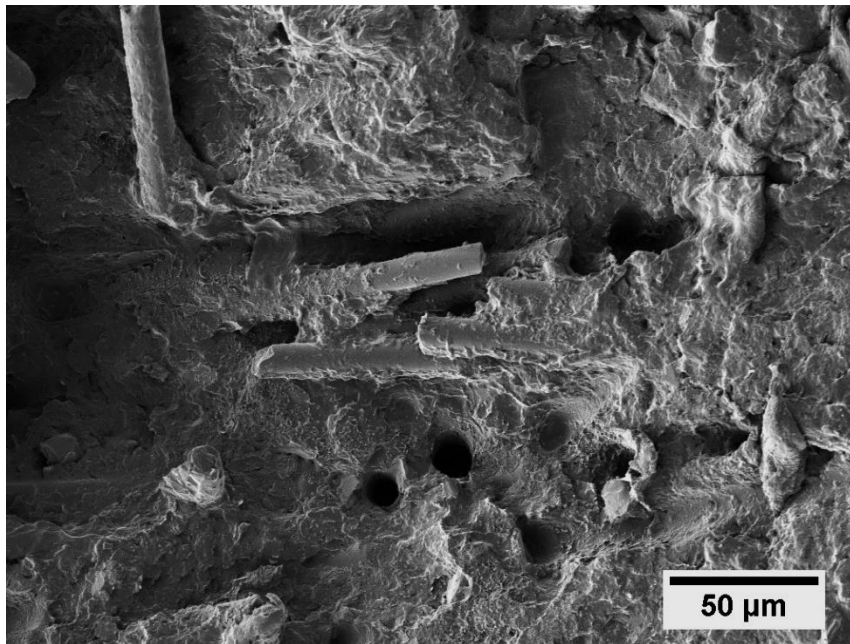
Figure 4: SEM image at the fracture surface of the component at 500x magnification

An important aspect of composites created from a polymer and fibre is the adhesion between the fibre and the matrix. Poor adhesion can result in small micro-voids forming, and this may result in stress concentration sites between the two materials. **Figure 4** shows an SEM image of the fracture surface where the fibres show reasonable embedding in the matrix, with no obvious visible voids between the fibres and the matrix. The light grey cylinders represent the glass fibres, of an average length of $\sim 50 \mu\text{m}$, within the dark grey PPS polymer matrix. Some evidence of fibre pull-out from the matrix is also observed – these being the two exposed holes in the matrix where fibres used to be embedded.

However, under mechanical loading such as the in-service conditions of this component with the forces applied by the cyclist, the distribution of the loading across the fibres and the matrix needs to be considered, which in turn depends upon fibre orientation [16] The fact that this component is produced with short fibres allows it to be isotropically strong. This would suggest that during normal service loads below the material yield strength, the reinforced polymer would allow for a rebalance of the forces transmitted via the fibres and the matrix in proportion with the strength of the separate phases such that the imparted strain is constant across the two, thus the two phases of the composite remain fully aligned, with no delamination.

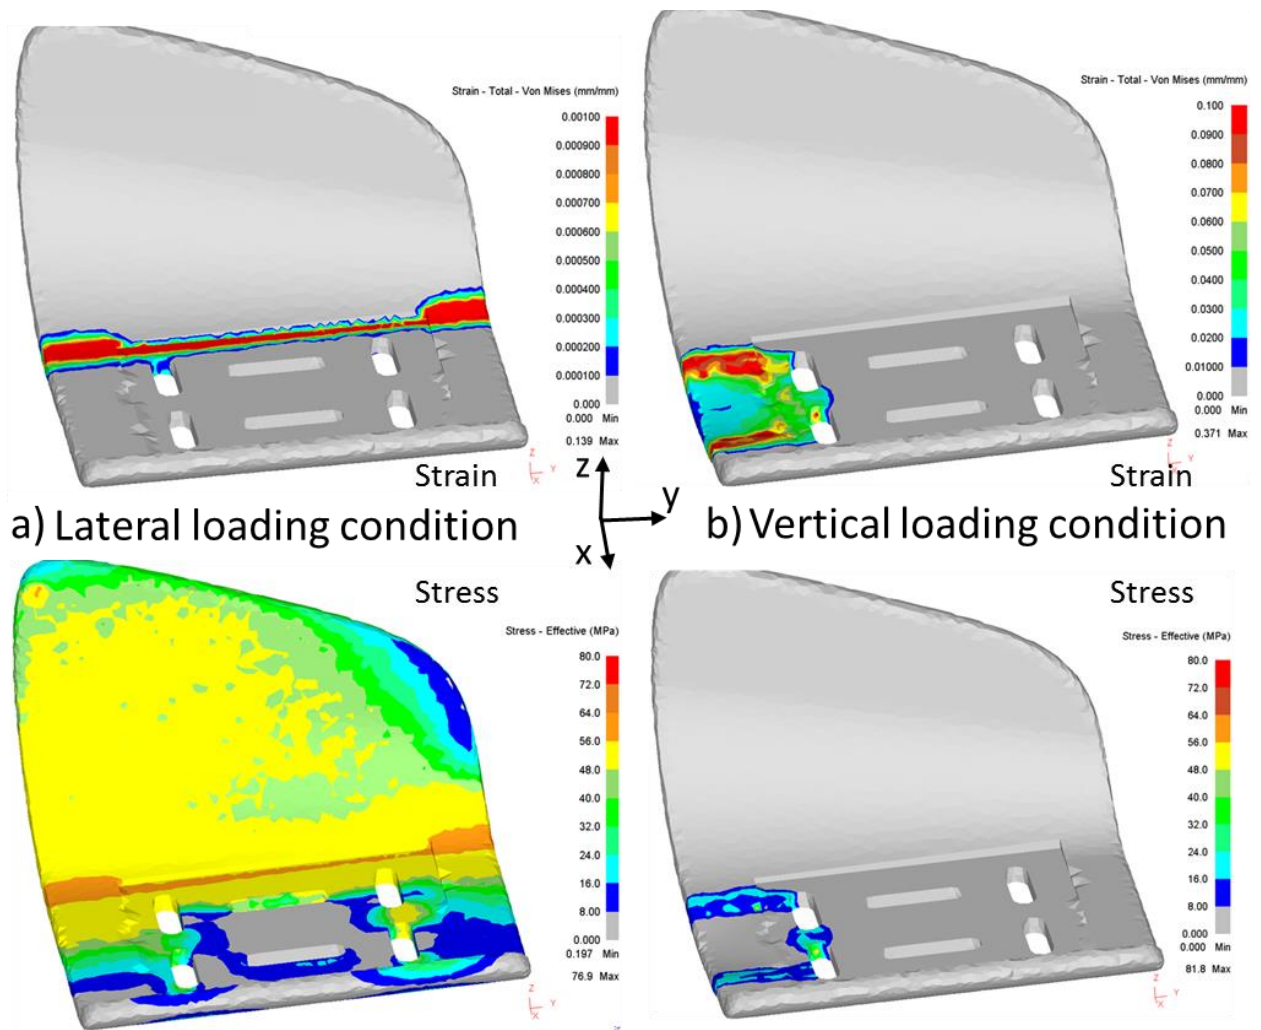
The FE modelling framework to simulate in-service loadings upon the component for the two loading scenarios considered were performed in FE software Deform v11.1. The outputted predictions for the total strain and the effective (von Mises) stress are presented in **Figure 7**. It can be observed from the predicted strain and stress fields (see **Figure 7a**) that for the lateral loading condition the highest regions of effective (von Mises) stresses and effective strains accumulate along the sharp radius of the recessed flat base section of the component. The von Mises stress values are peaking at approximately 60-70MPa according to FE predictions, which is not of concern given the strength of the material in different loading scenarios ranges from 145-180MPa.

Figure 7: FE predictions for plastic strain and Effective stress fields under the two loading conditions

However, this will force the component to flex along this corner placing one surface in to tension and the other in to compression, providing a potential driving force for any accumulation of damage and cracking to propagate entirely along the recessed section radius. By comparing to the real component that suffered sudden-onset failure (shown in **Figure 2**), it can be clearly observed that the crack path propagated along much of the sharp-radius corner of the recessed base section where it meets the curved wing. It is therefore highly likely that the driving force to exacerbate the crack propagation came from a lateral force as the cyclist's arm slipped during service.

Whereas, when the component is subjected to the vertical loading condition, a small location of high von Mises stress and strain accumulates in between the two affixing holes within the component closer to the vertical force provided (see Figure 7b) and around the radii of these two affixing holes. The region in-between the affixing holes will likely be subject to crack propagation driving forces associated with regions of high stress, and potentially this just requires an initiation site to provide potential failure. As described previously, characterisation and analysis of the fractured component was carried out using Micro CT. These experiments provide detailed information about the internal structure of the component. The bulk component was observed as a dense solid with no sporadic voids visible confirming complete filling of the mould during manufacture. However, a single void in the component was clearly visible in the Micro CT scan along the surface of the crack (**Figure 8**).

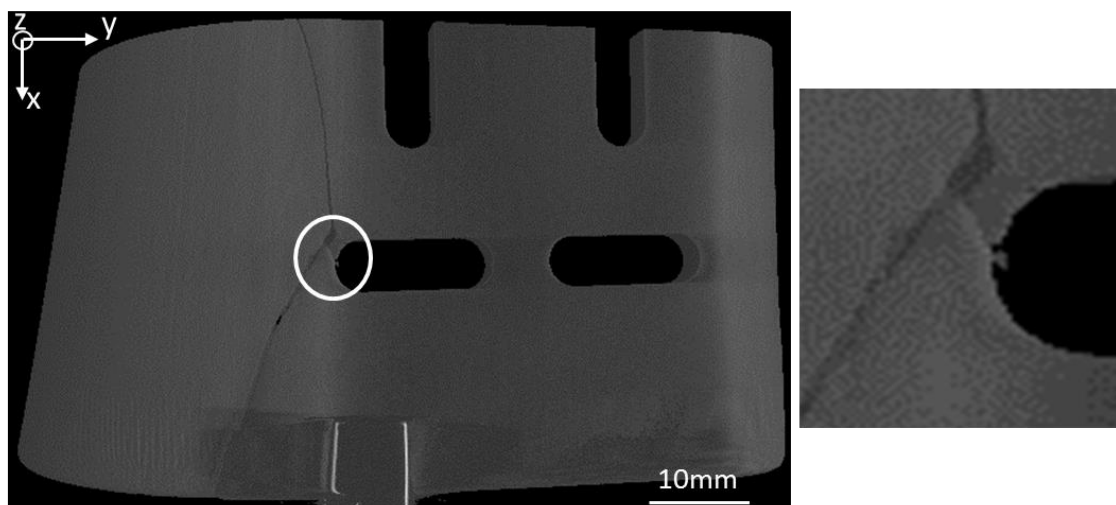
Figure 8: Micro CT image of a void on the crack interface within the component. An additional crack is indicated as another region of interest (circled) and is zoomed in on the right

This void, due to the location of the actual crack surface may be a consequence of either; a) the component fracture and a subsequent loss of material in this location due to damage accumulation, or b) an incomplete moulding process leaving a residual void prior to the component failure. The location of the void - well away from any sharp or small features which may restrict the flow - would likely not suggest an incomplete mould operation and thus the observed void probably a result of the loss of material due to high localised damage at the onset of cracking. However, the direction of the crack from the fixing hole to the void would suggest that a weak point may have been present prior to the sudden-onset failure of the component.

Also observed within **Figure 8** is a crack emanating from the left edge of the left affixing hole, and which joins the main crack which propagated through the component. This crack observed with Micro CT methods is noted to match a location of increased stress and strain from the FE predictions for the vertical loading arrangement. Although the highest region of stress and strain was on the other side of the affixing hole, in the region of material between the two, the presence of the through thickness main crack may have changed stress fields in the component, if we assume this is a subsequent crack. Alternatively, this small crack leading from the affixing hole to the main crack may be another potential nucleation site for the sudden failure, although this seems more unlikely.

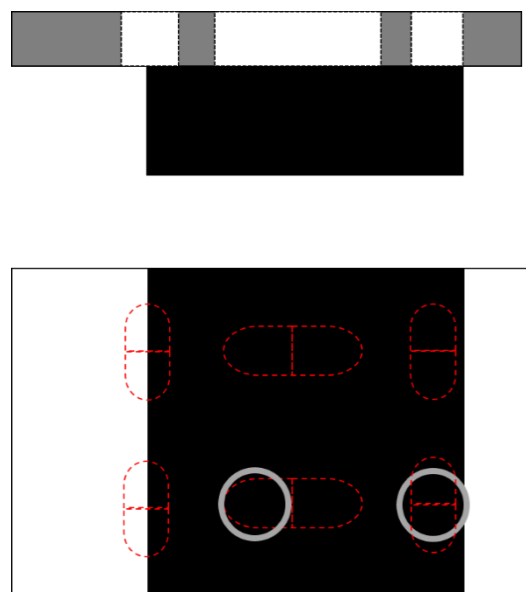
Finally, the location of the arm rest upon the customer-mounted supporting aerobar was believed to influence the failure of the component in this instance. The location of the supporting bar can be varied to accommodate the riders shape, size and riding preference. Two bolts are used to secure the arm rest. The user can choose from the available six affixing holes manufactured in to the component. The two affixing holes used to support this fractured component are shown in **Figure 9** (represented by the grey circles) from a choice of the six available (represented by the dotted lozenges). The black rectangle represents the support that was situated between the bar and the arm rest. It can be observed that the unused horizontal pair of affixing holes on the left of the image is situated on the very edge of the supporting bar. In this configuration, it is likely that the overhanging region acts as a lever for the loading to be applied and with the fulcrum across the centre of the fixing holes where there is a reduced amount of material.

Figure 9: The arm rest location mounted on the aerobar support.
