## Case Study and Back Analysis of a Residential Building Damaged by Expansive Soils

# **Case Study and Back Analysis of a Residential Building Damaged by Expansive Soils**

J. Li, D. A. Cameron and G. Ren

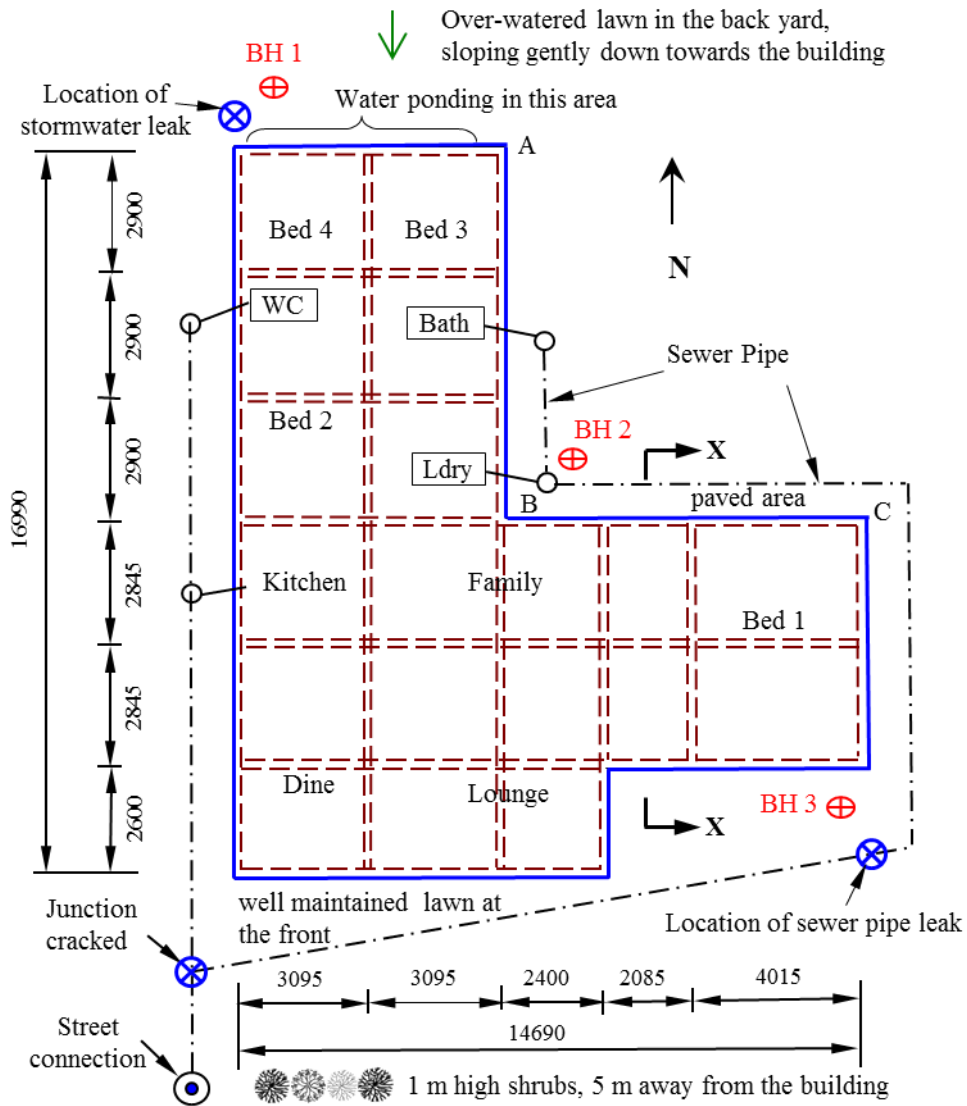
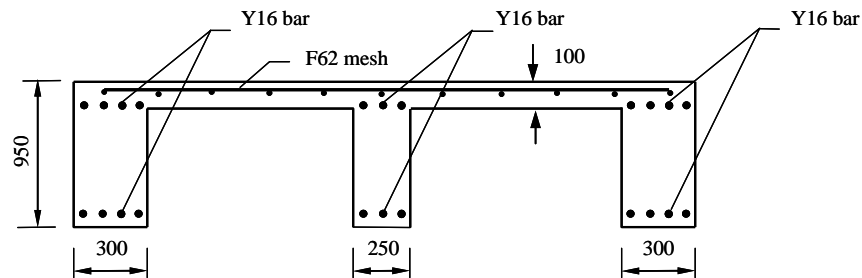
Figure 1 Footing Layout and Locations of Underground Pipe Leak (not to scale)

The site inspection indicated that sewer pipe leaking had occurred at the front of the house, as well as stormwater pipe leaking at the back of bedroom 4 (Figure 1). The inspection revealed there was a large well-watered lawn in the backyard, which sloped gently down towards the building. Water was observed ponding at the back of the building adjacent to the footing (see Figure 1). Four small native shrubs were planted at the front of the property, approximately 5 m away from the building and adjacent to the footpath. The lawn in the front yard was well maintained as well. Damage to the house superstructure consisted of severe ceiling cracking (4-20 mm) in the family area (Figures 2), and severe internal wall cracking (3-16 mm) in the dining room and lounge (Figures 3), moderate external wall cracking (2-3 mm) under the window of bedroom 2 (Figure 4), distortion of the cornice in the laundry (Figure 5), and a slope on the floors in most rooms. The floor of the house was distorted into a complex pattern, involving both bending and twisting.

The site investigation revealed that the main cause of house distortion may be attributed to leaks of both sewer pipe and stormwater pipe, and excessive watering of the lawn and garden areas, which resulted in non-uniform soil moisture conditions. The locations of the leaks and water ponding due to excessive watering are shown in [Figures 1 and 7](#).

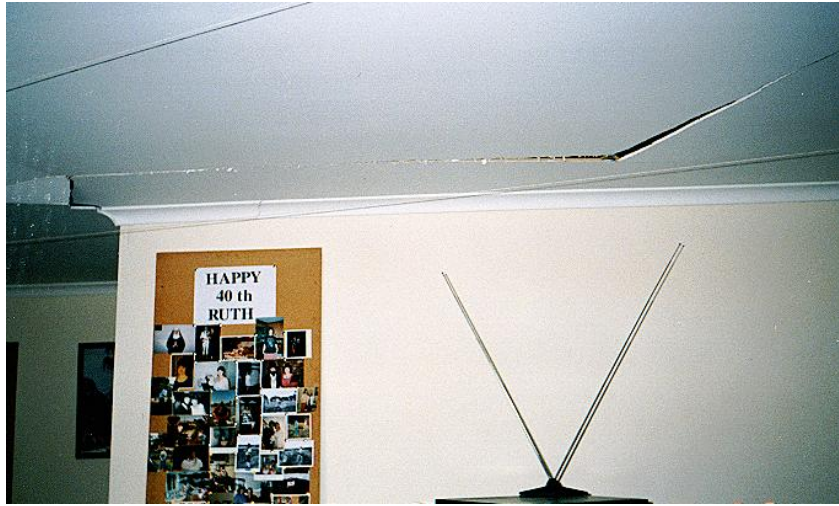
beams at the locations indicated on [Figure 13](#), close to the location of the observed superstructure cracks (refer [Figures 2-5](#)).

**Figure 2 Crack on Ceiling in Family Area**

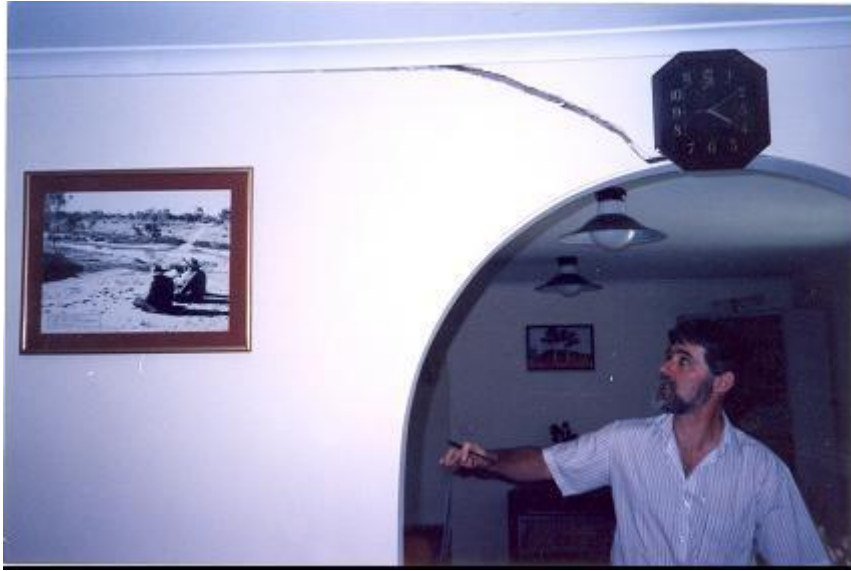
**Figure 3 Crack on the Interior Wall between Dining Room and Lounge**

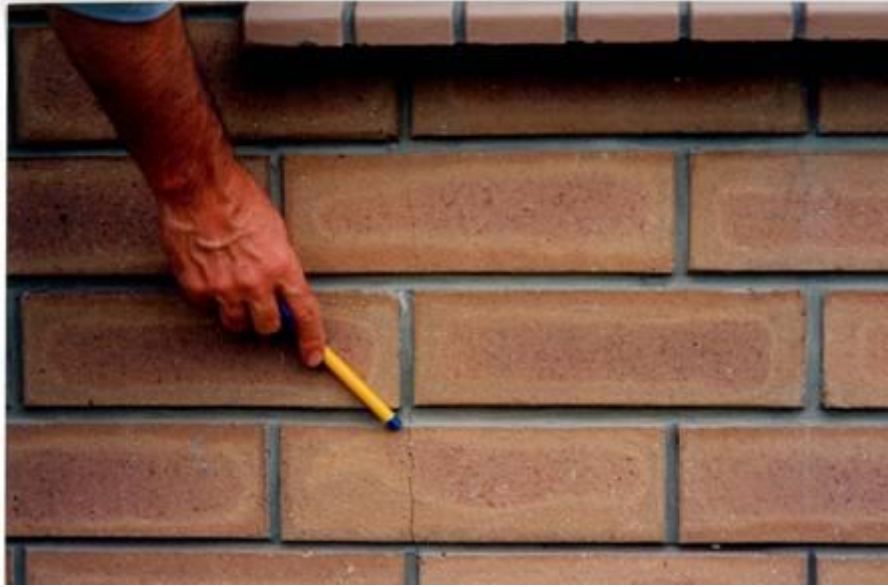
**Figure 4 Crack in Brick Wall under Window of Bedroom 2**

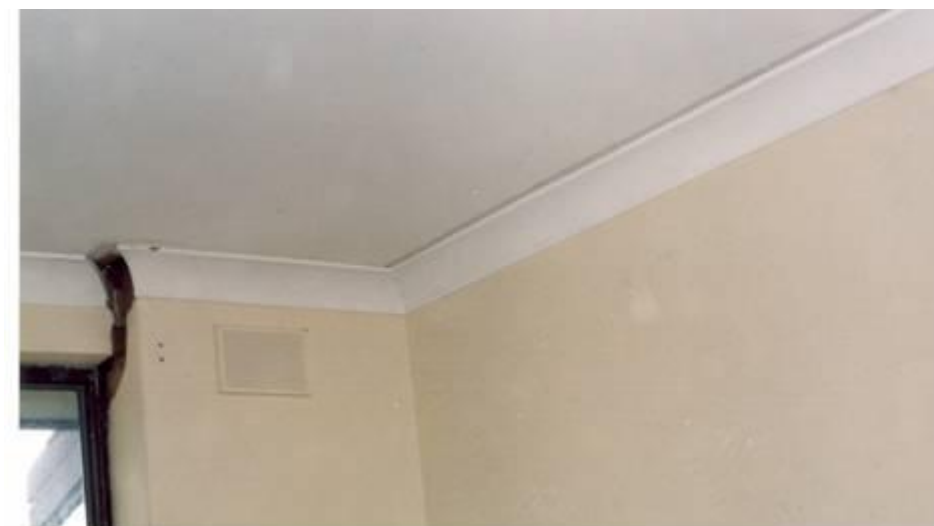
**Figure 5 Distortion of Cornice in Laundry Area**

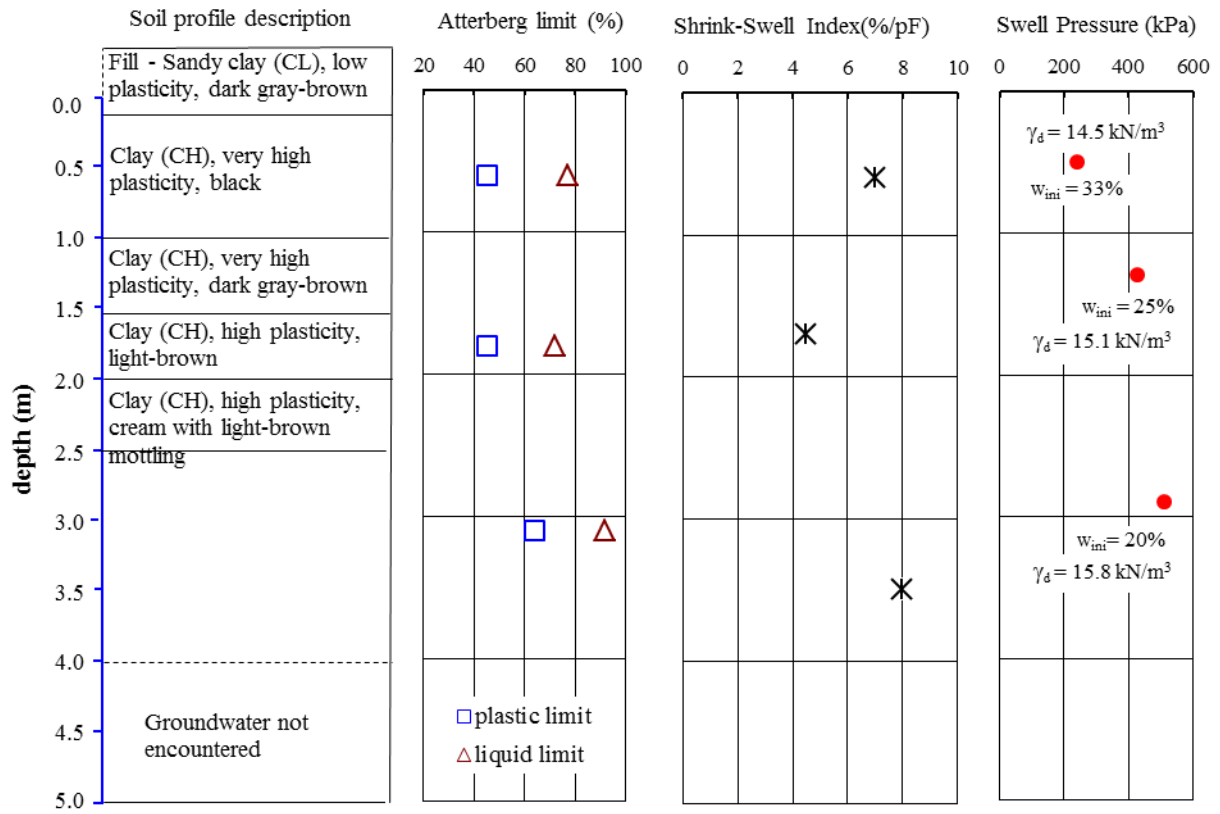
Figure 6 Geotechnical Profile at BH1

Figure 6 also shows Atterberg limits and the soil swelling pressures obtained from the oedometer swell-pressure tests. Swell pressure testing consisted of loading back a swollen soil to its original height. The swell pressures were modest as the soil from BH1 was relatively wet, as is discussed later.

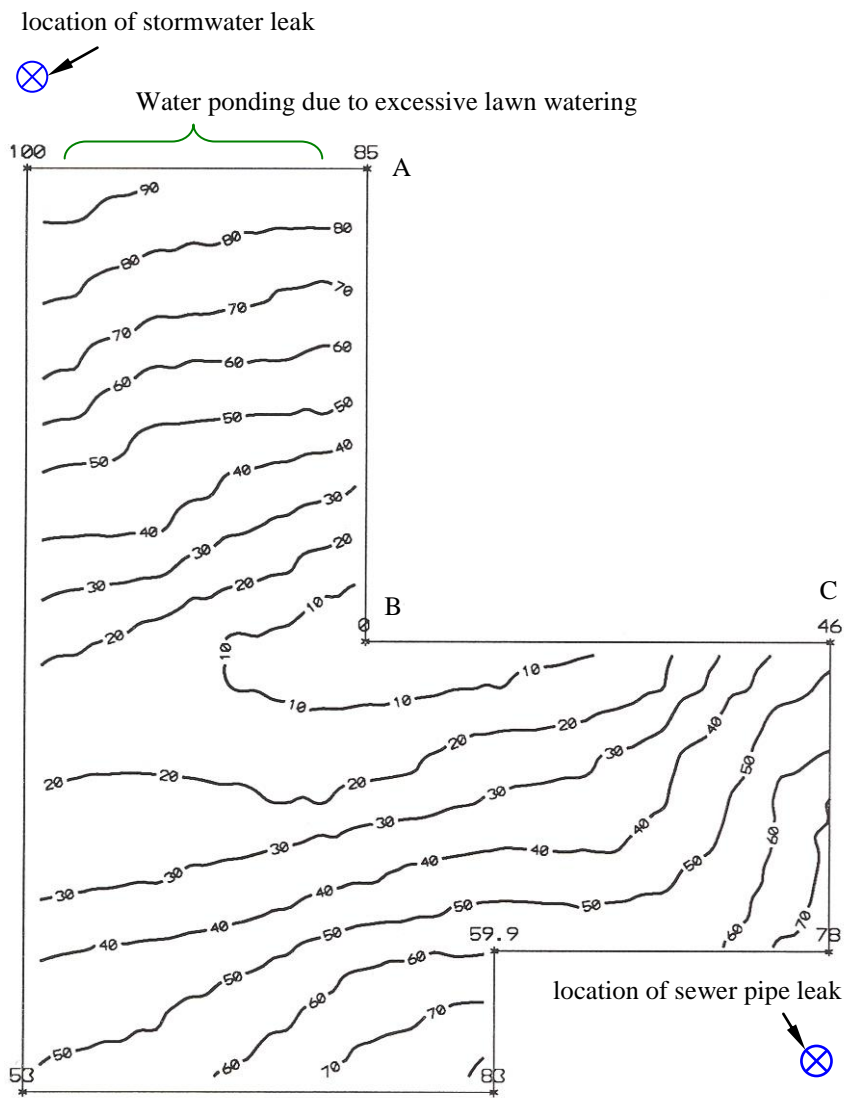
**Figure 7 Measured Relative Slab Deflection (mm)**

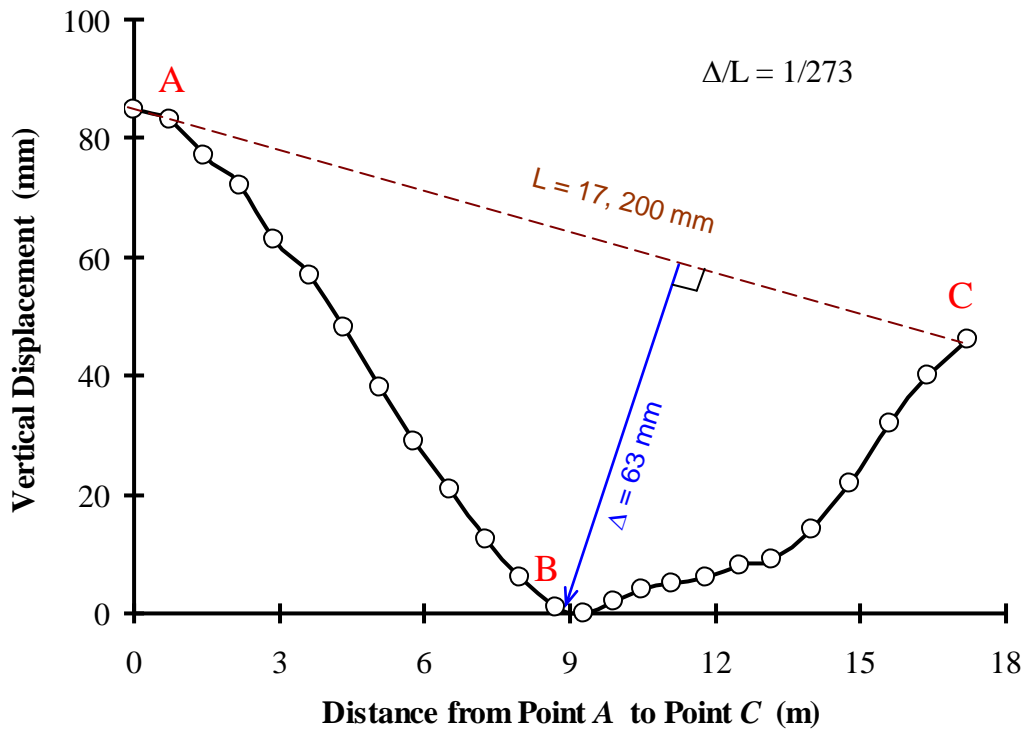
The measured level differences along the re-entrant corner are plotted in Figure 8. The second author found it necessary to extend distortion patterns around corners to better understand the causes of masonry wall cracking (Cameron and Walsh, 1981). The differential deflection to length ratio was  $1/273$ , exceeding the recommended maximum limit of  $1/400$  for articulated masonry veneer construction (AS2870 2011). The deflection ratio was derived as shown in Figure 8, and it did not include tilting movements, but rather considered only distortional movement. The maximum differential deflection along segments AB and BC was 85 mm and

46 mm respectively, much higher than the maximum allowable limit of 30 mm for articulated masonry veneer ([AS 2870, 2011](#)).

**Figure 8 Measured Level Differences along the Re-entrant Corner**

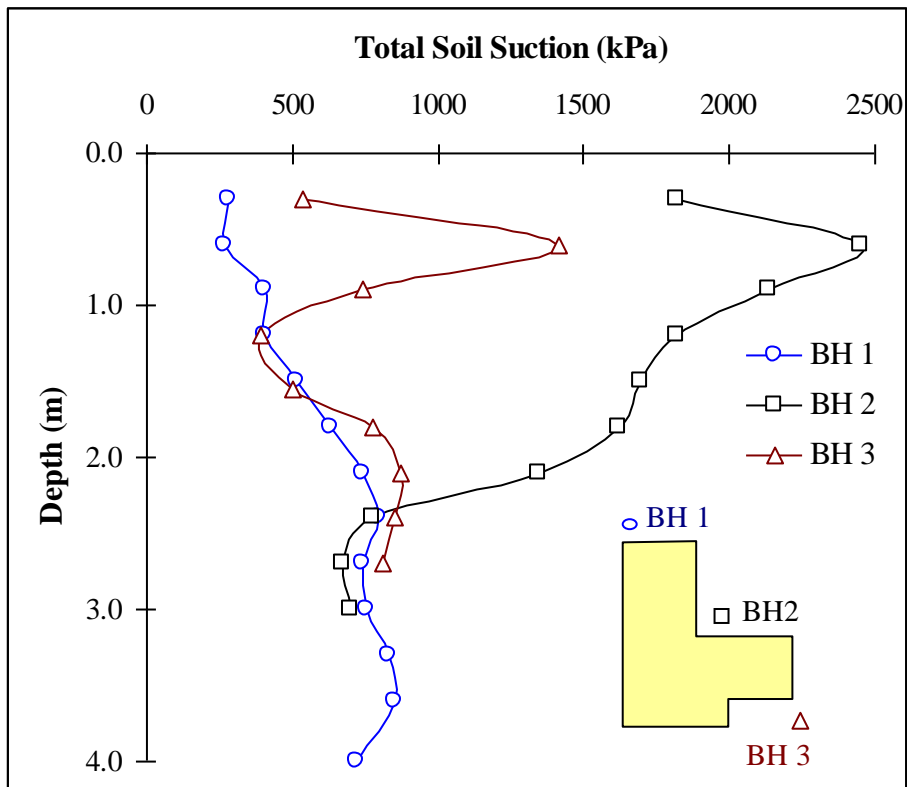
Each reported suction value was taken as the average value of at least three sub-samples. [Figure 9](#) shows the soil suction profiles and the locations of boreholes. The effect of the water leaking from the stormwater and sewer pipes is clearly evident in the suction profiles of [Figure 9](#). Suction profiles near the leaking pipes indicated unusually low suctions, or wet soil,

over the full depth of sampling. At the re-entrant corner of the house (borehole 2), the soil was much drier.

**Figure 9 Soil Suction Profiles**

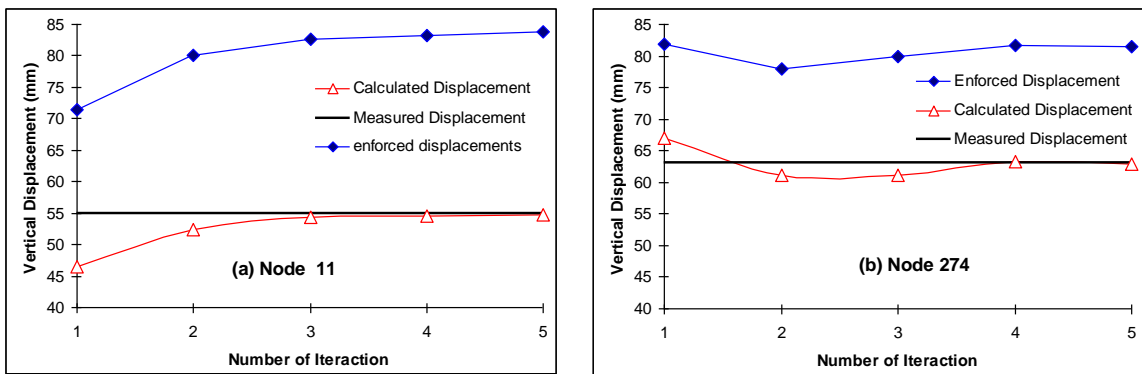
The back-analysis provided an estimate of the level of stress in the distressed slab footing. It was predicted that the footing was over-stressed at the re-entrant corner, B (see Figure 13). The calculated maximum torque and bending moment in the external beams in this region were 80 kNm and 399 kNm, respectively. The maximum shear force was 142 kN. The maximum compressive stress in the concrete was found to be 13 MPa, which was acceptable. The results of the back analysis indicated that the maximum tensile stress of 2.7 MPa in the concrete beams had been exceeded and that the steel bars at the bottom of the beam along section I-I should have yielded (see Figure 13). So this section of the slab had failed in a structural sense. The back analysis predicted concrete cracking in both edge and internal

**Figure 13** Difference between measured slab displacement and displacement of slab from the back analysis (the locations of nodes 11 and 274 are indicated in Figure 13)

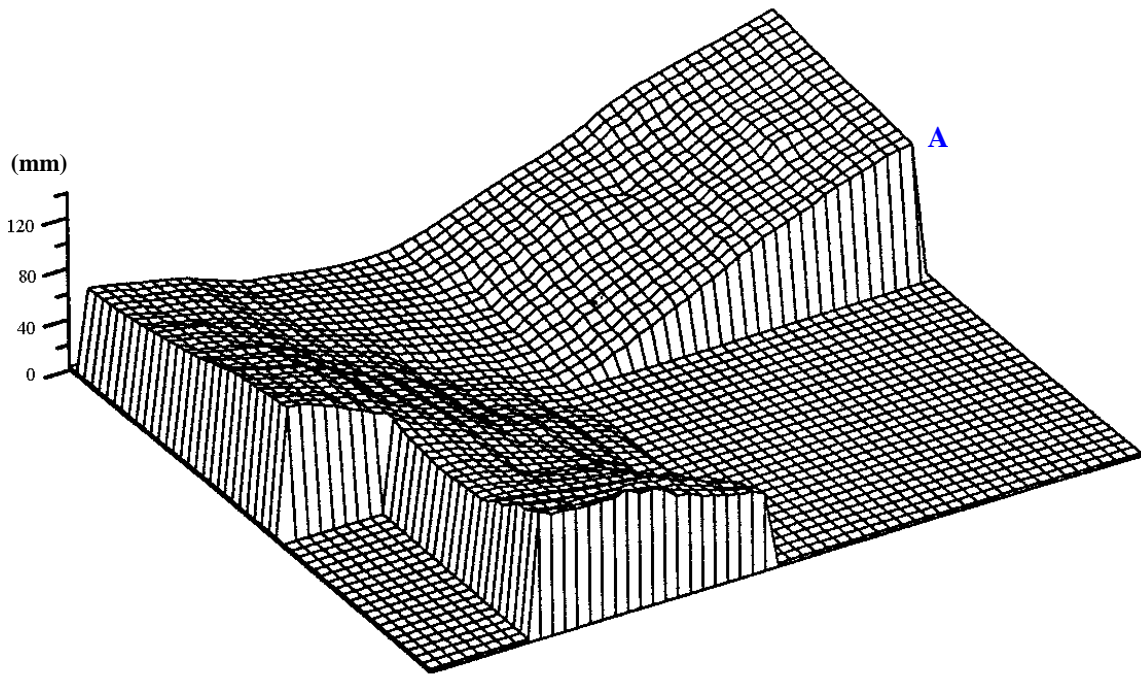
After five iterative analyses, the free soil mound shape (i.e. the enforced displacements in the 5<sup>th</sup> analysis run) was determined and is shown in a three dimensional view in [Figure 15](#). The maximum differential mound heave was found to be 120 mm. From [Figure 15](#), it can be seen that the foundation soils under the front and back of the house had heaved substantially more

**Figure 15 Free Swelling Mound Shape - 3D View (mm)**

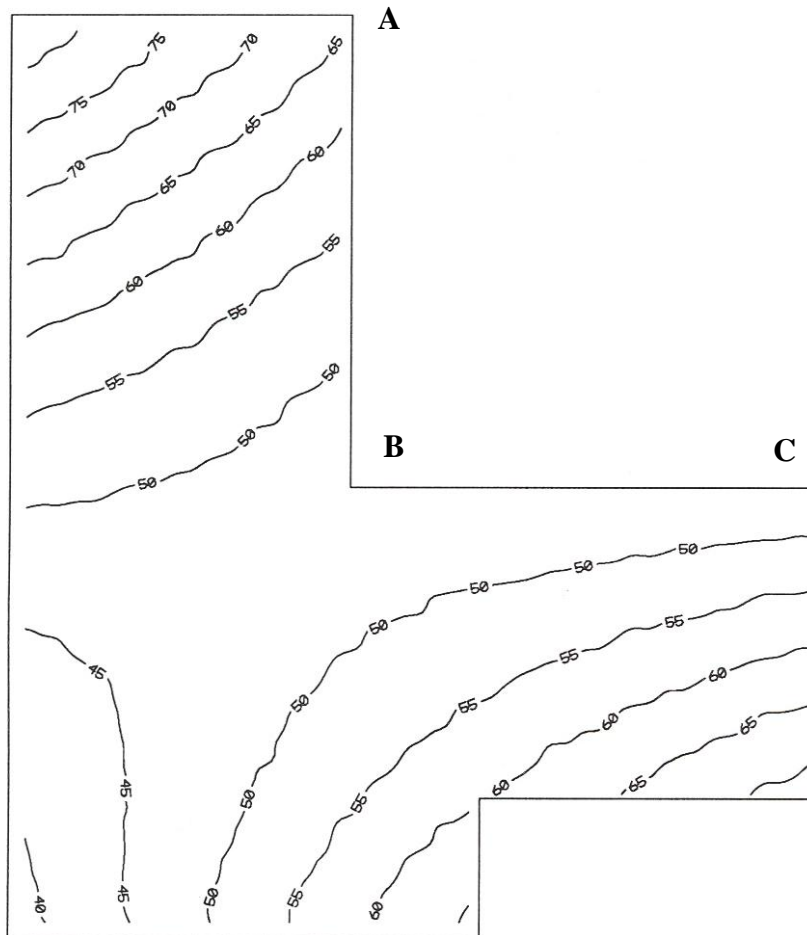
**Figure 16 Contour Plot of the Calculated Slab Deflections for Beam Depth = 1500 mm (mm)**

The back-analysis results indicated that a 1500 mm deep stiffening beam was required for the slab to be able to withstand the differential soil movement induced by abnormal soil wetting from leaking pipes and excessive watering. As such deep beams are outside the scope of the shallow footing designs intended in AS2870 and are not a practical solution, the case study has demonstrated the importance of site management for buildings on expansive soil sites, with the aim of maintaining a reasonably uniform state of subsoil moisture around the buildings.
