# The X-15 3-65 Accident: An Aircraft Systems and Flight Control Perspective

Jeb S. Orr<sup>(1)</sup>, Irving C. Statler<sup>(2)</sup>, and Immanuel Barshi<sup>(3)</sup>

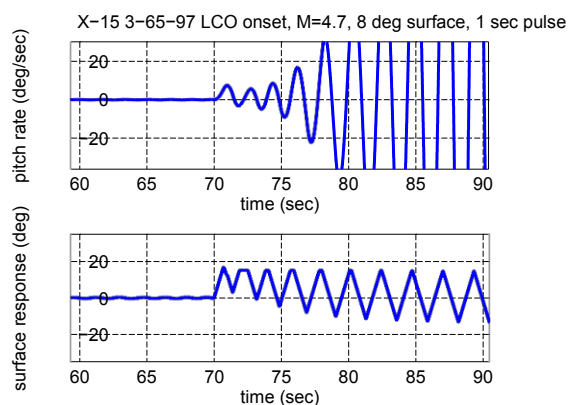
Figure 5.0-1. Flight 3-65 Divergent LCO Reproduced in Nonlinear Simulation ( $M=4.7$ ,  $q=390$  psf)

Nonlinear time-domain simulation and nonlinear frequency domain (describing function) analysis of a detailed model of the X-15-3 AFCS revealed that transition from the small-amplitude desirable LCO to the large-amplitude destructive LCO was caused by an

inner-loop instability due to large system lag in the structural notch filters coupled with the the rate-limited power actuator (Figure 5.0-1). The structural filters differed from the filters used in the fixed-gain SAS on the other aircraft, since the loop shaping requirements were different for the MH-96 adaptive mode. The mechanism by which a destructive limit cycle could be introduced involved an abrupt maneuver at relatively high forward gain, where the power actuator would reach rate saturation while inducing large angular acceleration on the rigid body. If this event occurred at a flight condition where the rigid-body short period damping was particularly low, as it did during Flight 3-65, the rigid-body oscillation was then divergent, even with fixed adaptive gains. This failure mode is not unlike a classical pilot-induced oscillation (PIO), where the pilot acts as the adaptive gain.

While the adaptation dynamics of the MH-96 AFCS were not directly involved in the LCO phenomenon, the limiting circuitry associated with the MH-96 adaptive loop could be saturated by large DC signals [14]. If this occurred as it did in Flight 3-65, the gains would ramp to maximum in an effort to reestablish the desired high-frequency limit cycle. This behavior further amplified the large-amplitude limit cycle, leading to a loss of rigid-body control.

The investigation following the Flight 3-65 accident concluded from simulation studies that the LCO could have been avoided had the pilot disabled the MH-96 and reverted to fixed-gain operation prior to entry. It is important to emphasize that simply disabling the adaptive mechanism would not have enabled the pilot to recover stability, but since the fixed-gain backup mode also used the lowest acceptable gain setting, the gain was below the threshold that would sustain rate limiting.
