TECHNICAL ASPECTS OF QUALITY ASSURANCE IN MAMMOGRAPHY: PRELIMINARY RESULTS FROM SERBIA

Short paper

This work presents the initial evaluation of mammographic practice in Serbia, with the aim of identifying the weak points and proposing appropriate corrective actions, having in mind the annual workload and its distribution, available diagnostic equipment and the fact that mammography is performed asymptotically on a large number of women.

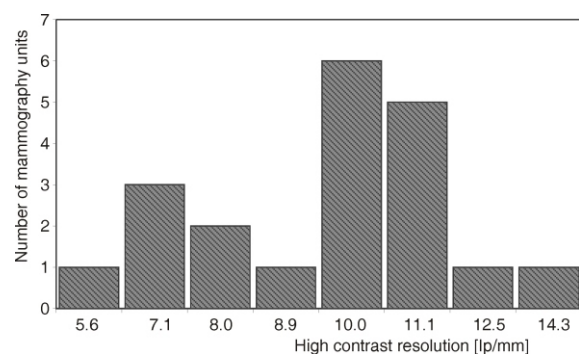
An objective assessment of image quality was performed using a TOR MAS test object. The results of our image quality scoring are presented in figs. 1 and 2. The minimal detectable contrast for 5.6 mm circular details, simulating tumour masses of 0.5 mm and 0.25 mm details, simulating microcalcifications, is presented in figs. 3 and 4, respectively. Results obtained demonstrate a wide range of image quality indicators: high contrast resolution ranges from 5.6 to 14.3 lp/mm, while the low contrast resolution was in the range of 1.8-5.0 lp/mm. With respect to the minimal acceptable level of high contrast resolution, this parameter, related to image sharpness, was suboptimal in 90% of the surveyed facilities. Similar findings pertain to all cases of low contrast and low detectability of microcalcifications, as presented in figs. 3 and 4. In a significant number of centres (40-90%), threshold contrast detectability was lower than the minimal re-

Figure 1. Results of high contrast resolution measurements in 20 mammographic units

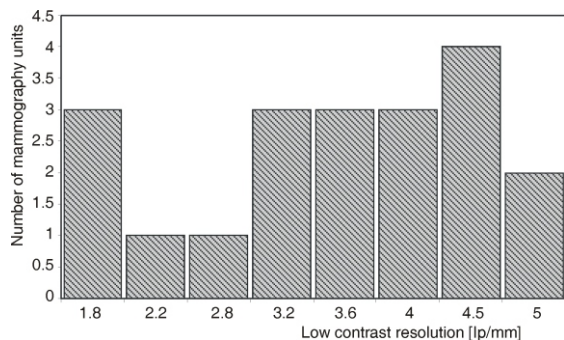
Figure 2. Results of low contrast resolution measurements in 20 mammographic units

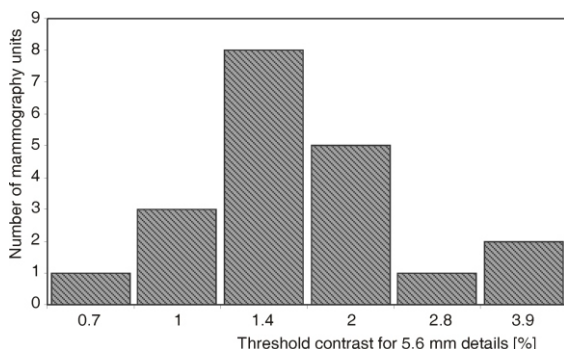
Figure 3. Distribution of measured values for minimal detectable contrast of 5.6 mm diameter details in 20 mammographic units

quired (1.2, 5, and 8% for details of 6 mm, 0.5 mm, and 0.25 mm diameter, respectively).

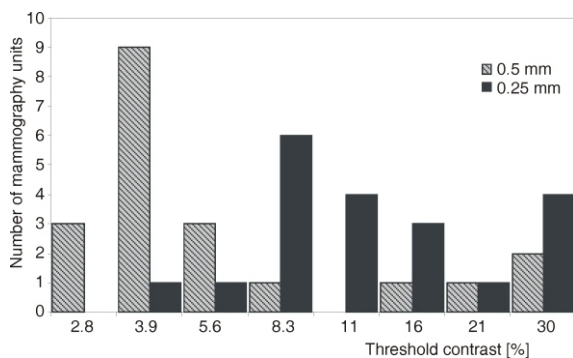
Figure 4. Distribution of measured values for the threshold detectable contrast of 0.5 mm and 0.25 mm diameter details in 20 mammographic units
