NASA/TM—2019–220176

The Role of Alerting System Failures
in Loss of Control Accidents
CAST SE-210 Output 2
Report 3 of 6

Randall J. Mumaw
San Jose State University Foundation

March 2019

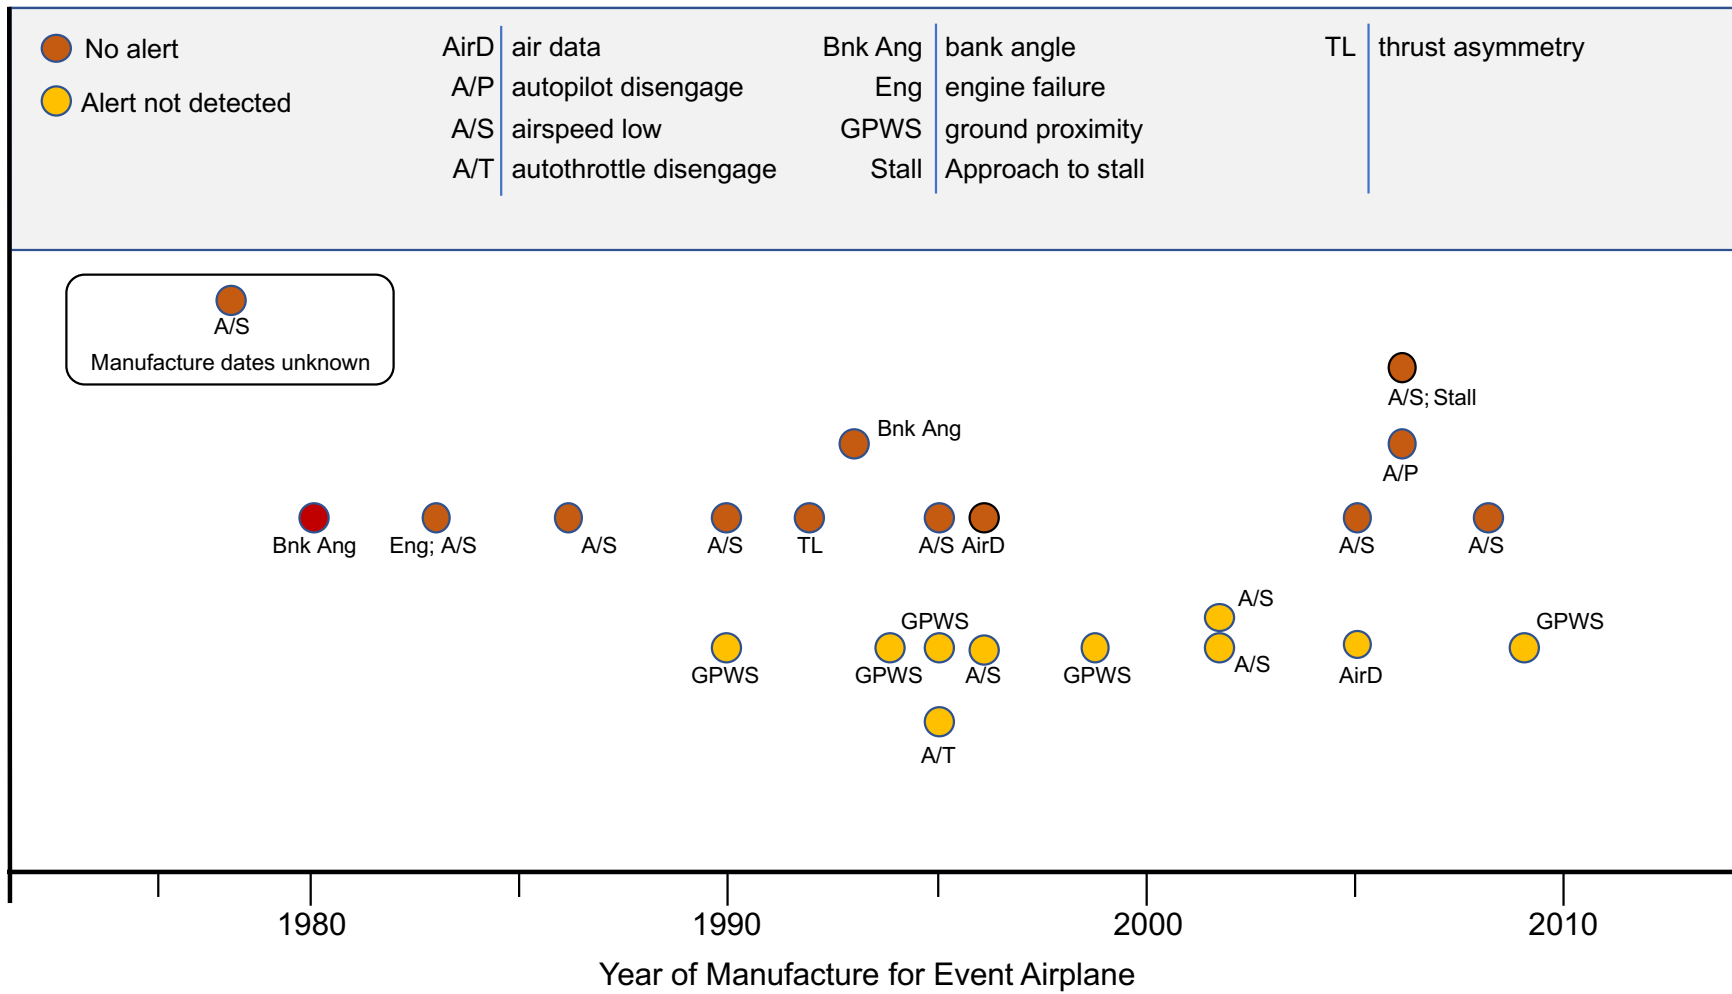
Figure 2a. Fail to orient as it relates to year of manufacture (marked for hazard).

Figures 2a and 2b organize the events according to when the event airplane was manufactured instead of when the accident occurred. The specific focus is on the events in which there was no alert or the alert was not detected to determine the extent to which only older airplanes fail to orient the flight crew. The oldest airplane in the event set was manufactured in 1980, and the newest airplane was manufactured in 2009.

Each dot on the figure represents an alerting failure from one of the 28 events. A red dot is used when there was no alert; the orange dot is used when the pilot did not detect the alert. Note that several events had two relevant alerting failures (for two different hazards).

Figure 2a shows the hazard associated with each red and orange dot. Figure 2b shows the airplane make and model for the same set of events. These figures show that red and orange dots continue to occur for more-recently manufactured airplanes. Summed by decades—for failure to alert—there were:

- 0 for airplanes manufactured in the 1980s
- 6 for airplanes manufactured in the 1990s
- 4 for airplanes manufactured in the 2000s

7. *Newer airplanes have problems as well.* Figures 2a and 2b show that the orientation failures were not just an issue with airplanes built more than 30 years ago, or just with unsophisticated, 2nd-generation airplanes. The majority of these failures occurred in airplanes built in 1990 or later. More than one third (8/22) of the airplanes that failed to present an effective alert for hazards such as low airspeed or ground proximity were built after 2000!
