NATIONAL AERONAUTICS AND SPACE ADMINISTRATION

TECHNICAL REPORT
R-54

FACTORS THAT AFFECT OPERATIONAL RELIABILITY OF TURBOJET ENGINES

By LEWIS CENTER STAFF

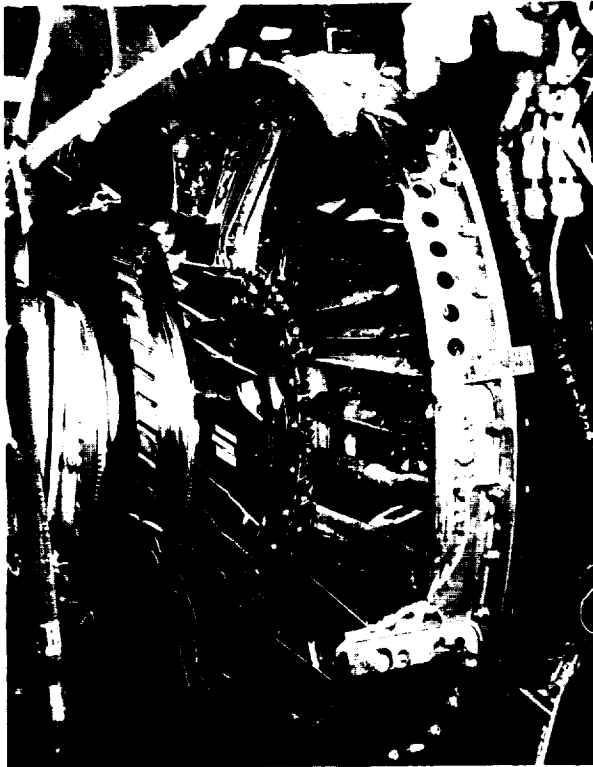
accumulated until it burst through the casing at the seventh stage. The damage resulting from a fatigue failure in a blade root is shown in figure 2. Six other blades in the same stage had extensive fatigue cracks in the roots and fractured upon impact. The remains of a more disastrous compressor failure are shown in figure 3. Part of the compressor went through the roof of the

FIGURE 2.—Damage resulting from fatigue of blade root in second rotor stage.

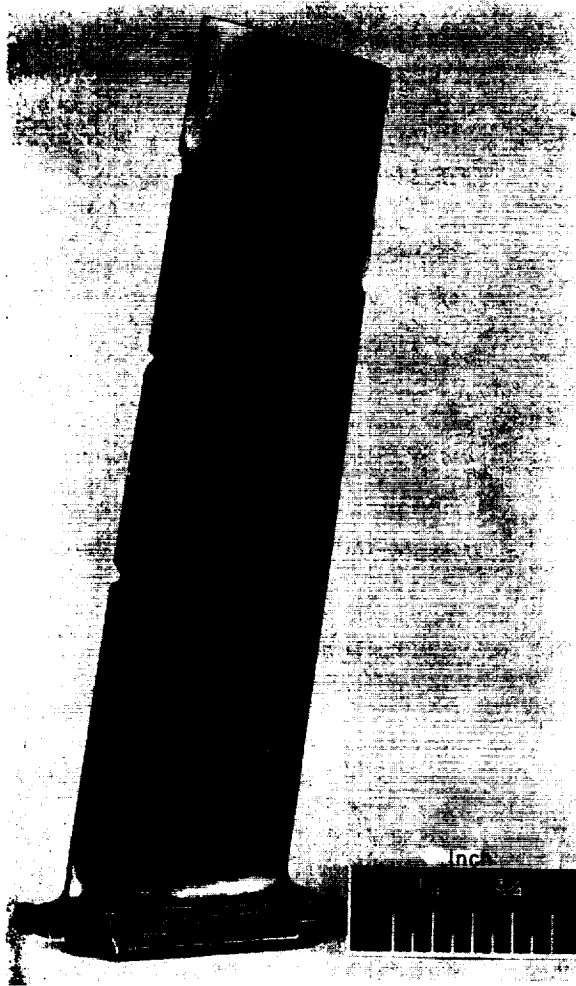
FIGURE 6.—Gouges in compressor blade caused by foreign object.

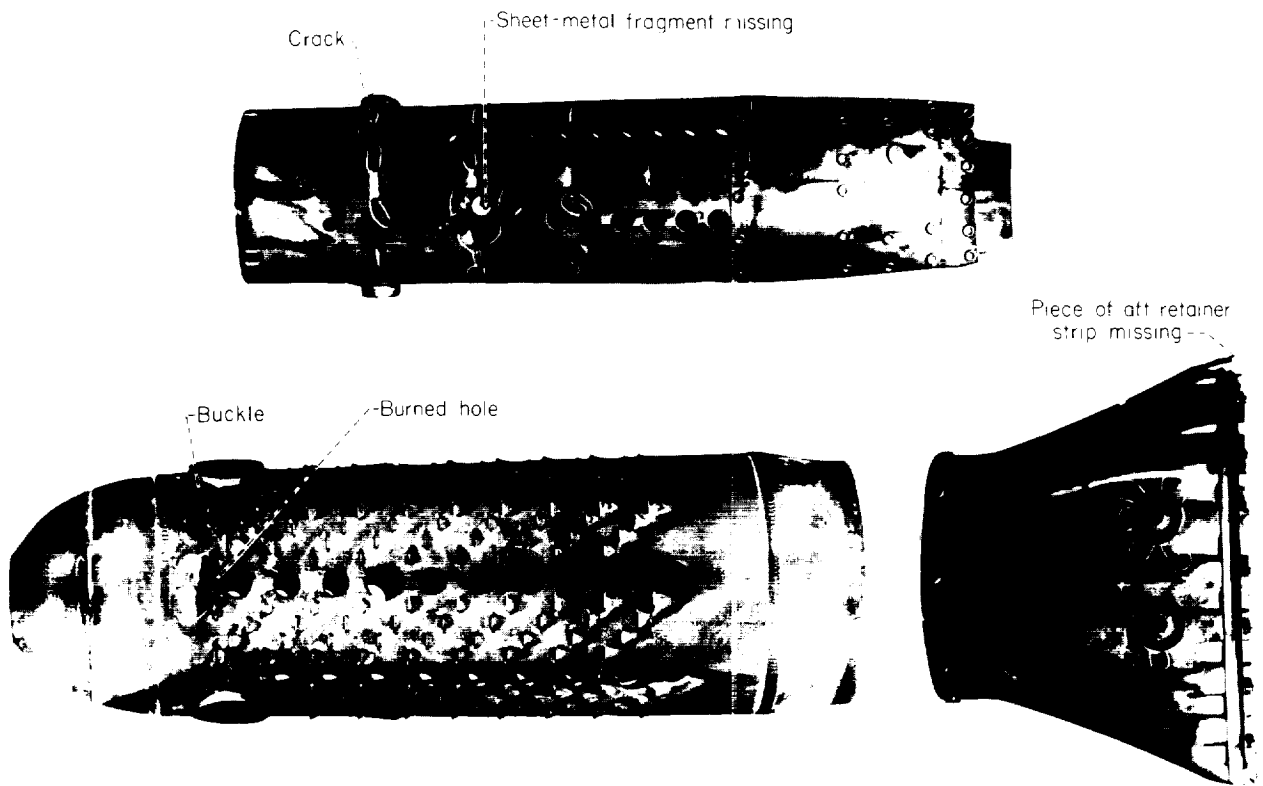
FIGURE 4.— Typical failures in turbojet liners.

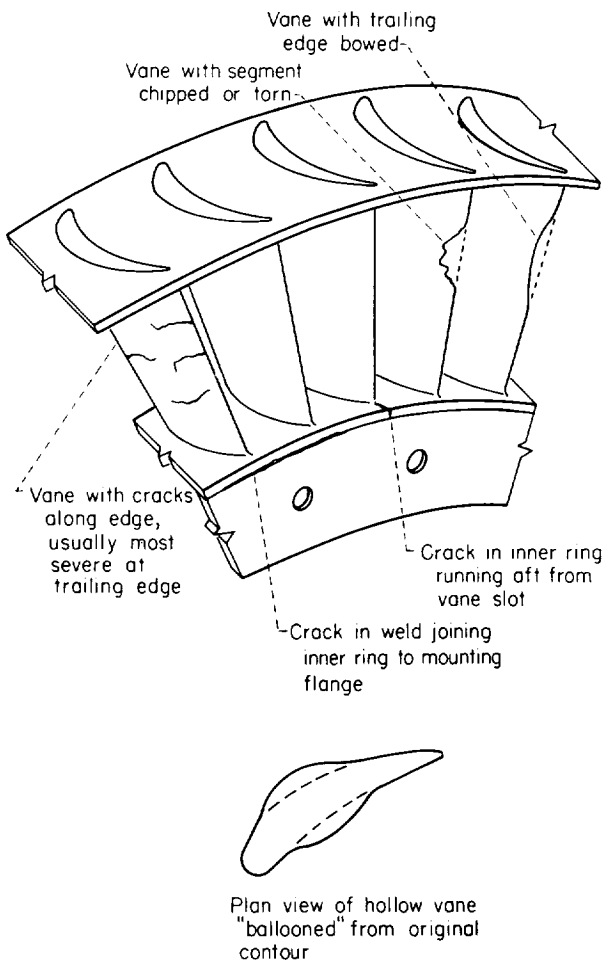
FIGURE 6.—Types of damage most common to nozzle diaphragms.

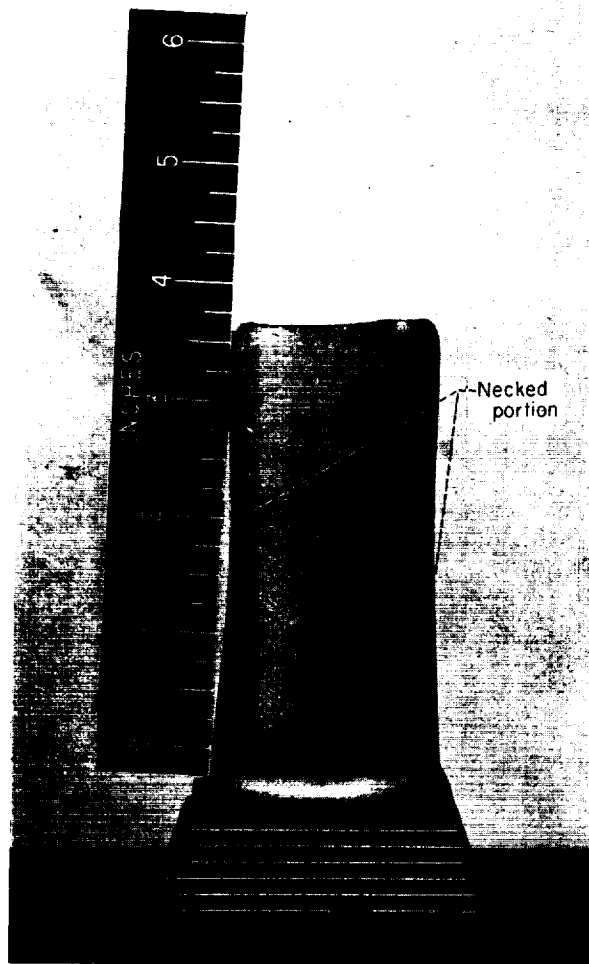
FIGURE 11.—Necked bucket.

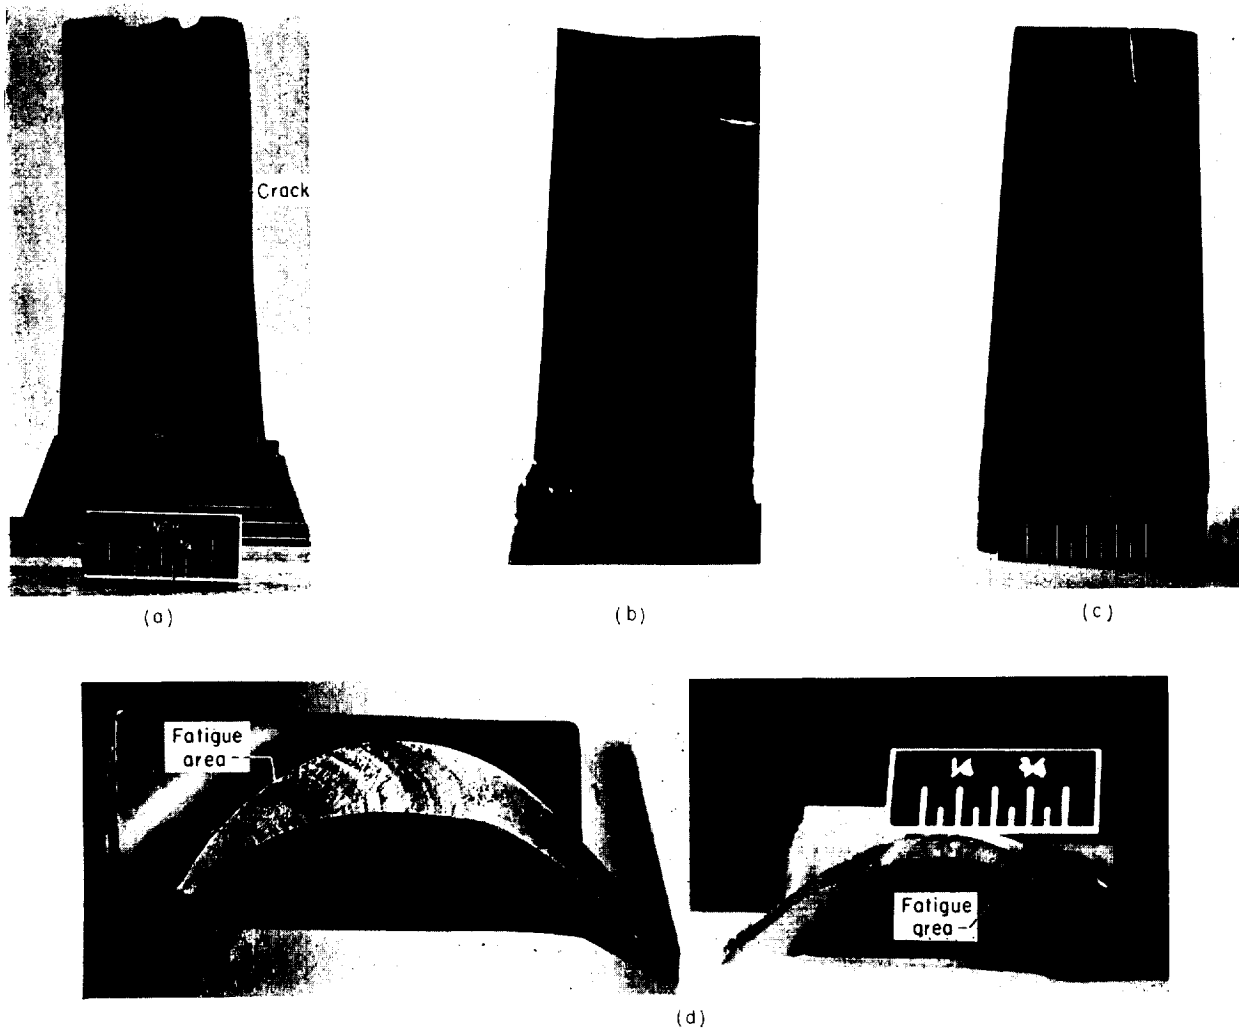
(a) Transverse cracks. (b) Transverse tip cracks. (c) Radial tip cracks. (d) Two typical surfaces.

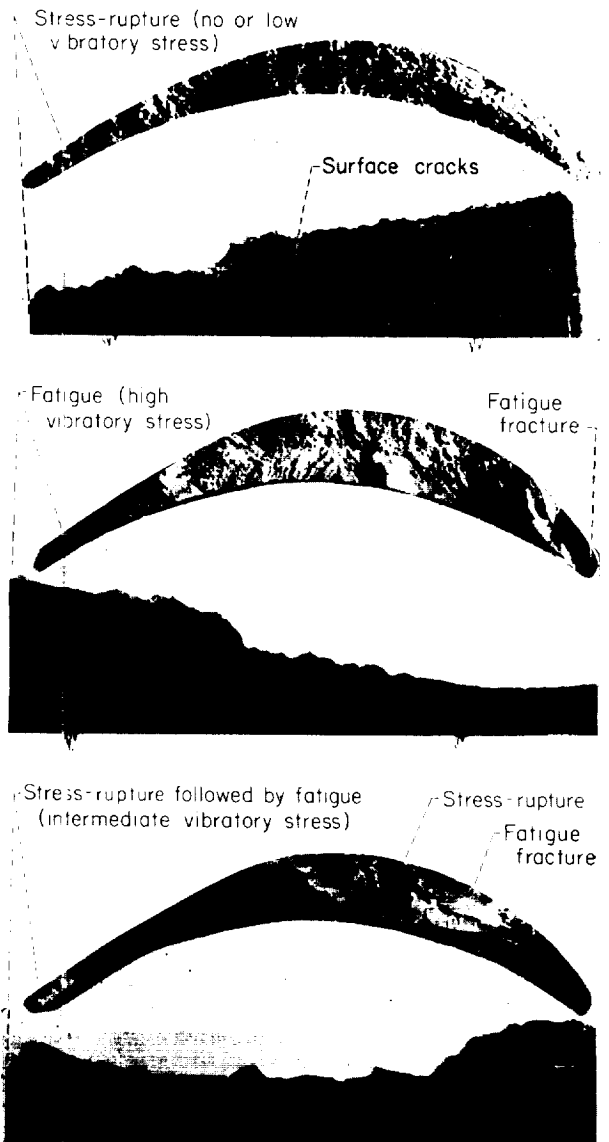
FIGURE 20.—Typical bucket failures.

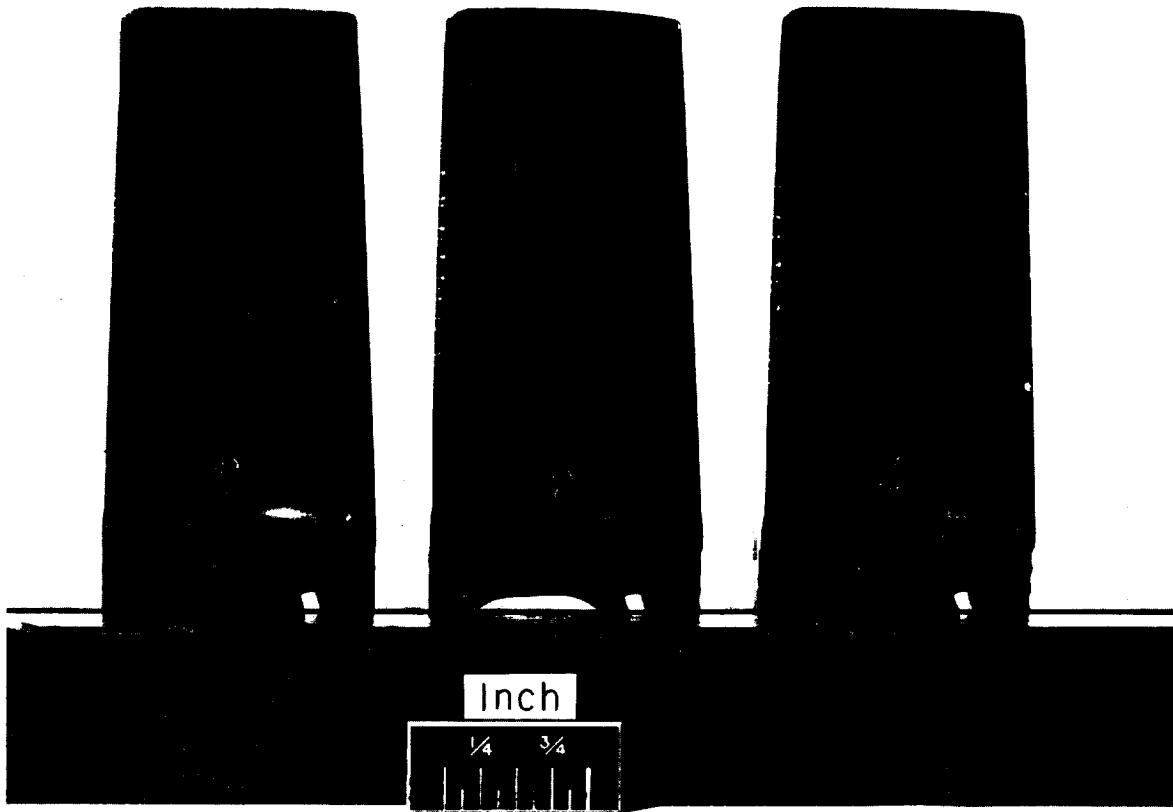
FIGURE 24.—Leading-edge cracking from repeated thermal gradients.

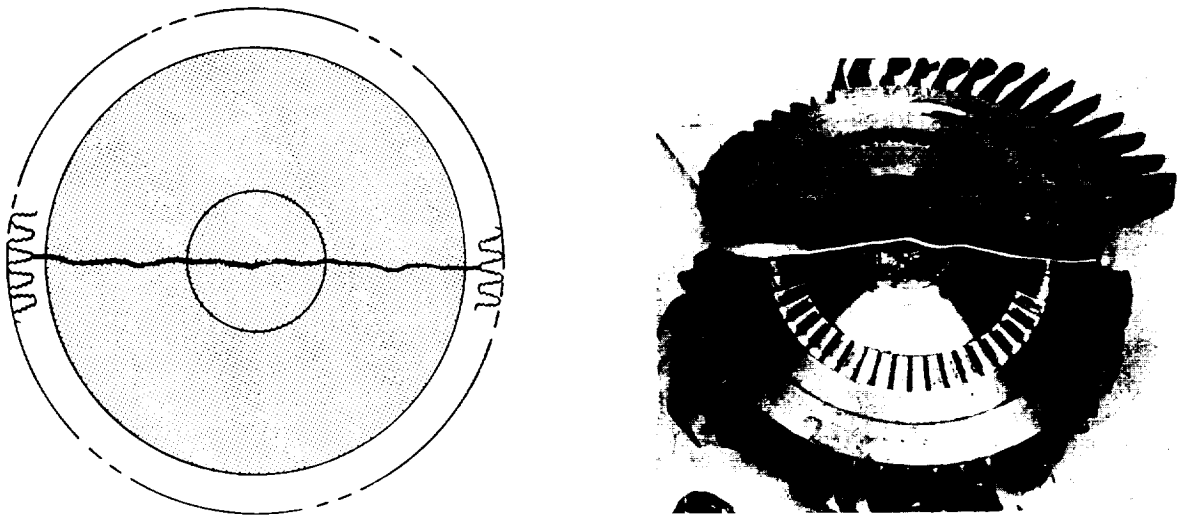
FIGURE 8.—Typical turbine-disk burst.

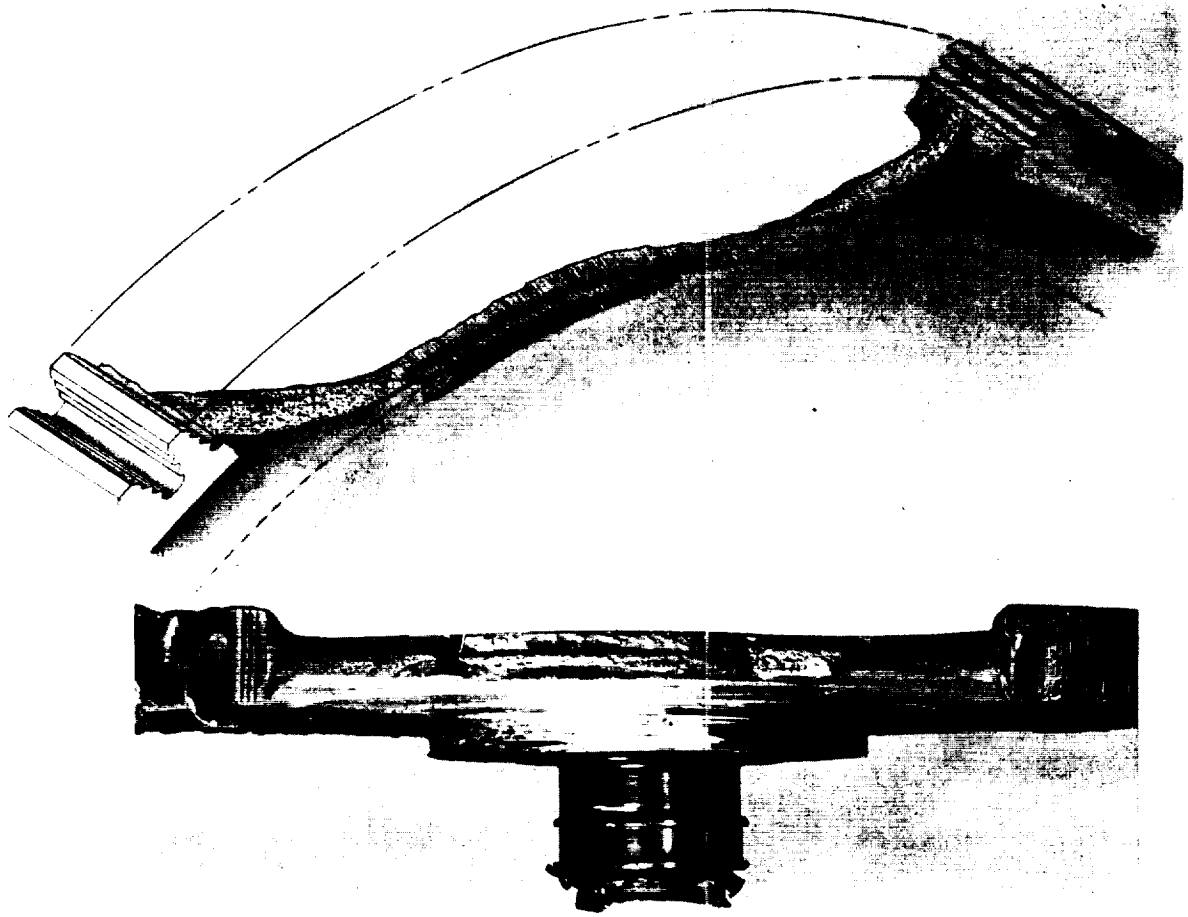
FIGURE 11. Weld failure.

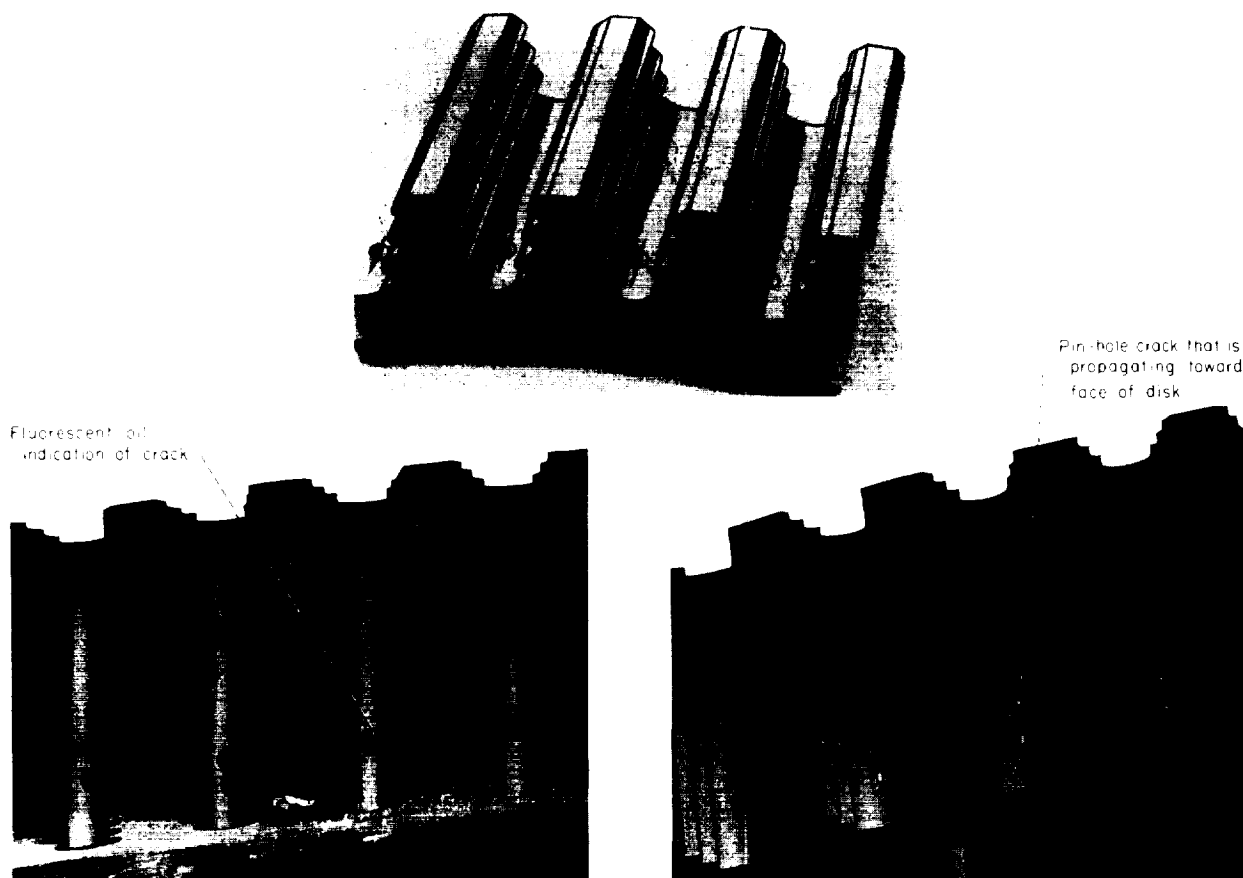
FIGURE 13. Pin-hole cracks.

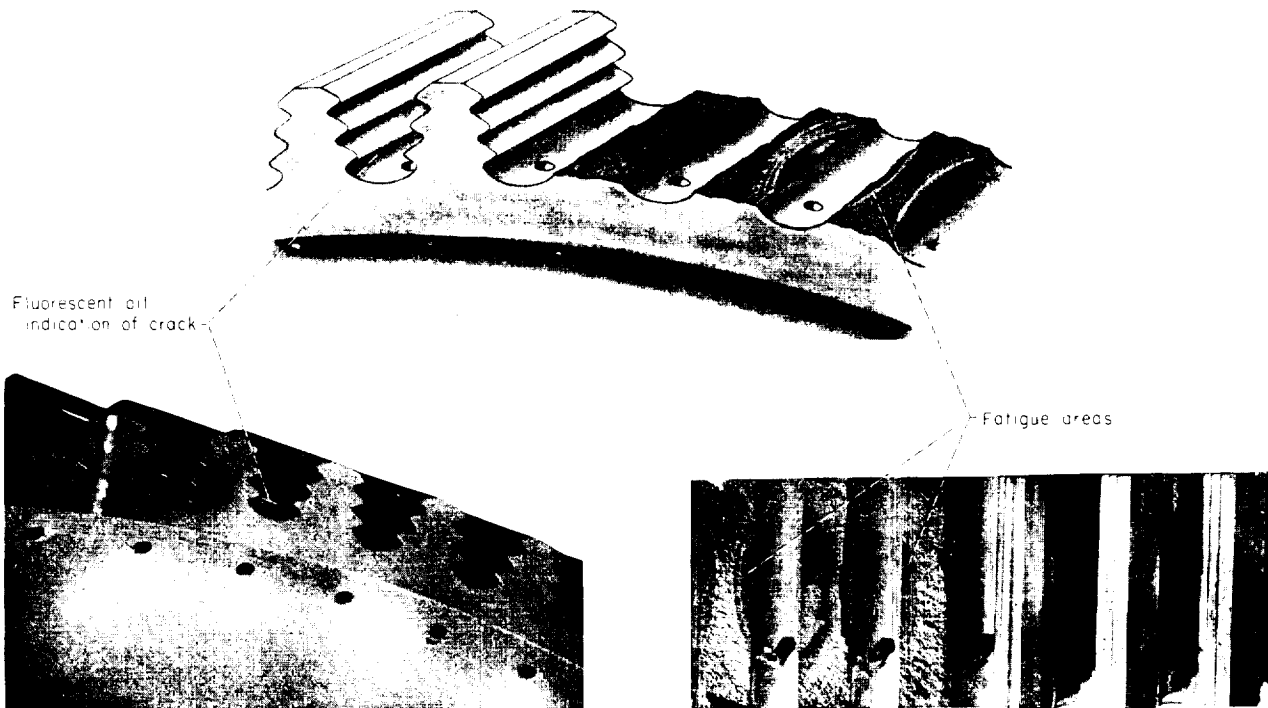
FIGURE 18. Serration failure.
