LATERAL LOAD TESTS ON EARTHQUAKE DAMAGED HOUSES IN CHRISTCHURCH

ABSTRACT: *Thousands of houses in Christchurch were damaged in the Christchurch earthquakes of 2010 and 2011. Uni-directional lateral load tests were undertaken on two houses in the residential red zone in Christchurch in June 2012. The aim of the tests was to measure the lateral load stiffness of typical moderately damaged houses to identify the change in stiffness due to the seismic load history. The wall bracing systems of the houses are assumed to satisfy the regulations in force at the time, which are outlined. Several relevant tests from the literature are briefly reviewed.*

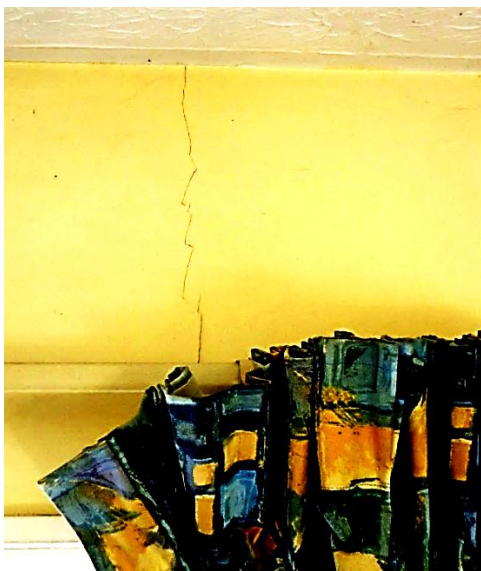
Both houses were visually inspected for damage prior to testing. Damage was typical of moderately damaged houses in Christchurch with cracking along joints in plaster board, particularly above openings, shown in Figure 10, and wrinkling of the wall paper layer. Movement between finishing lines and walls was indicated by the reveal of unpainted areas. Minor settlement, less than 20mm, was evident at Wairoa St. in the NE corner. Major settlement, greater than 50mm was seen at Bexley Rd.

Figure 10: Vertical crack above window corner existing prior to testing, Wairoa St. Photo D. Yeoh

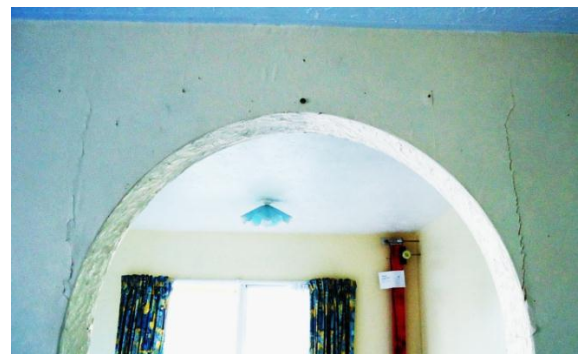
Damage caused by testing exacerbated that caused by the earthquakes, as shown in Figure 17. Test loads also created new cracks and additional movement between building components. Movement due to the applied test load was seen throughout both houses but the loaded end of the house exhibited greater local effects.

Figure 17: Arched opening in central bracing line of Wairoa St while under 100kN test load. This existing damage was enhanced by the application of the test load.

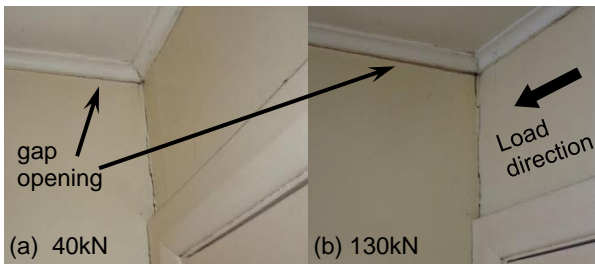
In addition to the cracking of wall panels, two other failure patterns were considered to be of particular interest. The first pattern was clear evidence of movement between the ceiling diaphragm and the adjacent walls as shown in Figures 18, 19 and 20. This indicated a failure in the connection between the two bracing elements. All deflections were measured off the walls so movement of the ceiling was not recorded. However, the exposed unpainted area, indicated in Figure 20, shows movement of approximately 5mm.

Figure 18: Increased cracking in corner and opening of a gap between scotia and wall while increasing the applied test load, Bexley Rd. Photo: L. Holt

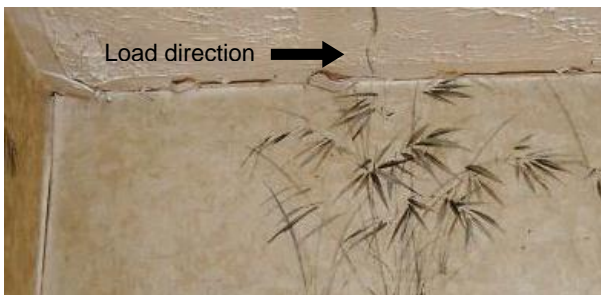
Figure 19: Cracking showing movement between ceiling and wall at 130kN load, Bexley Rd. Photo: L. Holt

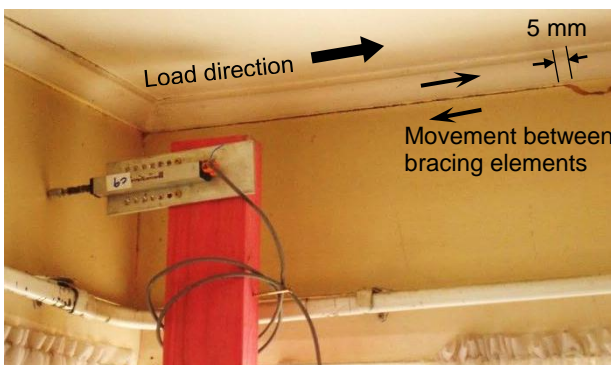
Figure 20: Movement of ceiling relative to wall during test, 130kN load, Bexley Rd. Photo: L. Holt

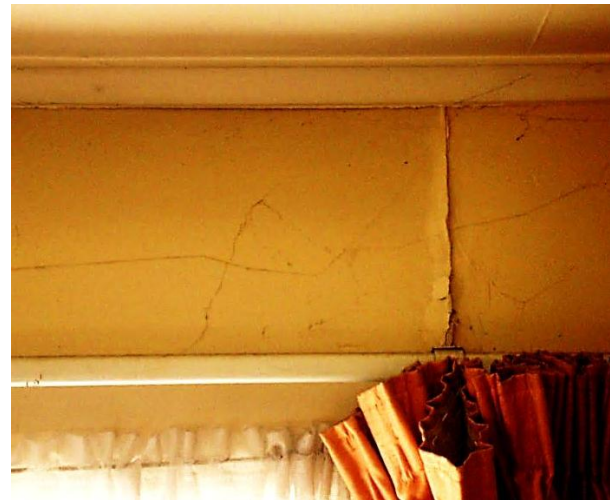
The second damage pattern investigated was evidence of shortening of walls parallel to the load direction. This is shown in Figure 21 by the buckling of the wall lining. The evidence of wall shortening in Figure 21 is confirmed by the changes in the recorded deflections along the length of the building shown in Figures 14 and 16 in the Results section. This particular damage pattern was specific to the nature of the test rig. This type of damage was due to the test rig applying a concentrated line load along one end of the building and was not seen in the existing earthquake damage as ground motion

distributes loading evenly throughout the structure. The loss in length of the wall was attributed to axial strain, local crushing and closing of gaps along the length of the top plate.

Figure 21: Buckling of wall lining above window at 130kN load, Bexley Rd. Photo: L. Holt
