Earth Fissures in Jiangsu Province, China and Geological Investigation of Hetang Earth Fissure

Abstract

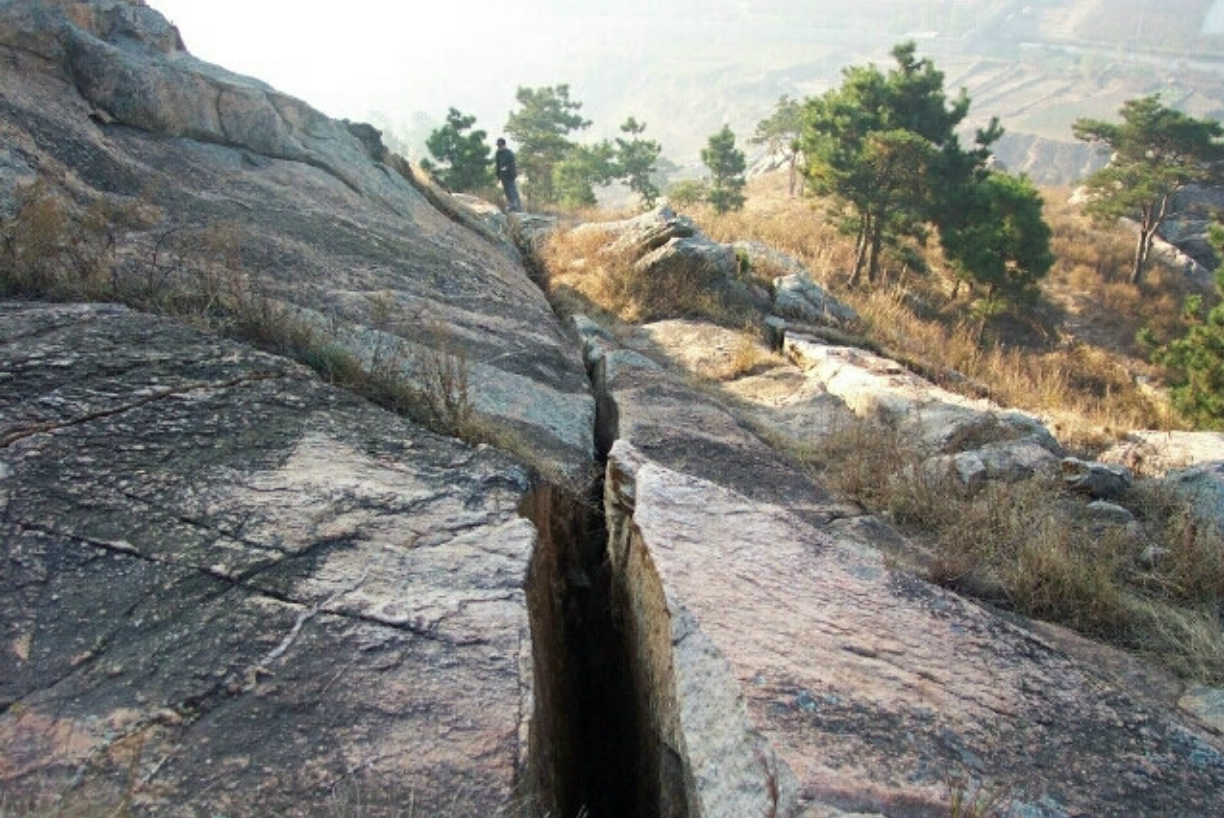
Phosphorite Mine as an example, there are two groups of earth fissures in the mine area. Fig. 2 is a photograph of the exposed rock fissure at a cliff. At present, the closed old workings are at -50 m, -110 m, -170 m, -230 m, -290 m, -350 m and -470 m levels. The area of land subsidence is about 600 000 m² and appears like an ellipse on the ground surface. The subsidence trough is 1,650 to 2,100 m long and 30 to 600 m wide. Earth fissures are developed surrounding and crossing the trough. The length of earth fissures is from several to hundreds of meters, the opening is from several to 1,800 mm and the depth is from several to hundreds of meters. The interval of fissures varies greatly. The surfaces of fissures are typically smooth and straight, with a dip angle of 69°-87°. Clustered fissures are parallel to the longitudinal axis of the subsidence depression. The earth fissure zone is controlled by underground mining activities. The peak occurrence of earth fissures was between 2000 and 2001, during which a national heritage in the vicinity was affected in addition to destruction of houses, landslides and inflows of surface water into tunnels.

Fig.2 Exposed rock fissure at Jinping Phosphate Mine

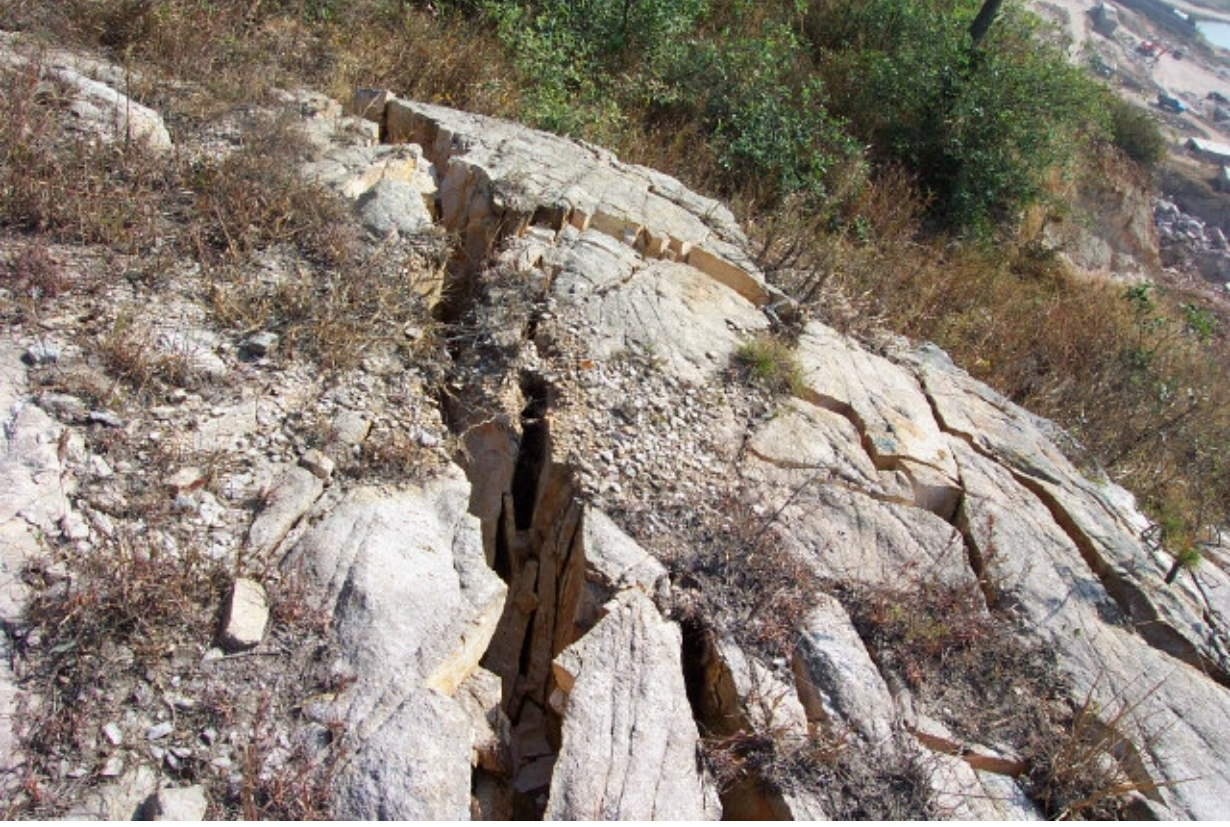
Fig. 3 Yuntai landslide rear fissure

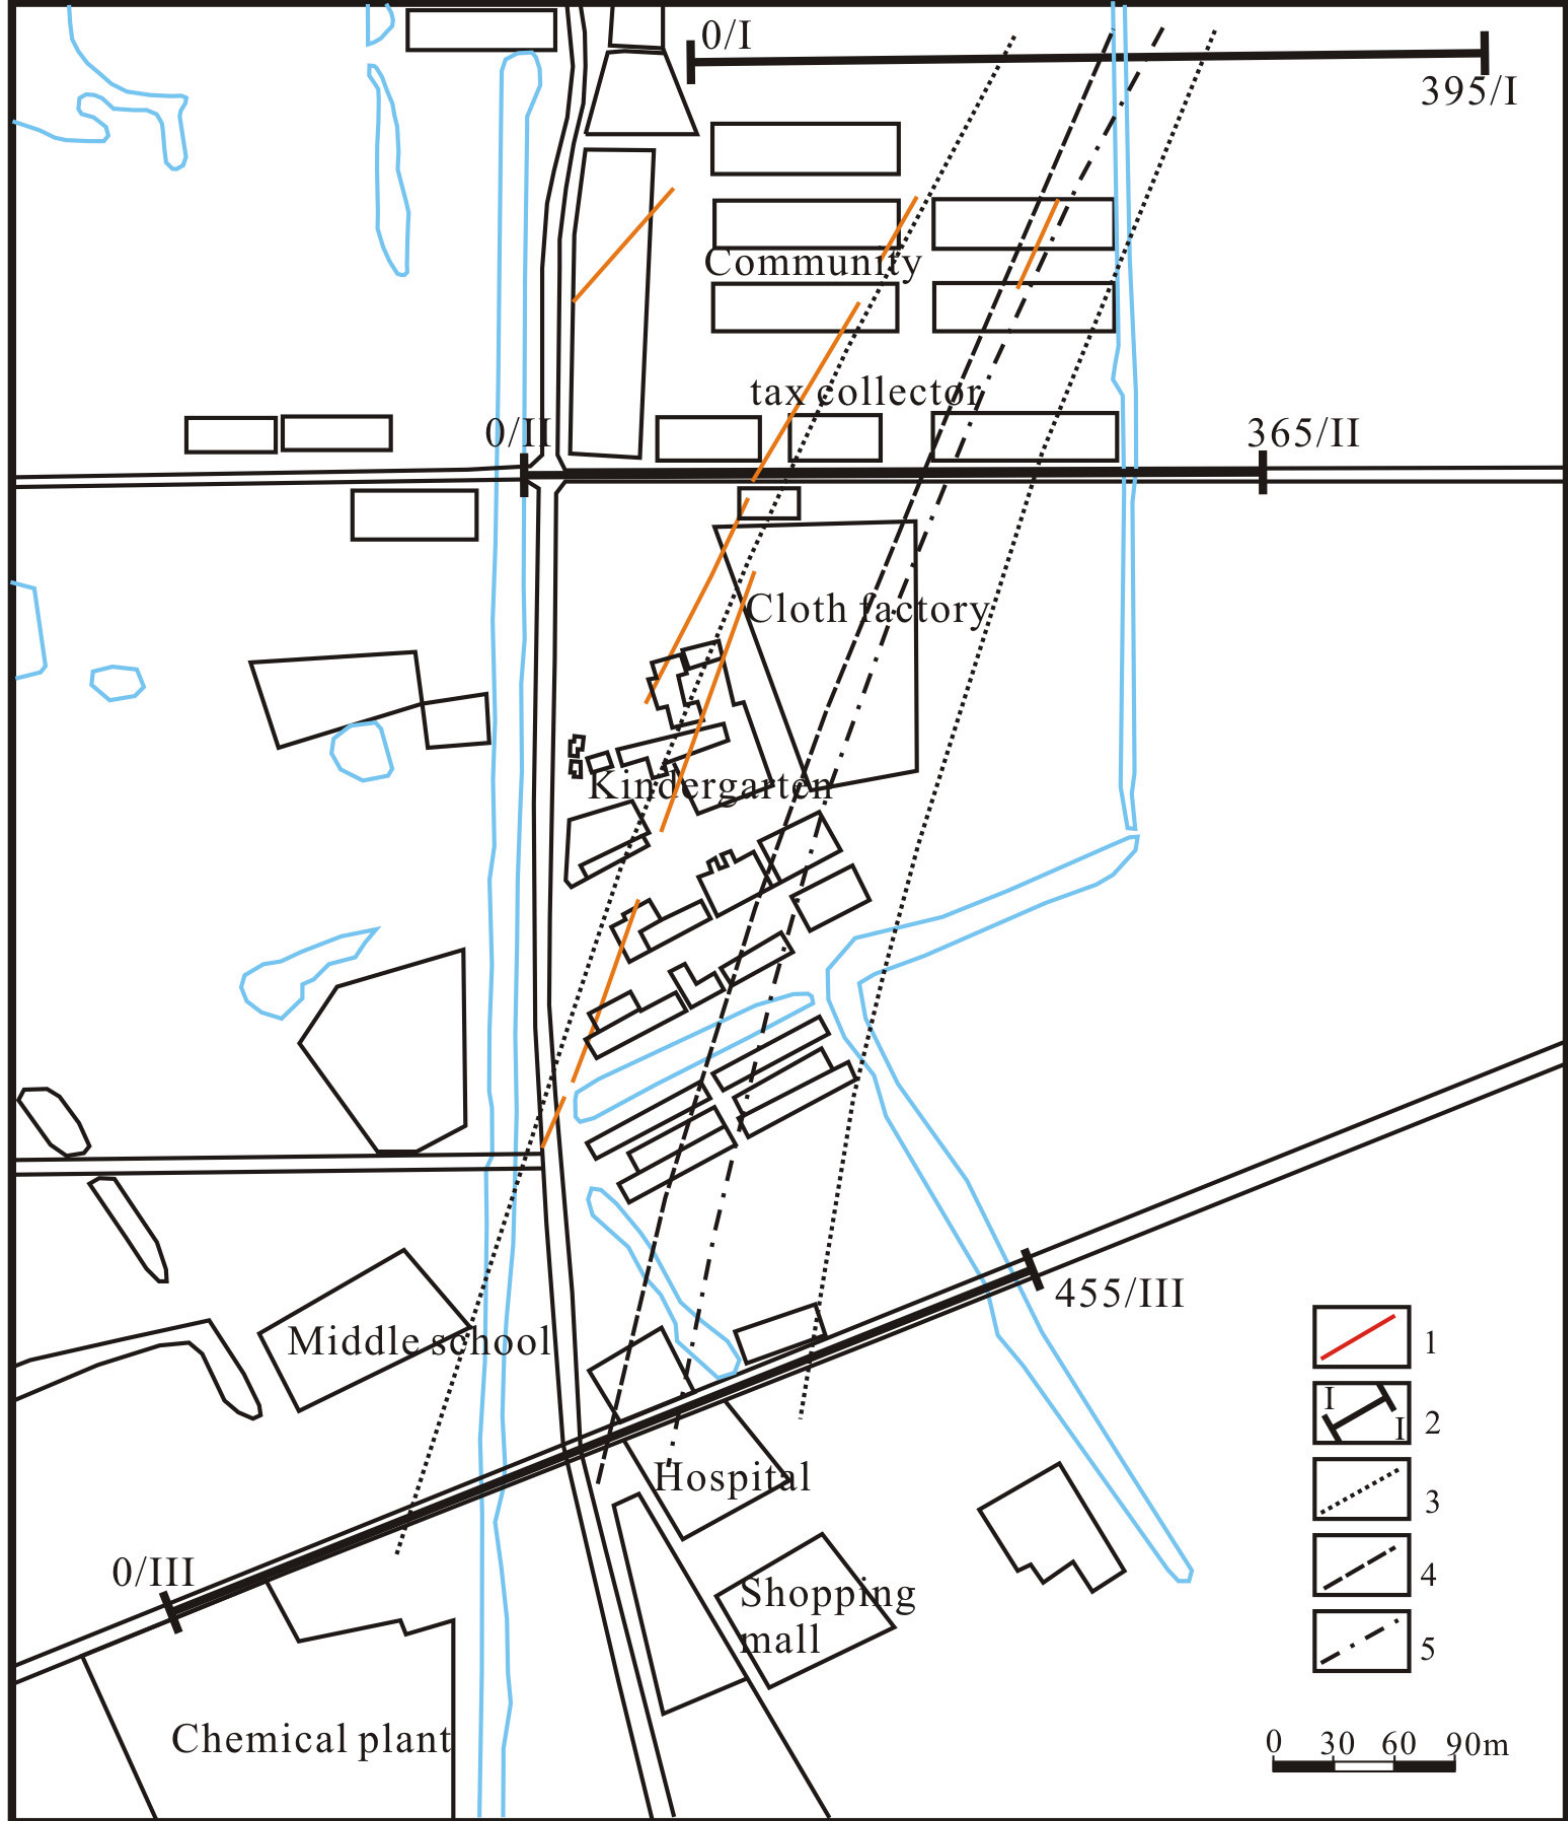
immediately organized right after the occurrence and a shallow seismic survey was conducted in 1997 along three lines as depicted in Fig. 4. The results of the site investigations and the shallow seismic survey (Wang et al. 2008a) are briefly summarized as following: The earth fissure trended at NE20°, gradually extended to the north and south and the development peaked in 1998. The earth fissure zone, comprising three fissures, was 500 m long and 60 m wide (Fig. 4). The northwest side of the fissure was offset downwards 50 to 150 mm with a maximum of 300 mm. The aperture of the fissure was 30 to 60 mm and the visible depth was 60 to 90 mm. Since it is located at an area of high density of buildings, the earth fissure has caused a severe damage to buildings and houses in the fissure zone. The direct economic loss is estimated at 1.5 million dollars. The bedrock topography revealed by the seismic survey indicates that there is a bedrock ridge underneath with a slope angle of 12 to 15° (Wang et al. 2008a).

Fig. 4 Distribution of earth fissures at Hetang (after Wang et al. 2008a)

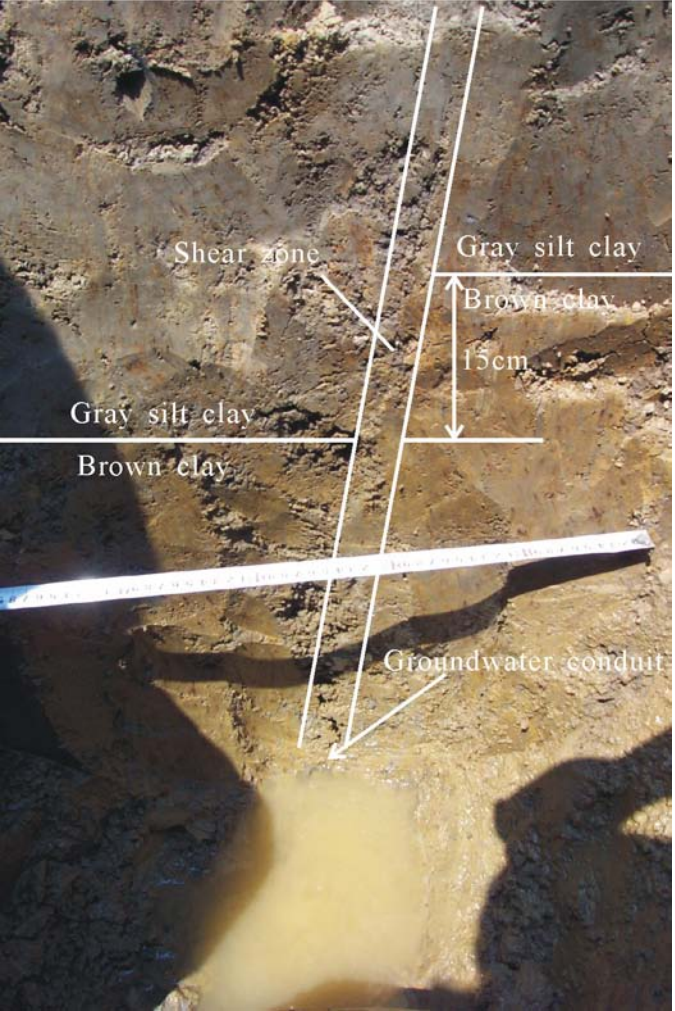
The earth fissure was not apparent in the loose fill on the cross section in Fig.5. In the

grey silty clay, the fissure of 1.0 mm aperture was visible. Further downwards, the interface between the silty clay and clay was clearly faulted by 100 mm with NW side downwards, and there was a shear zone of 20-50 mm wide where the soil was disturbed. Outside of the shear zone, there was no visible soil disturbance. The fissure within the trench was trended NE35°, dipping to the west of a dip angle 80° or steeper.

The groundwater level in the unconfined aquifer is very shallow; it was 1.0 m below the ground surface on 12 September 2007 in a well 20 m away from the excavation. Though the ground surface at the site is 500 mm higher than that at the well, the excavation was expected to encounter an inflow of groundwater. So during the excavation, there was a pause at the 1.5 m depth, then accelerated the excavation till 1.8 m deep. A small inflow from the fissure was observed at this level. As the excavation was within the clay layer, not reaching the water-bearing sand layer, it can be inferred that the clay layer is ruptured and the fissure becomes a channel to the aquifer.

Fig. 5 Cross section of the open trench excavation of Hetang Earth Fissure

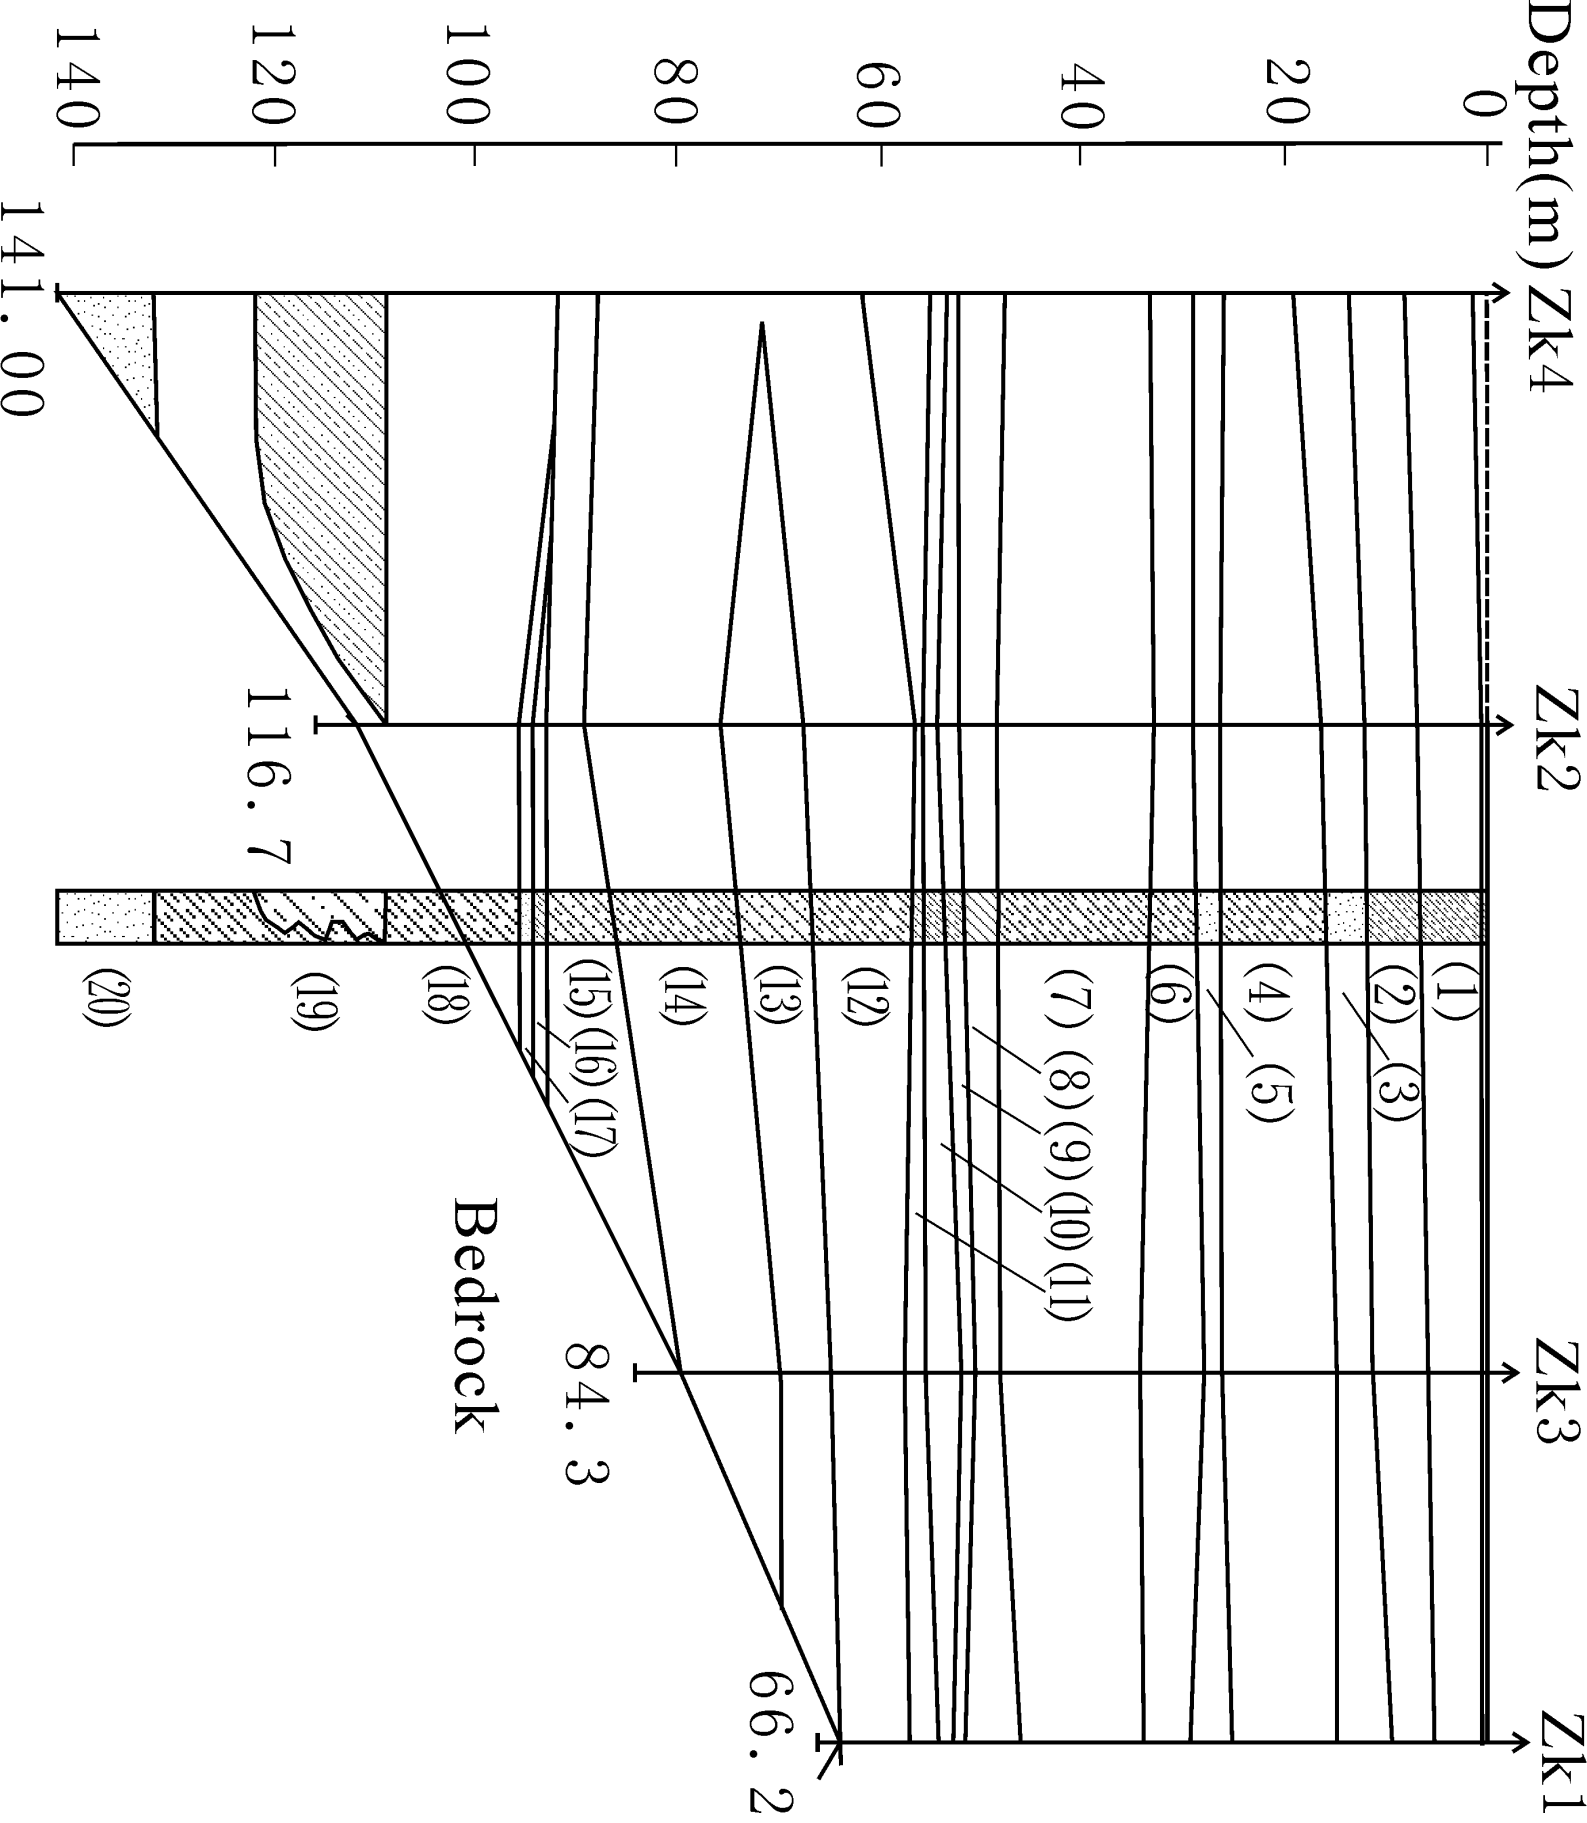
Between 20 August 2007 and 10 September 2007, three geologic drill holes, denoted as ZK1, ZK2 and ZK3 in Fig. 6, were completed along No.1 Line of the shallow seismic survey in 1997 (see Fig. 4). The total drilling was 267.2 m, and the thickness of the Quaternary was 64.0 m, 111.9 m and 79.9 m at ZK1, ZK2 and ZK3, respectively. Soil samples were extracted at different levels from the drill holes for laboratory tests. The soil stratigraphy along the line is shown in Fig. 6. The geological cross section confirms the bedrock abnormality found in the shallow seismic survey (Wang et al. 2008a).

At Hetang earth fissure, there is a spatial correlation between the development of earth fissures and the ridge and slope of the underlying bedrock hill. The bedrock hill affects the stratum structure of the Quaternary aquifer system (Fig. 6). In this area, groundwater has been excessively extracted for a long period, so large differential settlement has been formed due to the consolidation of the sediments under the increased effective stresses from the groundwater drawdown. Tensile deformation can be developed in sediments overlying the bedrock ridge due to bending. Once the tension exceeds the limit of the

Fig.6 Geological cross section of Hetang Earth Fissure
