FAULT MOTIONS AT THE BALDWIN HILLS RESERVOIR SITE

BY DONALD E. HUDSON AND RONALD F. SCOTT

ABSTRACT

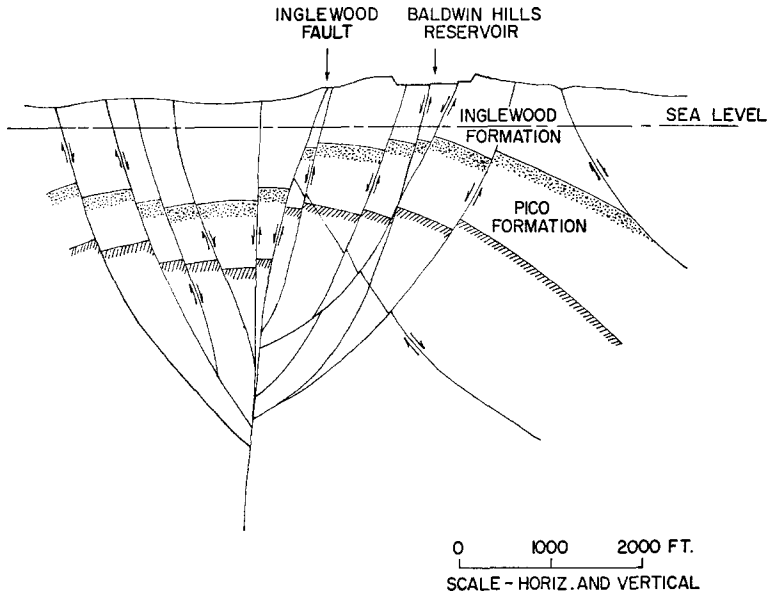
A vertical cross-section through the fault zone and the reservoir, at right angles to the major trend of the fault is shown in fig. 1 (State Report, 1964). This is a schematic diagram which merely aims to indicate the main features of the situation. These major features are also shown in fig. 2, where the surface fault traces have been taken from a recent map prepared by Castle for the U.S. Geological Survey

FIG. 1 SCHEMATIC DIAGRAM OF INGLEWOOD FAULT SYSTEM AT THE BALDWIN HILLS RESERVOIR (APPROX. TO SCALE - REF. STATE REPORT, 1964)

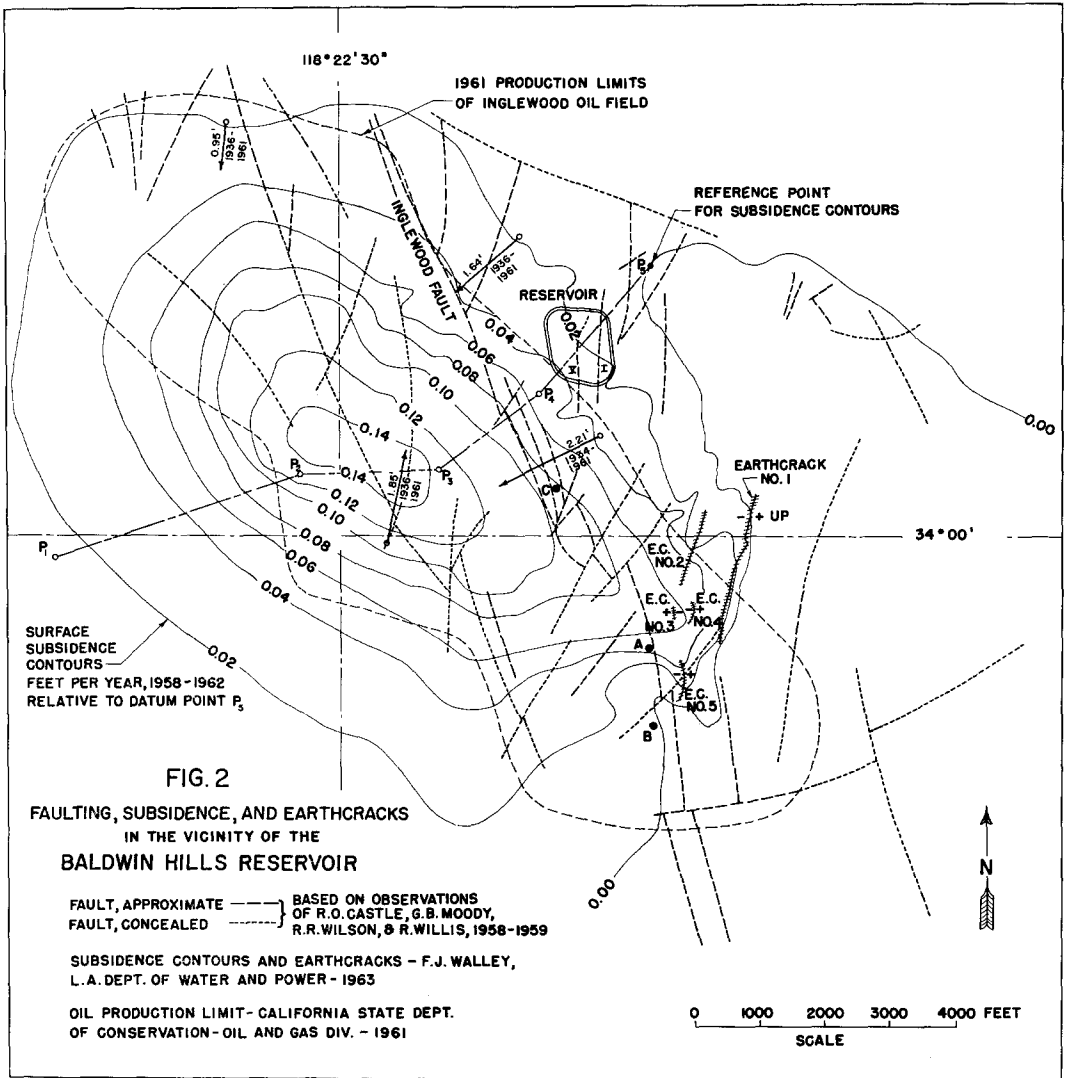
The fault running through the east side of the reservoir, marked I on fig. 2, was investigated in some detail during the excavation for the reservoir. At the center of the proposed reservoir, vertical motions of some 13 ft were noted increasing to 26 ft at the north side. Total horizontal movements could not be determined. It was not possible to determine the time at which these fault motions had occurred, but on the evidence of the appearance of the fault gouge and slicken-slides, the fault was termed active (Wilson, 1949).

The solid contours of fig. 2 define the pronounced local subsidence bowl which coincides roughly with the Inglewood Oil Field ("California Oil Fields", 1961). These contours are based on measurements made by the Department of Water and Power of the City of Los Angeles (Walley, 1963). Similar maps have been prepared by the Los Angeles County Engineer, and by the Geodetic Section, Survey Division, Bureau of Engineering, of the City of Los Angeles. The maps from these three sources vary slightly because they include different time intervals, are perhaps based on different reference points, and presumably involve some independent measurements, but the general features are all very similar.

Related to the whole subsidence pattern in the Baldwin Hills are a number of earth cracks that have been observed since 1957. On fig. 2 are marked several of these cracks which have caused considerable damage to streets and paved areas during the past few years. These cracks, which involve some vertical offset but no observed horizontal displacements, evidently occur in regions where the rate of subsidence is rapidly changing over short distances (State Report, 1964).

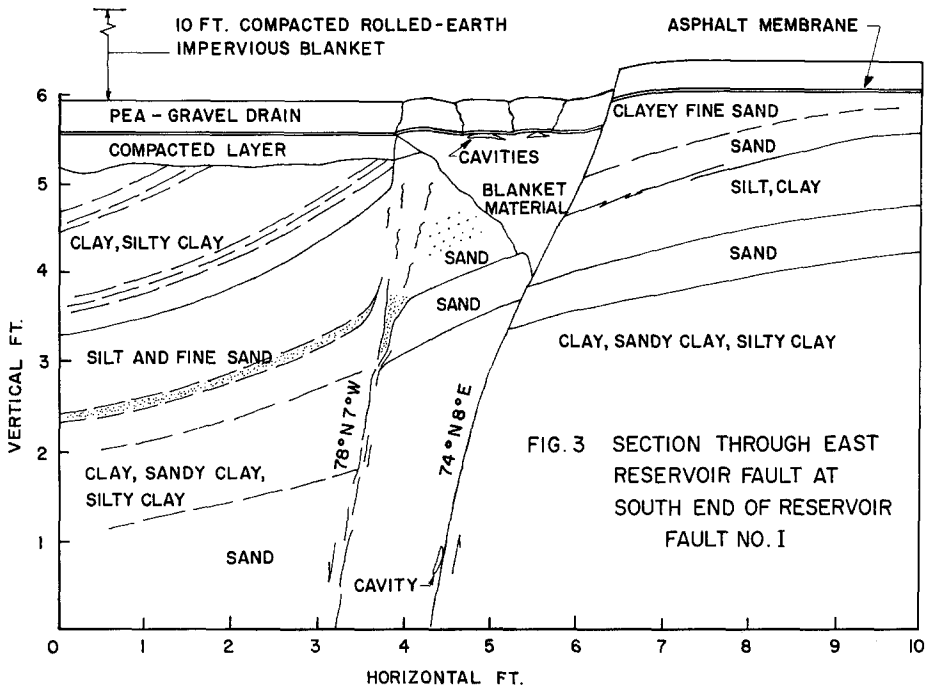
FIG. 3 SECTION THROUGH EAST RESERVOIR FAULT AT SOUTH END OF RESERVOIR FAULT NO. I

Following the drainage of the reservoir during the failure, displacement along Fault No. I since the time of construction was made apparent by a crack running across the reservoir floor. In the course of the subsequent investigations, the fault zone was examined by trenching and tunneling to a depth of about 45 ft below the original reservoir floor. The vertical section of fig. 3 shows in some detail this reservoir Fault No. I. Since the completion of the reservoir in 1951, a total maximum vertical displacement of about 7 inches has occurred on Fault I and about 3 inches on Fault No. V (fig. 2) as evidenced by the relative displacement of the asphalt seal underneath the reservoir. (State Report, 1964)

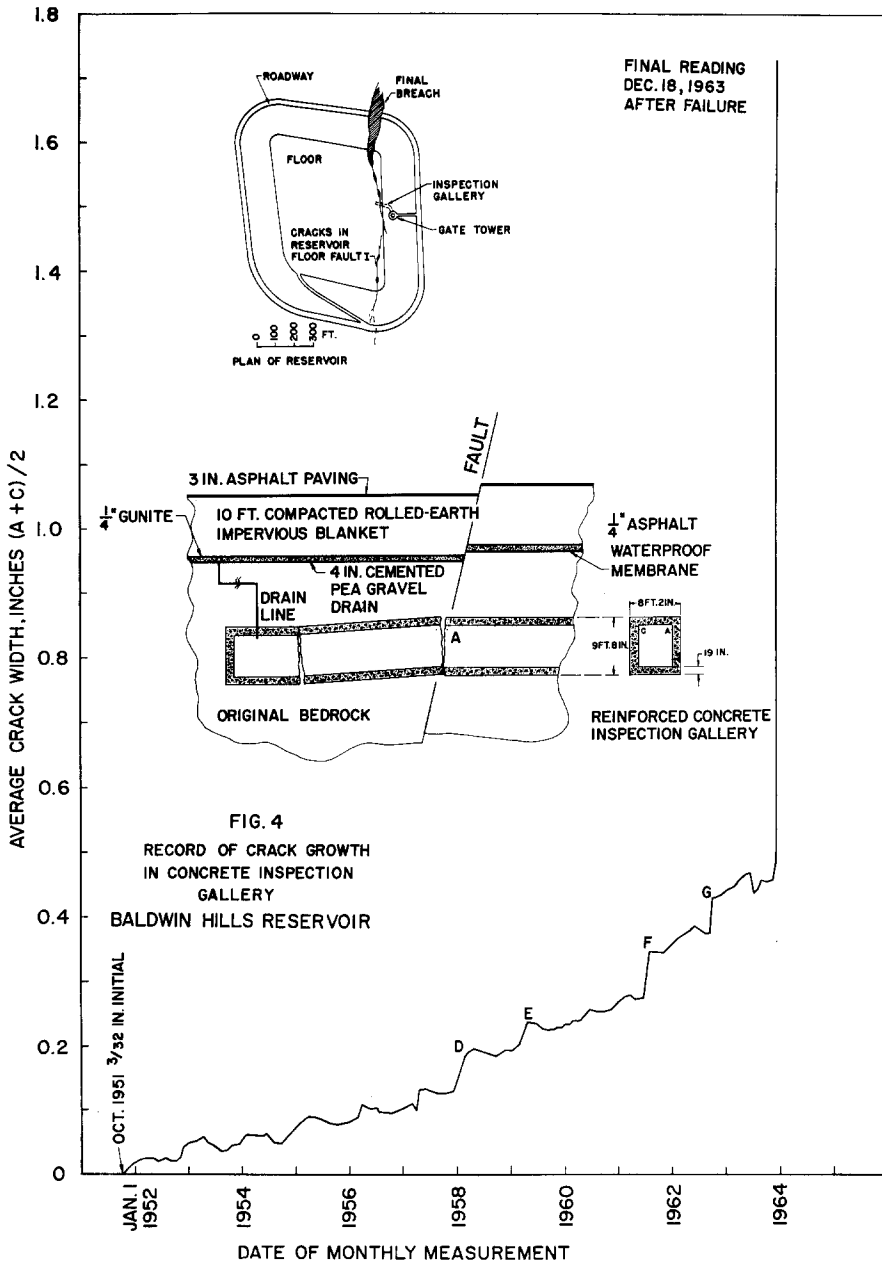
The most direct evidence bearing on the time-scale involved in the fault movements is that provided by the record of crack growth in the concrete drainage inspection chamber underneath the reservoir. This reinforced concrete gallery (fig. 4) was provided to carry the drainage system pipes coming from the floor of the reservoir through the fault zone to the base of the gate tower. In October of 1951, a $\frac{3}{32}$ in. crack was noted in the ceiling of this chamber in the region of the fault zone. Strain gage points were established across the crack, and readings were taken at monthly intervals. In February of 1958, a new crack appeared on the floor of the chamber on the other side of the fault zone, and this crack was similarly monitored. In January 1960, two new cracks developed in the concrete between the gate tower and the location of the original cracks.

Figure 4 shows the average of strain gage readings at the two ends of the ceiling crack at "A" plotted for the whole history of the crack. It should be noted that although the crack was wide enough before the reservoir failure so that the steel reinforcing bars in the concrete were visible, no leakage through the crack was reported prior to failure.

It will be seen from fig. 4 that the configuration of the two major cracks corresponds to the relative fault motions that are known to have occurred, and that the width of the cracks, the distance between them, and the size of the chamber are compatible with the observed magnitude of the local fault motions. The location of the fault shown in fig. 4 is of course only approximate, as a zone of faulting of perhaps several feet wide is undoubtedly involved.

Referring again to fig. 4, it will be seen that the record is characterized by several rather abrupt jumps at points marked D, E, F, and G, for example, superimposed on a curve of continually increasing slope. There is also an indication of a definite change in the rate of crack development some time in 1957 and in 1961. As mentioned previously the reservoir was drained and cleaned in March 1957 at which time no evidence of major cracking on the floor of the reservoir was reported. This operation may have taken place just prior to the noticeable increase of crack growth

It will be observed that the crack growth curve of fig. 4 shows a pronounced yearly periodicity, with peaks occurring in the spring. This apparently does not correlate with any factors involved in the operation of the reservoir, such as water level. It

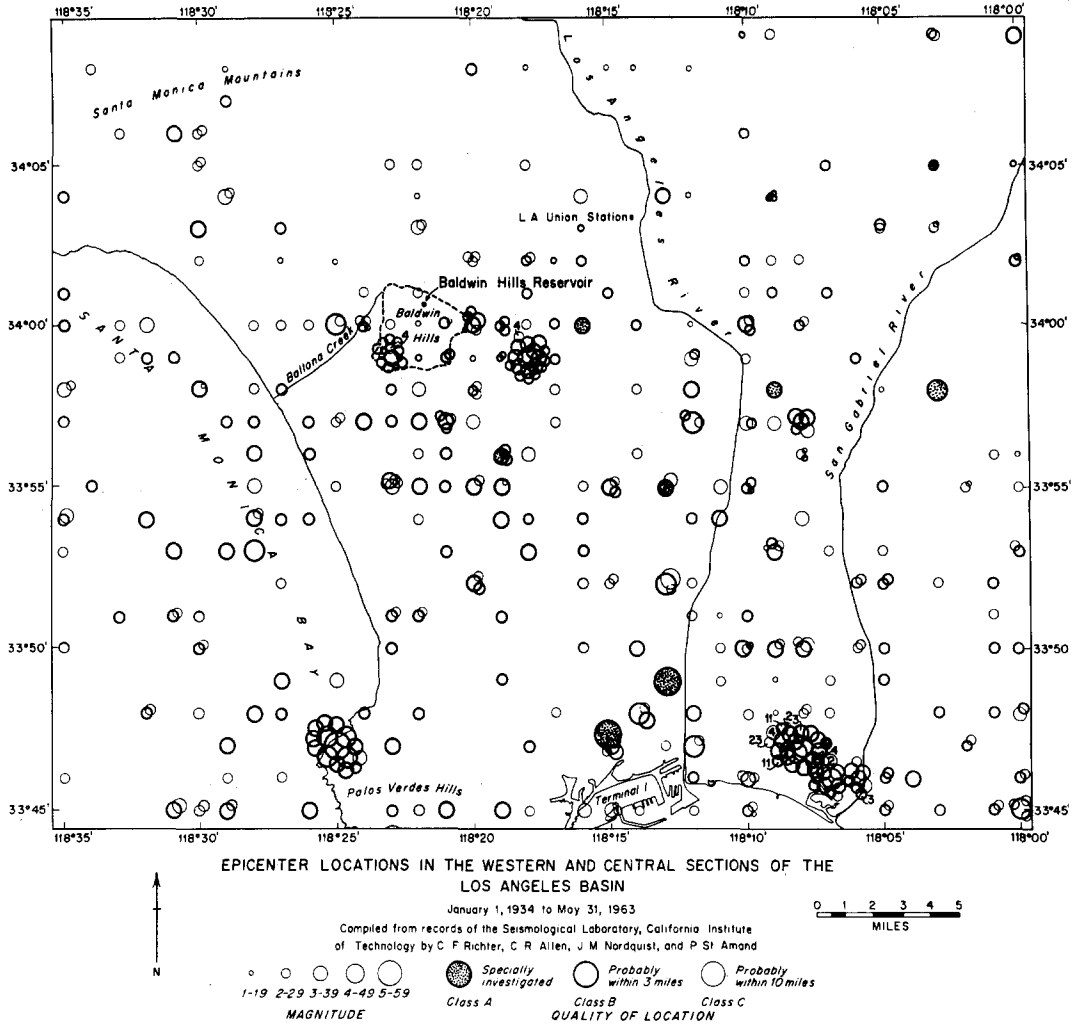
FIG. 5

As one means of evaluating the general seismicity of the Baldwin Hills Area, an epicenter map of past earthquakes was prepared for a region of some 30×35 miles centered on the reservoir. This compilation was much facilitated by a new Catalog of Southern California Earthquakes prepared by Richter, Allen, Nordquist, and St. Amand on I.B.M. punched cards (Nordquist, 1964). Using this catalog, it is possible to program a digital computer to compile such data as location, depth, magnitude, and quality of data, for all shocks of a specified size within a specified distance of a prescribed point. Figure 5 shows the results for earthquakes occurring within the dates of January 1, 1934 to May 31, 1963. Within the accuracy of the epicenter location, the map reveals essentially a uniform distribution of epicenters throughout the area. The tendency to line up on coordinate axes is, of course, a consequence of rounding off the coordinate values. It is evident that there is no detailed correspondence between the epicenter locations and known fault locations. If the ac-

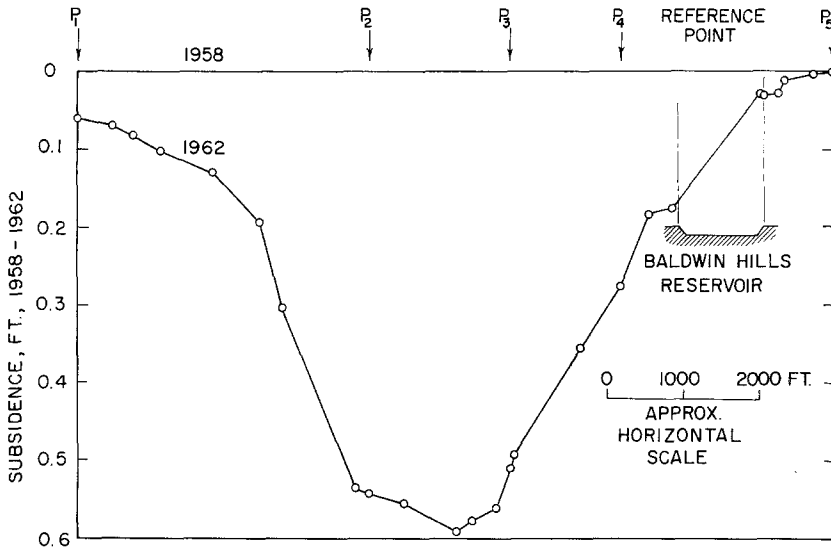
In fig. 6 is shown a vertical cross-section through the reservoir along the line P_1, P_2, \dots, P_5 of fig. 2, which passes approximately through the center of the subsidence bowl (Walley, 1963). It will be noted that the reservoir is located on the subsidence profile in such position as to be subject to tension. This is further established by repeated measurements of the dimensions of the reservoir, which show that

FIG. 6 ELEVATION CHANGES ALONG LINE THROUGH THE BALDWIN HILLS RESERVOIR (FIG. 2) (REF. WALLEY, 1963)
