Troubleshooting Challenges on the James Webb Space Telescope (JWST)

July 23, 2019

John McCloskey

NASA/GSFC Chief EMC Engineer

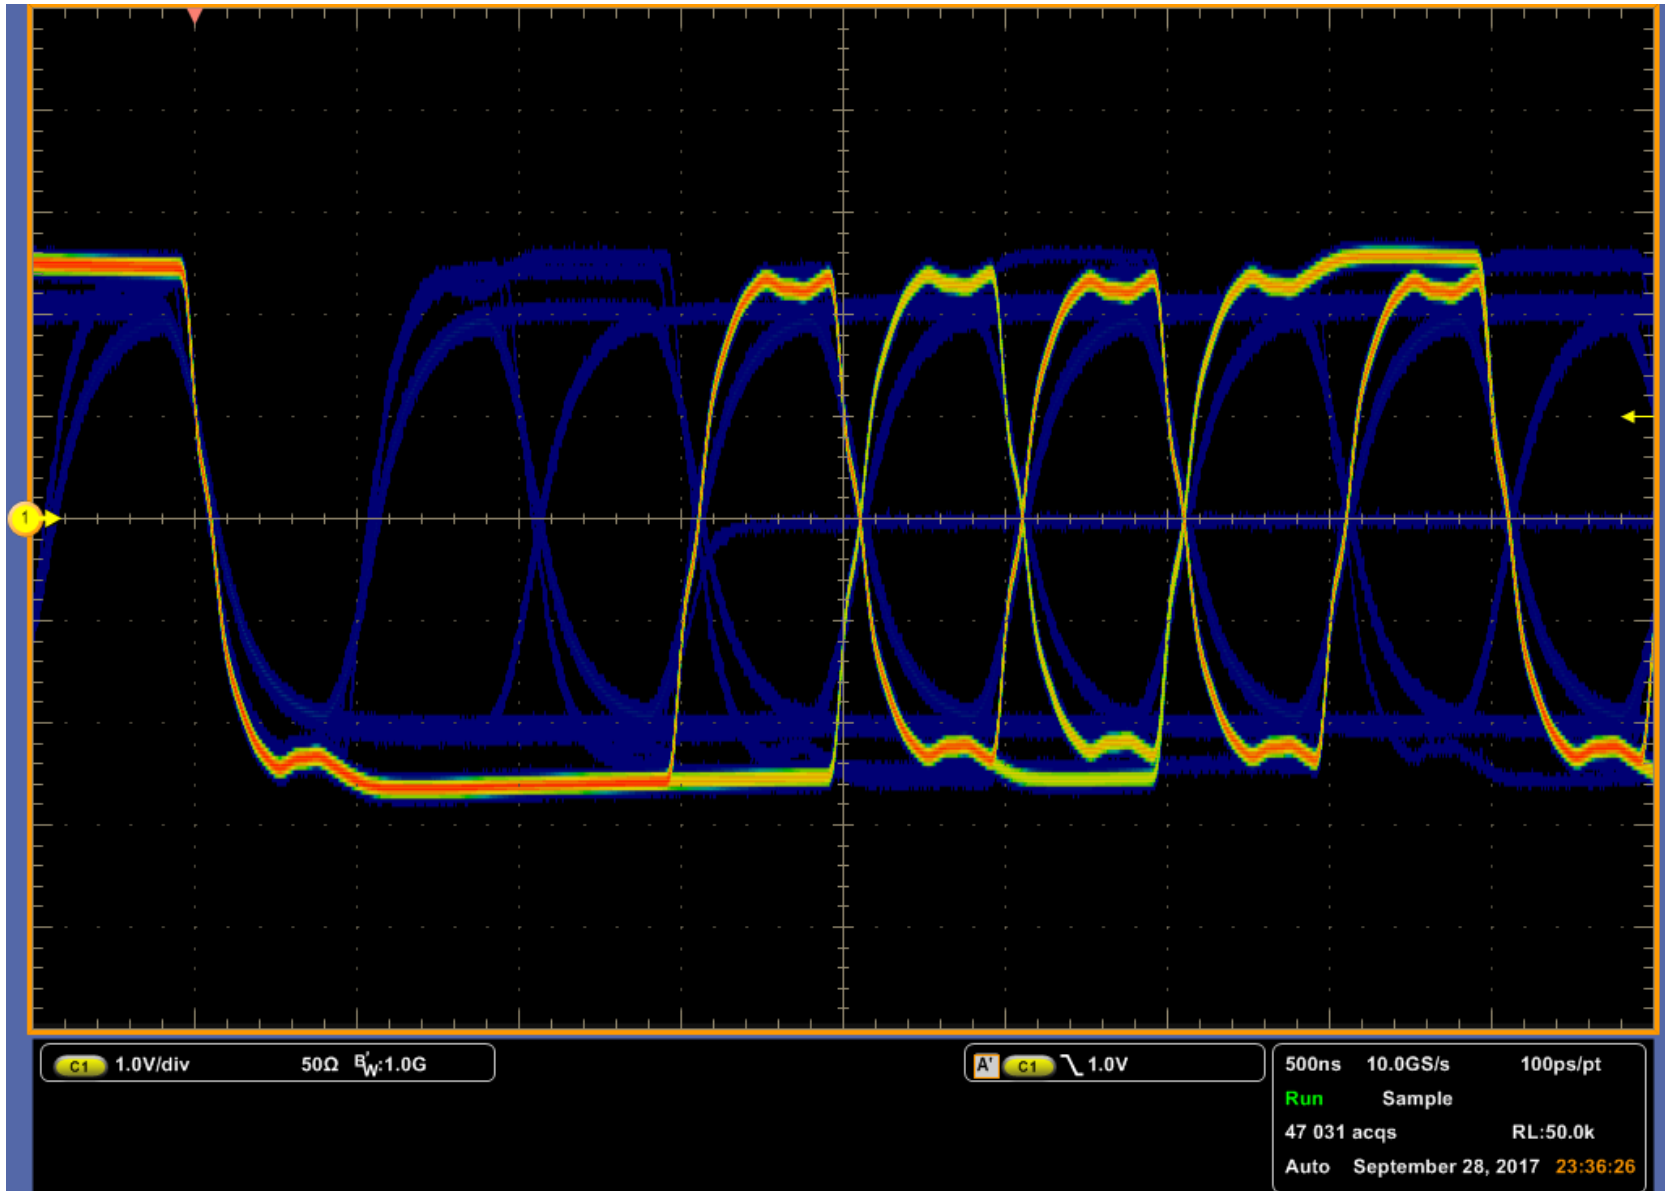
1553 Bus Signals

- **Possible 1553 bus problem (ruled out quickly)**
 - Bus signal quality looked good on oscilloscope (next slide)
 - All other 1553 I/F's work fine; points away from 1553 problem
- **Combed through telemetry surrounding events for clues**
 - Correlation observed to unexpected changes on current on primary power feed to box in question (MIRI ICE-B)
- **Looked at power interface of MIRI ICE**
 - Limited e-mail and phone support from ESA contractor
 - Hardcopies of schematics provided to local ESA representative
 - Includes undervoltage shutoff function ($V < \sim 18\text{ V}$)
 - Robust multi-pole filter with roll off frequency of a few kHz
- **Took closer look at power interface between spacecraft simulator (SCSim2A) and MIRI ICE-B**
 - Focus of investigation and this presentation

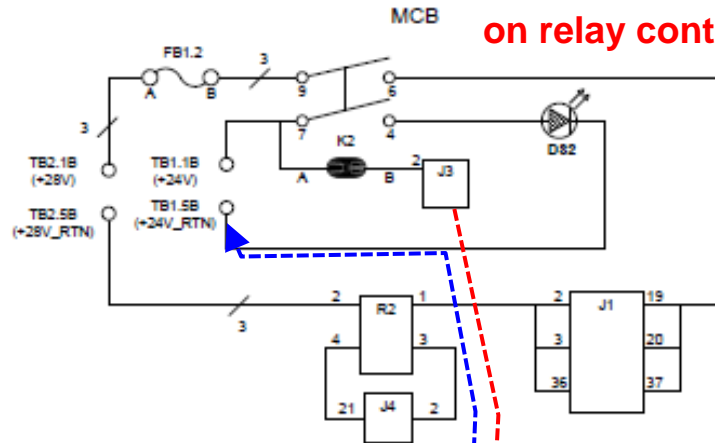
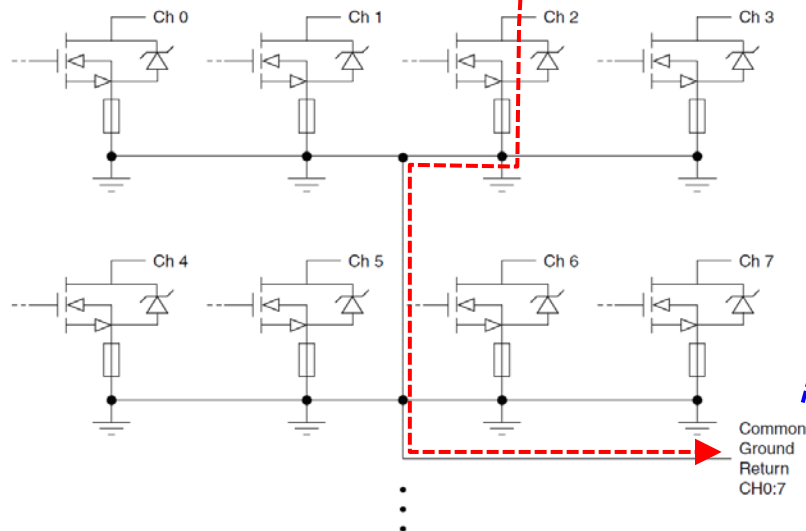
SI Redundant Power Drawer Block Diagram

No transient suppression elements on relay contacts or coils

Power drawer

~3 meters of cable provides ample opportunity for transient energy to couple throughout SCSim rack

Relay driver card

Limited transient suppression (~3 meters of cable from relays)

- **Mechanical relays**
 - Inherently noisy (contact bouncing, etc.)
 - No transient suppression elements (transorbs, etc.)
- **Long cables and large current loops**
 - Increased risk of coupling
- **Measurements show significant noise generated by relay switching transients, but...**
 - These relays were not operating when 1553 events occurred (relays close to turn on box and stay closed)
 - Transient energy couples EVERYWHERE; no credible explanation for why only one side of one box would be affected
 - Ringing in switching transients has resonant frequency of ~1 MHz
 - MIRI ICE B has robust input filter with lots of attenuation at 1 MHz
 - **RELAY SWITCHING TRANSIENTS UNLIKELY ROOT CAUSE**

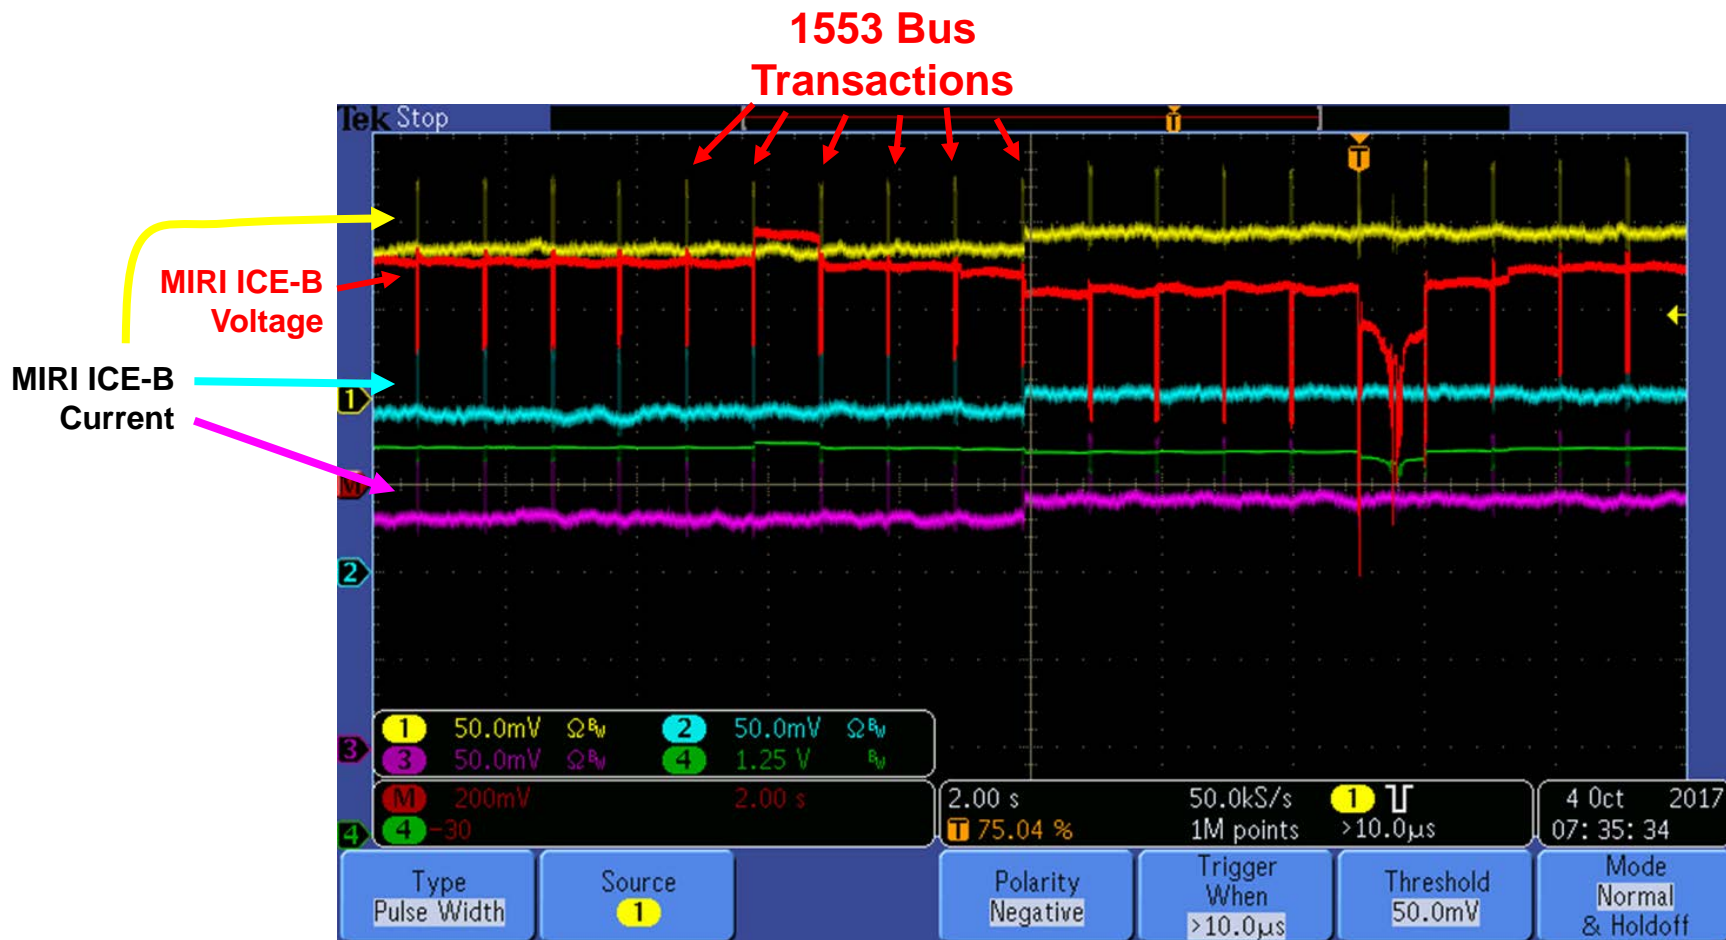
MIRI ICE B Power Feed (measured at RIVETS)

- **During 1553 transactions:**
 - $\Delta I \approx 120 \text{ mA}$, $\Delta V \approx 200 - 300 \text{ mV}$
- **Effective $Z \approx 1.7 - 2.5 \Omega$**

- AWG20 wire, 30 mΩ/m
- MIRI ICE feed
 - 3 AWG20 pairs in parallel
 - ~50 feet (15 m) between SCSim and feedthrough plate
- Total resistance on MIRI ICE power feed
 - $(0.03 \text{ } \Omega/\text{m}) \times (15 \text{ m}) \times (2) / 3 = 0.3 \text{ } \Omega$

- **HARNESS RESISTANCE DOES NOT FULLY ACCOUNT FOR OBSERVED VOLTAGE DROPS**

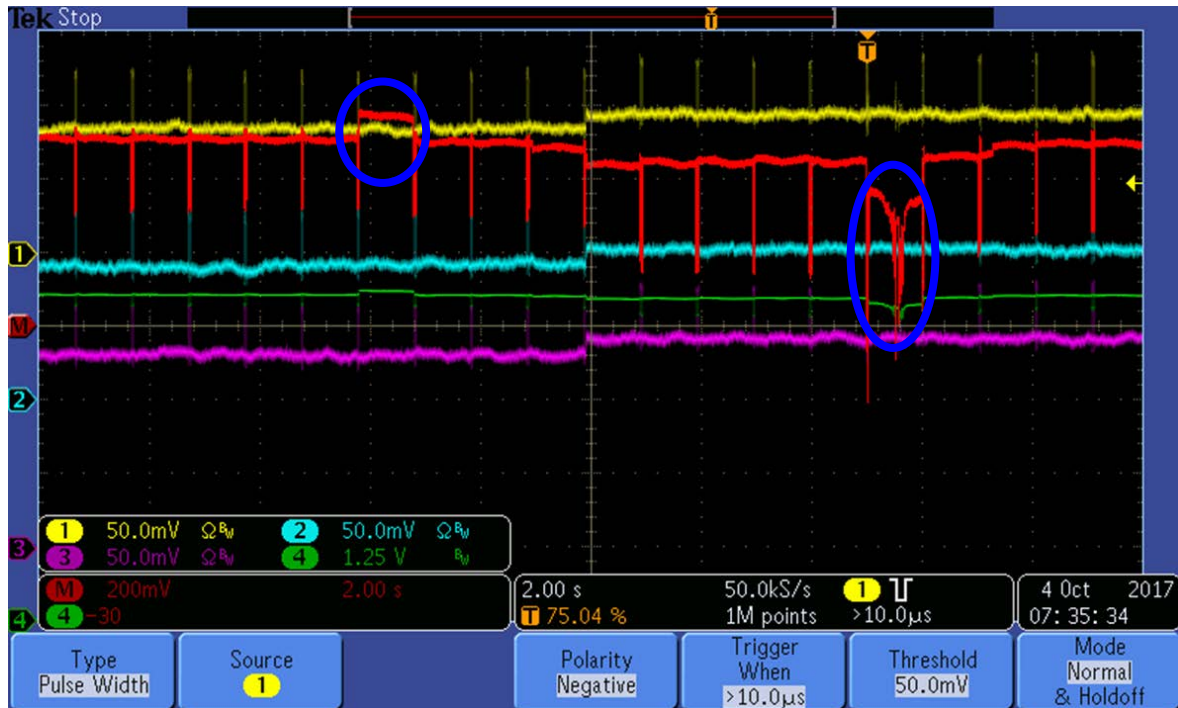
Unexplained Voltage Shifts

- Occasional shifts in voltage with no corresponding change in MIRI ICE-B current
 - Did not coincide with 1553 events, but indicated erratic behavior on power bus
- IEC heaters only equipment switching on/off power bus
 - Voltage shifts did not coincide with switching events
 - Most switching events produce no such transients
 - **NOT CREDIBLE CAUSE OF VOLTAGE SHIFTS**

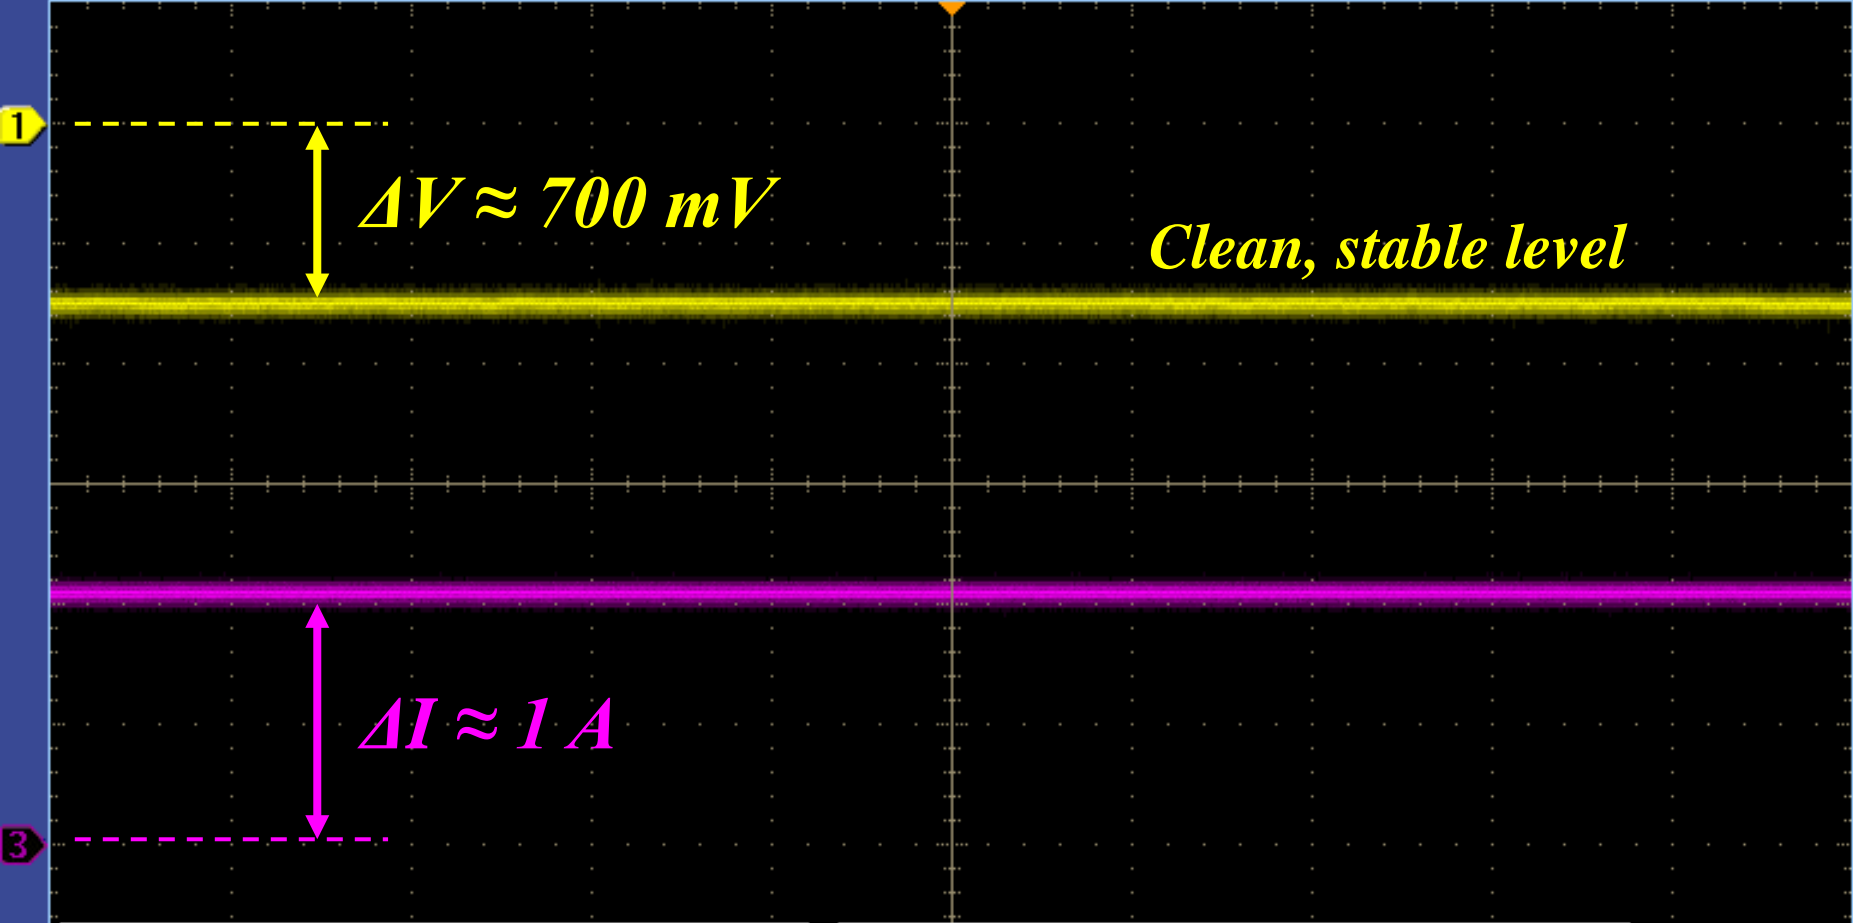
MIRI ICE B – 30 Ω load

Higher than expected ΔV

Not so clean, not so stable...

*1 second/division
This noise will easily get through input filter*

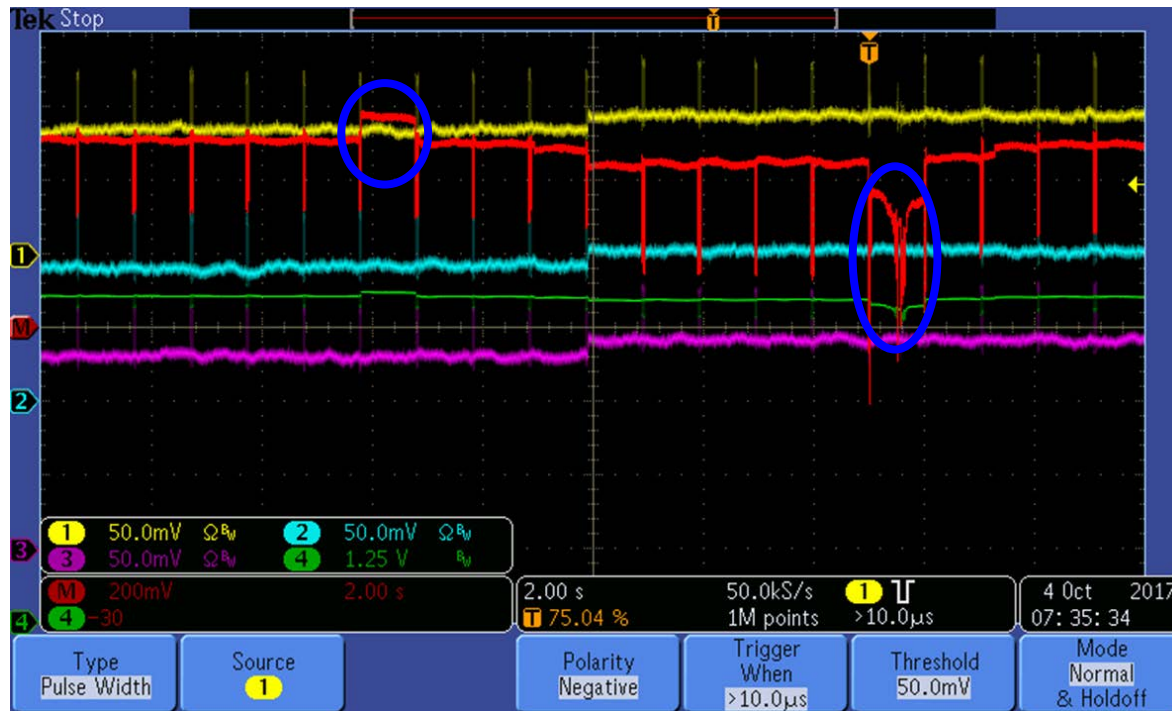
Possible Relay Corrosion

- Per GSFC Parts Branch (Code 562), erratic behavior is consistent with previously observed behavior of corroded relay contacts (SCSim has been in near continuous use for > 5 years)
- May contribute to instability in power interface
- May correlate to previously observed events

- **All relays and sockets replaced in SCSim2A**
 - All power feeds now “clean”; show no trace of erratic behavior
 - Relays provided to GSFC parts branch for evaluation; could not reproduce erratic behavior 🤨

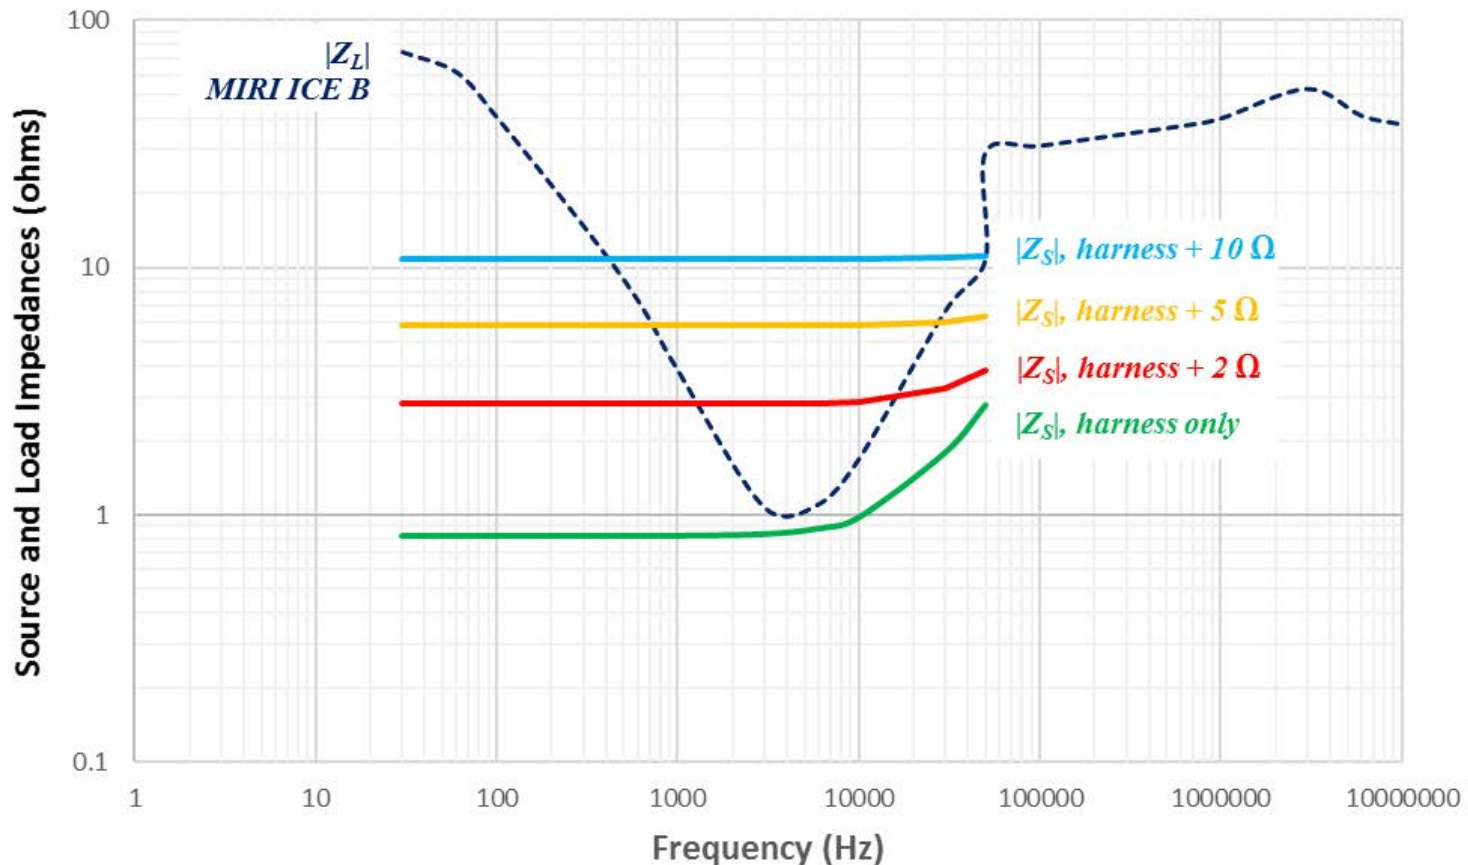
$|Z_S|$ vs. $|Z_L|$

- Middlebrook magnitude criterion met when $|Z_S|$ curve is under $|Z_L|$ curve at all frequencies (curves never cross each other)
 - Met for harness only with not much margin
- Violated for increasing values of relay contact resistance – need to look at phase at frequencies where violated (next slide)

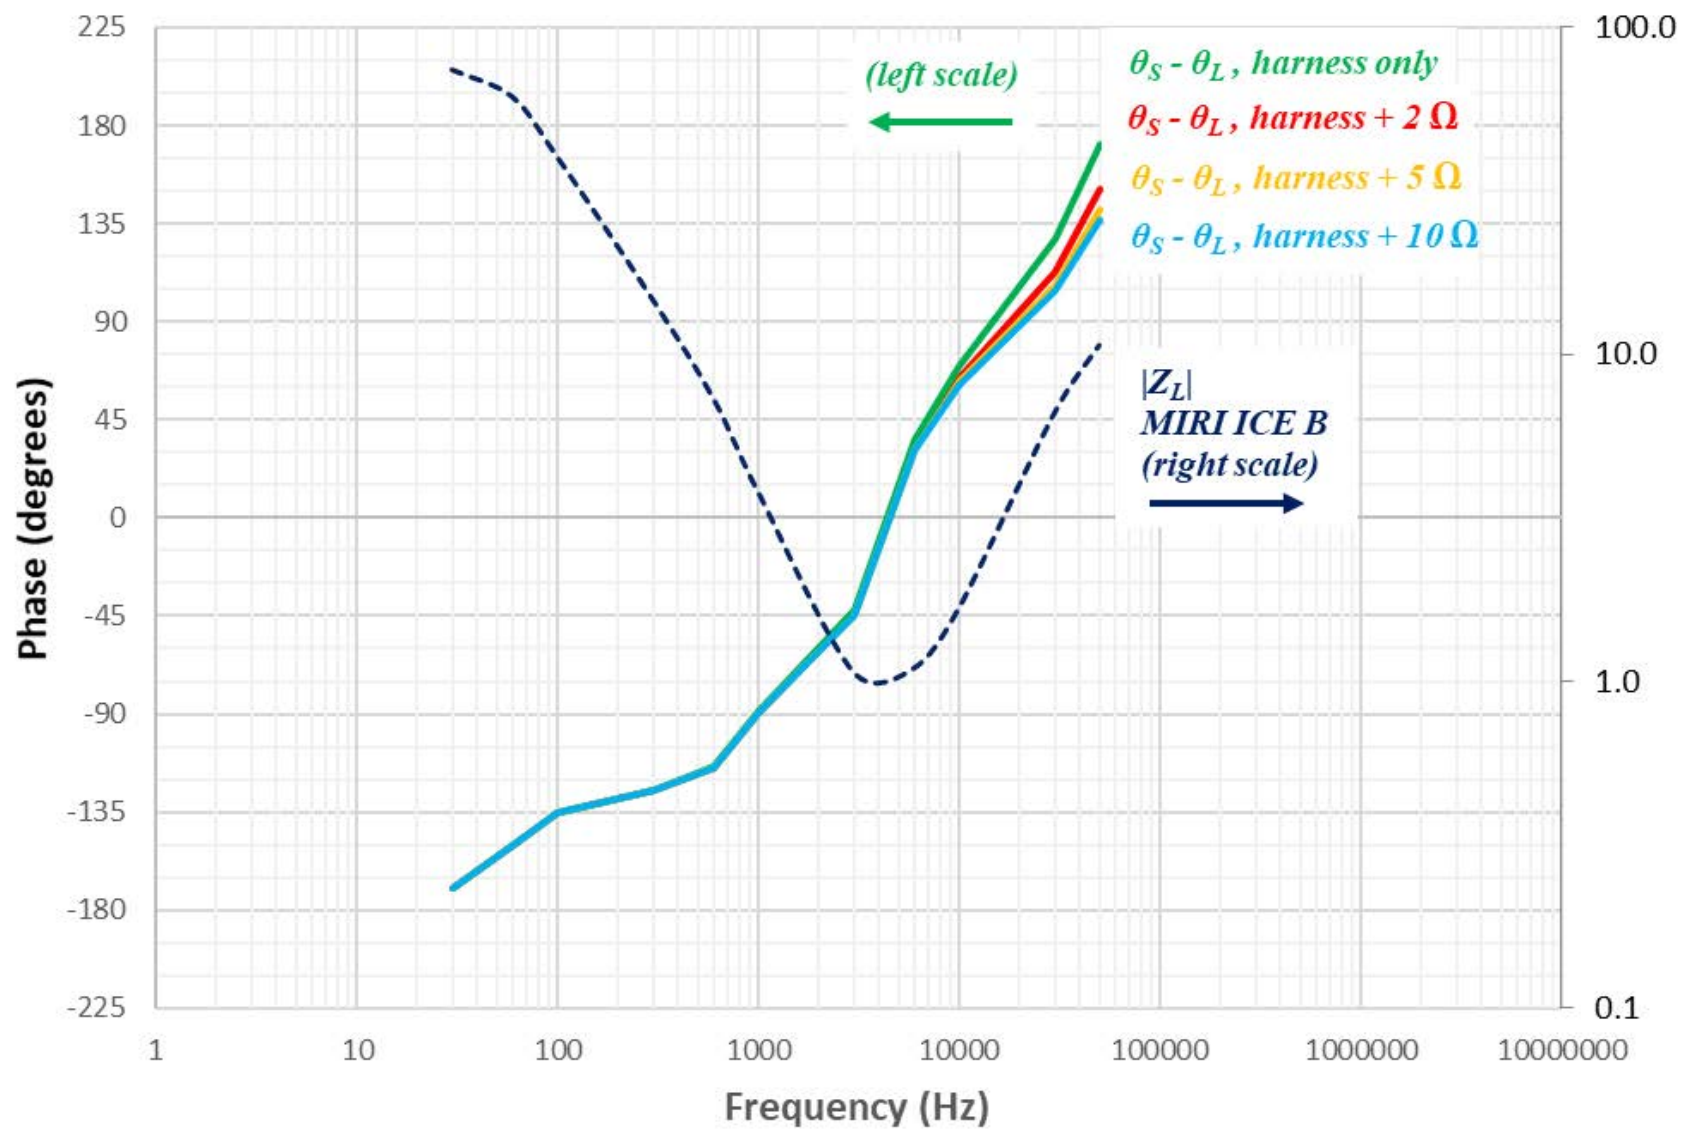
$$\theta_S - \theta_L$$

- **Though not proven, instability is leading theory for root cause**
 - Middlebrook magnitude criteria violated from ~500 Hz to ~50 kHz for increasing values of relay contact series resistance

- Decent phase margin (difference between $\theta_S - \theta_L$ and 180°) for most of frequency range where magnitude criteria violated
 - Could violate magnitude and phase criteria with temporary large increase in resistance

- Narrow frequency range of potential instability is consistent with intermittent nature of original problem under investigation
- **If true, places problem squarely on SCSim2A and exonerates MIRI ICE-B**
