REPORT NO. 251-14

WEB BUCKLING TESTS ON WELDED PLATE GIRDERS

PART 4: TESTS ON PLATE GIRDERS SUBJECTED TO COMBINED BENDING AND SHEAR

Fritz Engineering Laboratory
Lehigh University
Bethlehem, Pennsylvania
May 1960

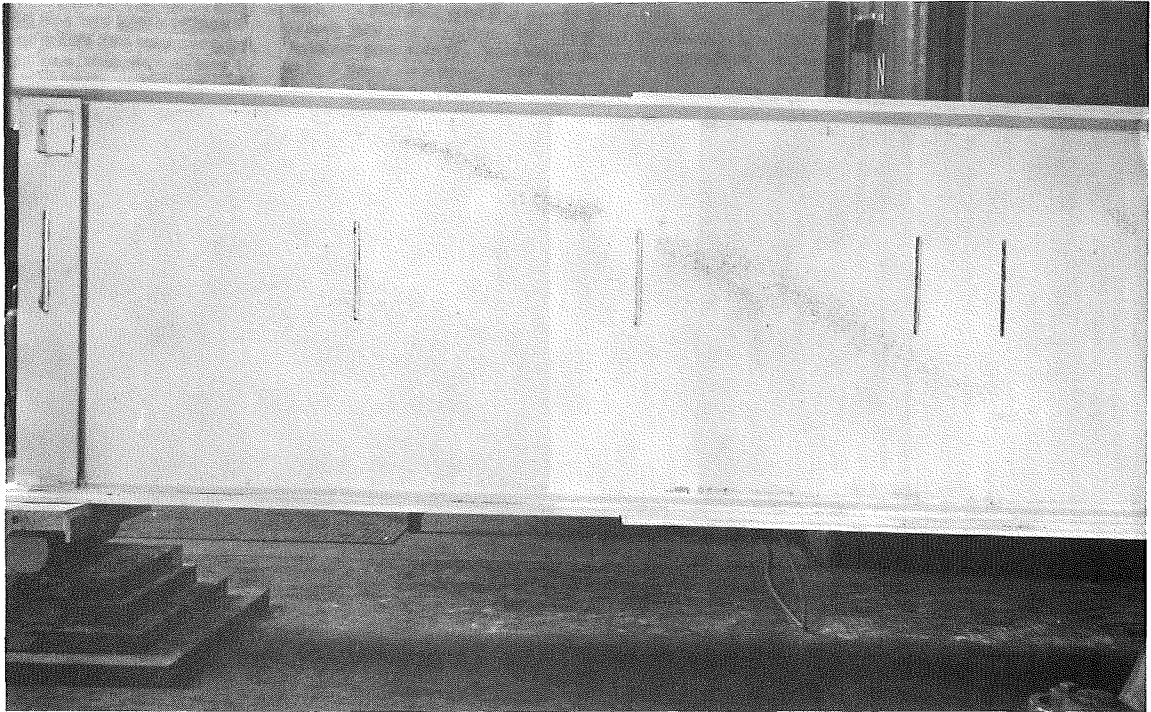
It is seen that when the applied load was increased above load No. 7, the highest load which could be statically maintained, the ultimate load, was 555 kips. Upon unloading to load No. 15, the first test was complete. In this test a clear shear failure occurred in the long panel where $\alpha = 3.0$, as is indicated by the right hand sketch in the first row of Fig. 4.3. A photograph of the failed panel is included as Fig. 4.4 where it can be seen that permanent web distortion was located along the general direction of the yield lines. However, this distortion was small enough that the panel could be reinforced by two pairs of transverse stiffeners fitted to the distorted shape and welded to the web at its third points, as seen in the third sketch of Fig. 4.3. This reinforcing operation is always indicated by a welding symbol in the load-deflection diagrams.

Fig. 4.4 Shear Failure, EI-T1

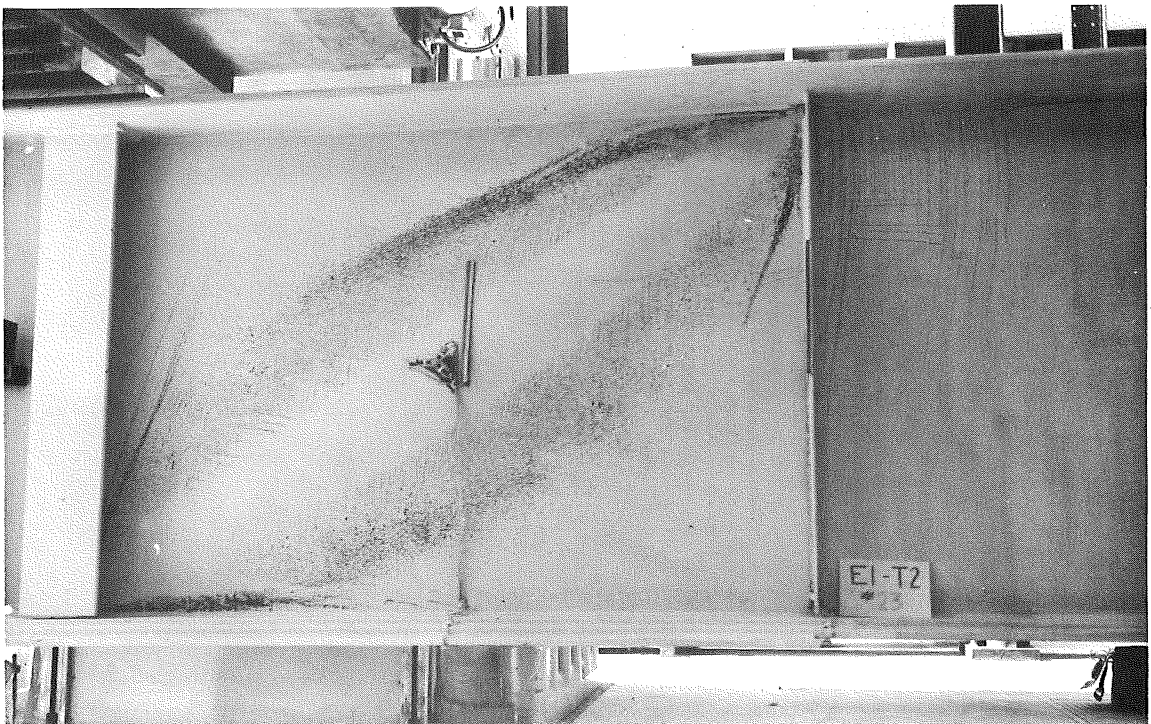
The second test, T2, extended from load No. 16 to load No. 24. According to the definition adopted in Sec. 2.4, the ultimate load for this test was attained at load No. 22, where $P_u = 580$ kips. Occurring in the panel to the right of the loading point, this failure was identified as a shear failure, as the photograph of Fig. 4.5 reveals. Fig. 4.6 is a photograph taken of the far side of this failed panel. Evidently, the width of the yielded strip as appearing in these pictures must not be identified

Fig. 4.5 Shear Failure, EI-T2, Near Side

After completion of the second test, the failed panel was reinforced by welding two single, half inch thick stiffeners to the far side of the web, Fig. 4.3, third sketch on the left. Upon loading again in test T₃, the recorded centerline deflections followed the predicted ones fairly well up until load No. 29. It is interesting to observe that the load-deflection curve exhibited a type of hysteresis loop. This was due to the fact that before being reinforced, the panels acting in a tension field manner underwent greater shear deformations than those predicted by simple beam action. However, after adding rigid and closely spaced transverse stiffeners, the shear force in this panel was essentially carried by beam action and the predicted deflections were followed more closely.

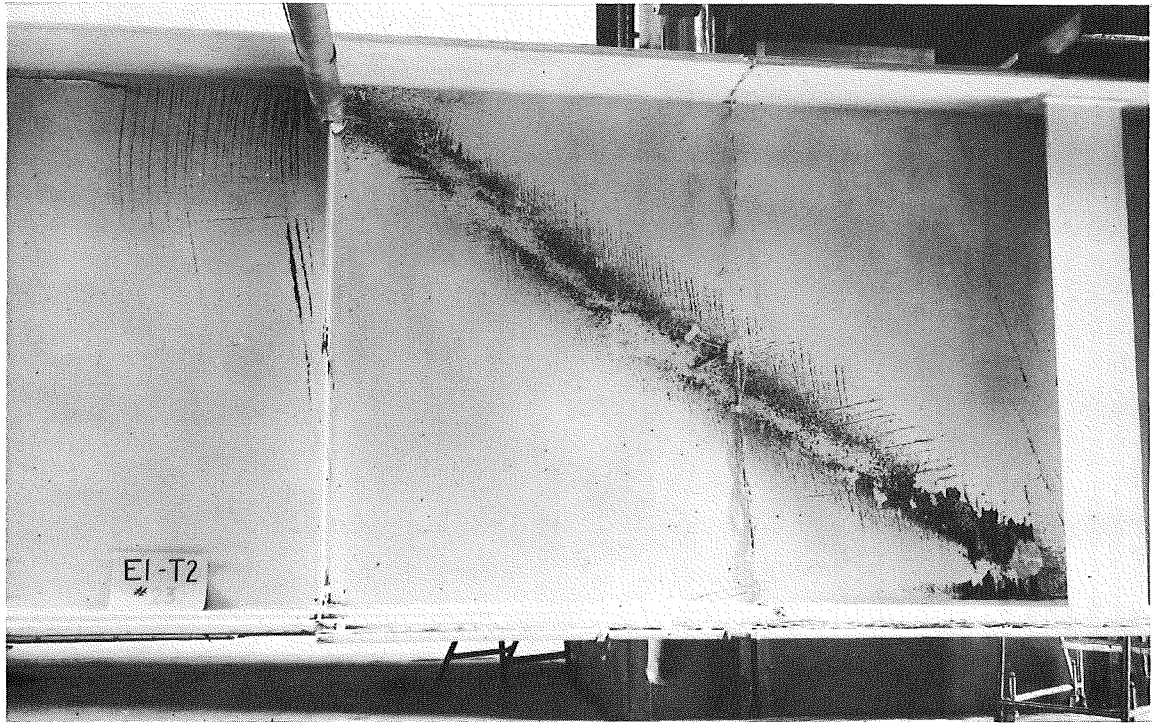
Fig. 4.6 Shear Failure, EI-T2, Far Side

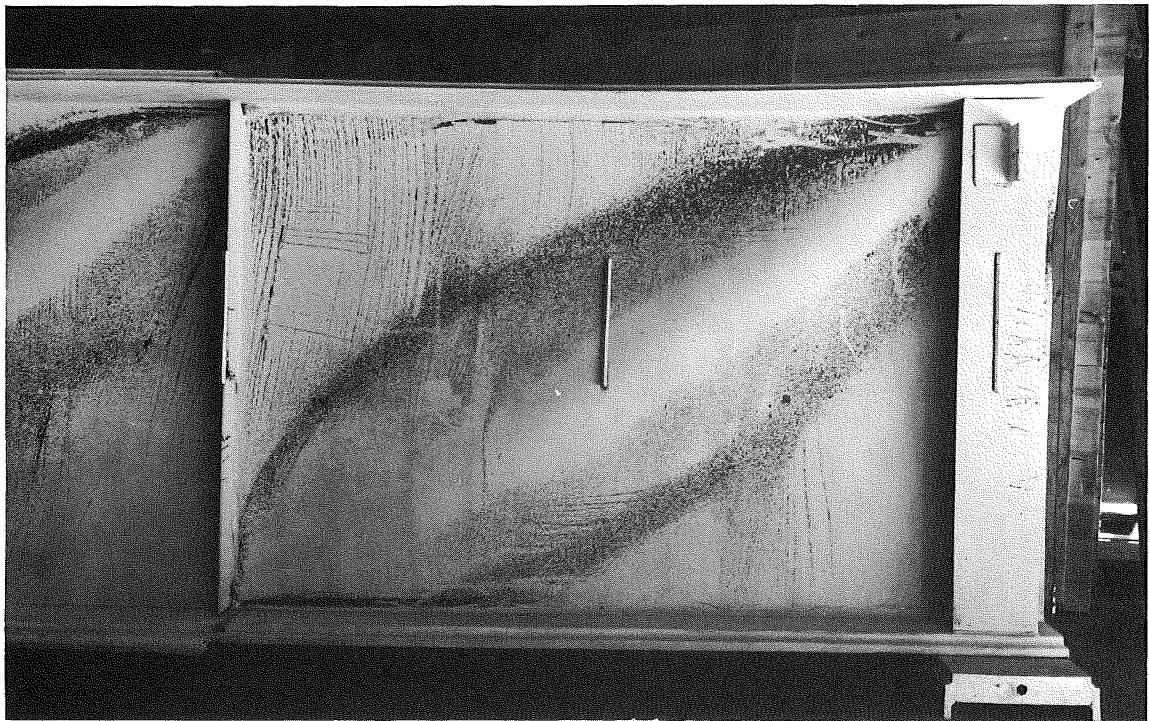
This diagonal reinforcement, added between load No. 32 and load No. 33, is again indicated in Fig. 4.2 by a welding symbol. Continuing with T3, an ultimate load of $P_u = 634$ kips was reached at load No. 39 and an unloading curve furnished by loads No. 40 and 41. Again, failure was in a shear pattern which occurred in the end panel extending from $X = +84$ to $X = +159$. The corresponding sketch in Fig. 4.3 shows the additional yield lines created by this third test, while Fig. 4.7 gives a photographic verification of this failure.

Fig. 4.7 Typical End Panel Failure of Plate Girder (EI)

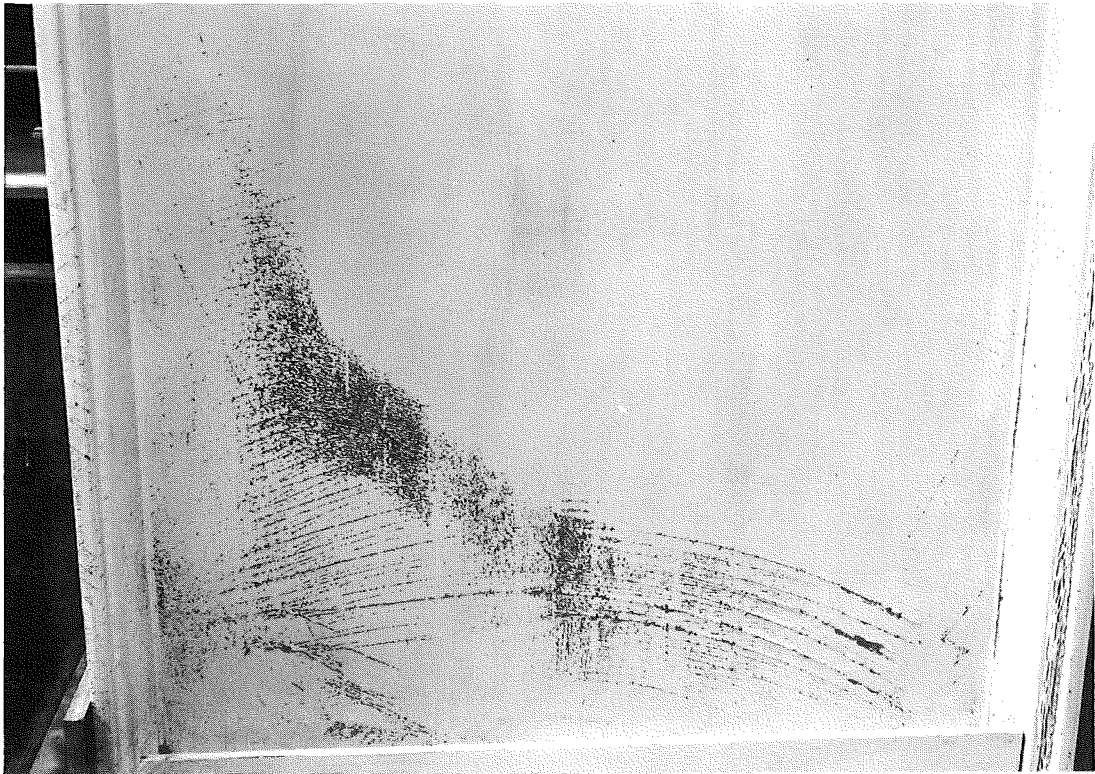
Fig. 4.19 Detail of Failed Section, Girder E2, Test T1

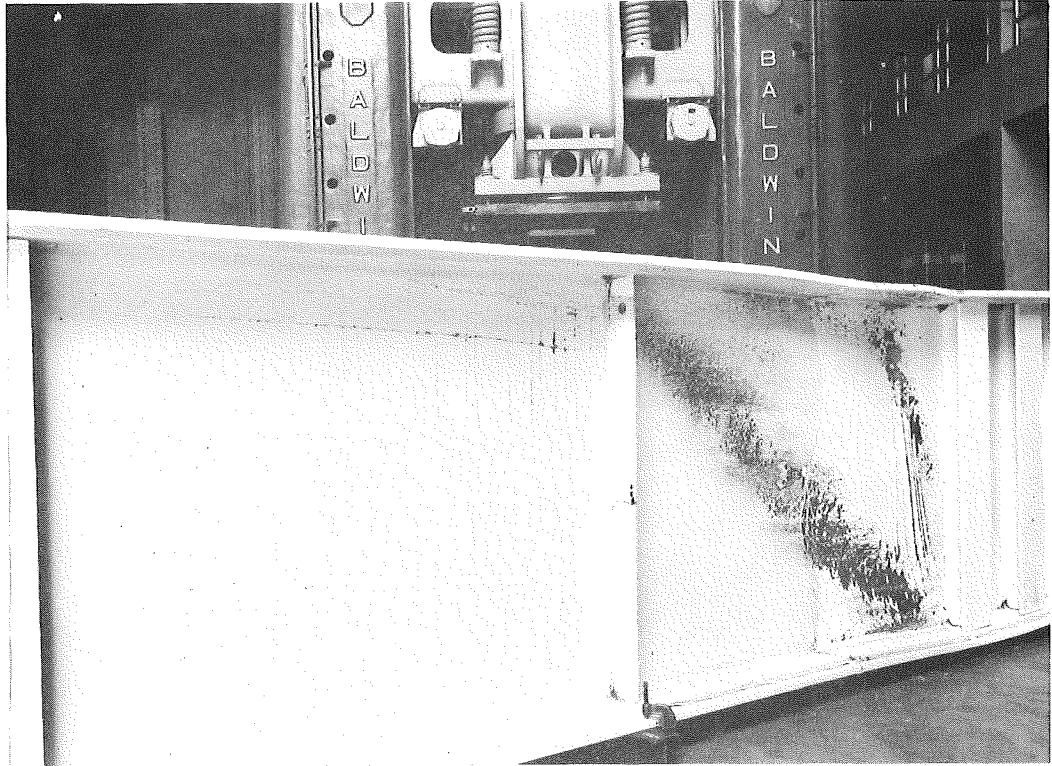
Fig. 4.20 Appearance of Girder E2 After Testing (T2)

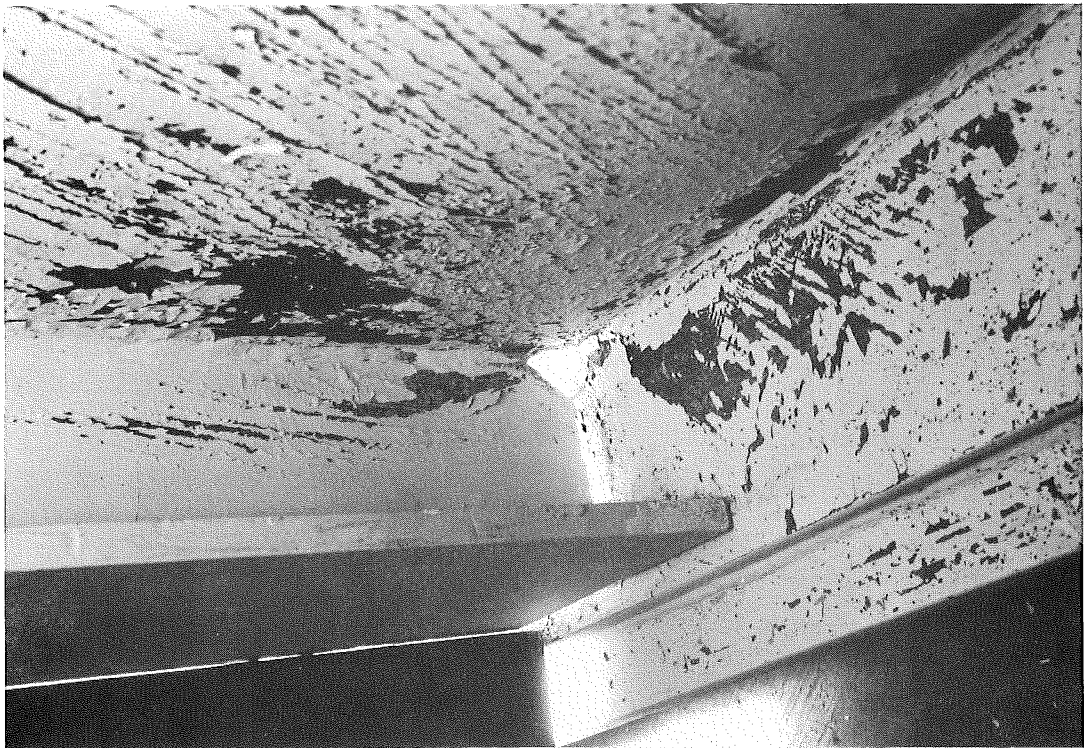
Fig. 4.21 Typical Stiffener Detail at Tension Flange (E2-T2)

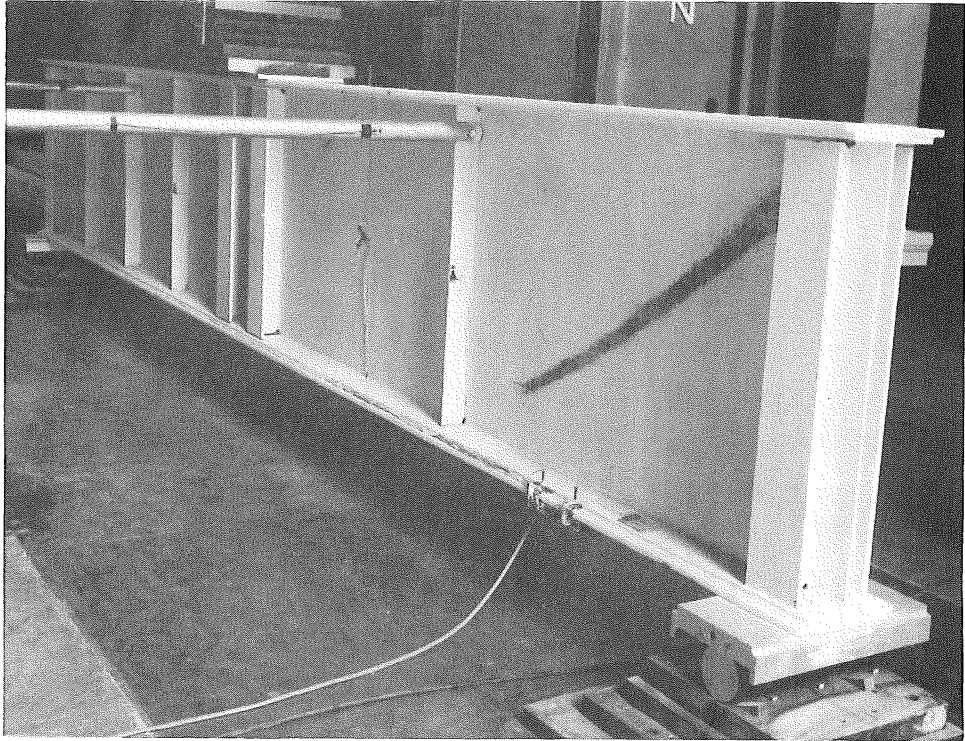
Although no local failure was developed at the loading point, the details at the ends of the test girders proved to be of more concern. Considering, for instance, the test of girder E₄, one would assume that failure occurred somewhere near midspan, but the actual case was an almost sudden failure of an end panel, Fig. 4.28.

The reason for such a failure is that the tension field action cannot build up to its full extent without a neighboring panel, unless the end post has enough bending rigidity to serve as an anchor for the tension field. The end posts made from a 12WF50 section seemed to be sufficient for a very long panel, $\alpha = 3$, where the tension field action is less pronounced. However, for a shorter panel, $\alpha = 1.5$, the end post collapsed in the manner shown in Fig. 4.7. Of course the web slenderness also influences the end failure. For girder G9 having an extremely thin web, the shear resistance depended almost entirely on tension field action and end failure occurred also for a stiffener spacing $\alpha = 3$, Fig. 4.57. When this happened again at the other girder end, two steel plates were tightly clamped to the outstanding web as shown in Fig. 4.58. Thus, the shear strength of G9-T2 could be increased 30% as born out by the corresponding points in the load-deflection curve, where load Nos. 17 and 20A are the ultimate loads before and after the reinforcement respectively. In order to distinguish between true tests and premature failures due to insufficient end detail, the latter are marked in Table 4.1 with subscript "e". A detailed study of this end post failure will be given in the theoretical report.

Fig. 4.28 Premature Failure in End Panel, Girder E4

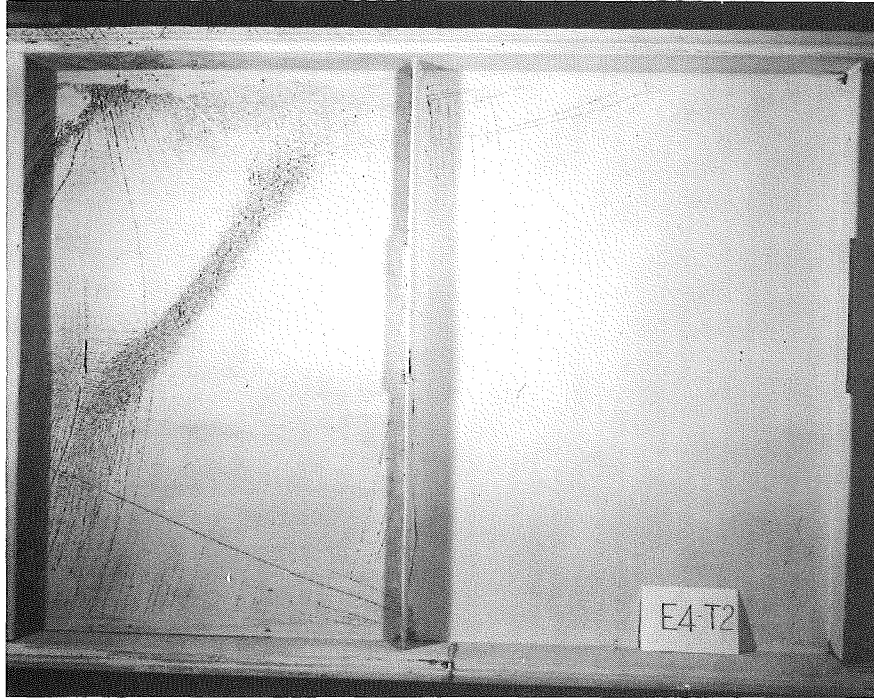
Fig. 4.30 Failure of Girder E4 in Test T2, Near Side

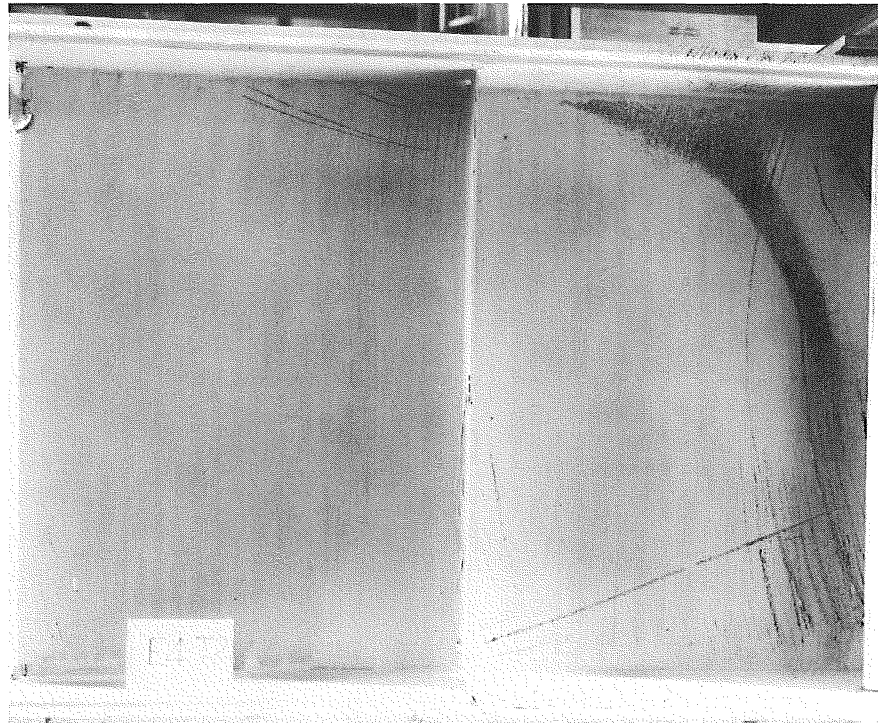
Fig. 4.31 Failure of Girder E4 in Test 2, Far Side

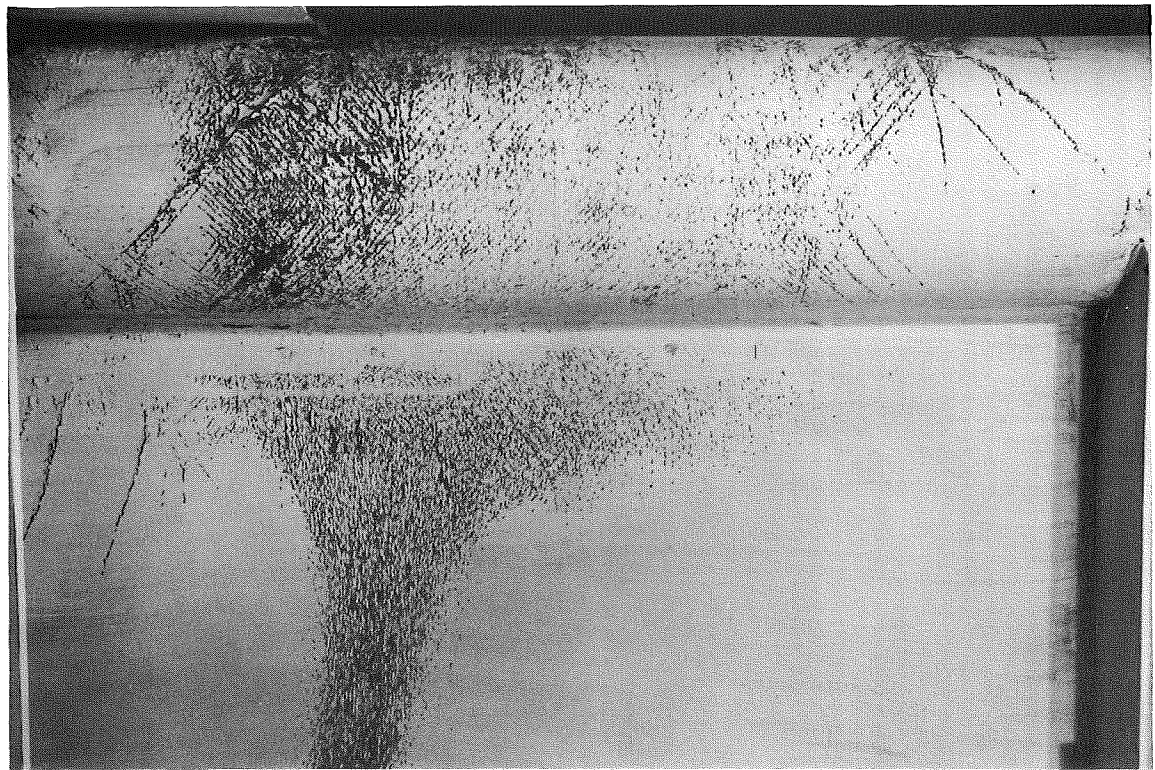
Fig. 4.39 Detail of Failure, Girder E5, Test T2

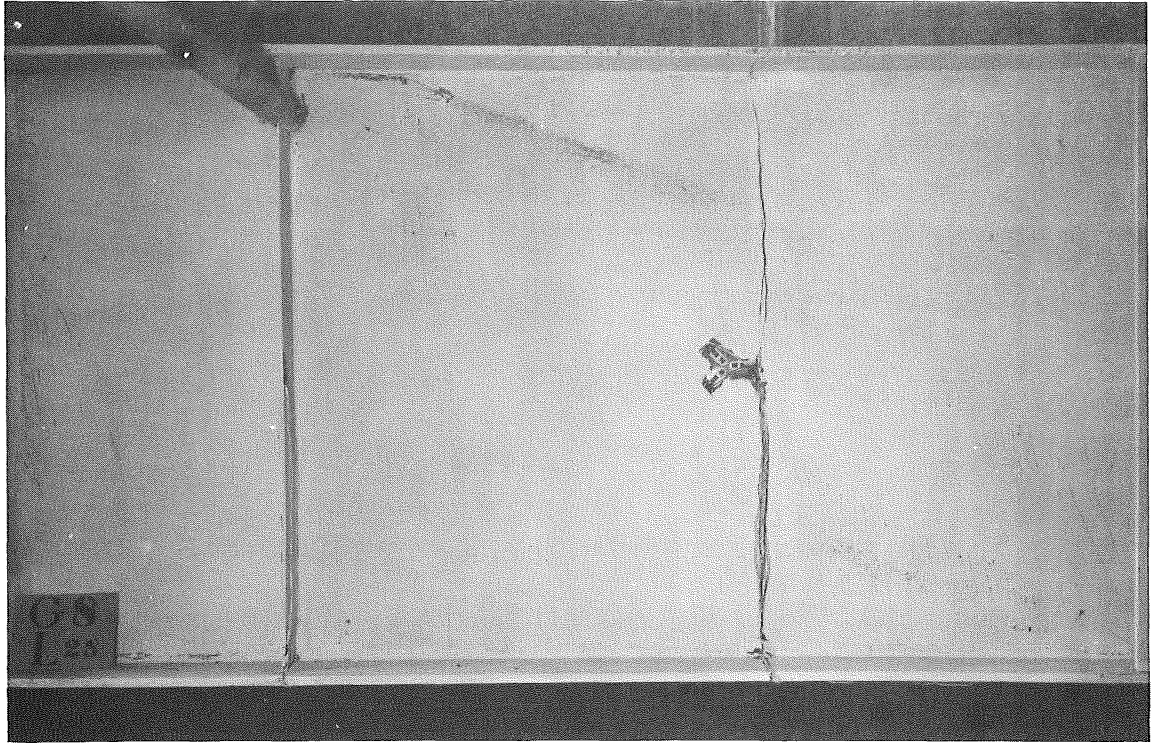
Fig. 4.48 Failure of Girder G8 in Test T3

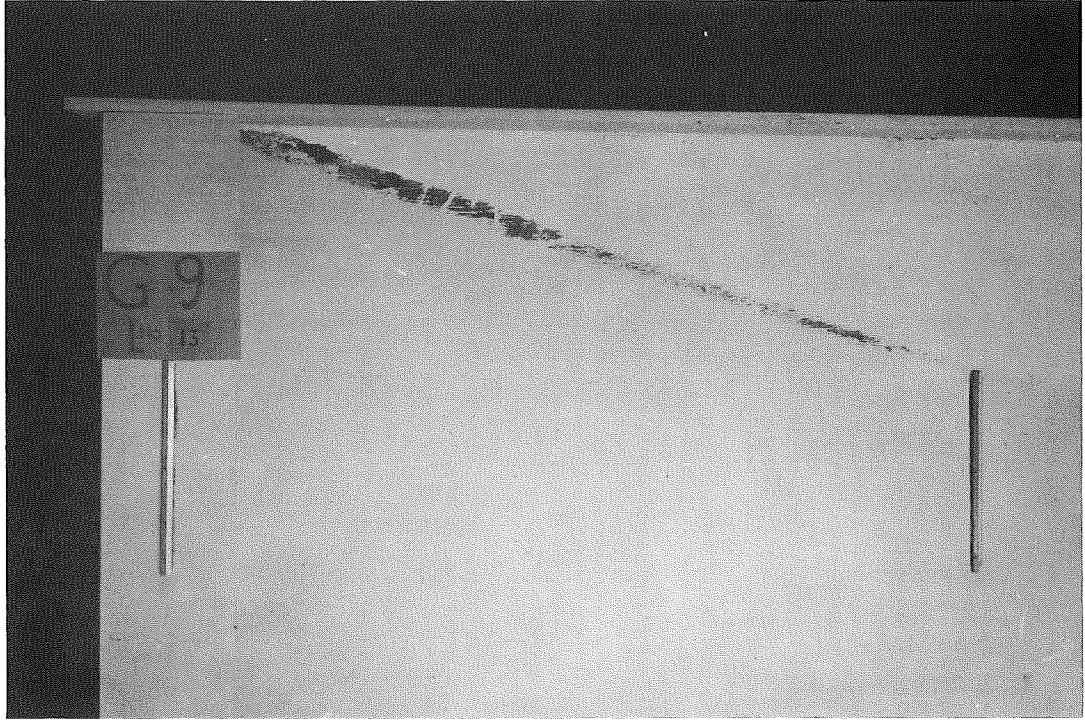
Fig. 4.56 Failure of Girder G9 in Test T1

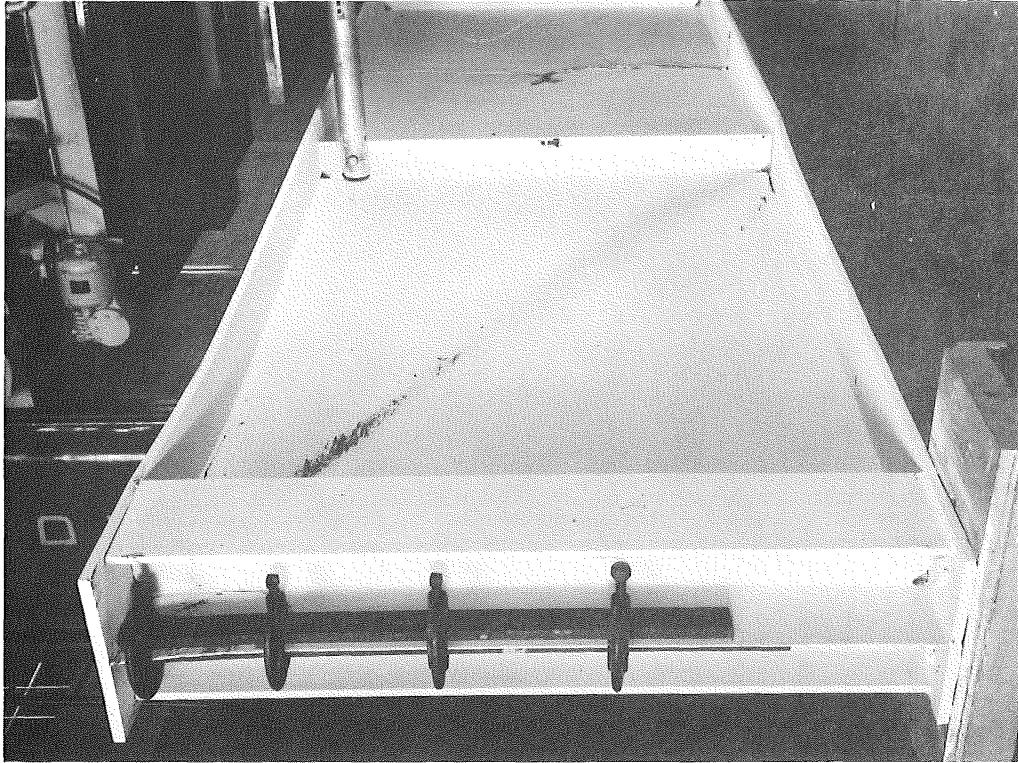
Fig. 4.58 Reinforcement After Premature End Panel Failure, Girder G9

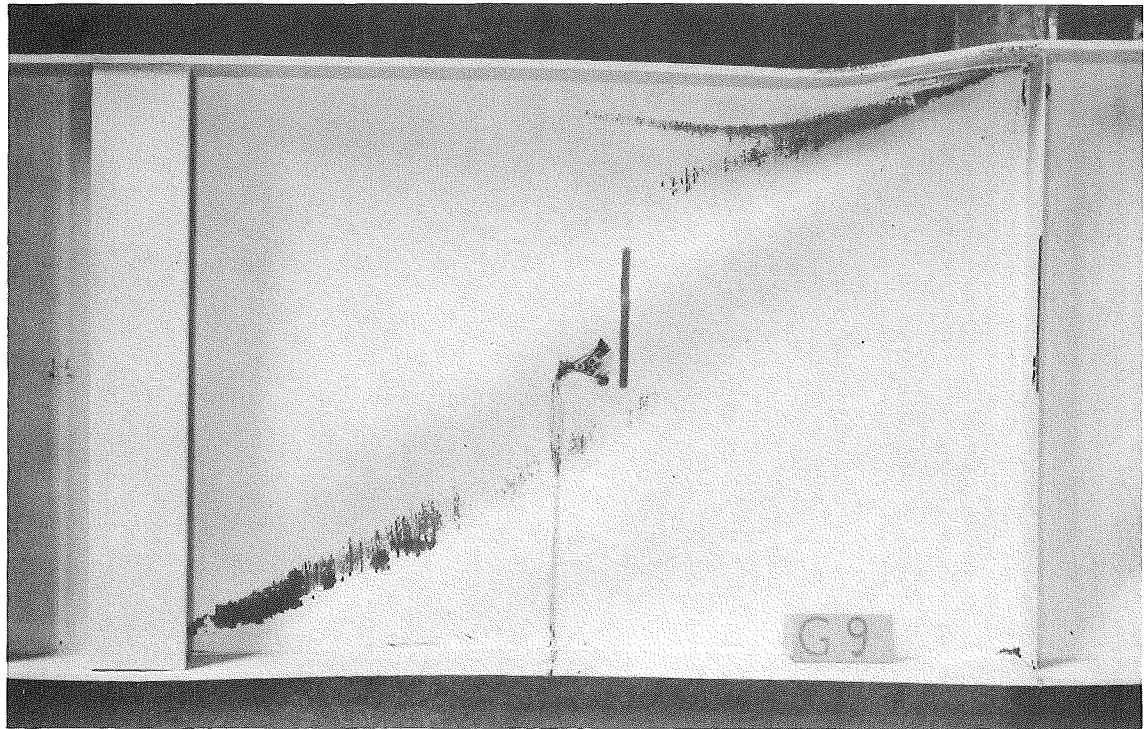
Fig. 4.59 Failure of Girder G9 in Test T3
