HIGHLIGHTS OF TESTS OF STEEL  
BEAM-TO-COLUMN BOLTED CONNECTIONS  
(C6, C7, C8, C9)

October 1974

Fritz Engineering Laboratory Report No. 333.29

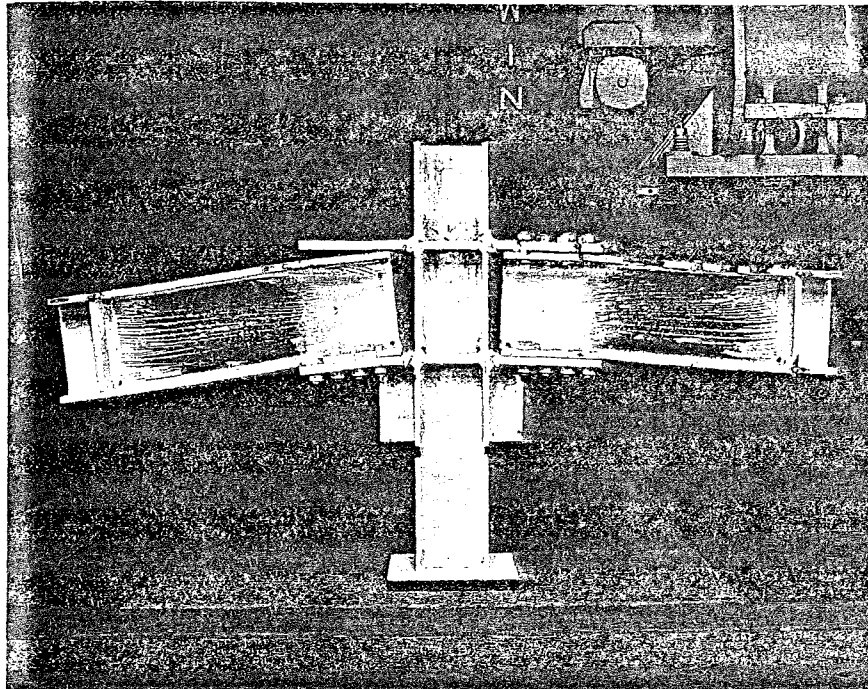
Fig. 4 Overall View of C6

Photographs describing the failure of connection C6 are shown in Fig. 4 through Fig. 7. Figure 4 shows an overall view of C6 at failure depicting the extensive yielding in the beam web up to the end of the moment plates. Failure of this connection occurred at a load of 478.5 kips when the eight bolts connecting the tension flange sheared off simultaneously. Figure 5 presents a closer look at the beam on which the eight bolts failed.

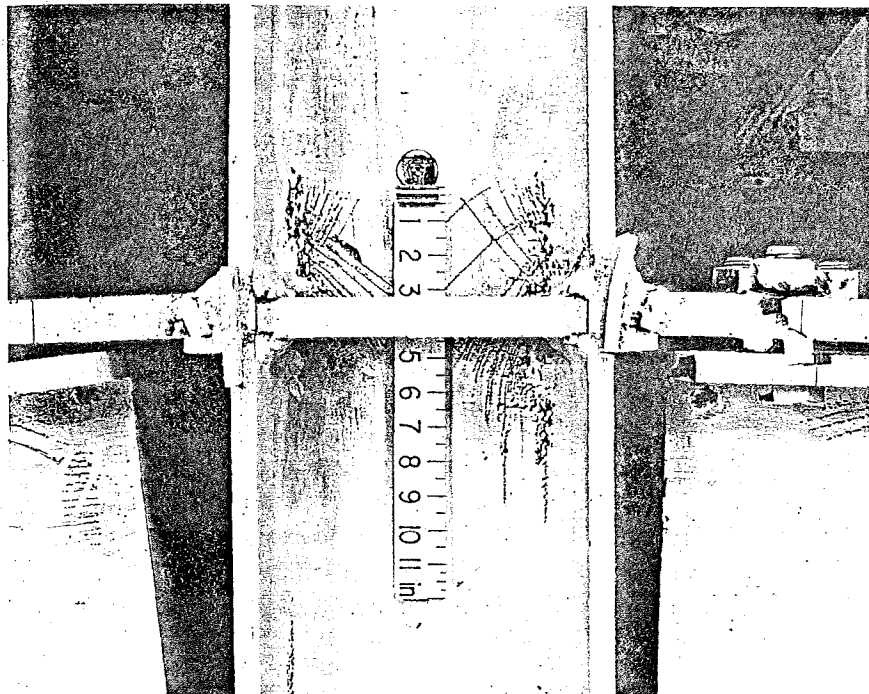
Fig. 6 Tension Panel Zone of C6

Shown in Fig. 6 is a view of the column panel zone adjacent to the beam tension flanges. Figure 7 shows the shear failure of four of the bolts and the extensive deformation of the bolts at failure.

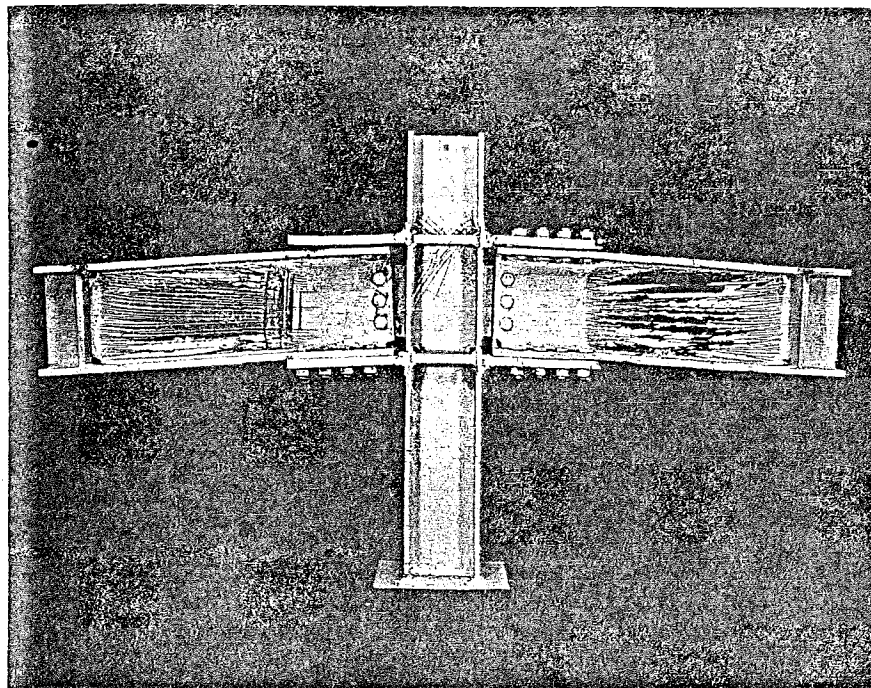
Fig. 8 Overall View of C7

Photographs detailing the failure of connection C7 are shown in Fig. 8 through Fig. 12. Figure 8 shows an overall view of C7 at

failure again depicting the extensive yielding in the beam web (Fig. 9) up to the end of the moment connection plates. Failure of this connection was due to the failure of five bolts in one of the tension flange connections. Two outside bolts in this flange failed at a load of 361 kips due to the prying action as shown in Fig. 10. Upon further loading three more bolts failed at the maximum load of 450 kips.

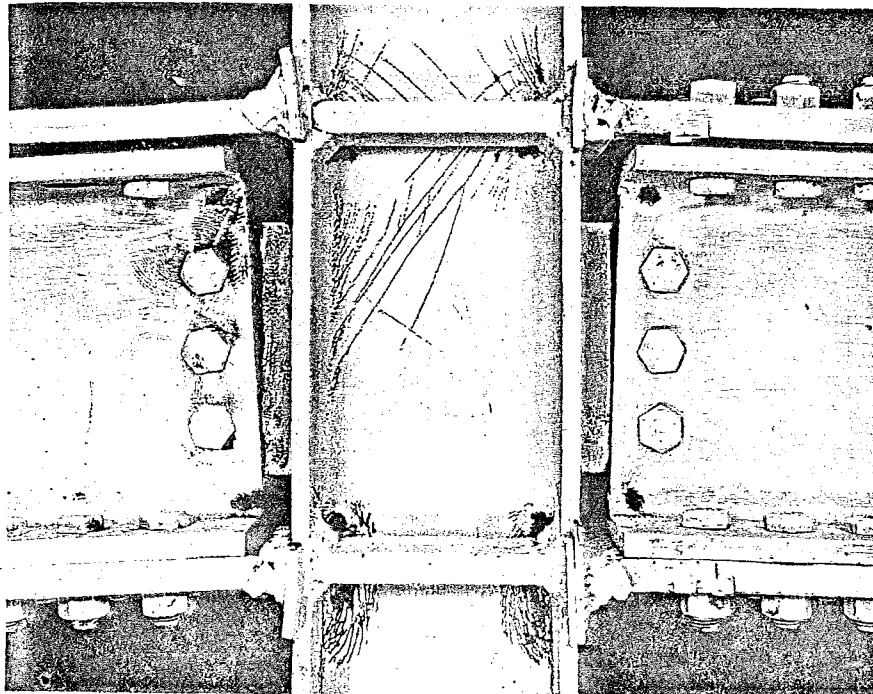
Fig. 11 Panel Zone of Connection C7

Shown in Fig. 11 is a view of the panel zone showing yielding and a view of the beam web connection plate and the relative rotation of the beam web and the web connection plate. Figure 12 presents a view of the five bolts which failed.

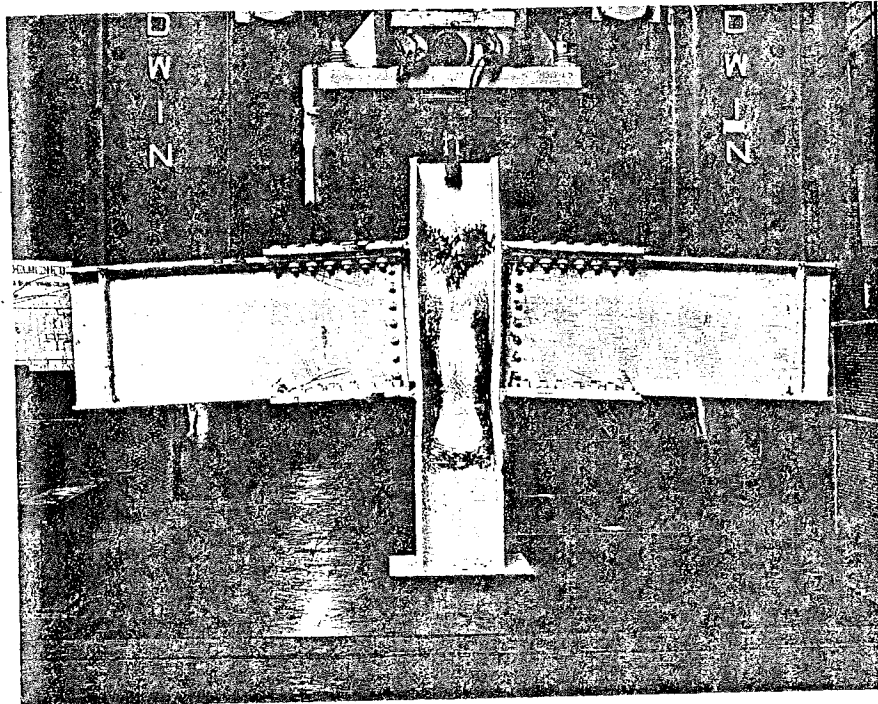
Fig. 16 Overall View of C8

Photographs detailing the failure of connection C8 are shown in Fig. 16 through Fig. 19. The maximum load reached on this connection was 516 kips. After reaching this level, the load dropped off due to column web buckling and the test was terminated for safety reasons. Figure 16 shows an overall view of C8 at the termination of test.

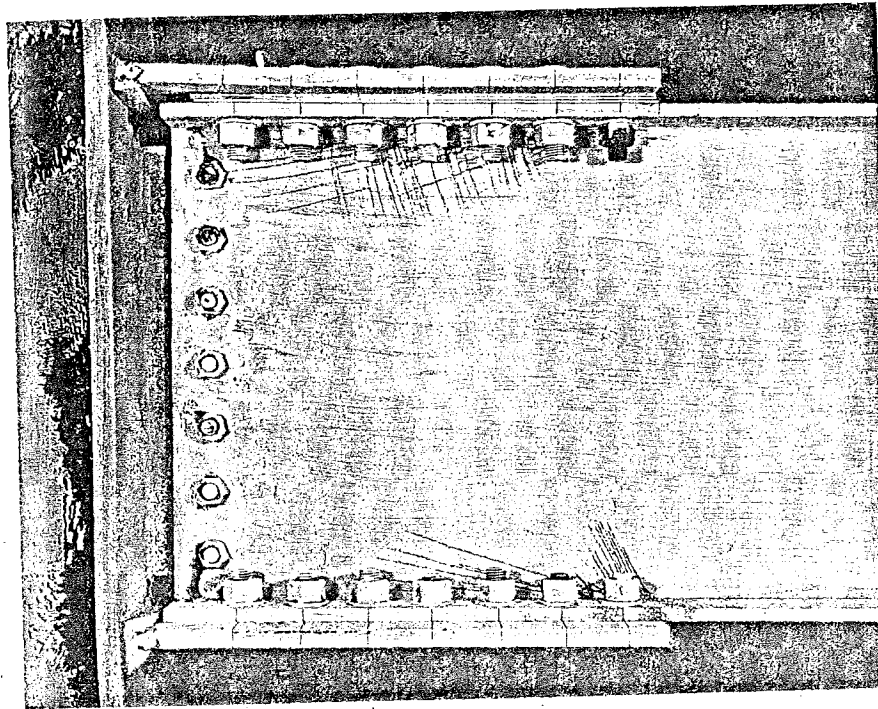
Fig. 17 View of C8 Beam

Shown in Fig. 17 is a view of one of the beams where it is connected to the column. On this view the appearance of slip on the tension flange (top) can be detected by the relative movement of the vertical lines. Slip in the compression flange (bottom) was much less. Figure 18 shows the extensive yielding which occurred in the column panel zone and Fig. 19 shows the extent of the buckling of the column web in the compression region.

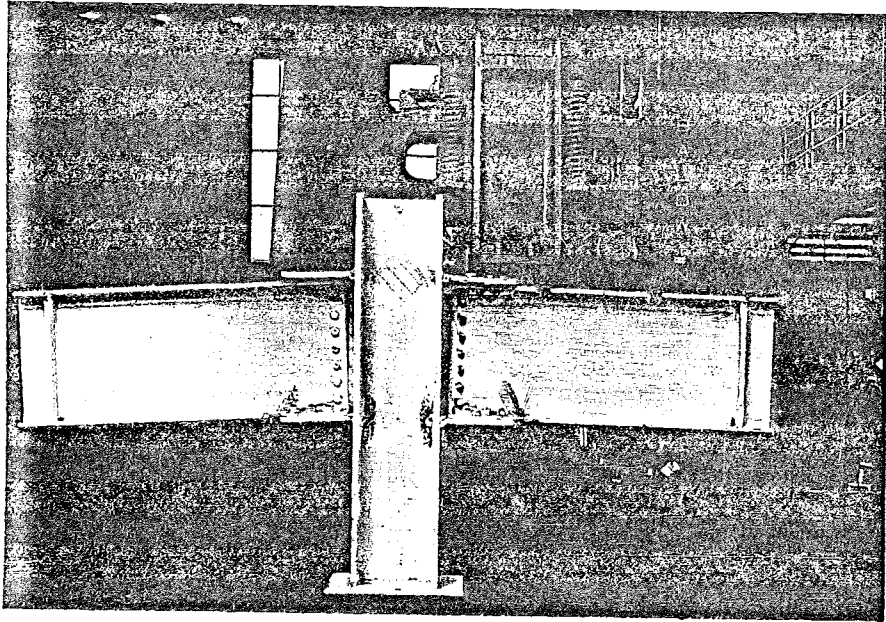
Fig. 20 Overall View of C9

Shown in Fig. 20 is an overall view of the connection at failure. Figure 21 presents a closer view of the column panel zone and beam ends showing the yield pattern.

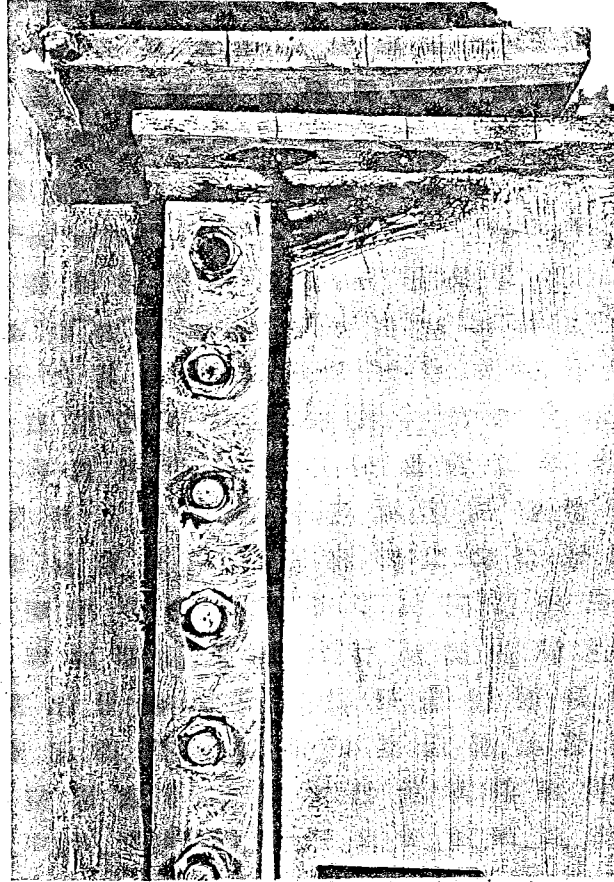
Fig. 22 View of C9 Beam at Connection

Photographs showing the failure of connection C9 are given in Fig. 20 through Fig. 22. The maximum load on this connection was 402 kips. Failure occurred when the six bolts on one of the tension flange connections and one of the web bolts sheared off simultaneously.

This can be seen clearly in Fig. 22.
