A STUDY OF THE DEFECTS AND ELECTROSLAG WELDS IN THE I-79 BRIDGE AT MEADVILLE

September 1982

Report No. 455-1(82)

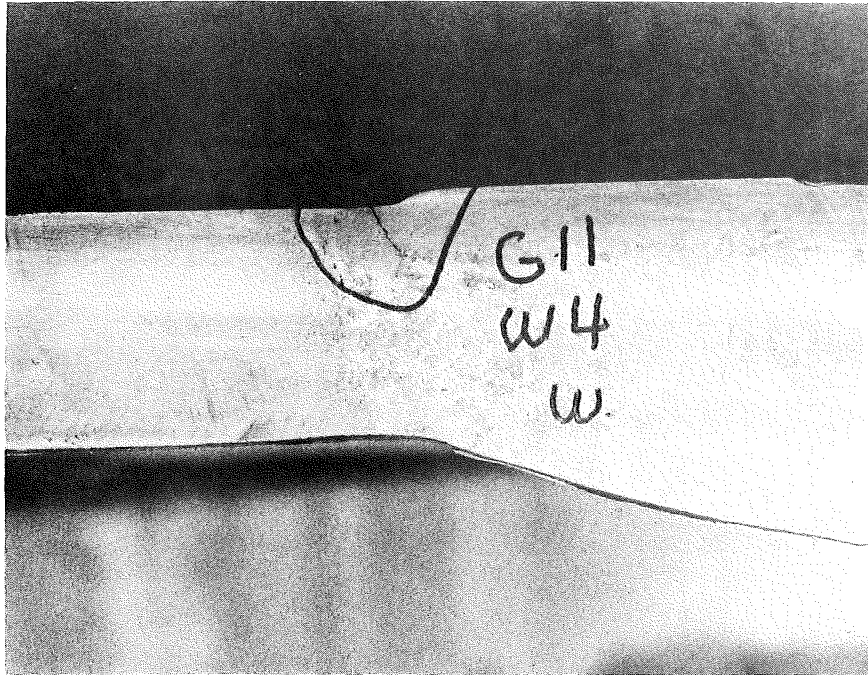
Fig. 4. Crack in flange tip of northbound girder G11 W4A . Crack in electroslag weld near reinforcement.

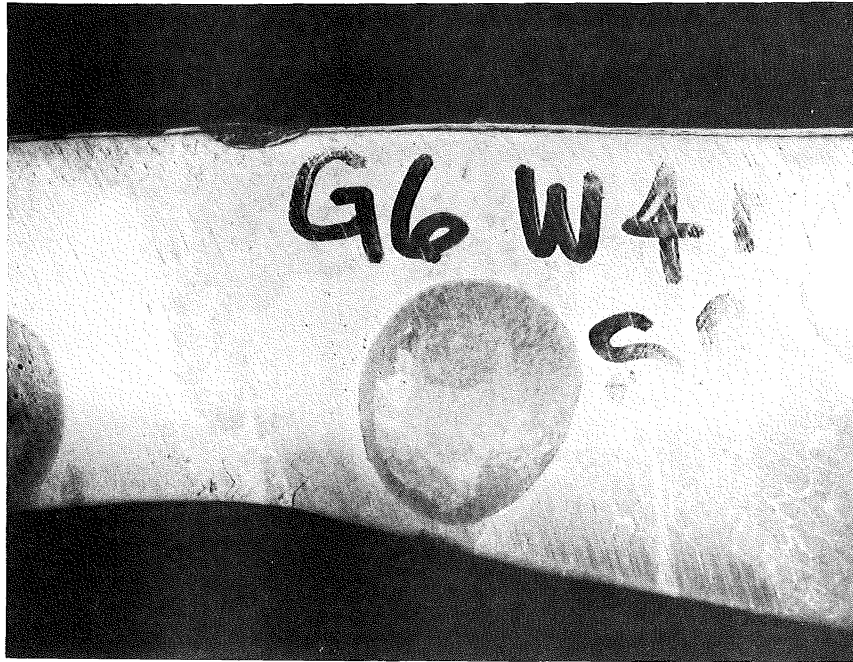
Fig. 5. Cracks in southbound girder G6 W4A at transition region. Irregular cracks follow grain boundaries, note that reinforcement has been removed from this weld joint.

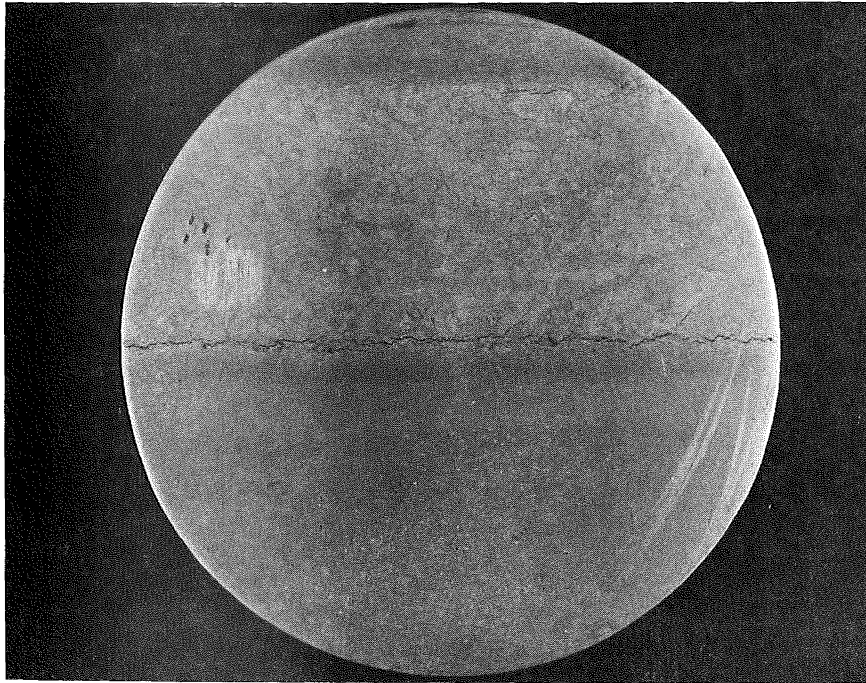
Core A

Figures 6, 7 and 8 show cores taken from three of the more seriously cracked joints after metallographic preparation and etching of their exterior surface. These cores show the typical fusion line cracking that was commonly found in the electroslog welded joints. Figure 9 shows the core removed from northbound girder G5 weld W3B with the lack-of-fusion crack. As is apparent in this figure, the crack has initially formed at the tip of the flange (flat edge of core), along the fusion line, and then has propagated into the flange. Figures 10 and 11 show a similar condition in the core removed from the northbound girder G4 weld W2A, where a repair weld has been made at the location of the crack.

Fig. 6. Sample core removed from the southbound girder G5 W4B

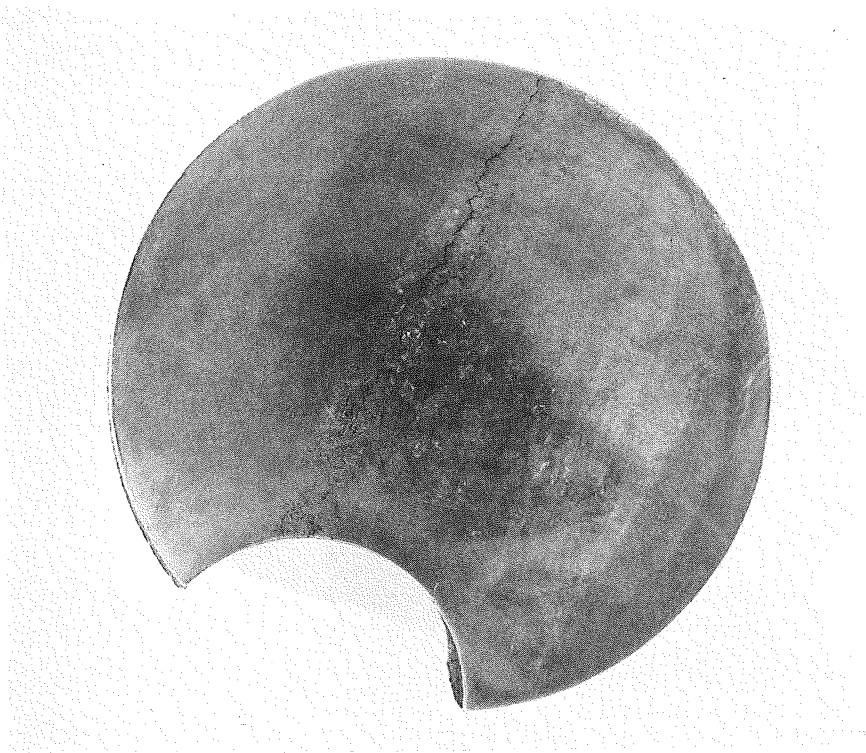
Core B

Fig. 7. Sample core removed from the southbound girder G7 W3B.

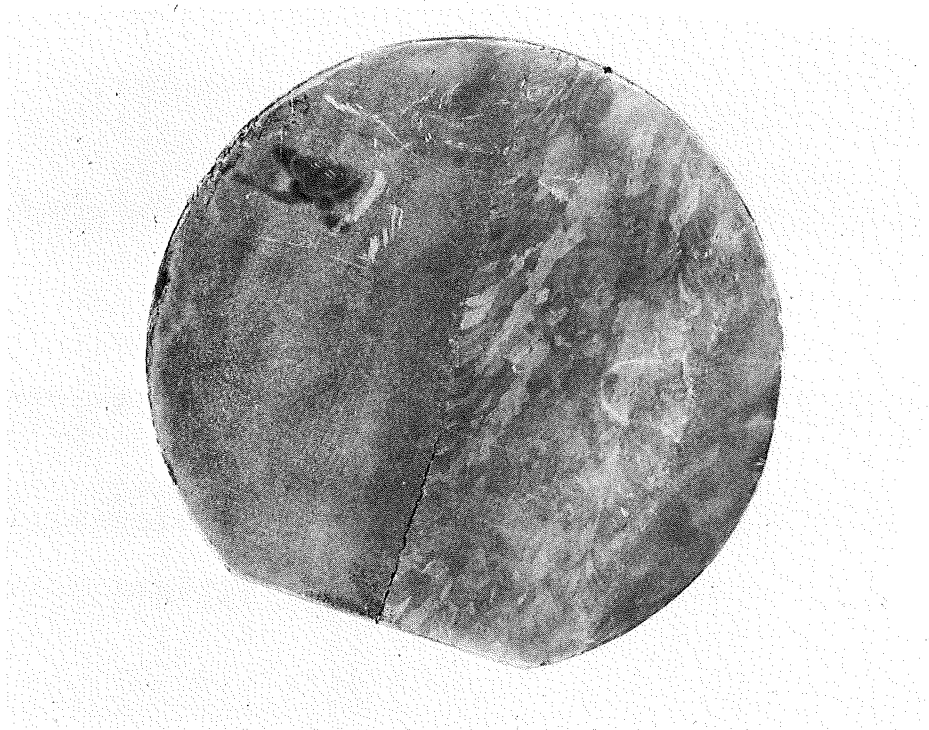
Core D

Fig. 9. Core removed from northbound girder G5 W3B, showing propagation of flange tip crack.

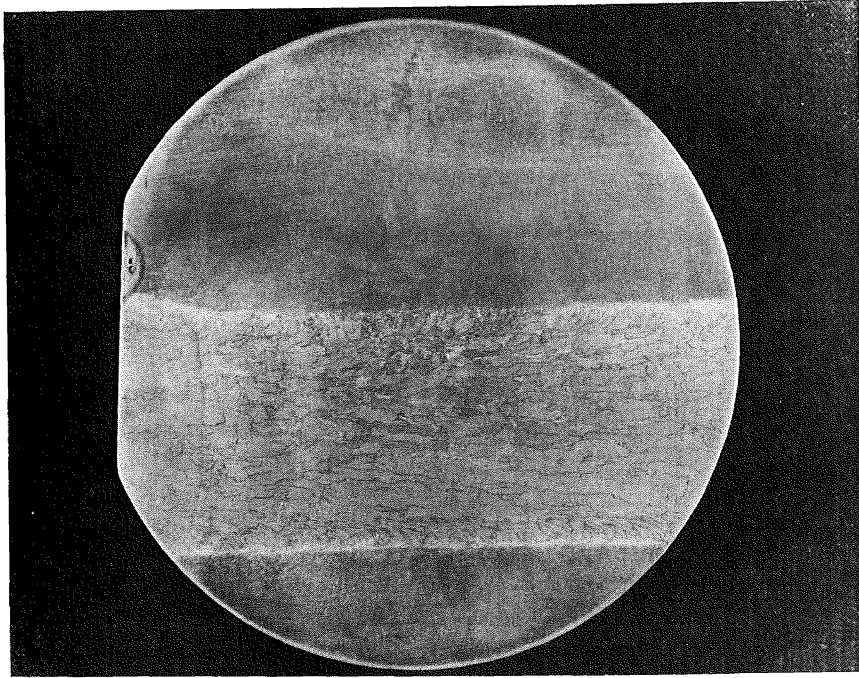
Fig. 10. Core removed from northbound girder G4 W2A showing repair weld on flange tip crack.

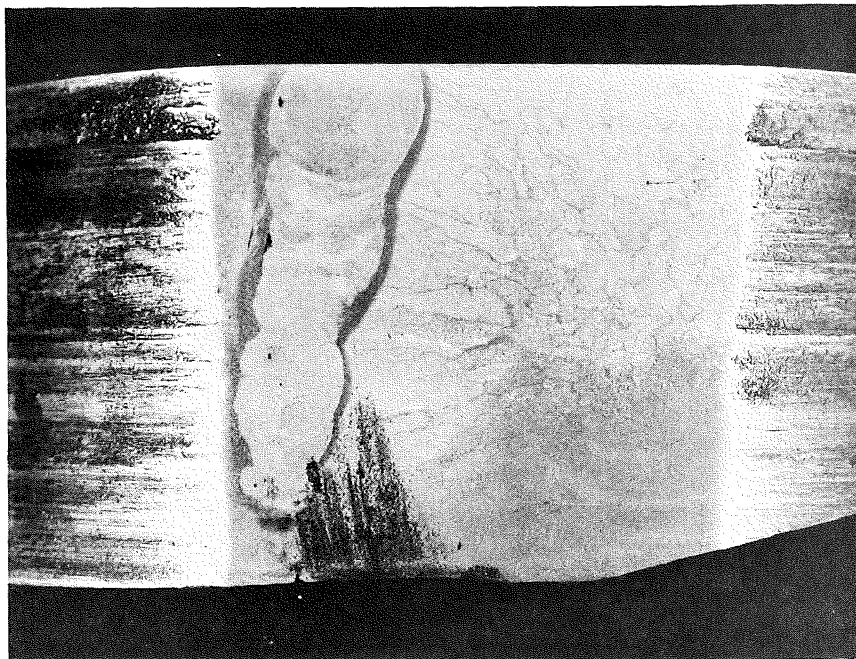
Fig. 11. Side view of core from northbound girder G4 W2A showing repair weld.

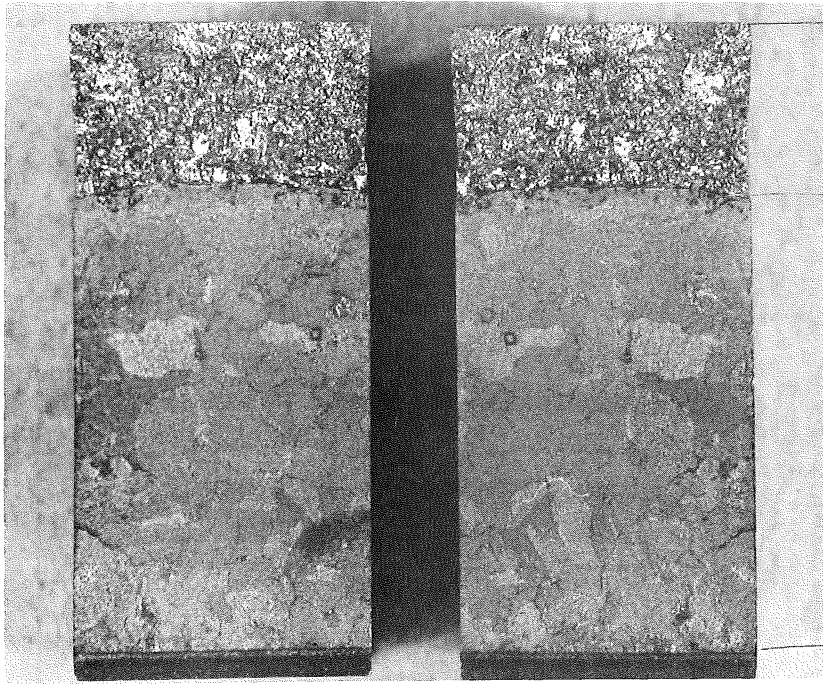
The variations in the microstructure of the weld metal caused marked differences in the topographic features of the fatigue crack surfaces, as illustrated in Figs. 25 and 26. However, these variations did not influence the crack growth rates markedly, as can be seen by comparing the test data in Figs. 20 and 21.

Fig. 25. Topographic features of a fatigue crack through zone II weldment.

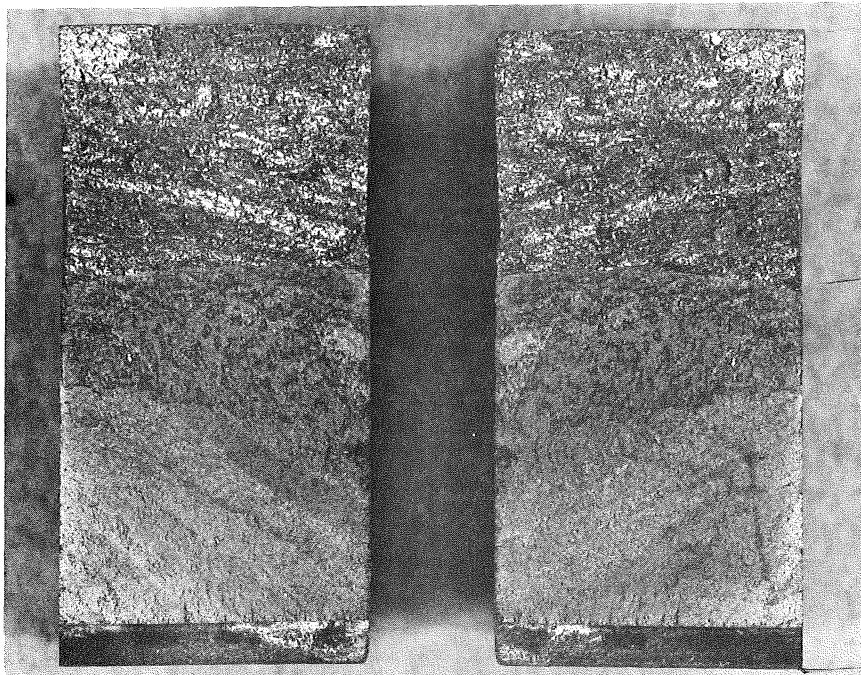
Fig. 26. Topographic features of a fatigue crack through zone I weldment.

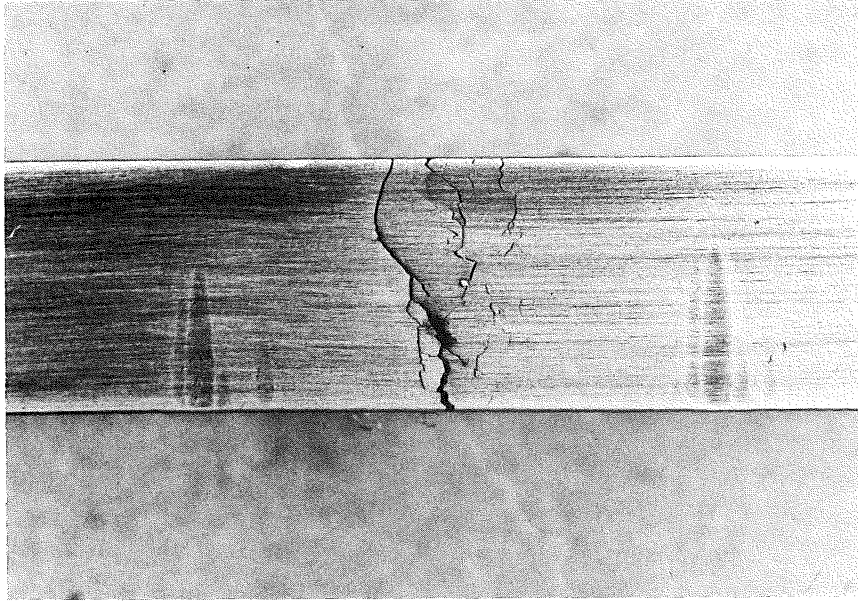
Fig. 28. Edge view of specimen A4 showing natural cracks at fusion line.

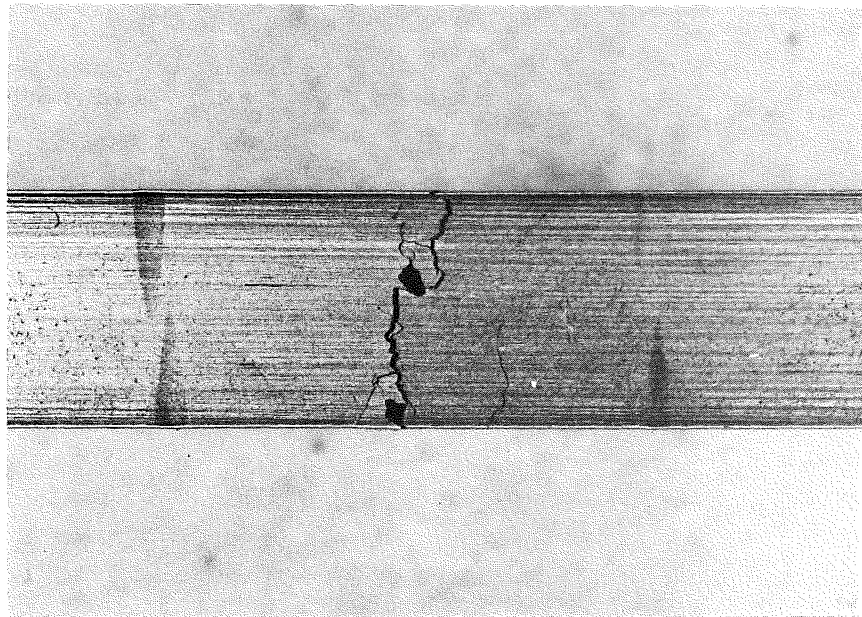
Fig. 29. Edge view of specimen F5 showing natural cracks at fusion line.

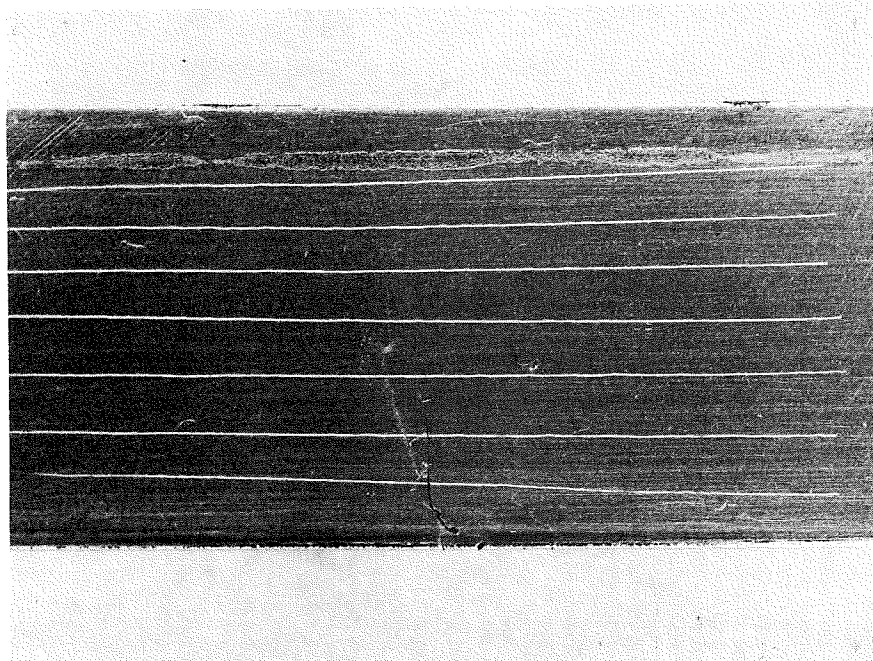
Fig. 30. Branching of the cracks in specimen A4.

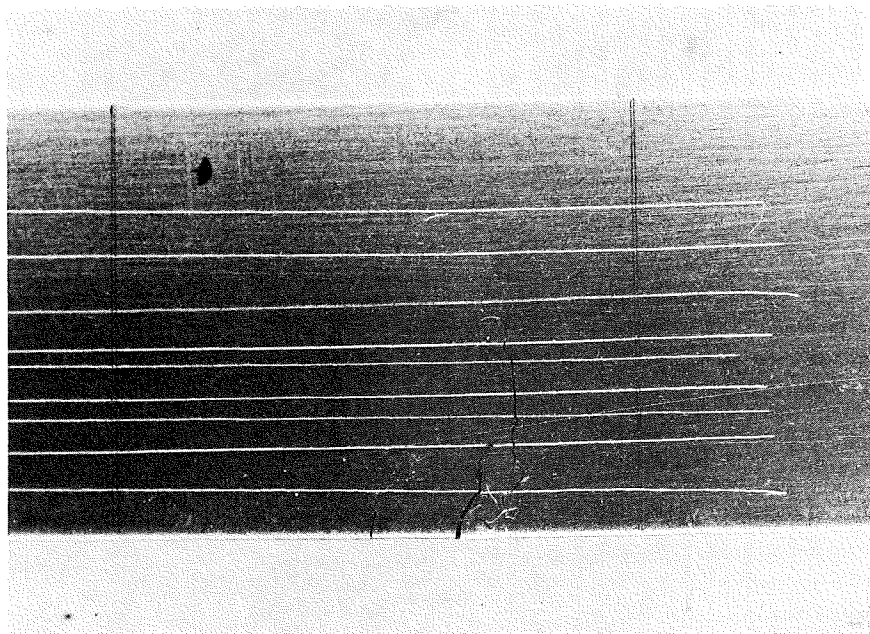
Fig. 31. Branching of the cracks in specimen F5.

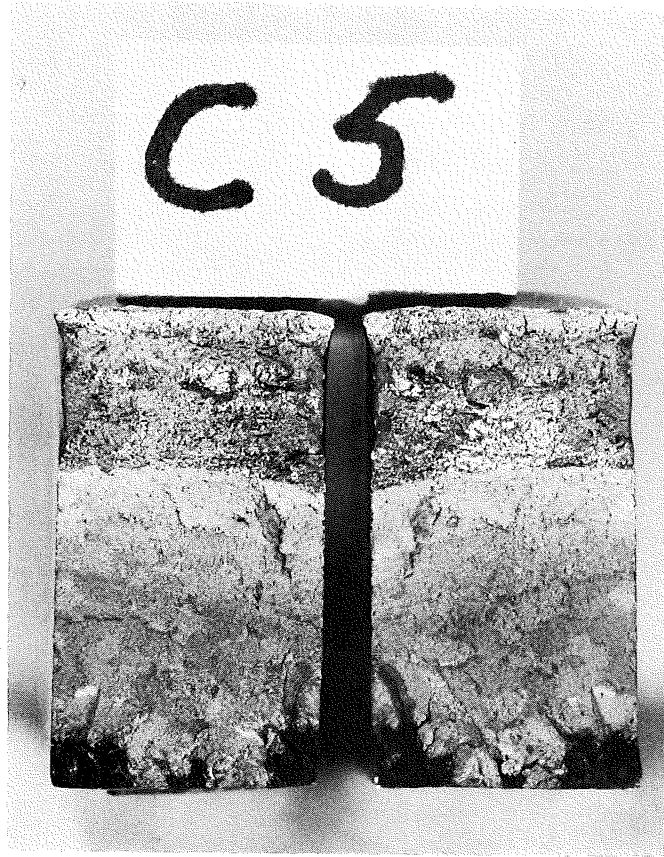
Fig. 32. Natural crack profile in specimen C5.

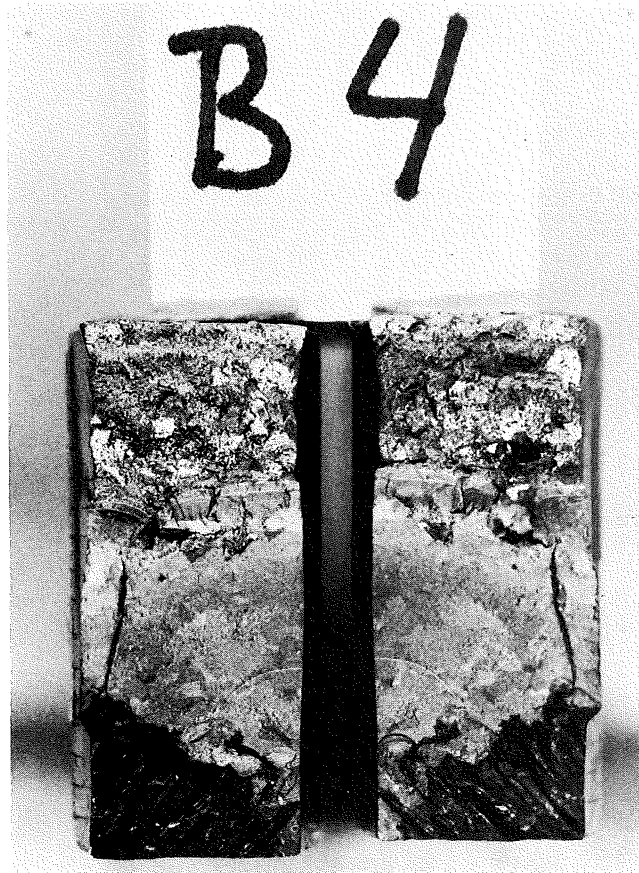
Fig. 33. Natural crack profile in specimen B4.

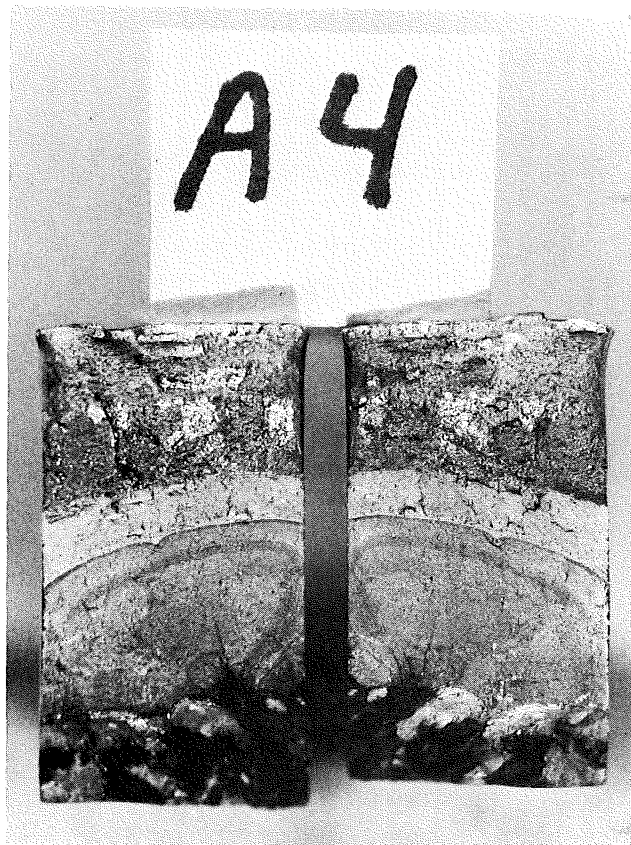
Fig. 34. Natural crack profile in specimen A4.

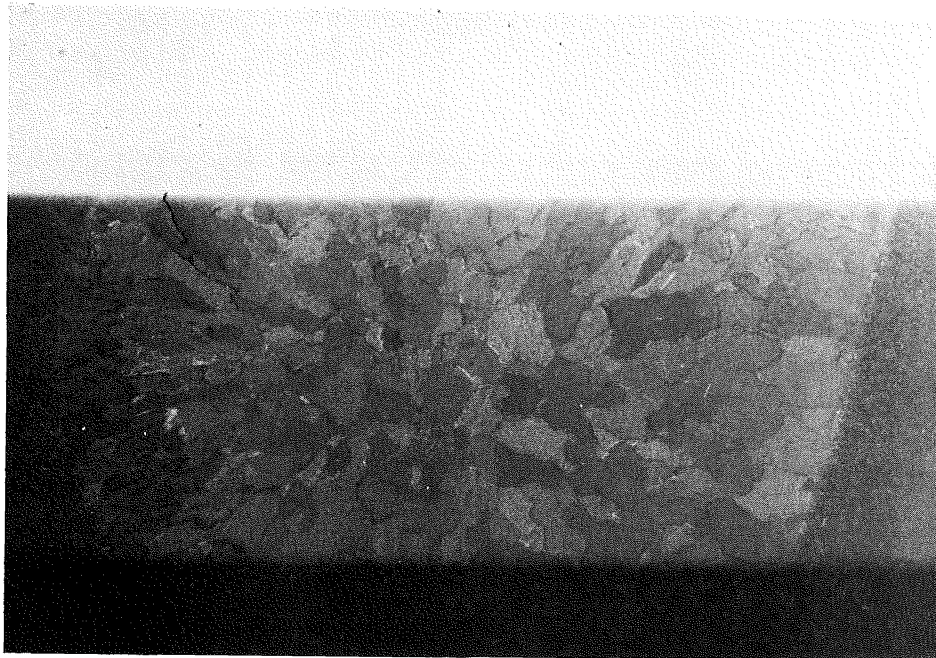
Fig. 48. Transverse section of the weldment showing intergranular cracks near the fusion line.

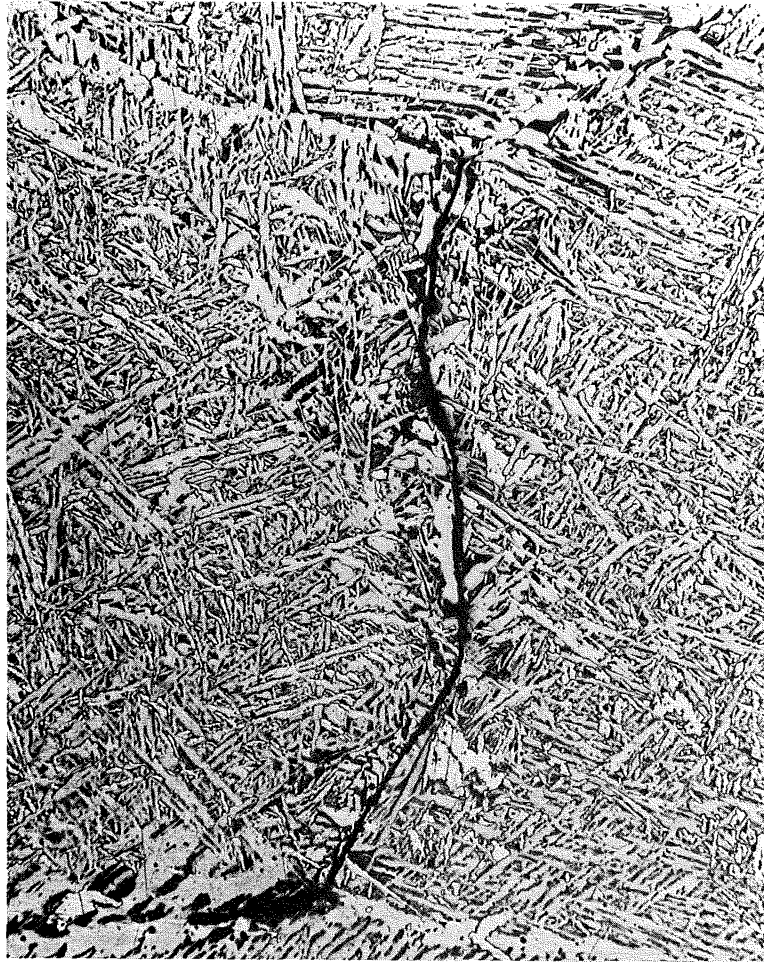
Fig. 49. Crack propagation along the ferrite band.

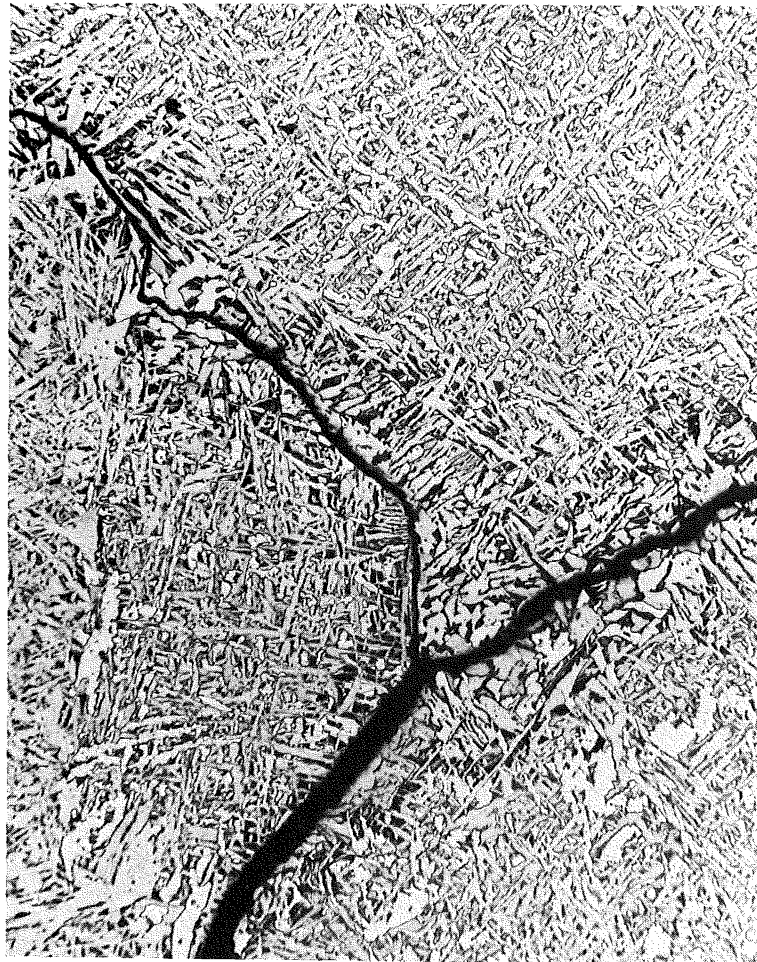
Fig. 50. Crack branching along the ferrite network.

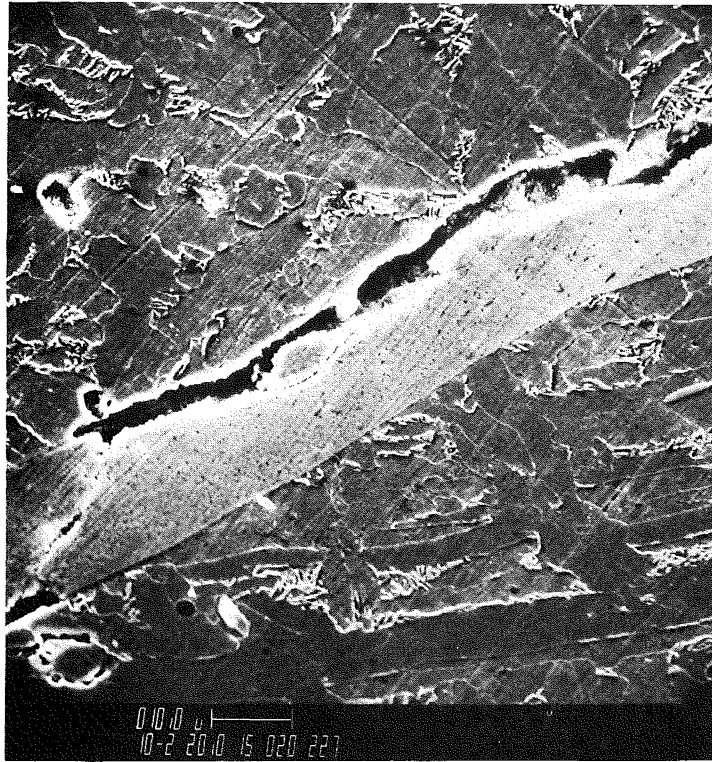
Fig. 51. SEM photograph of a crack filled with copper (Core F).

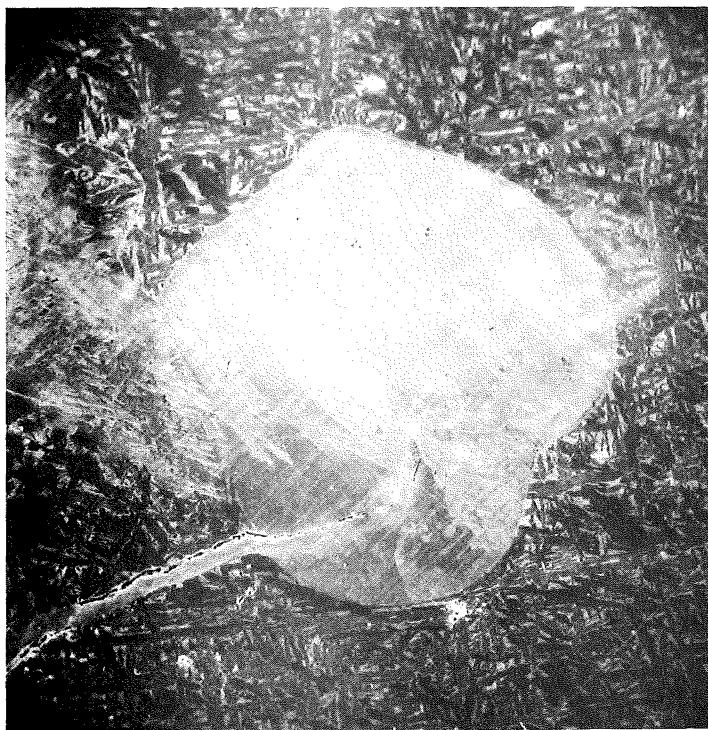
Fig. 53. SEM photograph of a crack emanating from a copper globule.

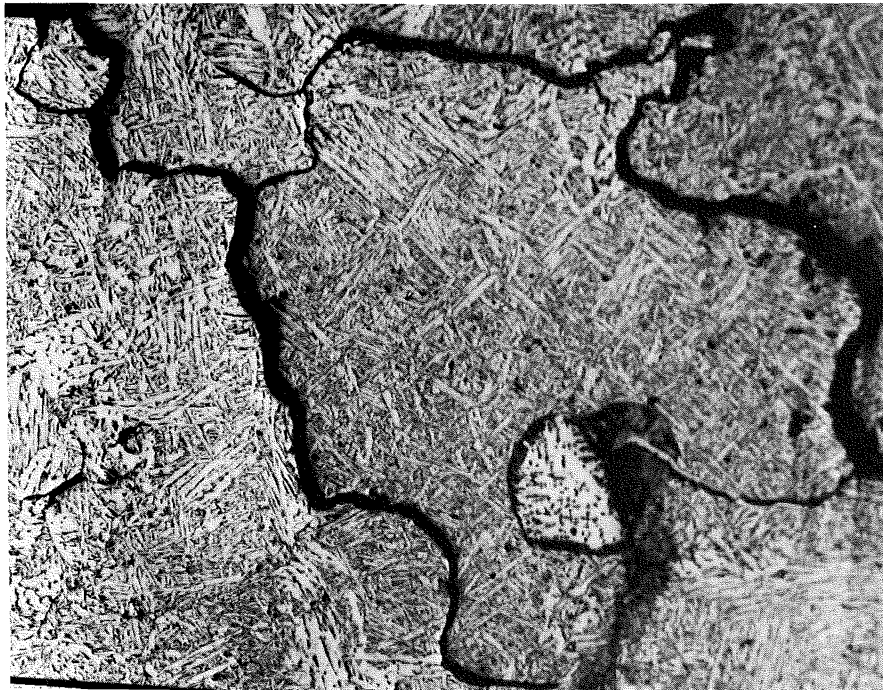
Fig. 55. Intergranular cracks along the ferrite bands.
Note the copper globule and the crack emanating
from it.

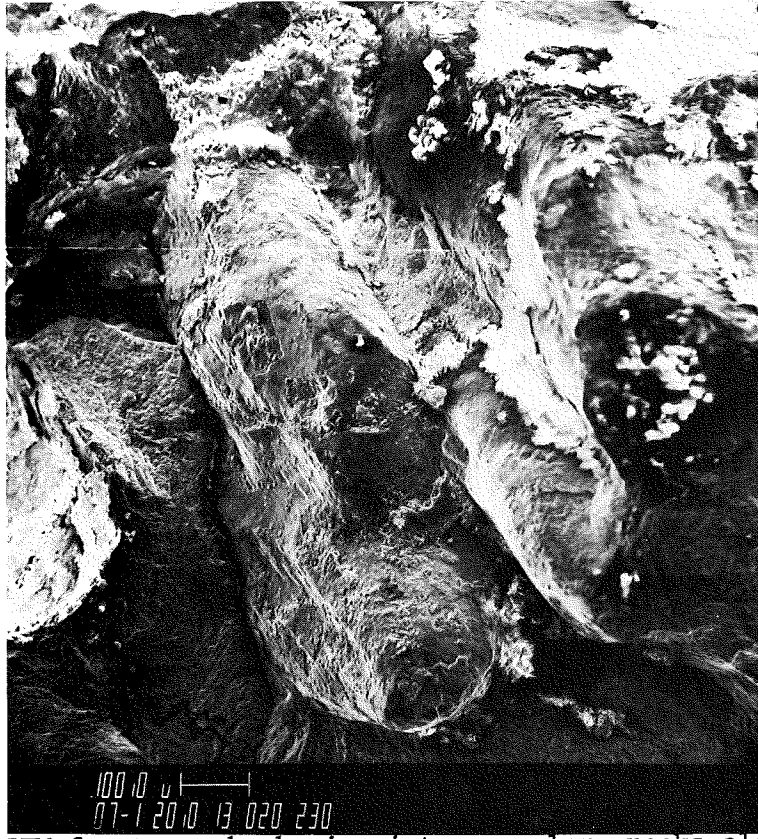
Fig. 56. SEM fractograph showing intergranular cracks along the large columnar grains.

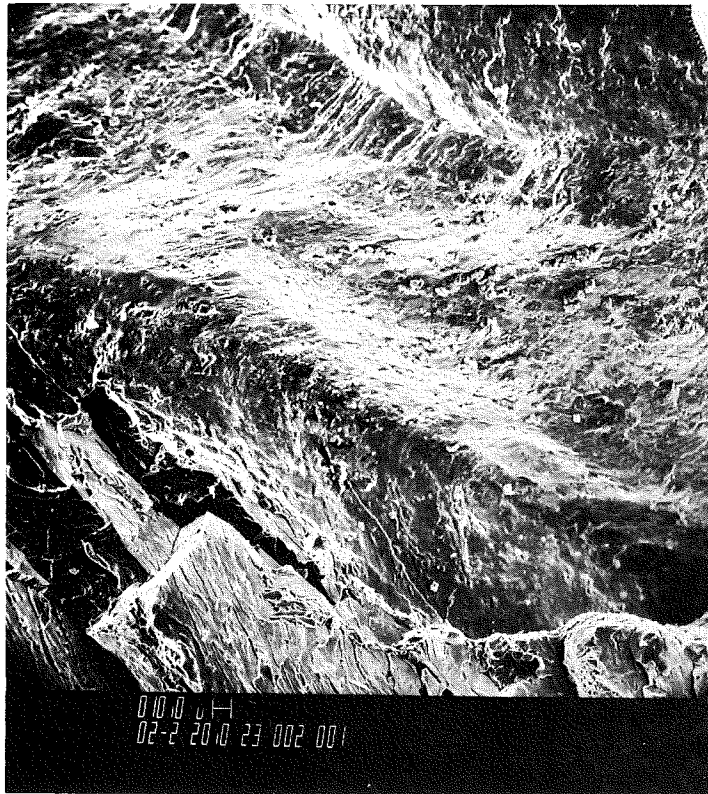
Fig. 57. SEM fractograph of the natural crack tip.

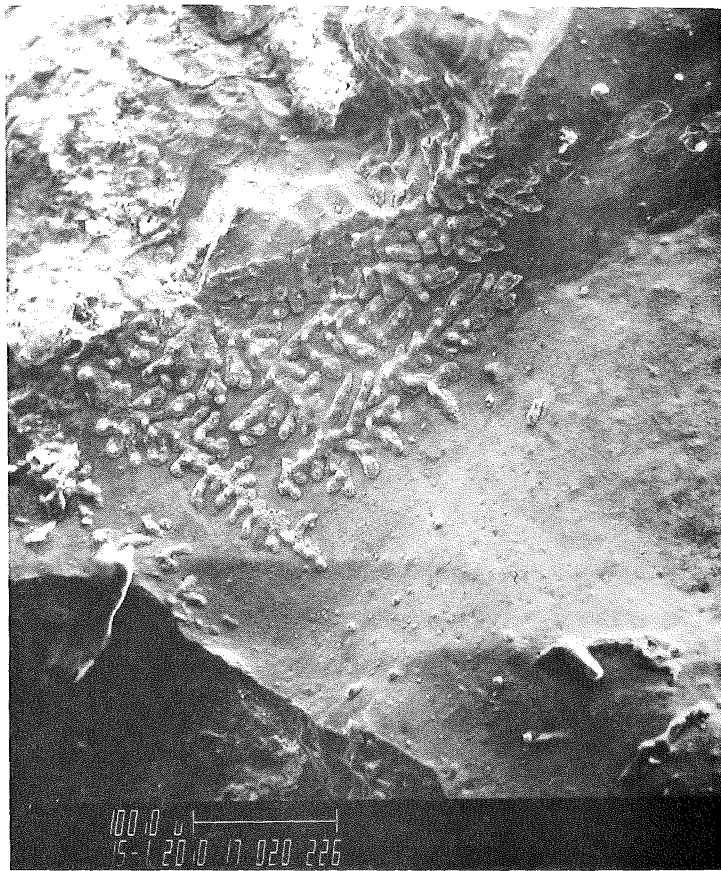
Fig. 58. SEM fractograph showing dendritic copper on the intergranular crack surface (Core F).

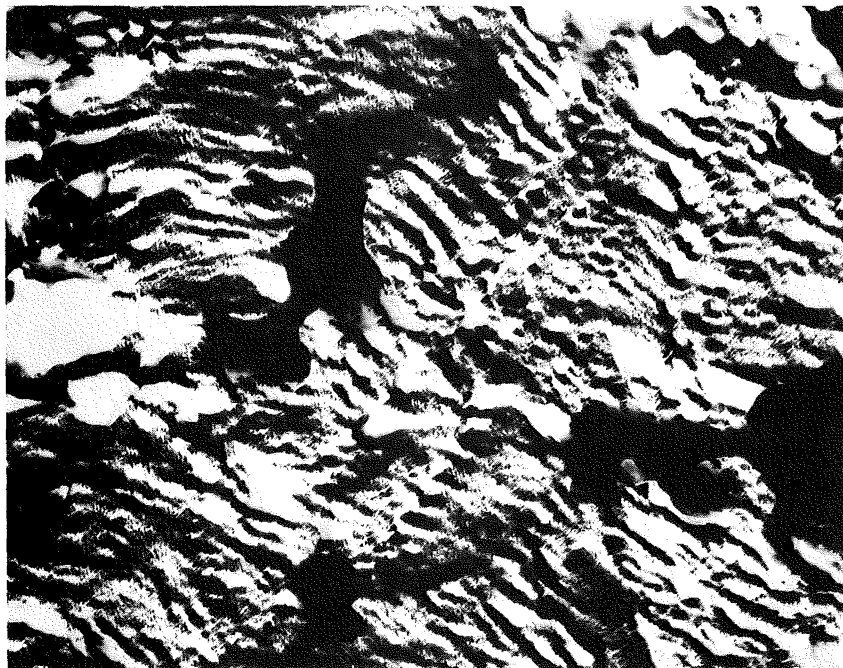
Fig. 63. TEM fractograph of a replica showing fatigue striations at the tip of the natural crack (Core N).

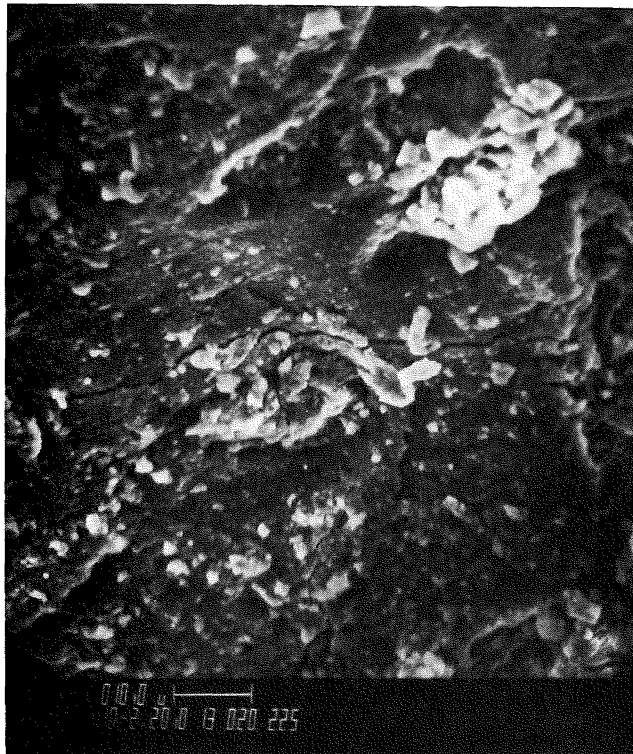
Fig. 64. SEM fractograph of surface of Core N showing heavy corrosion product.

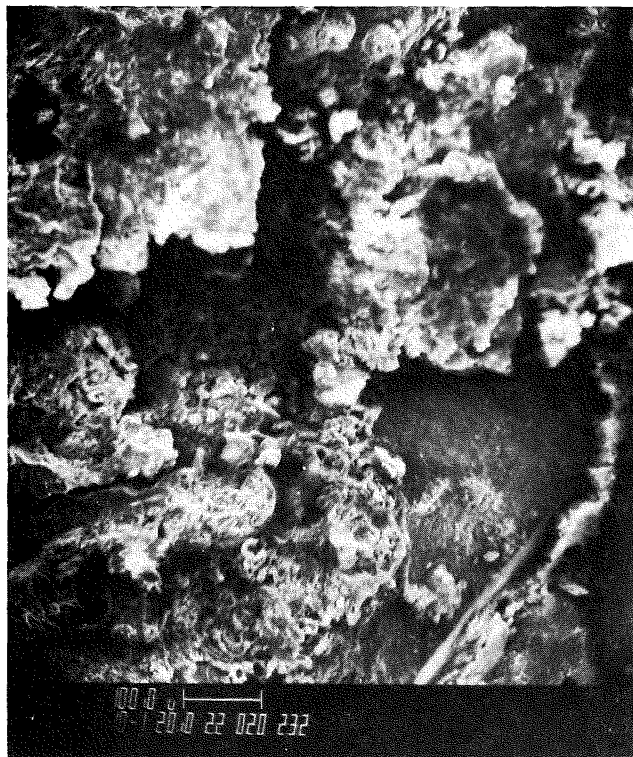
Fig. 65. SEM fractograph of surface of Core N showing heavy corrosion product.
