1981

**Study of Blue Route Bridge
Defects and Structural Response**

**AN ASSESSMENT OF THE BLUE ROUTE
BRIDGE ELECTROSLAG WELDMENTS**

**December 1981
Report No. 457-1 (81)**

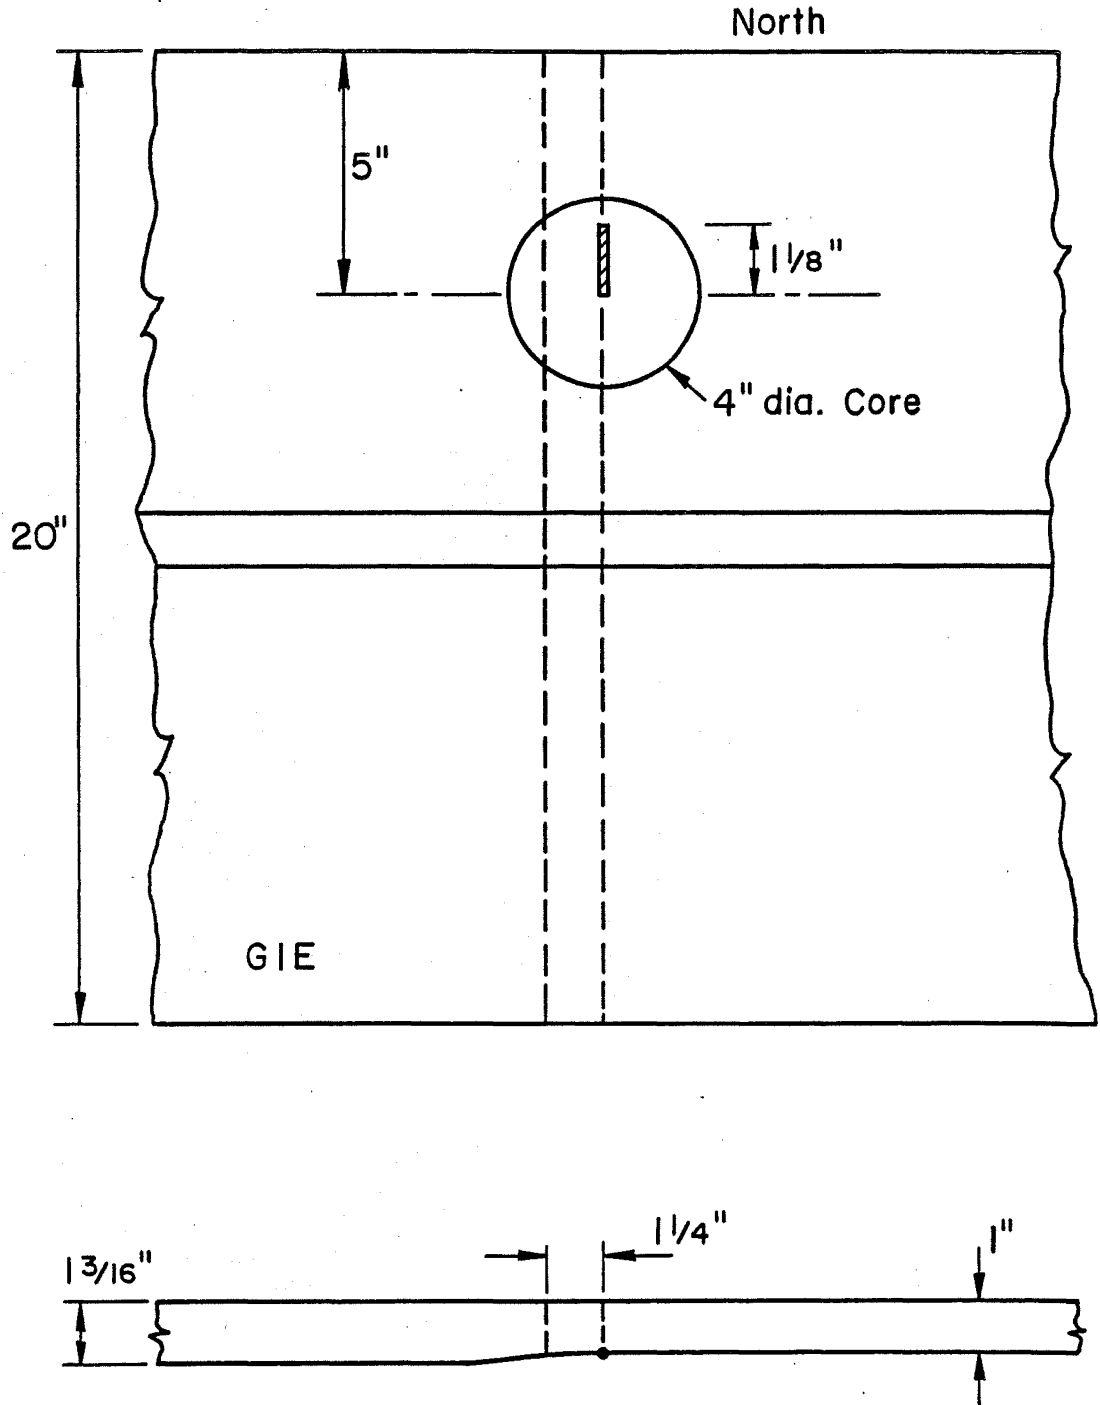
Fig. 23 Location of Defect in Electroslag Weldment G1E by Nondestructive Testing

Core G1E - Span 6, North Girder of the southbound bridge, weld 2, first joint south of pier 6. See Fig. 23.

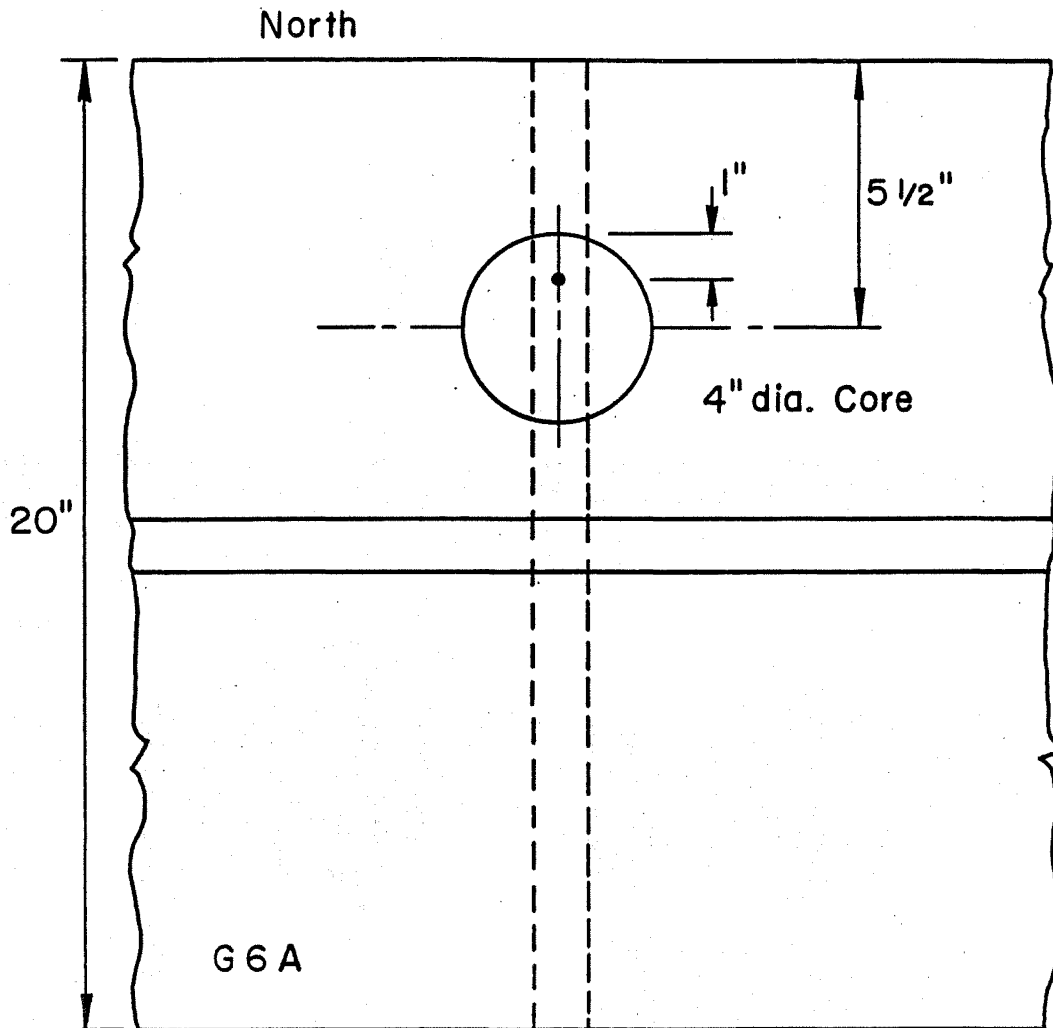
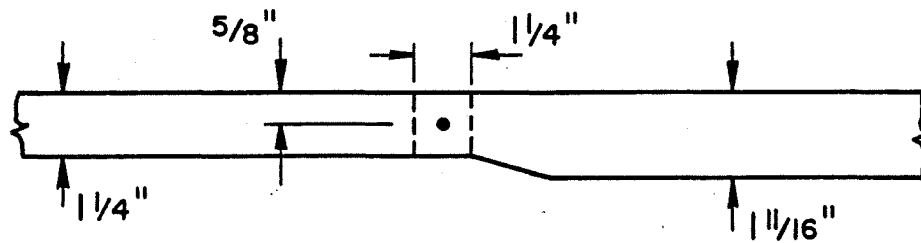
Fig. 24 Location of Defects in Electroslog Weldment G6A by Nondestructive Testing

Core G6A - Span 7, South Girder of the southbound bridge, weld 1, first joint north of pier 6. See Fig. 24.

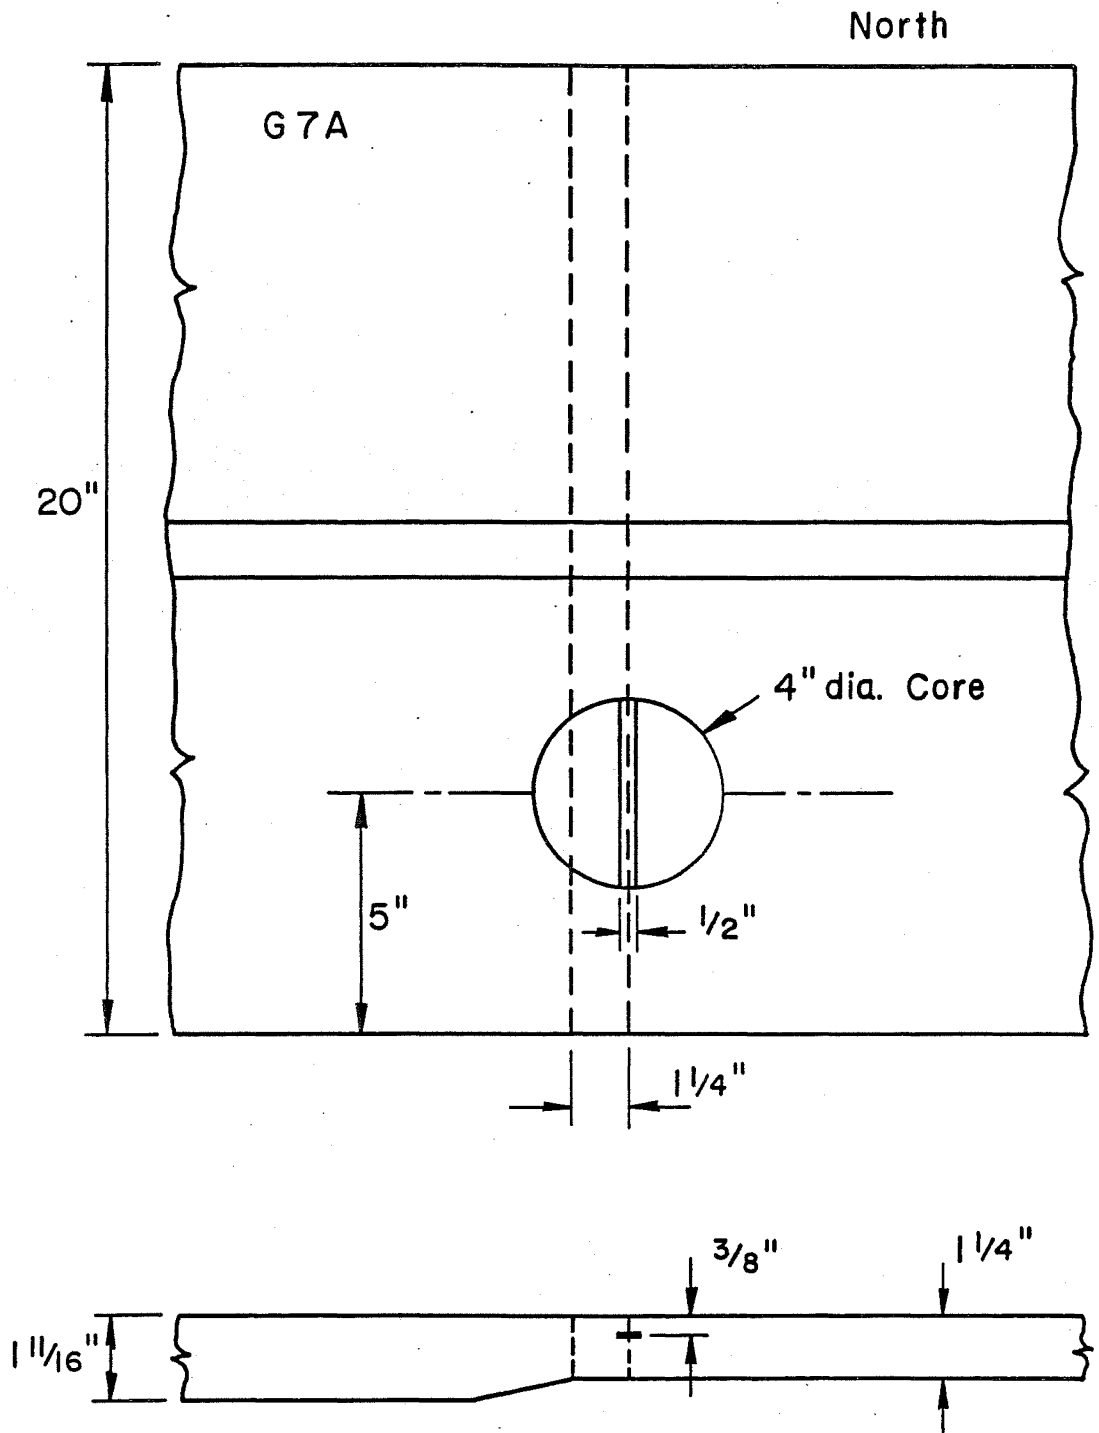
Fig. 25 Location of Defect in Multipass Weldment G7A
by Nondestructive Testing

Core G7A - Span 11, North Girder of the northbound bridge, weld 3, first joint south of pier 11. See Fig. 25.

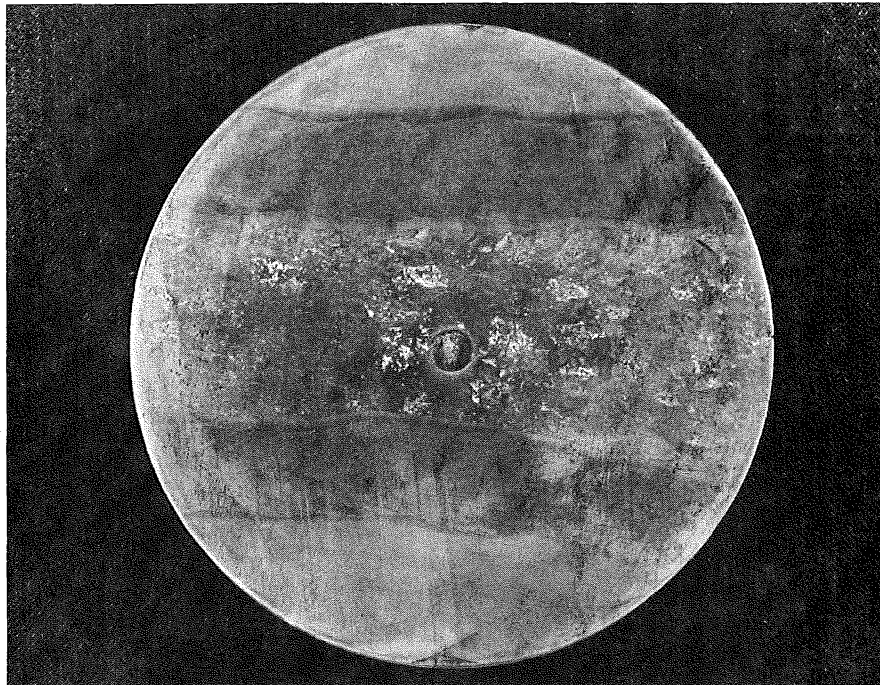
Fig. 30 Polished and Etched Surface of Core G1E

Cores G1E, G6A and G7A were also polished and etched to reveal the welds. The electroslag weldment from G1E (see Fig. 23) had substantial repair welds along the fusion lines as can be seen in Fig. 30. Figure 31 shows the multipass submerged arc weldment G7A with a repair weld near one end. Figure 32 shows the electroslag weldment from G6A. No defects were detected on the surfaces of any of these weldments.

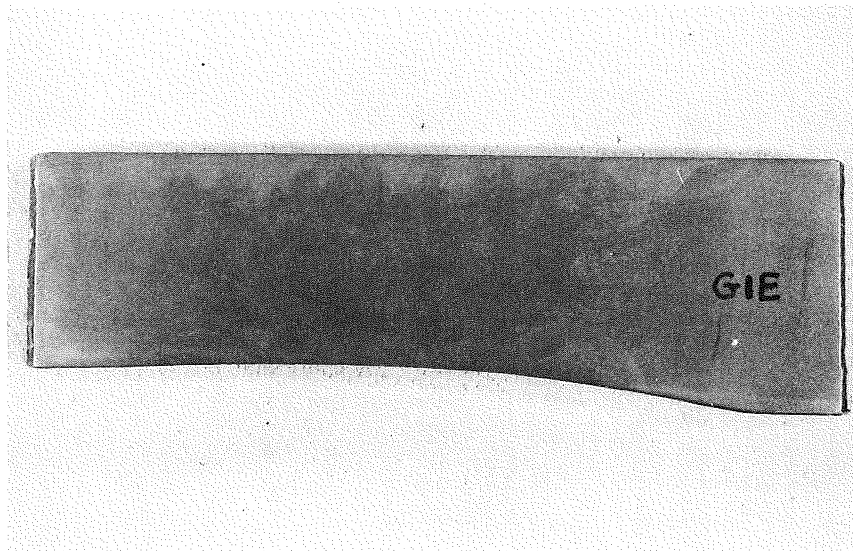
Fig. 36 Polished and Etched Surface GLE

A slice near the weld defect which was indicated to exist in core G1E did not reveal any major defect as can be seen from the polished and etched

surface shown in Fig. 36. The photomicrograph shows several repair welds at the fusion line.

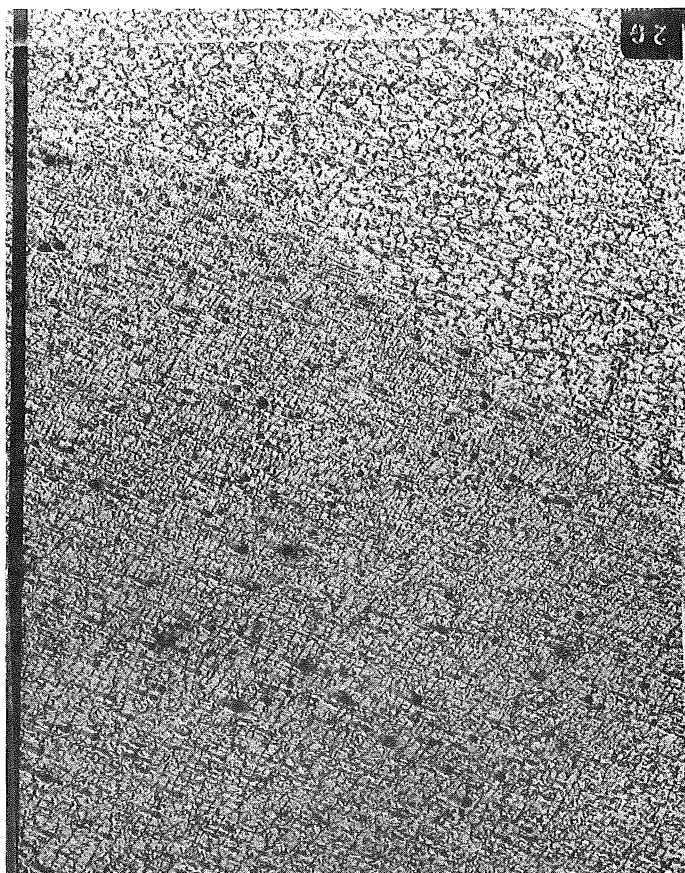
Fig. 37 Photomicrograph at 50X GLE

The fusion line region was examined at 50X at the weld repair region. This is shown in Fig. 37. The photomicrograph shows a dispersion of nonmetallic inclusions near the fusion line. Apparently the large number of these small discontinuities were responsible for the +9Db ultrasonic test rating indicated to exist at this location. No other discontinuities were observed on any of the other polished and etched surfaces.

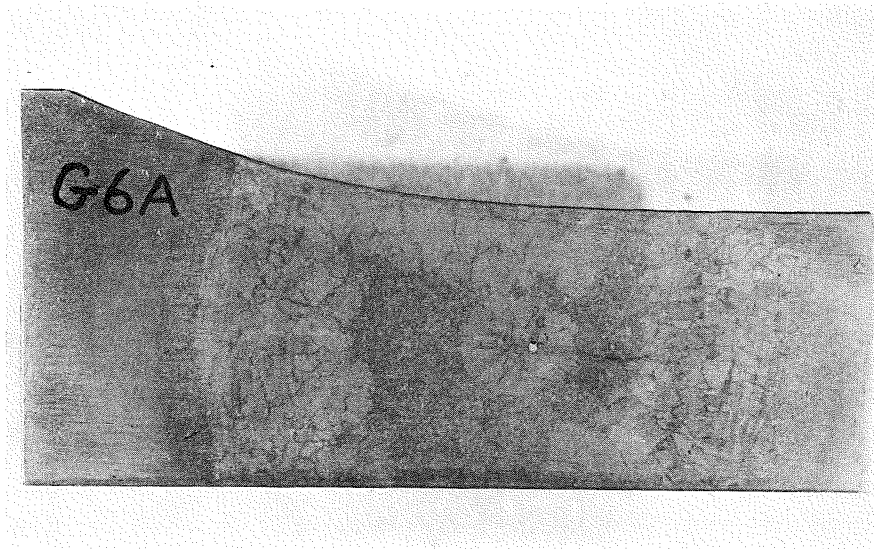
Fig. 38 Polished and Etched Surface G6A

Figure 38 shows the polished and etched segment of core G6A near the indicated defect. The microstructure of the electroslag weldment is readily apparent. The defect can be seen near the center of the weldment in Fig. 38. It was identified as a slag inclusion about 1 mm (0.04 in) in diameter. Figure 39 shows a photomicrograph at 40X of the slag inclusion which has a circular shape on the sawcut plane. The large grain structure of the electroslag weld is apparent in both Figs. 38 and 39.

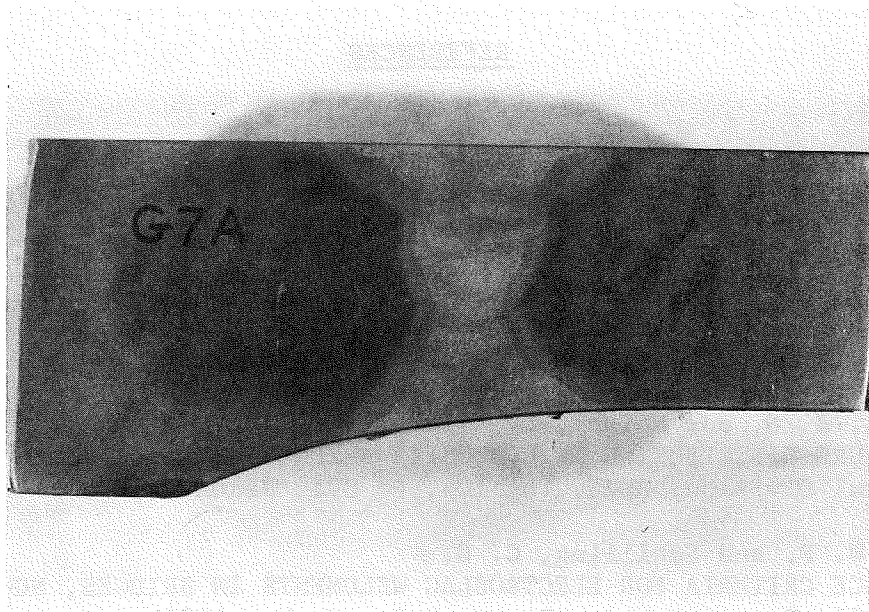
Fig. 40 Polished and Etched Surface G7A

Figure 40 shows the polished and etched edge of the sawcut of the submerged arc weld in core G7A. No significant defect was apparent on the surface except a small slag inclusion on the fusion line. Figure 41 shows a photomicrograph at 50X of the slag inclusion. It can be seen that a spherical shaped piece of slag was trapped on the fusion line.
