**FINAL REPORT
ON I79 TIED ARCH CRACKING
- NEVILLE ISLAND BRIDGE**

Report No. 494-1(84)

Cracks were detected in the diaphragm to tie girder web welds of the I79 Neville Island Bridge in July 1983. These cracks were observed at the top and bottom ends of the transverse welds between the diaphragm and the outside plate at floor beams. Samples removed from these cracked regions showed that all of these cracks developed from lack of fusion in the welded connections. Cyclic stresses developed in the diaphragms normal to these welds resulted in fatigue crack growth.

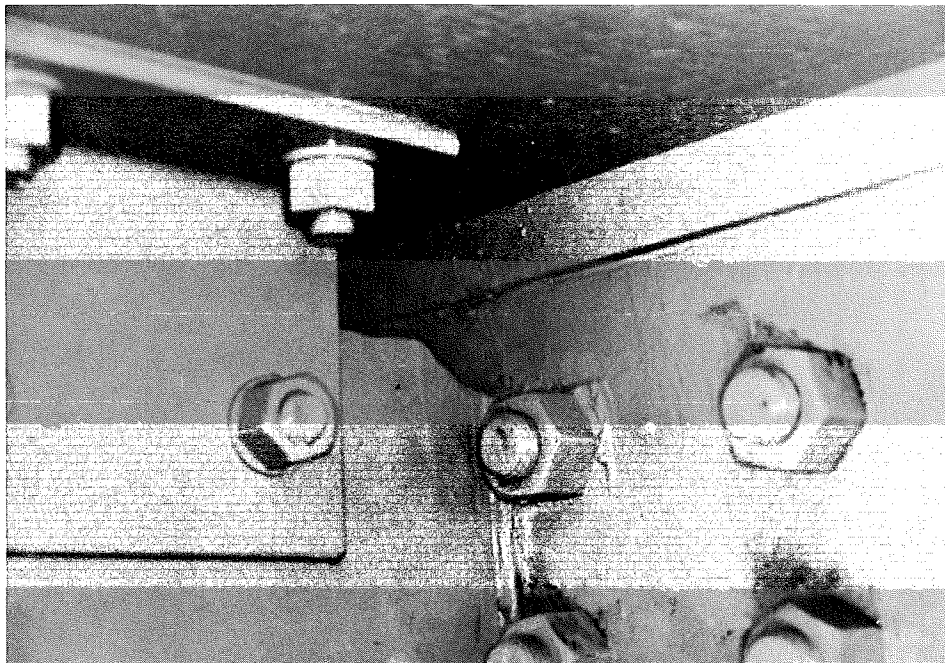
The initial retrofit consisted of pairs of 7 x 4 x 1/2 in. angles connected to the diaphragm and top and bottom flanges, as illustrated in Fig. 21. At several locations the cracked weld had been removed, as illustrated in Fig. 22.

Fig. 22 Close-up of Upper Outside Gap Showing Retrofit Angle and Region of Diaphragm Where Crack Was Removed

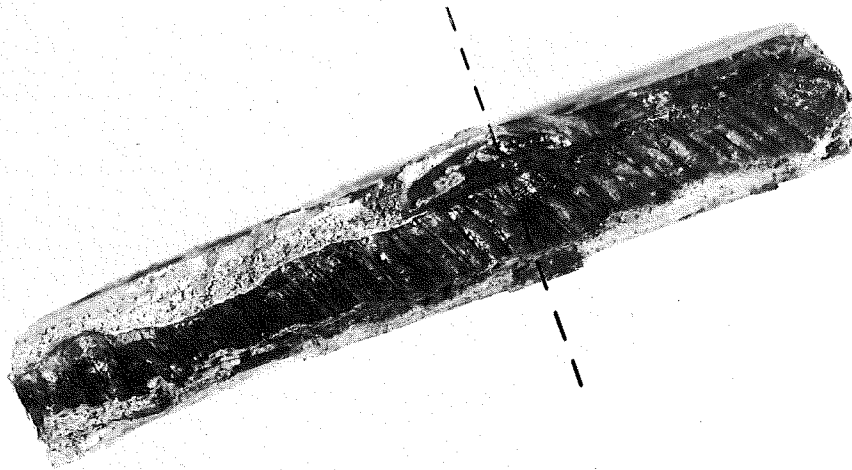
segments and their crack surfaces. It is readily apparent from most of the crack surfaces that large unfused areas existed in the groove weld that connected the diaphragm to the tie girder web at the top and bottom web gaps. The original flame cut edge is visible on many of these surfaces (see Figs. 33, 35, 37, 39, 42, 48, 50 and 52). Furthermore, many of the weld joints do not appear to be beveled. As a result, very shallow surface welds appeared to exist along the edges of the diaphragm and web, much like small fillet welds.

Fig. 33 View of Crack Surface of TIA-NB Bottom Showing
Flame-Cut Edge of Diaphragm and Large Lack of Fusion

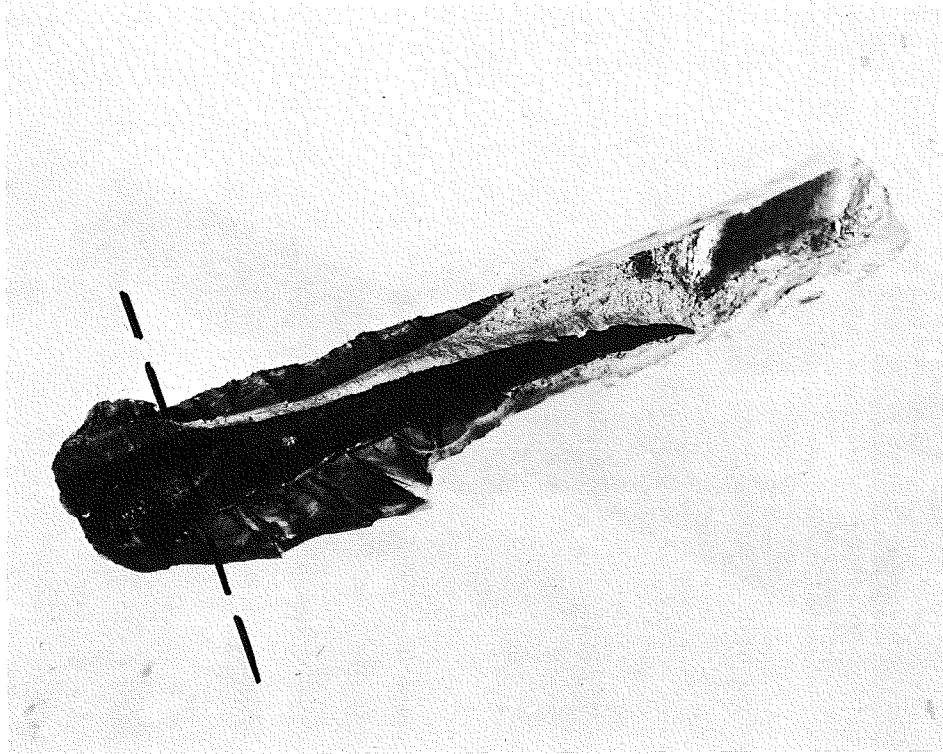
It is apparent that the lack of fusion was primarily responsible for the fatigue crack propagating from the weld root. The weld toe crack shown in Fig. 53 can be seen to extend over several inches in Fig. 35. Root cracking can also be observed on the other side of the diaphragm plate.

Fig. 35 Crack Surface of T1A-NB Top Showing
Lack of Fusion and Fatigue Crack Growth

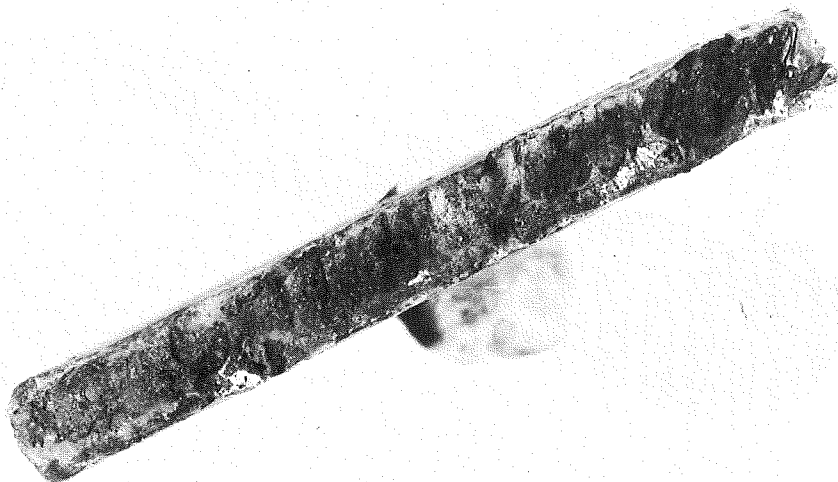
Fig. 37 Crack Surface of T2A-NB Bottom
Showing No Significant Fusion

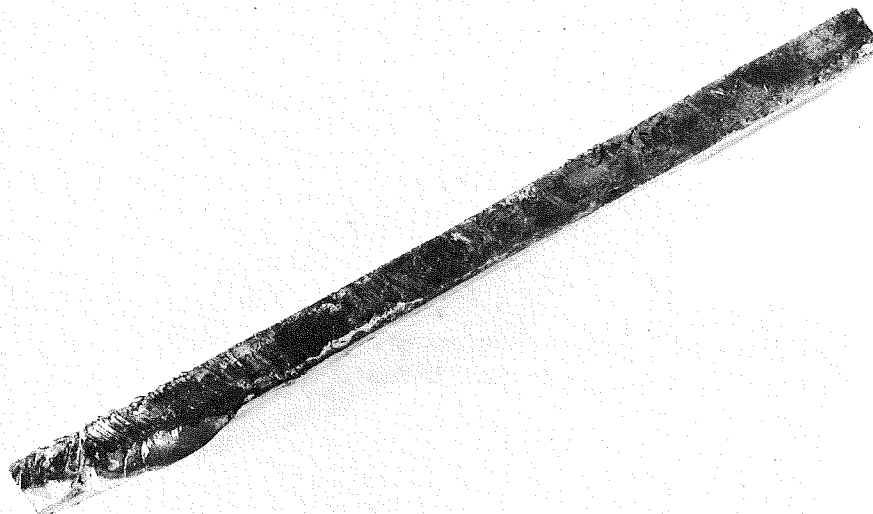
Fig. 39 Crack Surface Showing Large Lack of Fusion Area and Fatigue Crack Where Fused

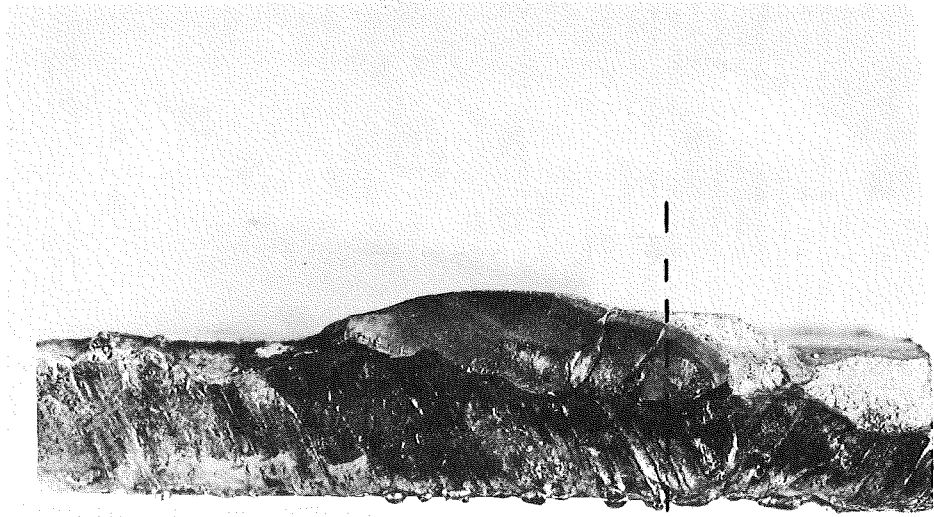
Fig. 40 Close-Up View of Fatigue Crack
at Small Fused Area

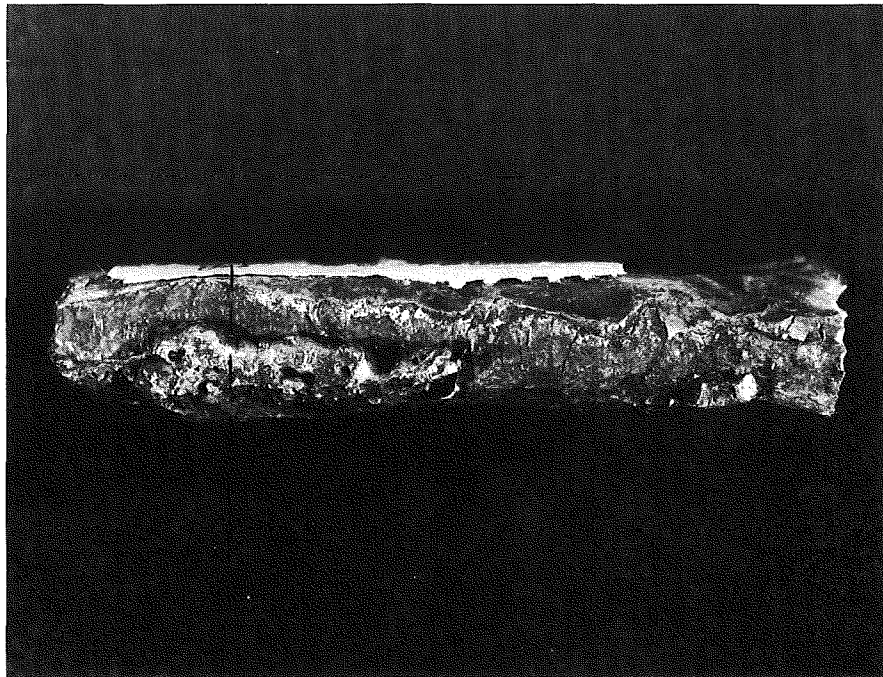
Fig. 42 View of Crack Surface Showing Lack of Fusion

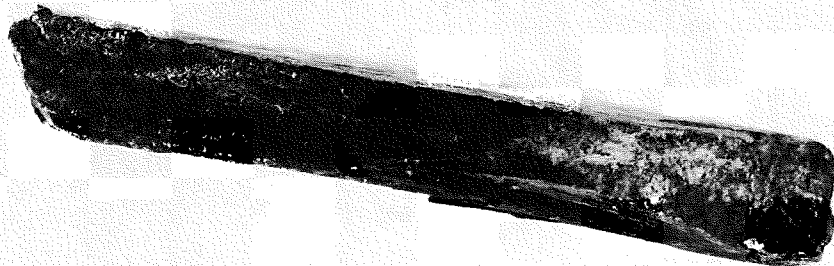
Fig. 48 Crack Surface at T4A-SB Bottom
Showing Large Unfused Areas

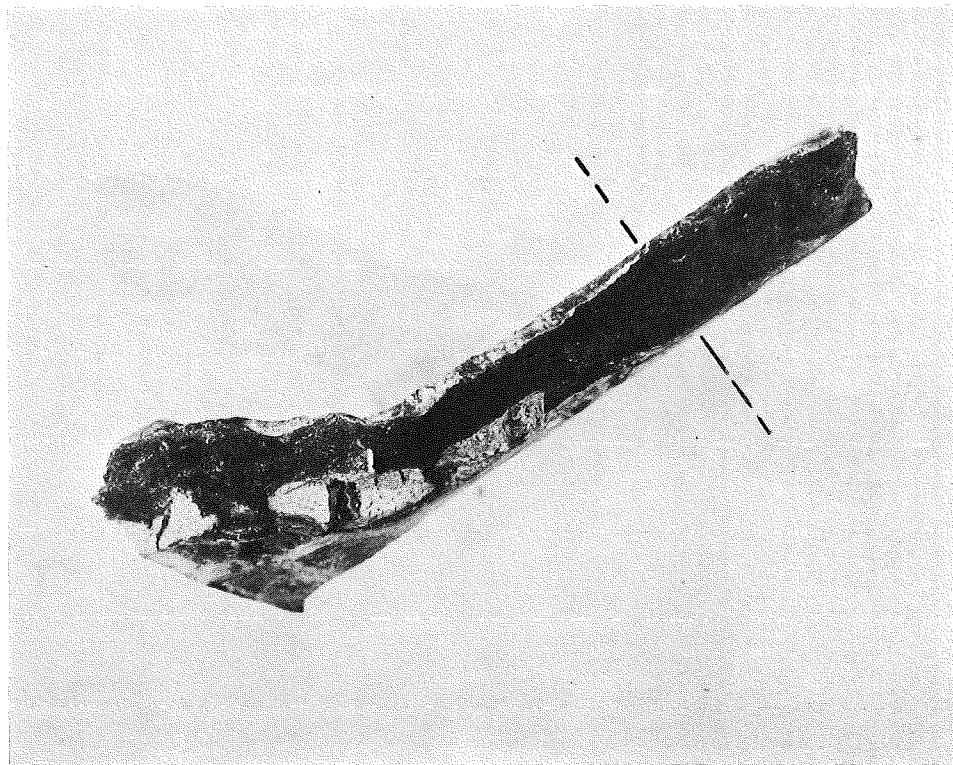
Fig. 50 Crack Surface Showing Large Lack of Fusion Region
at End of Diaphragm

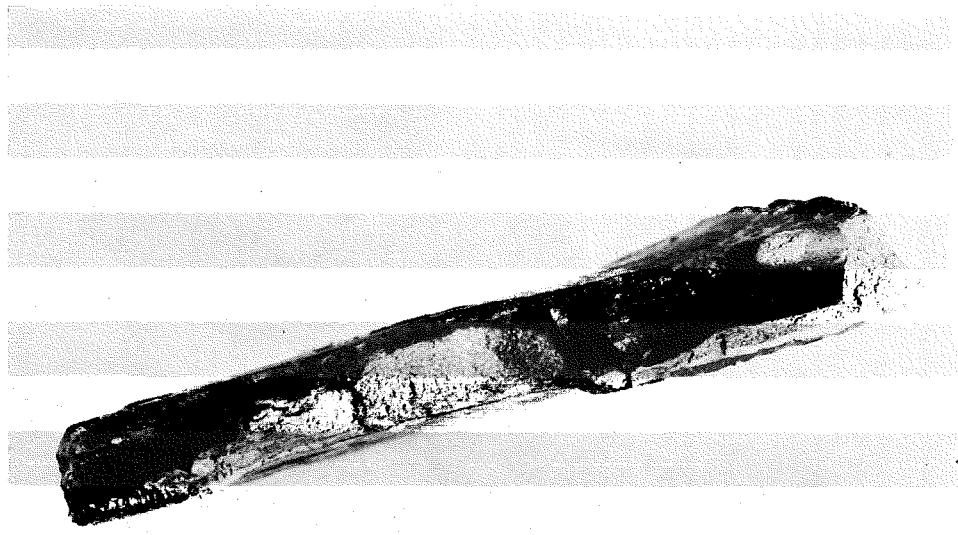
Fig. 52 Crack Surface Showing Large Lack of Fusion Regions

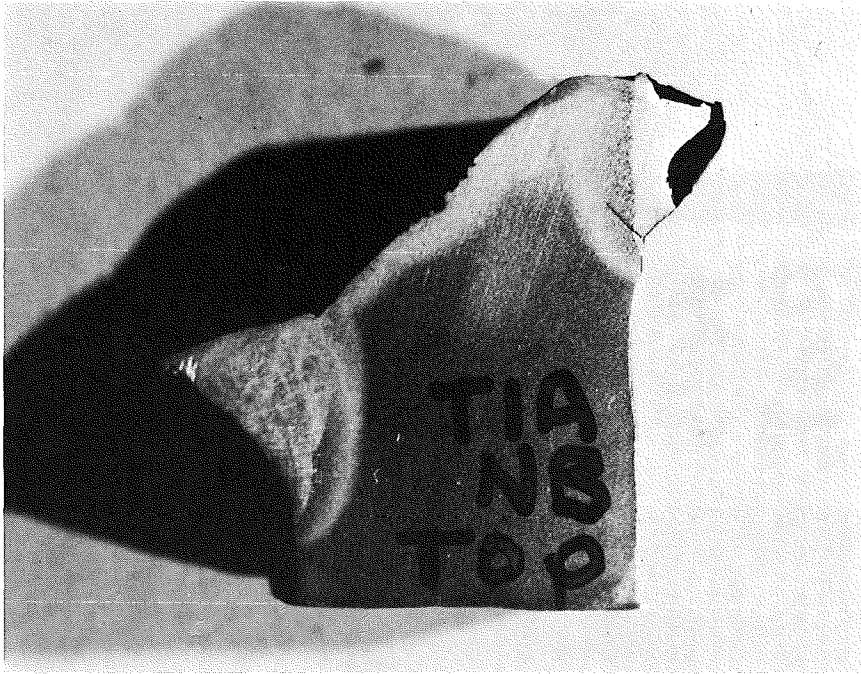
Fig. 53 Polished and Etched Section of T1A-NB Top
Near End of Diaphragm (see Fig. 35)

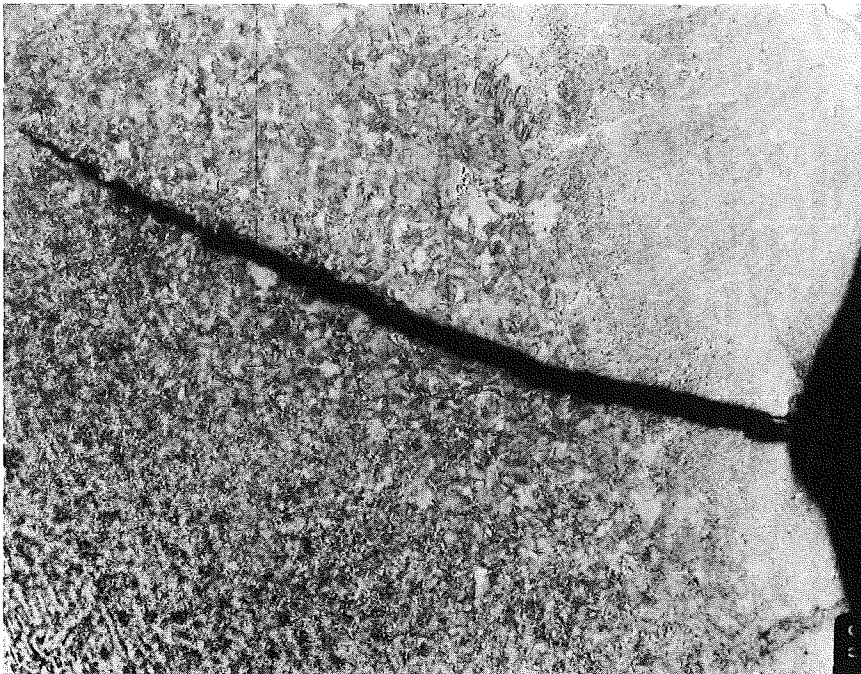
Fig. 54 Close-Up View of Secondary Crack Growing From
Weld Toe (see Fig. 53) @ 40X

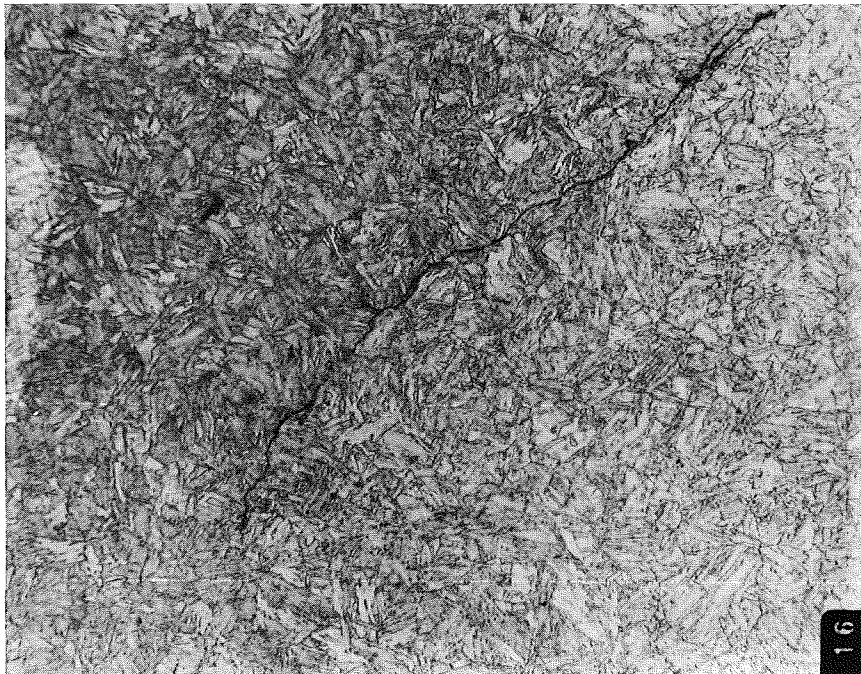
The fatigue crack turned and propagated into the web plate at panel point T1-NB top (see Fig. 46). The core sample was milled to the crack tip, as shown in Fig. 60. This showed that the crack had propagated about halfway through the web thickness. A view of the crack tip at high magnification can be seen in Fig. 61.

Fig. 61 Fatigue Crack Tip at Midthickness of Web Plate at 500X

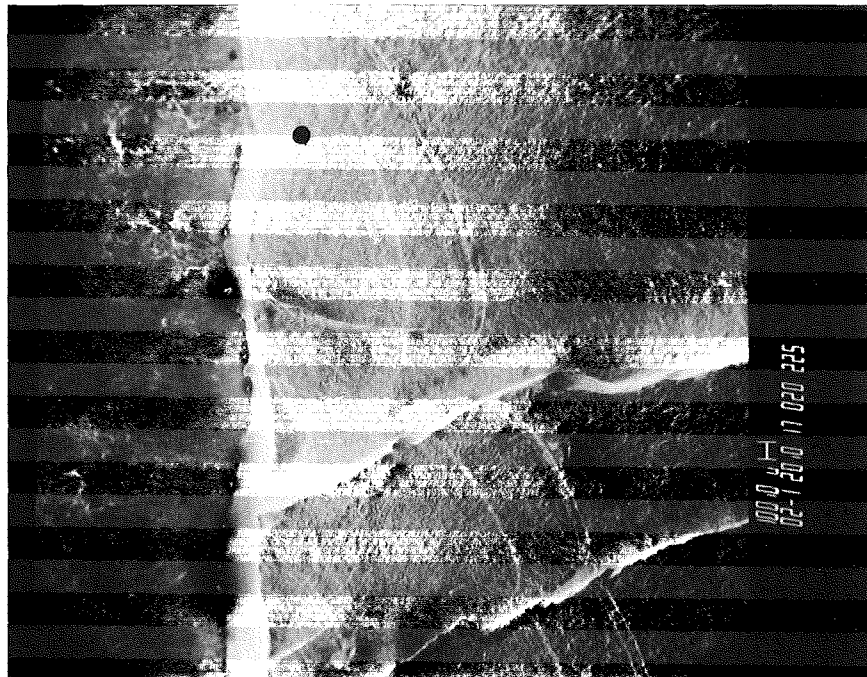
crack growth. The evidence of fatigue crack growth is clear from the beach marks seen in Figs. 63 and 66. Striations can be clearly seen in Figs. 64 and 67.

Fig. 63 SEM Fractograph @ 20X Showing Beachmarks on Crack Surface

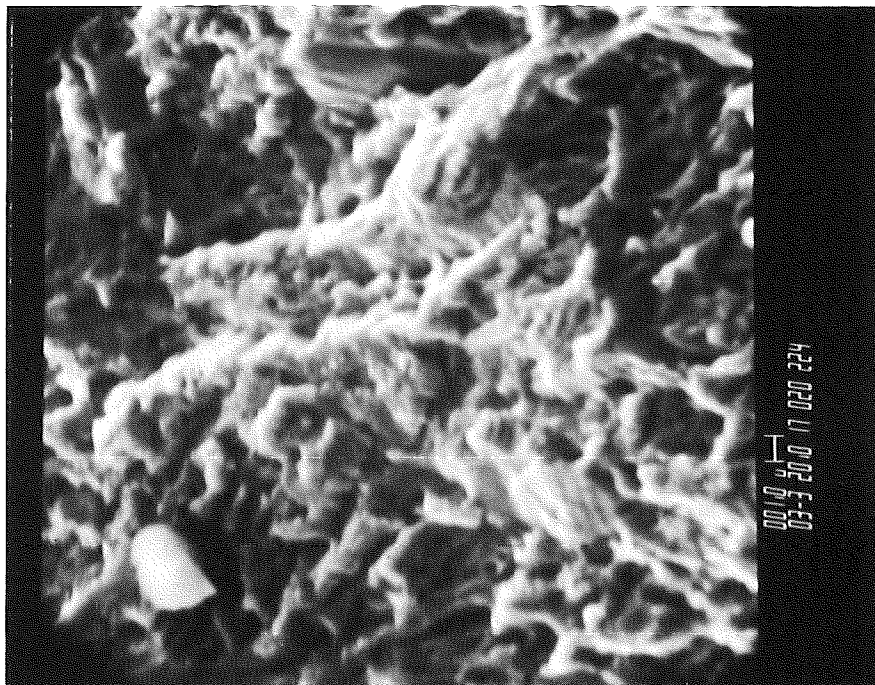
Fig. 64 SEM Fractograph @ 3000X Showing Corrosion Product and Striation-like Features at Black Dot Marked in Fig. 63

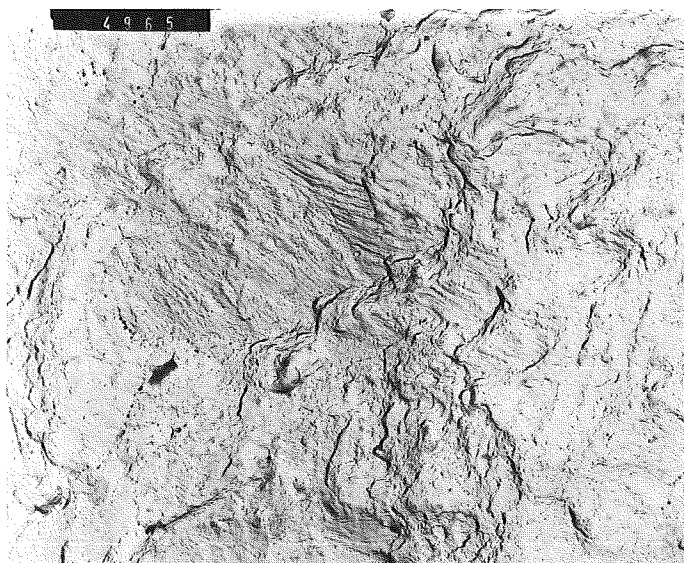
Transmission electron micrographs were also prepared from replicas taken from the crack surfaces. These fatigue striations are clearly seen in Fig. 65 and 68. The fatigue crack growth developed at high ΔK levels. From the striation spacing in Figs. 65 and 68, it appears that the crack growth rates are between 2 and 5×10^{-6} in/cycle for the cracks observed in T1A-NB top and T2A-NB top.

Fig. 65 TEM Fractograph at 6300X Showing Striation Features on Crack Surface of T1A-NB Top

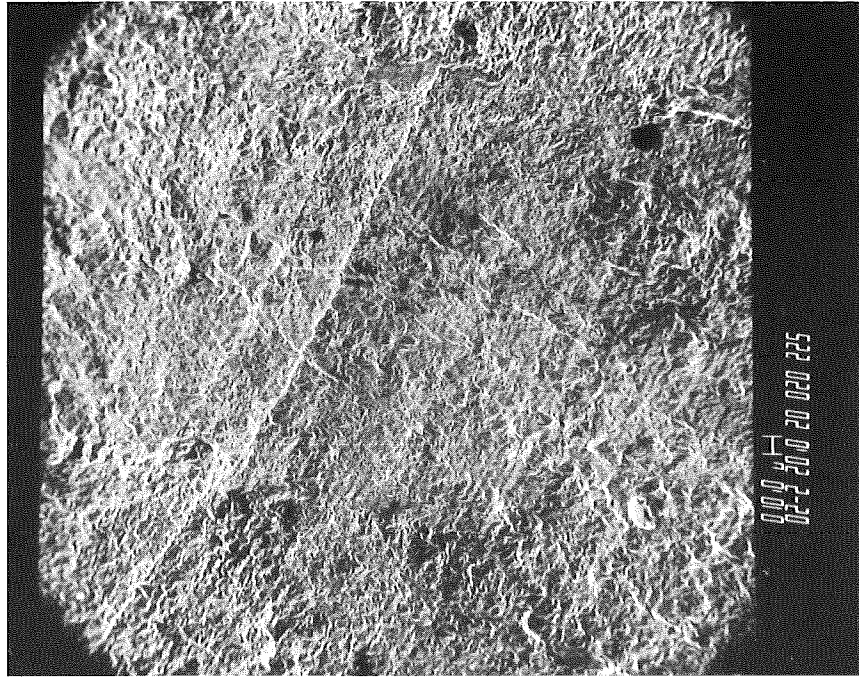
Fig. 66 SEM Fractograph of Fatigue Crack Surface Shown in Fig. 40 @ 20X Showing Beachmarks on T2A-NB Top

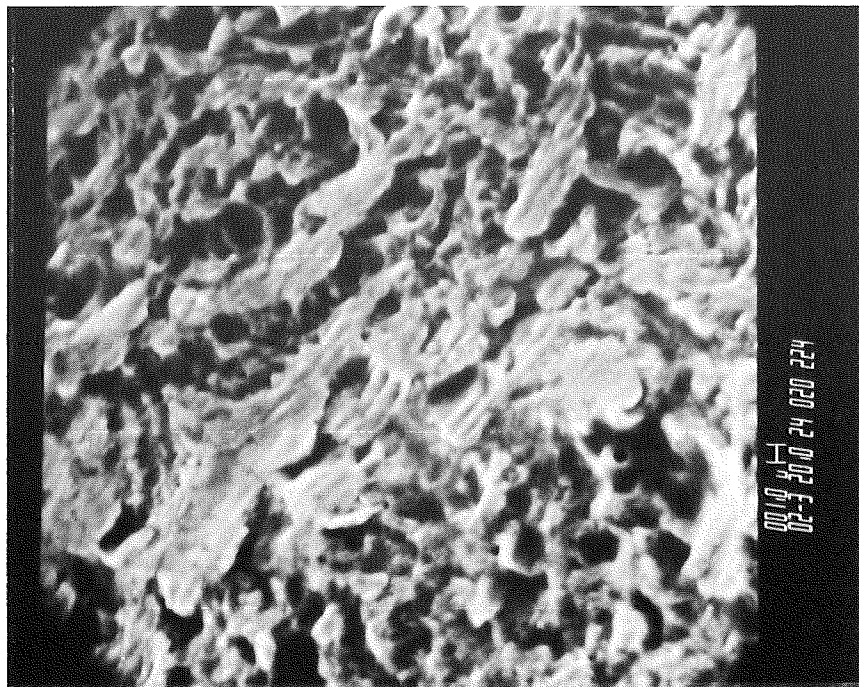
Fig. 67 SEM Fractograph at 2000X Showing Striation-like Features

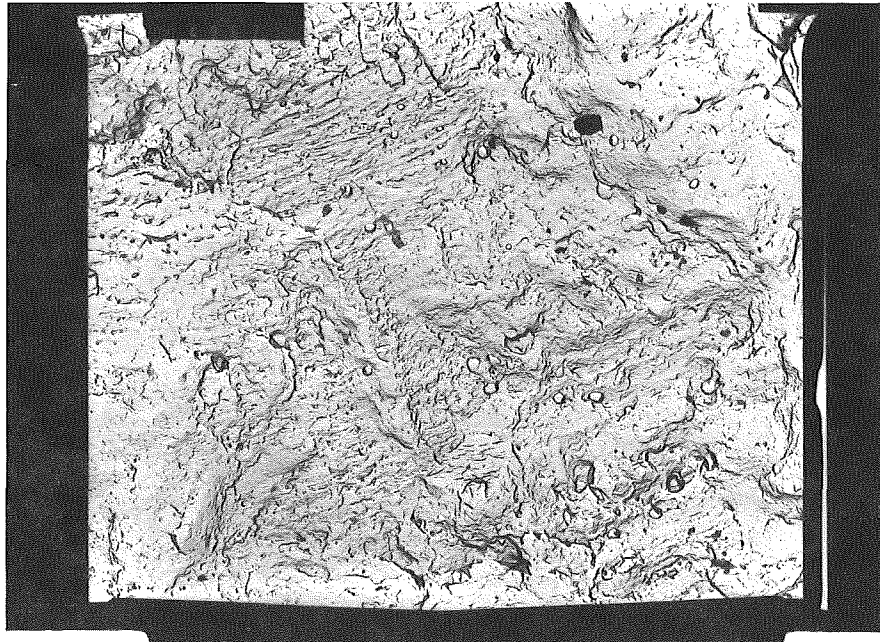
Fig. 68 TEM Fractograph at 7800X Showing Striation Features
on Crack Surface of T2A-NB Top

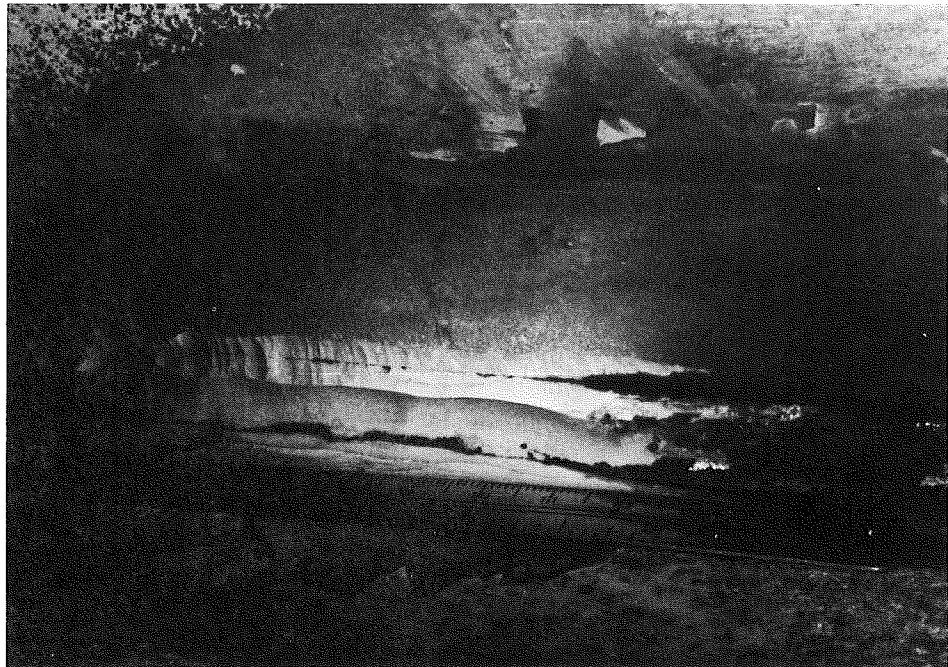
The "weld toe" along the web that remained after removal of the backing bar and the toe at the lack of fusion plane on the flange surface were ground, as illustrated in Fig. 71. This removed the weld toe from the girder web and also removed more than 1/8 in. of the weld at the flange surface. The ground areas were then treated with liquid penetrant, as illustrated in Fig. 72. This demonstrated that fatigue crack growth had developed in the girder web and that the lack of fusion plane on the flange surface had been extended, as can be seen in Figs. 72 and 73.

None of these crack extensions are significant since they lie in a plane parallel to the primary stresses in the tie girder and the structure has been retrofitted to prevent further web-gap distortion.

Fig. 73 Cracks Can Be Seen in Web Plate at "Weld Toe"
and From Plane at Flange Surface

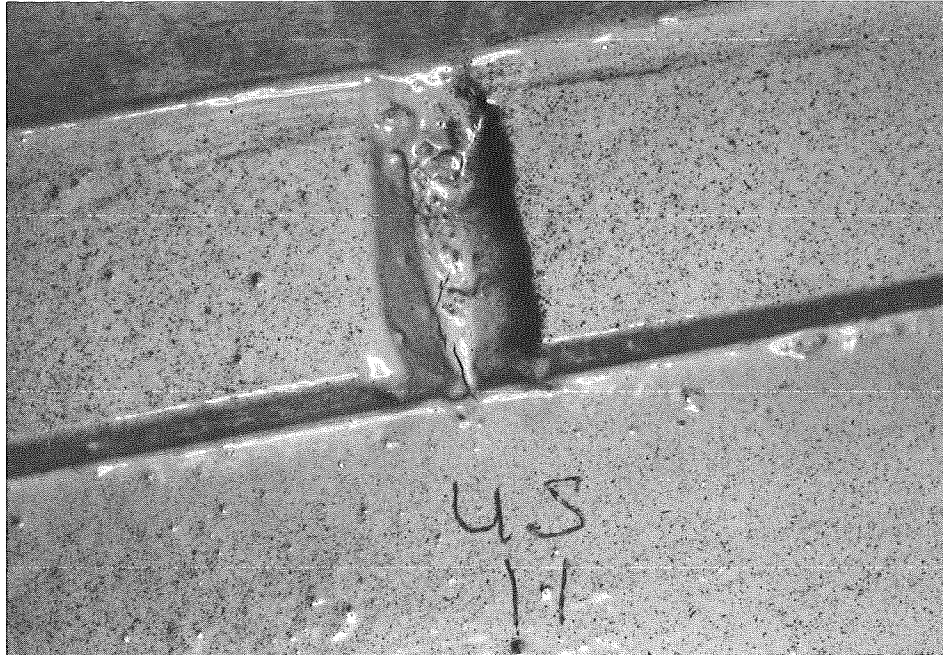
as illustrated in Fig. 74. A crack-like indication can be seen in the paint film although no significant oxide can be observed. It was recommended that these locations be ground out to remove any cracks and prevent their subsequent extension.

Fig. 74 Crack-like Indication in the Web Plate
at Termination of Backing Bar

- (4) Several backing bars in the tie girder were observed to be installed without a full fusion groove weld to provide continuity in the backing bar during the November 1, 1984 site visit. It was recommended that these locations be ground out and inspected to insure that transverse cracks did not extend into the box corner weld. This was carried out by the contractor in November 1984.

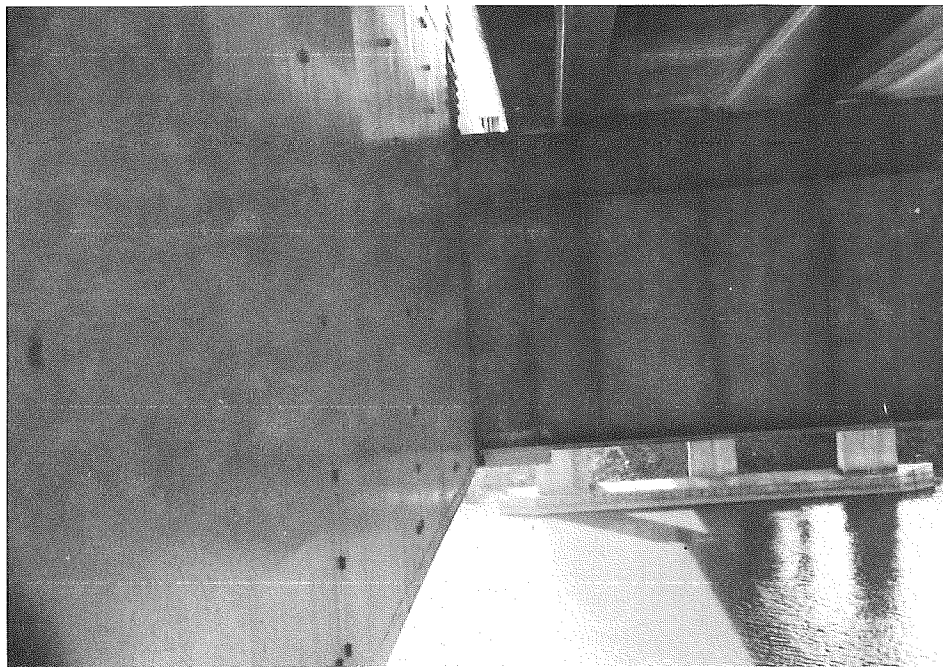
The retrofit plates recommended in May 1984⁽⁵⁾ can be seen installed between the bottom flanges of the floor beam and tie girder in Fig. 75. This condition violates the AWS Specification which requires that backing bars be continuous.

Fig. 75 Splice Plate Installed Between Bottom Flange
of Floor Beam and Tie Girder

- (3) The April 1984 strain measurements verified that a more positive connection was needed between the bottom flange of the floor beams and the bottom flange of the tie girder. It was recommended that a bolted splice plate be installed to provide
