Transmission tower test, 1936

FRITZ ENGINEERING LABORATORY
LEHIGH UNIVERSITY
BETHLEHEM, PENNSYLVANIA

TRANSMISSION TOWER TEST

by H. J. Godfrey

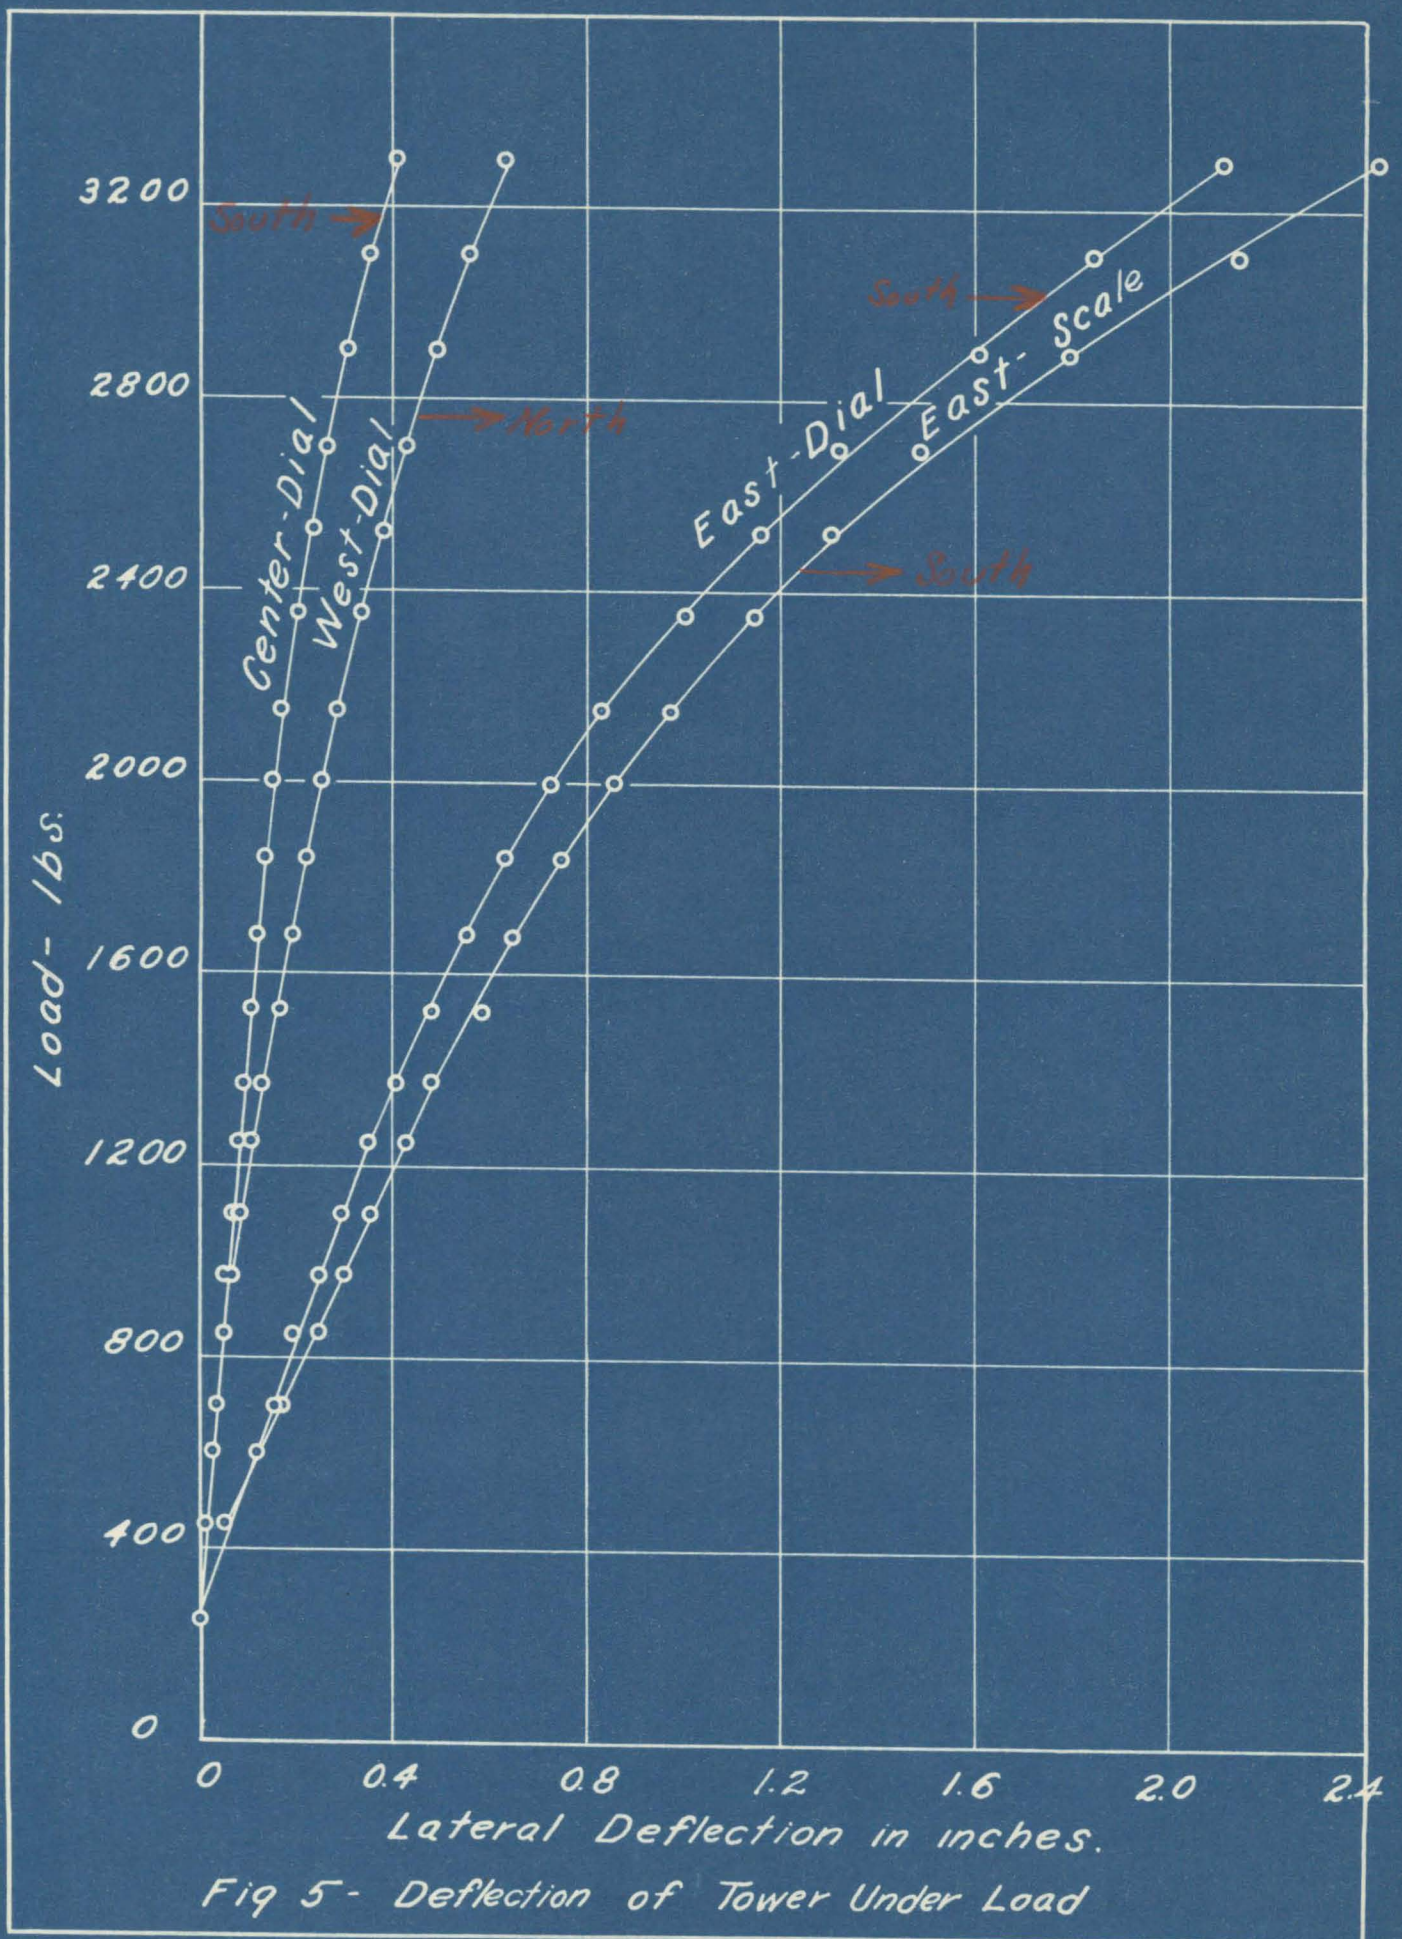
The deflections of the three points on the cross-arm of the tower are presented in Fig. 5. The East cross-arm which was the loaded one, had considerably more deflection than the West cross-arm. It should be noted that there is a small difference in the measured deflection of the East cross-arm as determined by the two methods. This may be accounted for since the scale was clamped on the end plate to which the cable was attached, whereas the dial was connected directly to the two horizontal angles of the cross-arm.

The center and West deflections indicate that the tower as a whole was still capable of carrying further load. The deflection of the East arm however, definitely shows that this section was very highly stressed and that the failure was primarily a local one.

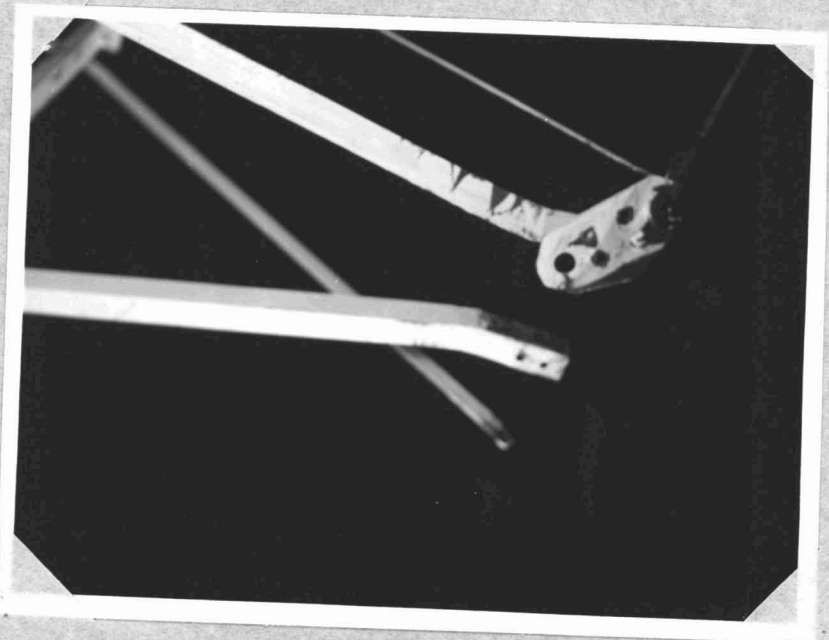
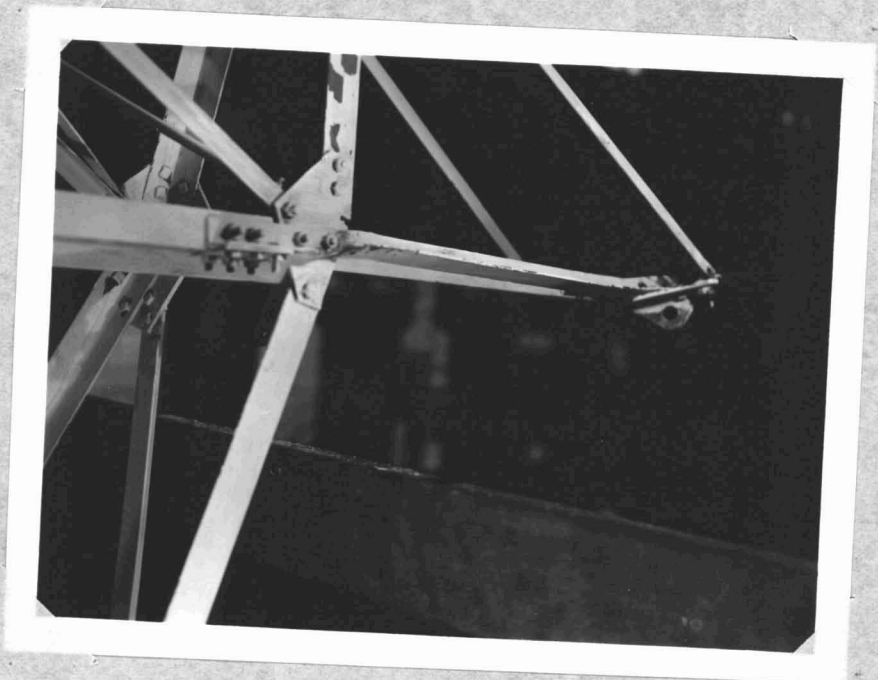
Up to a load of 2000 lb. nothing exceptional happened except for the slipping of a few members at the joints and the buckling of members which were extremely slender. Strain lines were first observed at a load of 2150 lb. These strains occurred about five inches from the end of the two horizontal members (No. 38-40 and 39-40) of the East cross-arm. At a load of 2525 lb., scaling of the whitewash was observed at the point where these same two members were connected to the main part of the tower (Joints 38 and 39). At a load of 3100 lb., one of the two bolts connecting members (38-40) and (39-40) at the end of the East cross-arm sheared off. At a load of 3500 lb. the end connection on the East cross-arm

failed entirely and the remaining bolt between members (38-40) and (39-40) fractured. Three of the four bolts in the end connection to which the cable was attached fractured and resulted in a very sudden failure. Fig. 6 and 7 show the condition of the East cross-arm at failure.

Fig. 6 & 7 - Condition of East Cross Arm
at Failure

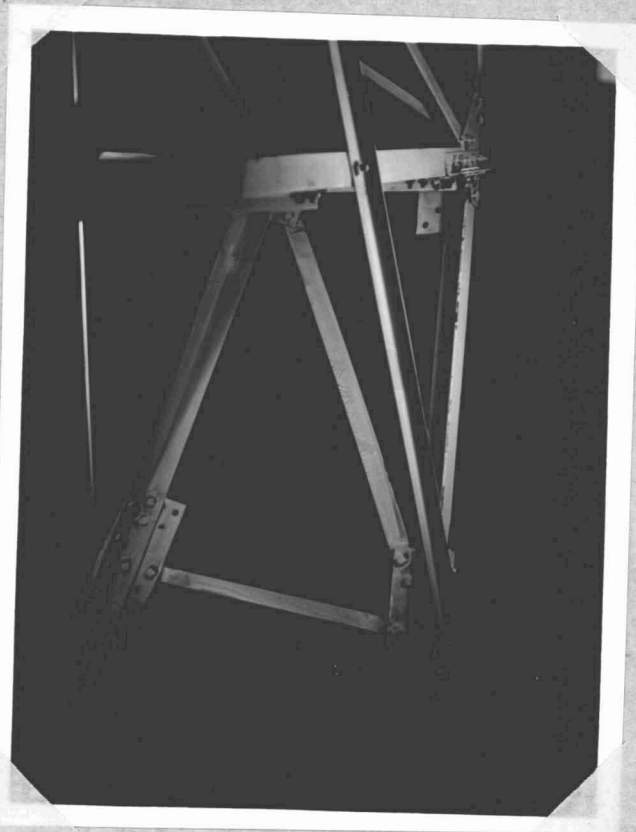
The only other place in the tower where actual strain lines could be observed was in the compression diagonal (27-39) directly below the East cross-arm. These are shown in Fig. 8.

Fig. 8 - Strain Lines in Compression
Diagonal (27-39)
