Fatigue tests of welded plate girders in shear, November 1965

Progress Report on the Fatigue Strength
of Welded Plate Girders

FATIGUE TESTS OF WELDED PLATE GIRDERS IN SHEAR

Lehigh University
Department of Civil Engineering
Fritz Engineering Laboratory Report 303.6
November, 1964

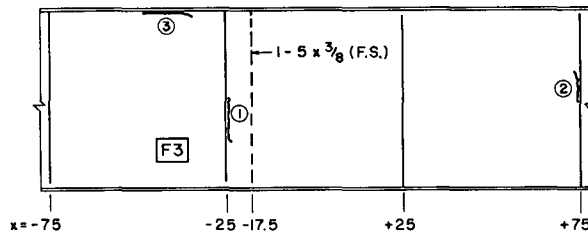
(a) Crack Location and Repair

The final appearance of Crack 1 is sketched in Fig. 6(a). Also shown are the subsequent repair ^{and} cracks. The X-coordinates of the girder are given for reference. Figure 6(b), a diagram of applied loads P versus total number of cycles of application N , may be helpful for reviewing the testing chronology.

Crack 2 was detected at 2,510,000 cycles with initial coordinates of $(74\frac{3}{4}, 2\frac{3}{8}$ to $5, \frac{3}{32})$. Like the first crack, it was on one side of the web only, developed along the toe of a stiffener fillet weld, and was in the web. Because it had no effect on the loads or the deflection of the girder, the test was continued without repair. At 2,640,000 cycles, Crack 3 was noted along the top flange of panel 1 at $(-37\frac{5}{8}$ to $-41\frac{1}{8}, 24\frac{7}{8}, -\frac{3}{32})$, horizontally. Again, the crack was located in the web along a fillet weld, on the far side. Without repairing either Crack 2 or 3, the pulsating continued up until 4,640,000 cycles. That is, the test was stopped at two million cycles after the observation of Crack 3. The final lengths of Cracks 2 and 3 are shown in Fig. 6(a). At this stage these cracks had penetrated through the web and measured about 8 inches to 13 inches, respectively, on both sides of the web. Regardless of such lengths, the loads on the girder were not affected and the girder deflection remained stable.

It is to be noted from Fig. 6(a) that all cracks had a tendency to propagate into the web, somewhat diagonally. From Fig. 6(b) it is seen that the test load was reduced to zero only once in order to repair the girder.

Repair of Crack 1 began with gouging out the cracked material with a compressed air chisel and then filling in the excavation with weld beads. It was first done on one side and then on the opposite side of the web. A 5" x 3/8" plate was welded onto the far side of the web at $X = -17\frac{1}{2}$ and completed the repair. As all other intermediate stiffeners, this reinforcing stiffener was cut short of the tension flange and was welded to the compression flange. After the repair, a static test was run up to 85 kips and the fatigue test continued at the same speed and the same range as before, as indicated in Fig. 6(b).

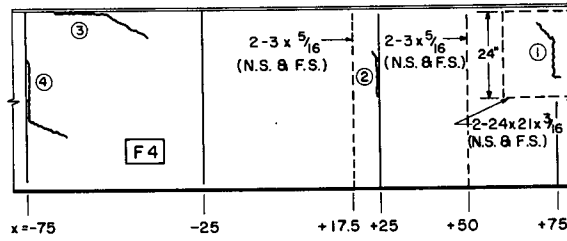
(a) Crack Location and Repair

Inspections of girder F4 were made at one hour intervals throughout the test. After 430,000 cycles of repeated load applications, Crack 1 was detected in the web of panel 3 at the toe of the stiffener fillet weld. The coordinates of the tips of the crack were $(74\frac{3}{4}, 11\frac{1}{2}$ to $15\frac{1}{4}, 3/32)$, on the near side only. At 700,000 cycles, when it became apparent that there was a tendency for the load to drop and the girder deflection to increase, the loading was stopped. The length of Crack 1 was about 12 inches on both sides of the web, as measured after stopping. Also, it was discovered that there existed another crack, Crack 2, at $(24\frac{3}{4}, 6$ to $10, 3/32)$, in the web of panel 2 along the toe of the stiffener fillet weld and only on one side of the web. Repair of Crack 1 was made by welding a 3" x 5/16" plate on each side of the web at $X = 65$ without welding the crack itself. No repair was made of Crack 2 at this time (Fig. 7).

When the pulsating load was again applied, it soon was noticed that Crack 1 continued to propagate. Since the load and the deflection were stable, testing was continued without repair. At 1,130,000 cycles, Crack 3 was observed along the top flange of panel 1, at $(-59\frac{1}{4}$ to $-62\frac{1}{4}, 24\frac{7}{8}, 3/32)$.

As pulsating continued, Crack 4 occurred at $(-74\frac{3}{4}, -3$ to $-4\frac{5}{8}, -3/32)$, along the stiffener in panel 1 at 2,340,000 cycles. It again was situated in the web at the toe of the fillet weld. At 2,460,000 cycles, Crack 5 was noticed in the 3/16" web at the toe of the fillet weld of the reinforcing doubler plate, near the isolated Crack 1. This crack grew horizontally along the flange and vertically along the side of the doubler plate. The girder deflection showed a tendency to increase at 2,600,000 cycles and at about 2,900,000 cycles the load began to decrease slightly. The test was terminated at 3,100,000 cycles when the maximum load dropped to 80 kips and the end deflection had increased by about 0.06 inches (about one-quarter of the total elastic end deflection). At this time Cracks 3, 4, and 5 had final lengths of about 29, 30, and 30 inches, respectively.

Figures 7(a) and 7(b) summarize the testing and repair of girder F4. Final lengths of the cracks, except that of Crack 5, are sketched in Fig. 7(a) together with the repairs made. In Fig. 8(a), the final appearance of Crack 3 is again sketched. The growth of this crack can be traced by using Fig. 8(b), a diagram of total crack length (l) versus the number of cycles of load application after the first observations of the crack (n). (N denotes total cycles of load application on a girder). It is seen from Fig. 8(a) and (b) that, when first observed on the near side of the web, the crack had a length of about 3 inches along a flange. It propagated through the web to the far side at $n = 330,000$ cycles. Then, changing direction, it turned into the web at about 45 degrees from the horizontal. Further growing and changing direction to about 30 and 20 degrees occurred at $n = 1,470,000$ cycles and 1,800,000 cycles, respectively. As the test drew to a close, the rate of increase of crack length accelerated sharply. At the completion of the test, the crack length on both sides of the web was approximately 29 inches.

It was at the toe of the fillet weld, in the web. In the meantime, Crack 1 had grown across the stiffener towards the end section. To avoid damage to the web butt weld nearby, two minor reinforcing plates were put on at 1,520,000 cycles and 1,560,000 cycles (Repairs a and b) without welding Crack 1 itself. At 1,600,000 cycles, when the length of Crack 1 grew to 23 inches, a major repair (Repair c) was made by removing all previous repair plates from the web, gouging and welding the crack, and placing 24" x 21" x 3/16" web doubler plates over the crack.

With Crack 1 finally isolated, the test was continued. Crack 2 had been increasing in length ever since 700,000 cycles and, at 1,840,000 cycles, a repair of it was made when its overall length was about 13 inches. This repair (Repair 2) was done by grinding out the crack and welding it, first on one side then on the other side of the web. A pair of stiffeners, 3" x 5/16" plates, was added and welded to the web and the compression flange at $X = 17\frac{1}{2}$, as shown in Fig. 7(a).

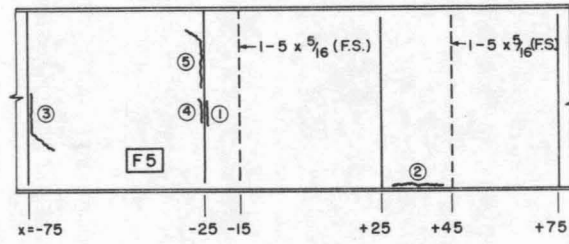
(a) Crack Location and Repair

When the repairs were completed, the cyclic loading of 36 to 110 kips was resumed. Crack 3 was first detected at 3,650,000 cycles with initial coordinates of $(-74\frac{3}{4}, -8$ to $-9\frac{3}{4}, -3/32)$. Crack 4 was noted at 3,810,000 cycles at $(-25\frac{1}{2}, -1\frac{5}{8}$ to $-3\frac{1}{2}, 3/32)$ and Crack 5 appeared at 3,870,000 cycles with coordinates of $(-25\frac{1}{2}, 12$ to $14\frac{3}{4}, -3/32)$. All three cracks were in the web of panel 1 at the toes of the fillet welds along the transverse stiffeners. Without repairing any of these cracks, pulsating was continued. At about 3,900,000 cycles the girder deflection began to increase slowly. At 4,110,000 cycles the test was terminated when the load began decreasing

and the deflection rapidly increasing. At the test's completion, Cracks 3, 4, and 5 had final lengths of about 20, 5, and 18 inches, respectively.

This testing condition was continued for 192 hours, or 3,000,000 cycles, then the test was stopped for a thorough inspection for hair cracks. When no cracks were discovered, it was decided to increase the maximum load magnitude to the capacity of the loading system to force a failure. This was 110 kips and approximately equal to the predicted static strength of the girder. Thus, a second static test was made with loads of 4, 90, and 110 kips. An inspection at 110 kips still failed to reveal any cracks. A new cyclic load range of from 36 to 110 kips was then applied. Inspections were now made at two hour intervals. At 3,400,000 cycles (N), Cracks 1 and 2 were observed simultaneously, with initial coordinates of $(-24\frac{3}{4}, -2\frac{1}{8}$ to $-5\frac{3}{8}, 3/32)$ and $(34\frac{1}{2}$ to $39\frac{1}{2}, -24\frac{7}{8}, -3/32)$, respectively. Crack 1 was located in the web of panel 2 at the toe of a stiffener fillet weld; Crack 2 was along the bottom (compression) flange fillet weld of panel 3, in the web. (See Fig. 9.) These cracks grew to about 6 and 13 inches long when the test was stopped at 3,500,000 cycles for their repair. Repairs 1 and 2 consisted of gouging out and welding the cracks and placing one-sided stiffeners of 5" x 5/16" plates at X = -15 and X = 45, as indicated in Figs. 9(a) and (b).

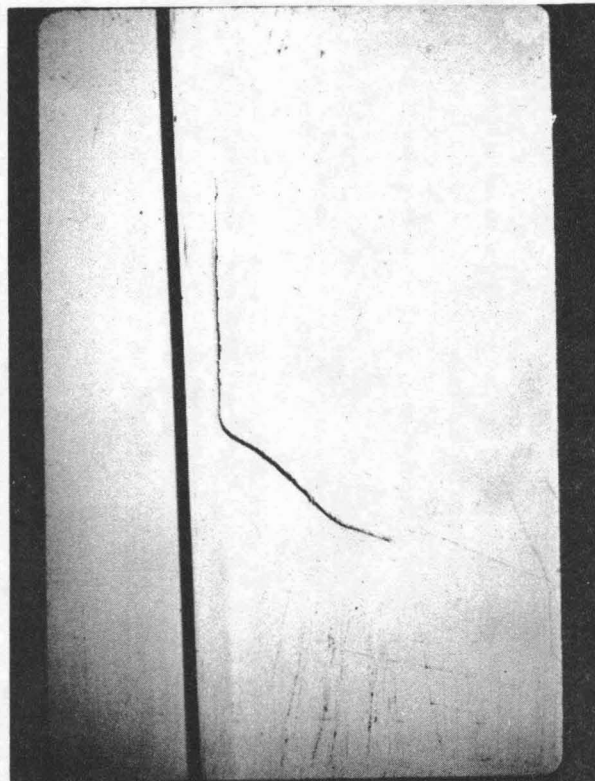
Fig. 10 Final Appearance, Crack 3, Girder F5

load equal to its estimated ultimate load, girder F5 was unaffected by Cracks 1 and 2 while they grew to their final length. When Cracks 3, 4, and 5 had attained lengths of about 17, 5, and 16 inches, respectively, F5 could no longer maintain its load.

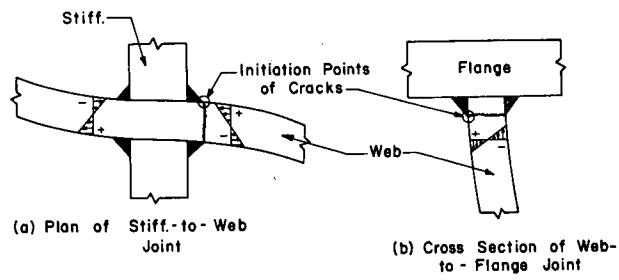
Fig. 24 Location and Appearance of Cracks When First Observed

All major cracks initiated in the web of the test section along panel boundaries. Specifically, each crack when first observed was located in the web at the toe of a fillet weld (the heat-affected zone) joining the web and its bounding flanges or intermediate stiffeners. Typical initiation points are sketched in Figs. 24a and 24b for cracks along the stiffeners and flanges, respectively. As is also shown here, every major crack initiated on the surface of the web which was subjected to the tensile stresses generated by lateral web deflections.

Figure 24c illustrates that most cracks first appeared as continuous lines parallel to a boundary. In Fig. 24d it is seen that Crack 2 of girder F4 consisted of several, small, disconnected cracks, each of whose lengths was partially parallel to the stiffener and partially inclined at some angle from the stiffener. These cracks consolidated as fatigue testing continued, propagating vertically. Later, when the crack branched into the web, it followed the path of an original small branch. This behavior of Crack 2 of girder F4 is typical of the cracks observed in the earlier tests on girders F1 and F2⁽⁶⁾. The final appearance of the cracks are sketched in Fig. 25 together with the idealized tension fields. From these sketches it may be observed that the branches of the cracks propagated into the web in a direction roughly perpendicular to the assumed tension fields.

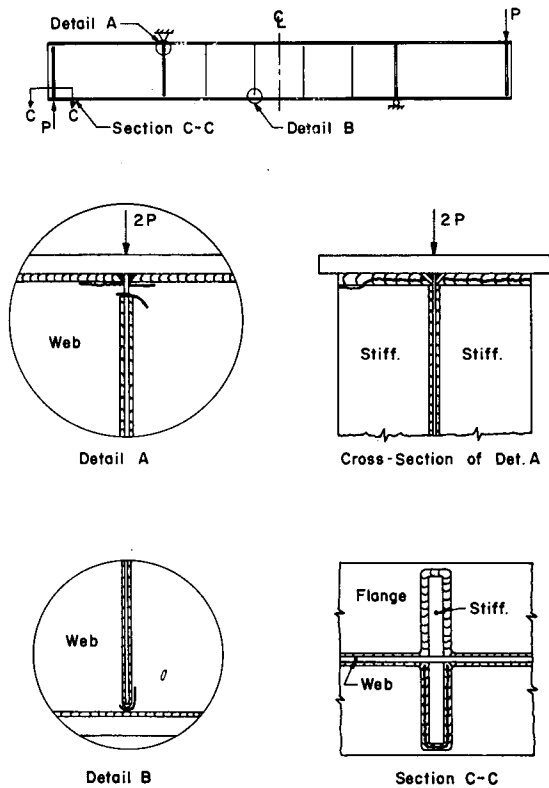
Fig. 27 "Minor" Cracks of Girder F4

Several cracks were observed in girders F4 and F5 in addition to the major cracks described above. These cracks primarily occurred at the bearing stiffeners and reaction stiffeners adjacent to the loading jacks or reaction plates, in areas of high direct compression. The final, typical shapes of several of these cracks are shown in ~~Figure 27~~ Fig. 27 for girder F4. Detail A reveals that two cracks occurred in the web. One was located at the toe of the web-to-flange weld while the other initiated at the end of the bearing stiffener where it was clipped to provide clearance for the web-to-flange weld. The cross-sectional view of Detail A also shows that the weld joining the bearing stiffener to the compression flange was cracked through its throat and, in fact, this connection was completely severed before the end of the test. Detail B gives the final shape of a crack observed at the end

of an intermediate stiffener. This was the only one of its kind in the three girders tested. Finally, a typical crack at the loading stiffener is shown in Section C-C. The crack began in the throat of the weld on one side of the stiffener and propagated completely around the stiffener on the near side. It may be observed that these cracks were not repaired at any time during testing and had no effect on a girder's overall performance.
