Low-Cycle Fatigue

CRACKED BEAM TEST

May, 1969

Fritz Engineering Laboratory Report No. 358.4

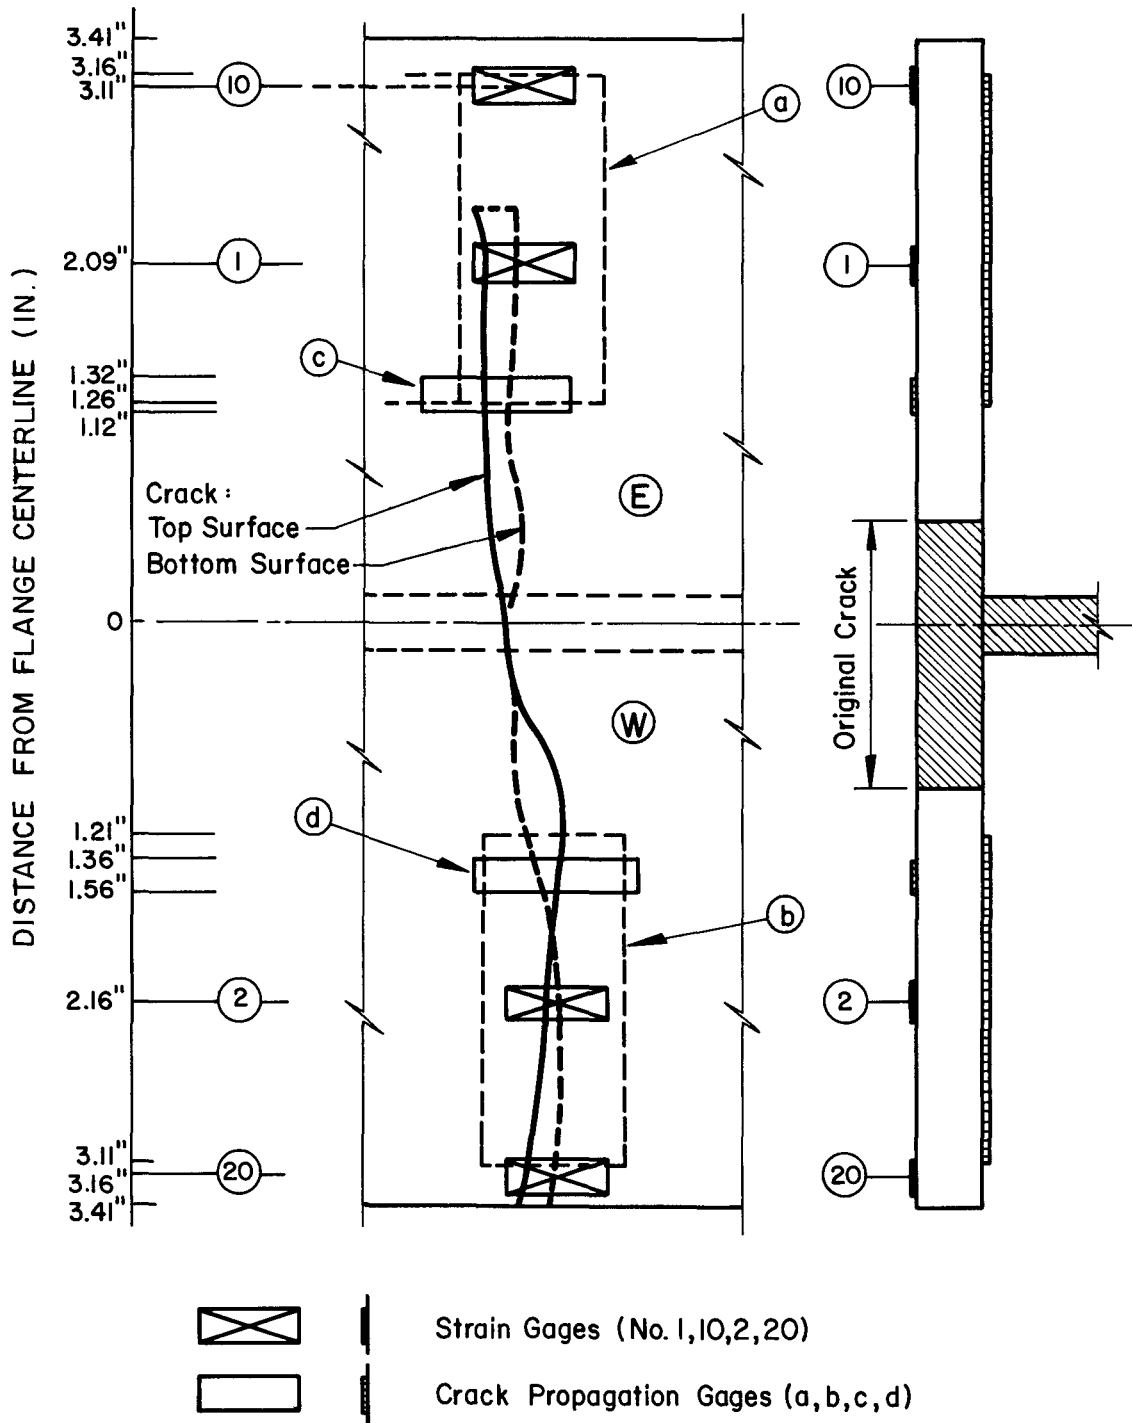
Fig. 2 Shape of the Crack and the Position of Strain Gages in the Flange.

The cracked welded beam marked PWC152-A514 which had been used already in a high-cycle fatigue investigation⁽¹⁾ was tested after its length had been altered to suit the testing machine and after some small cracks in the web and the flange away from the investigated section had been repaired. The cross-section and the position of the cracks are shown in Fig. 1. The original crack was obtained in the tension flange after 397,000 cycles of high-cycle fatigue testing, where the stress range in flanges was 42 ksi and the maximum nominal stress + 32 ksi. The original crack shape is presented in Figs. 1 and 2.

After comparison of visual records with records from crack propagation gages, the shape of crack (Fig. 2) and the relationship between the number of cycles and crack length (Fig. 6) was obtained. For the flange half marked W, Fig. 6 shows the information available about the crack propagation on both the top and bottom surfaces separately and also an average value curve. In the range from zero to 37000 cycles the crack propagation rate was almost constant, then it increased gradually to a very high value before failure.

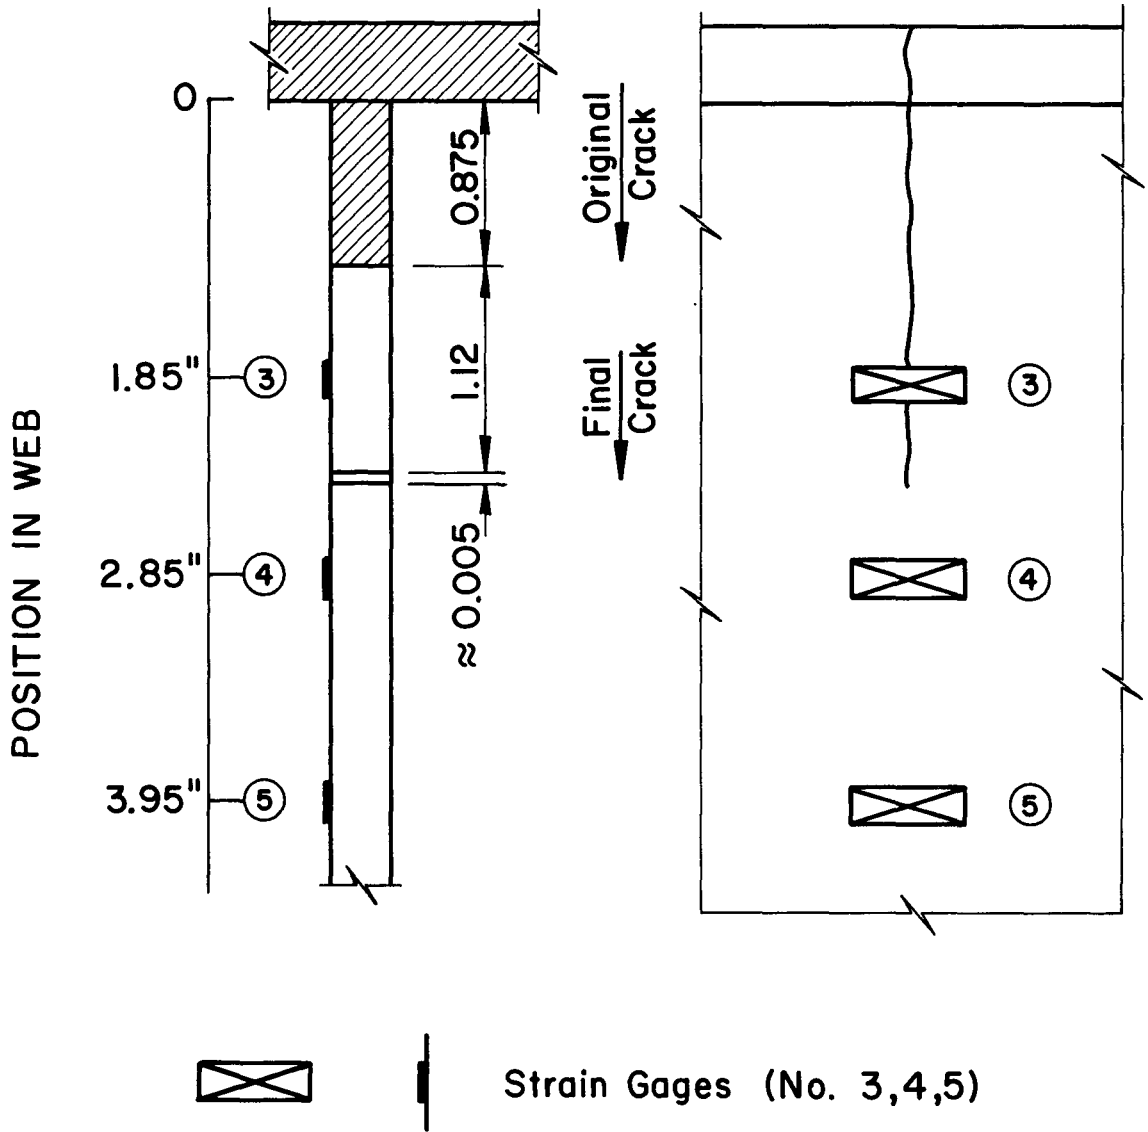
Fig. 3 Crack in the Web and Position of the Strain Gages.

The recording of crack propagation in the web was not satisfactory. Therefore only a little information is available. It includes the initial crack length, the final crack length and the number of cycles when the crack tip reached strain gage No. 3. The assumed crack propagation is shown in Fig. 10. The final crack

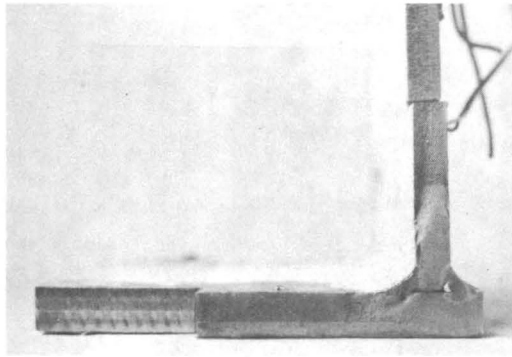
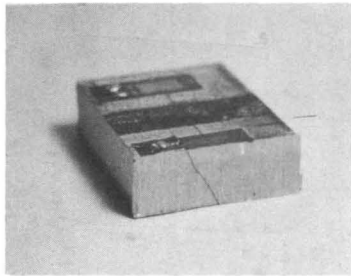
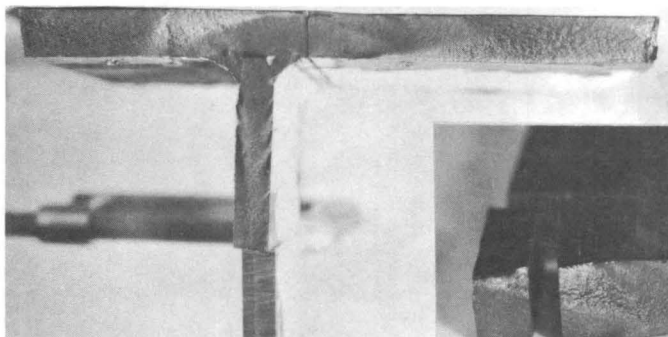
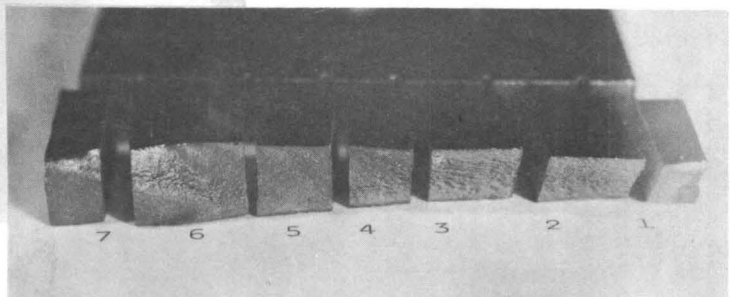
Fig. 5 Metallurgical Specimens

The fracture surfaces were examined macroscopically to characterize the nature (rough, delaminated, smooth) and orientation of the fracture to the test beam (see Fig. 5). After sectioning and polishing, see Fig. 4, the specimens were examined as-polished and after a Nital etch.

The surface of the high cycle fatigue crack was macroscopically fine textured and was normal to the flange and web (Fig. 5).

At the extremity of the flange the low-cycle fatigue crack assumes a macroscopically rough surface and is oriented at an angle of approximately 50° to the flange surface.

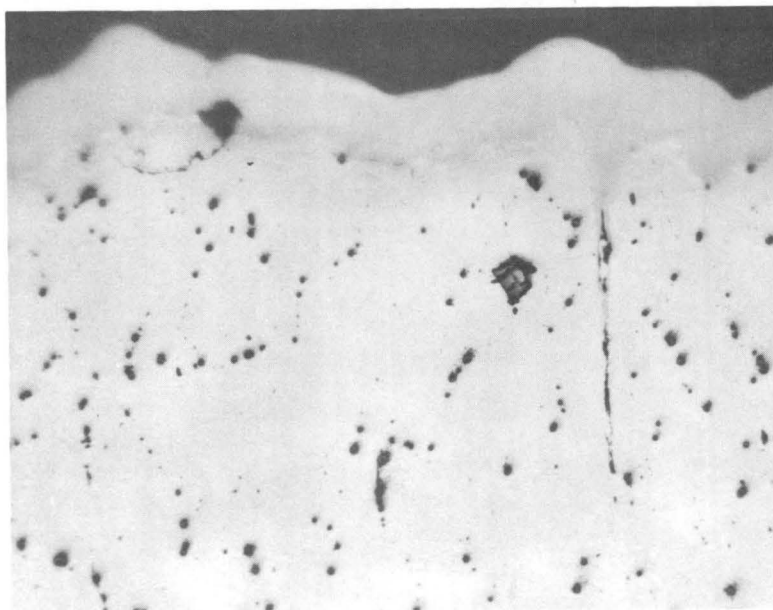
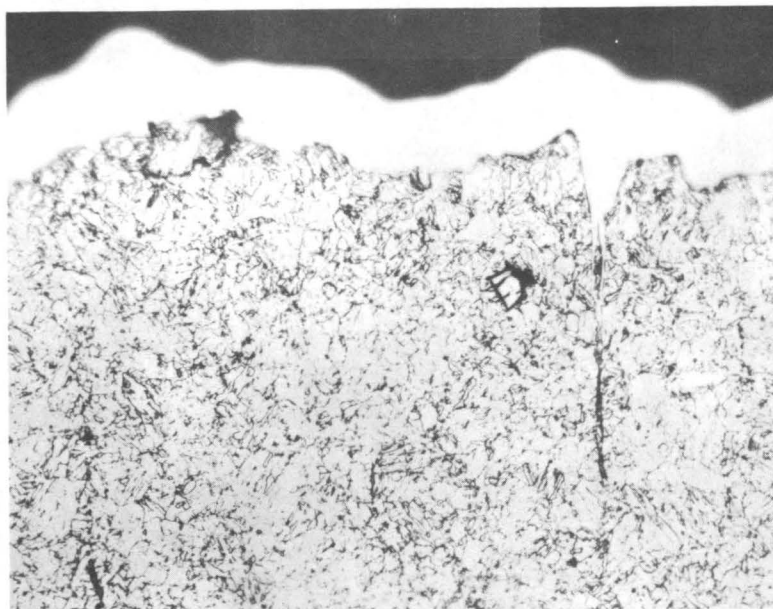
Fig. 11 Specimen 7. Above-Unetched, Below-Nital Etch (250x).

Figure 11 is a section normal to the flange crack in a region of the crack formed in high-cycle testing. Figure 12 is a section normal to the flange crack near the outside of the flange (low-cycle test range).

Microscopic examination of the high cycle fatigue crack on Specimen 7 (Fig. 11) reveals that the crack grows normal to the flange surface independently of any gross microstructural features. There is only a slight tendency to delaminate along rolled-out inclusions or to have a branched fracture path. The etched section shows that the fracture path follows the microstructure boundaries but the overall fracture path seems independent of the microstructural morphology and responsive only to the loading conditions.

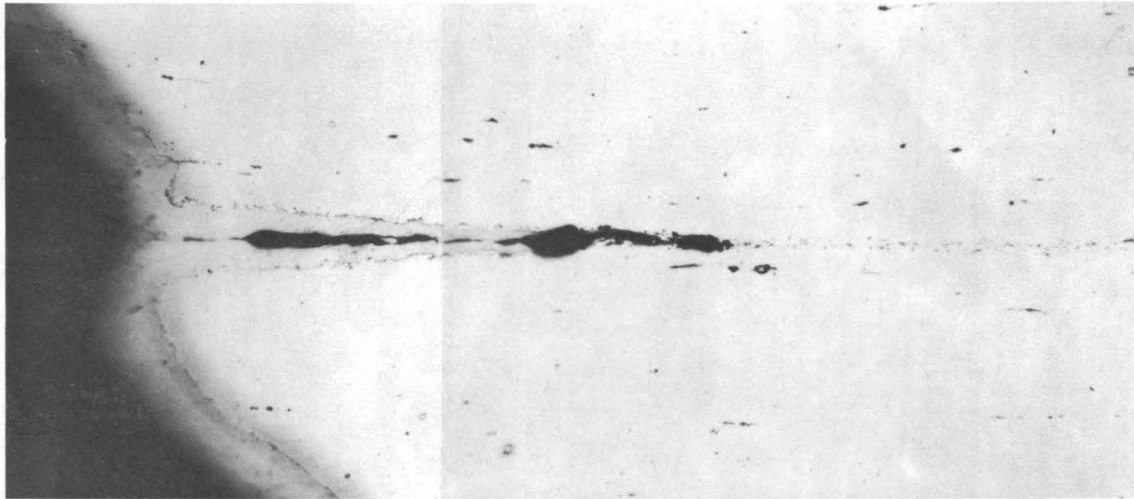
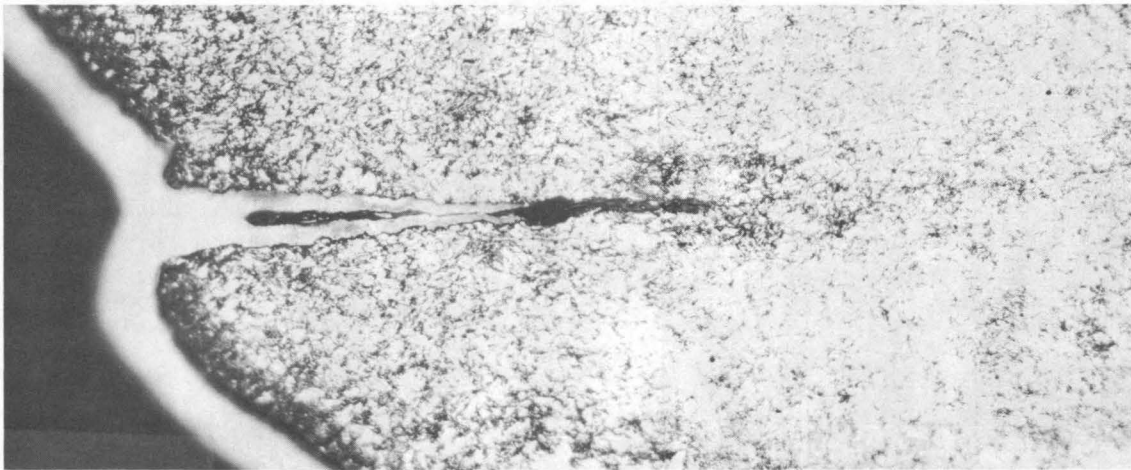
Fig. 12 Specimen 2. Above-Unetched, Below-Nital Etch (250x).

This oblique fracture surface when examined microscopically shows a strong tendency to delaminate along planes of rolled-out inclusions (Fig. 12). The overall direction of the fracture is independent of the microstructural features since the delaminations only influence the fracture surface in the local region of the defects. Otherwise the fracture direction is independent of microstructure and seems responsive primarily to the loading and stress conditions.

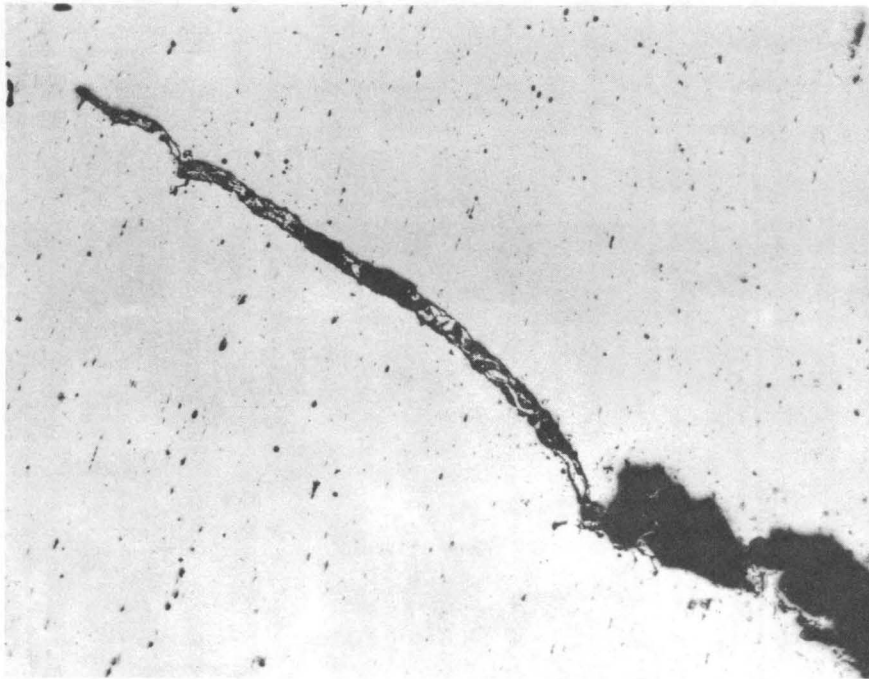
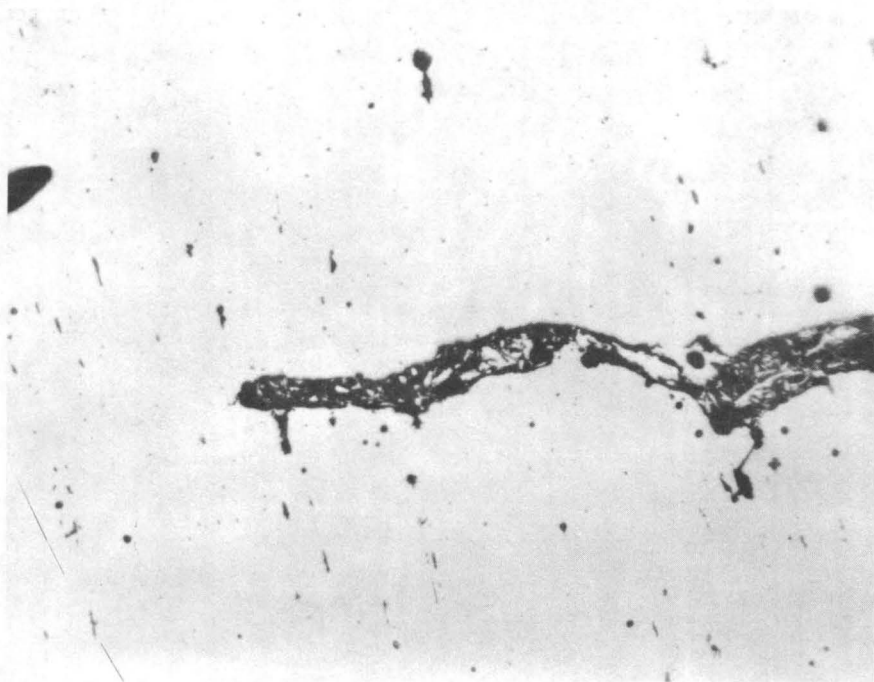
Fig. 13 End of Crack Polished in Plane of Web.

The ends of the flange and web cracks were polished parallel to their planes as shown in Fig. 4. The web crack was approximately 20° to the web surface. The flange crack was approximately 60° to the flange surface. Polished sections (Figs. 13 and 14) reveal that the nature of the cracks are quite different.

The web crack is wide and blunt with a discontinuous step to a finer size near the tip (Fig. 13). This latter portion of the crack may have been caused by the impact loading when the

flange crack broke through one end of the flange and rapidly transferred load to the web.

The etched web crack specimen showed no strong relationship between crack direction and microstructure. There is little tendency for the crack to branch.

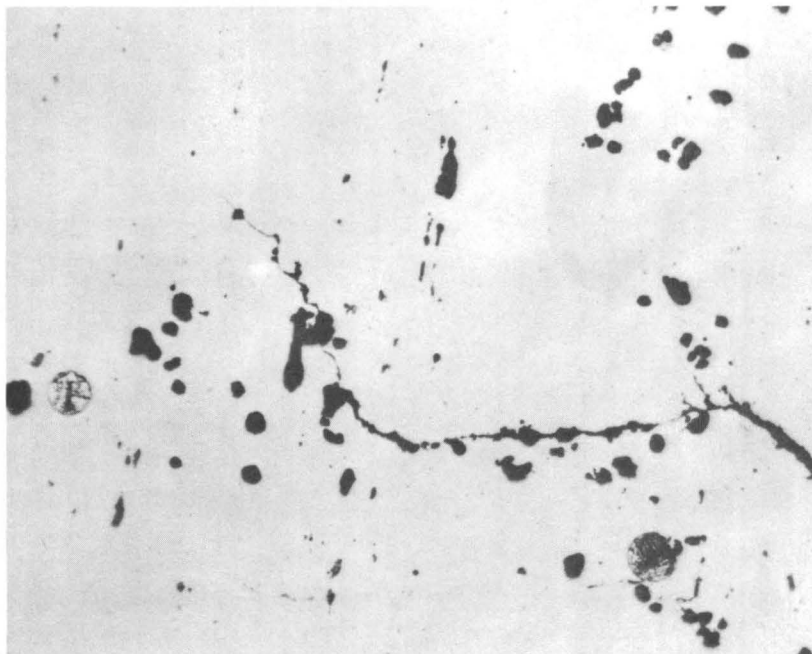
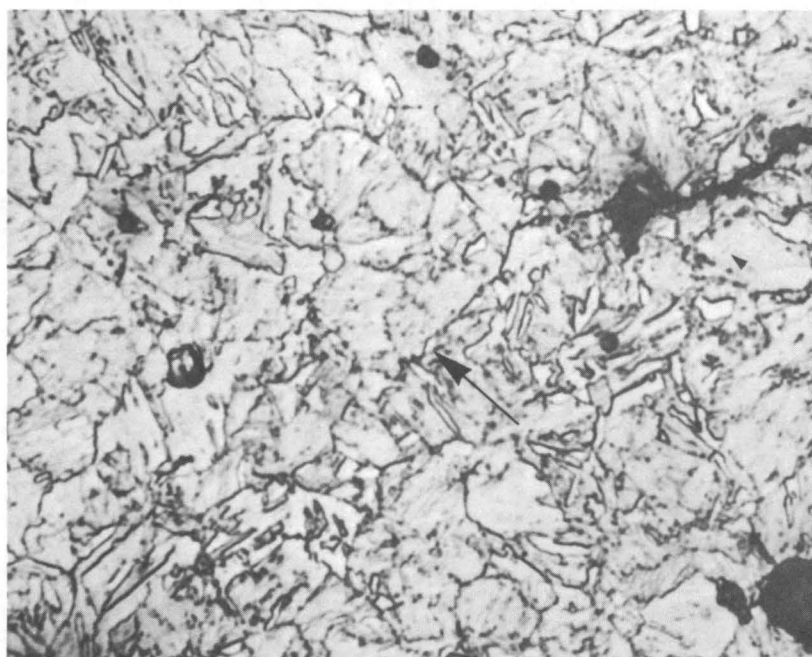
Fig. 14 End of Flange Crack. Polished Parallel
to Outside Surface of Flange.

The polished flange crack end shows (Fig. 14) that the fracture is very fine and generally follows a path through inclusions and carbides which were formed during tempering. There is multiple branching of the crack tip along its path. On a very fine scale (Fig. 14-arrow) the crack follows a path along microstructure boundaries between carbides and inclusions. The lower figure is of such a magnification that its field can not be seen in the upper one.

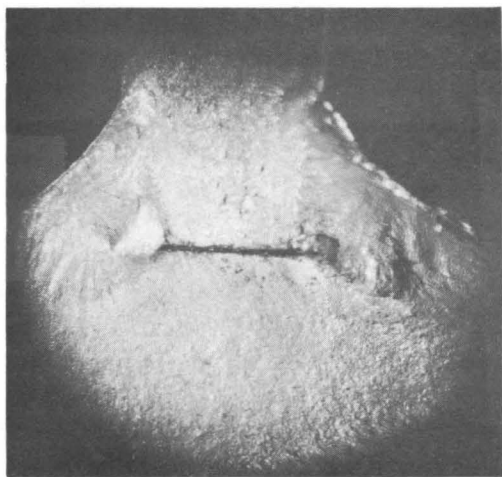
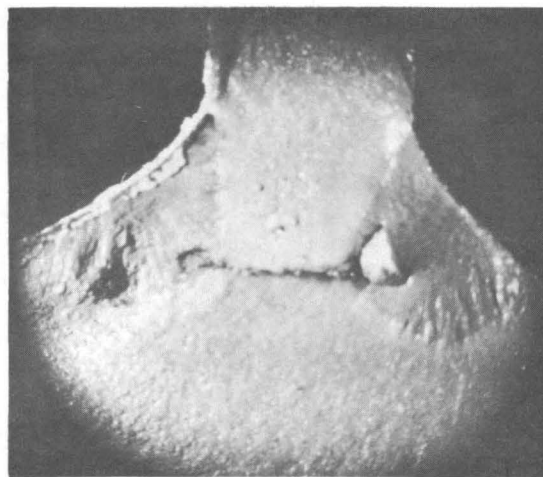
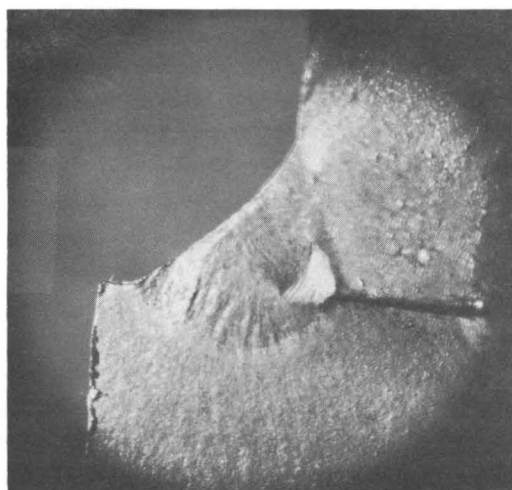
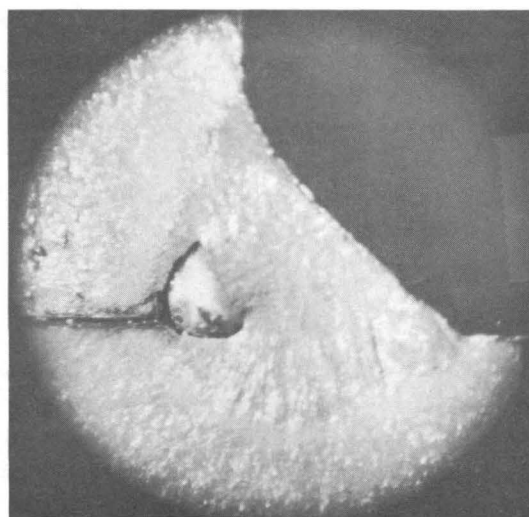
Fig. 15 Macrophotographs of Web-to-Flange Fillet Welds
in Fracture Surface.

The high-cycle fatigue testing and crack initiation studies on the beam are discussed in Ref. 1. In beam PWC 152 the crack initiated at a tack weld end as shown in Fig. 15 and was growing very slowly through the flange-to-web welds, the central part of the flange, and the top of the web. The crack was observed after only 386,300 cycles.

Examination of the fracture surface at the fillet welds showed that the fatigue crack started at the end of one of these tack welds. The tack weld had not fused to the web and flange, and produced a defect known as cold lap. (The fillet weld subsequently deposited did not melt through the tack weld.) It was this defect which served to initiate the high cycle fatigue crack. (See Fig. 15.)
