FAILURE TESTS OF RECTANGULAR MODEL BOX GIRDERS

April 1972

FAILURE TESTS OF RECTANGULAR MODEL BOX GIRDERS^a

By Joseph A. Corrado¹, A.M., ASCE and Ben T. Yen², M. ASCE

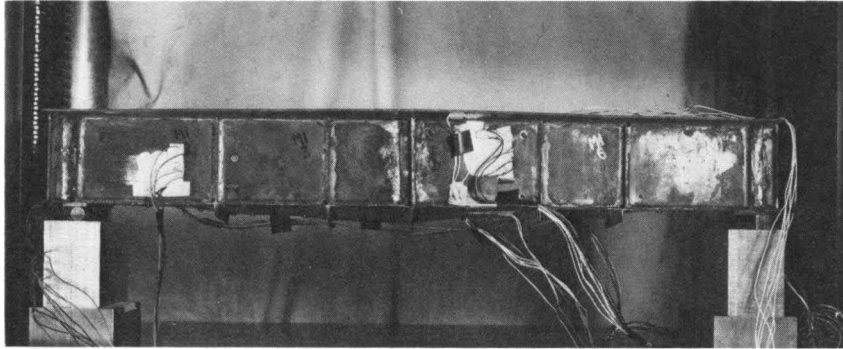
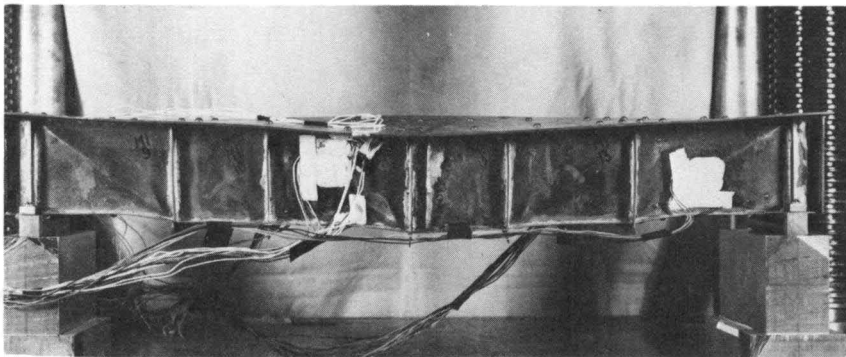
Fig. 5 Overall Deformations - Specimen M1

Final testing proceeded without incident up to 1200 pounds. Full sets of deflection and strain measurements were recorded for each 200 pound increment. At 1400 pounds the first definite signs of tension diagonal web bulging appeared in panel 6S. Loading continued and at 1500 pounds tension field action was very prominent in web panels 1S and 6S which had aspect ratios of 1.67 and 1.5, respectively. No visual evidence of tension field action could be detected in the corresponding web panels on the north side. It is significant to point out again that the load for this test was directly above the web on the south side. Upon further loading to 1600 pounds, a sharp cracking noise was heard and a portion of the top flange near the centerline of the specimen started to distort downwards on the south side. Large distortions of the cross section were beginning to take place. Later inspection indicated that failure of the midspan X-bracing was the cause of the cracking noise. The load was not steady at this point yet additional load could be supported. Pulling up of the bottom flange and pulling down of the top flange at the tension diagonal corners of web panels 1S and 6S started to occur at 1650 pounds. At 1750 pounds web bulging had occurred along the tension diagonals of 2S and 4S in addition to failure of the X-bracing at the east end. A maximum load of 1800 pounds was attained before excessive deflections and cross-sectional deformation prohibited further loading. Even at the maximum load no signs of web bulging could be detected on the north side. Figure 5 clearly shows the permanent deformations. Bulging of the web along the tension diagonals is obvious on the south side but not on the north side.

The load-deflection and load-rotation curves of Figs. 17 and 18, respectively indicate that little flexural or torsional stiffness remained once web panels 1S and 6S had yielded. This is also quite different than the behavior of M2 which possessed appreciable torsional and flexural stiffness after web panel 2N had yielded. Of course, the lack of torsional stiffness in M1 could be expected because web panel failures occurred almost simultaneously (1S and 6S) in each shear span. (For M2, web failure occurred in only one of the shear spans.) On the contrary, the absence of significant flexural stiffness was not anticipated and must be

attributed to the poor redistribution characteristics of the member. Failure of the midspan X-bracing at approximately 1500 pounds and the resulting cross-sectional deformation certainly had a major adverse effect on the ability to transfer the load from the south web to the north web. Subsequent failure of the X-bracing at the east end compounded the effect.

Thus, specimen M1 failed prematurely due to combined web panel yielding and excessive distortion of the cross section. It is clear that adequate diaphragms or X-bracing must be provided if the member is to provide full redistribution of the flexural shear and torsion and thus develop its true load-carrying capacity.

Repairs this time included straightening of the buckled web on the north side and the attachment of a heavy angle stiffener to each web at the load

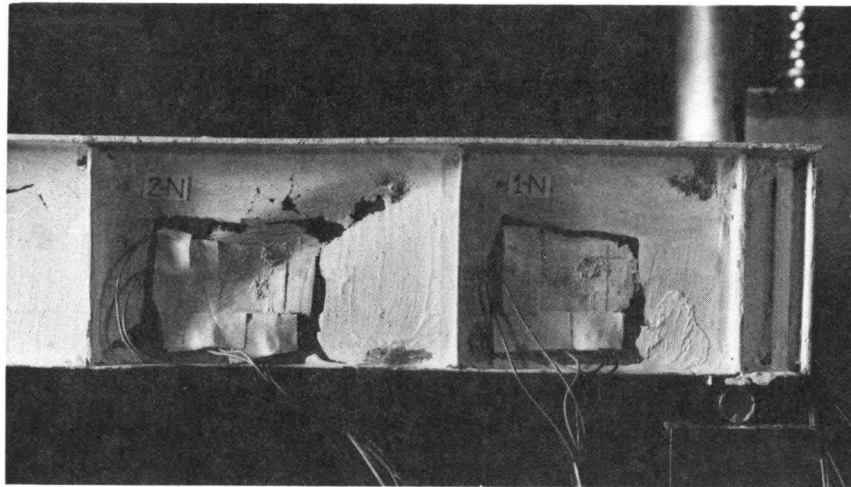
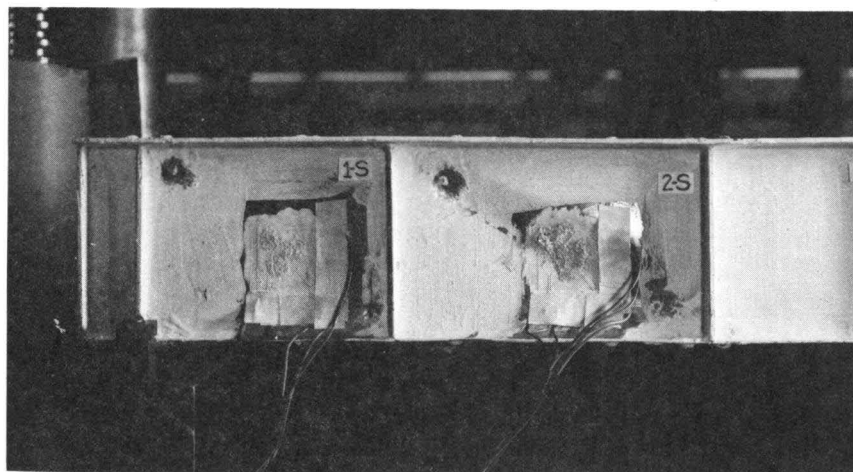
Fig. 6 Web Panel Deformations - Specimen M2
(Unsymmetrical Loading)

SPECIMEN M2 (Unsymmetrical Loading) - Symmetrical load applications were made to check the specimen and test setup. Following these, testing under the loading condition indicated in Fig. 4(a) was initiated. The load had an eccentricity of 1-inch to the north side of the cross section. Load was applied in 200 pound increments up to 800 pounds and thereafter in 100 pound increments. Dial gage readings and strain measurements were recorded for each load increment. The first significant observations involved bulging of the web along the tension diagonal of web panels 1N and 2N at about 1200 pounds. Further loading produced additional bulging and at 1700 pounds flaking of the whitewash along the tension diagonal of web panel 2N had occurred. Similar but less severe web deformations were observed in web panels 1S and 2S. None of the other web panels exhibited any signs of such deformations at this load level. After a short pause in testing during which time the load had been decreased to 400 pounds, loading was resumed using 100 pound increments. A load of 1800 pounds produced pulling up of the bottom flange at the lower tension field corner of web panel 2N. Web bulging also had begun in web panel 5N. Visual inspection revealed the absence of any noticeable cross-sectional deformations. Loading continued and caused additional bulging in web panel 2N while no further increases in web deformations of 1N could be detected. At 1900 pounds, web panel 2S exhibited considerable bulging along the tension diagonal. Shortly thereafter, the maximum load of 1930 pounds was attained. Unloading followed and the resulting permanent web deformations are shown in Fig. 6.

A recapitulation of the pertinent events leading up to the ultimate load will help to define clearly the mode of failure for specimen M2. Initial signs of failure showed up as tension diagonal yielding in the most critical web panel (2N), which has the most severe combination of stresses and geometry. Additional loading produced redistribution of the flexural shear to the other side of the cross section, that is, to web panel 2S. This obviously was accompanied by a redistribution of the normal bending stresses. The decreased torsional stiffness of the shear span containing panel 2N forced a redistribution of the twisting moment to the undamaged right shear span. The maximum load was reached when no additional flexural shear could be supported in panel 2. This took place after panel 2S had exhibited yielding along its tension diagonal and the flanges had been partially deformed due to frame action. Figure 6 portrays the failure mode configuration.

7. A box girder panel failed when both its webs developed tension diagonal yielding and followed by deformation of the flanges (panel 2, M2).

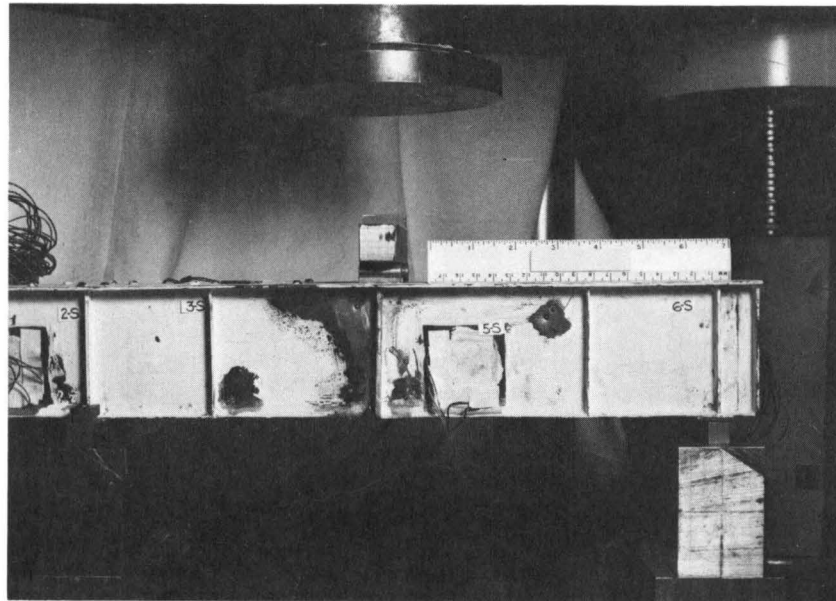
Fig. 7 Test Setup for Specimen M2
(Symmetrical Loading)

tested under symmetrical loading. Figure 7 shows the setup. It also depicts the absence of damage or permanent deformations in panels 3, 4, 5 and 6 during the earlier unsymmetrical load test. For the shortened span the symmetrical load subjected the specimen to high flexural shear, a moderate amount of bending moment and no torsion (Fig. 4(b)). Failure was expected to occur in either panel 4 or 5.

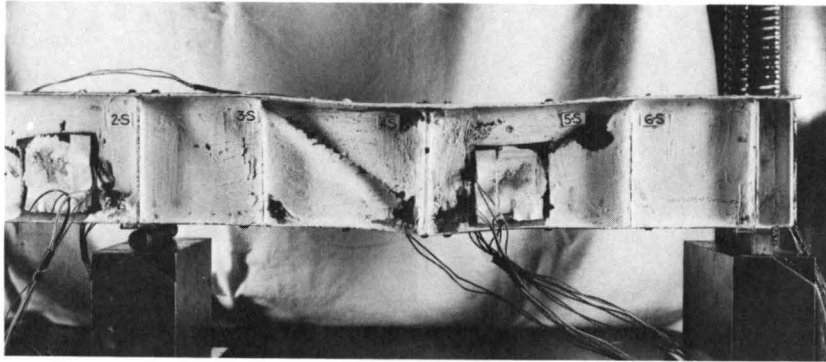
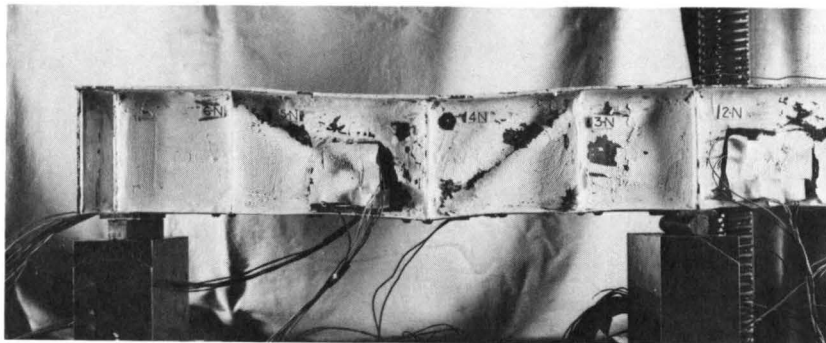
Fig. 8 Overall Permanent Deformations - Specimen M2
(Symmetrical Loading)

The testing procedure was very similar to that employed in the previous tests. The first visual signs of tension field action showed up in both webs of panel 5 at 1700 pounds. The lateral deformations of the webs in this panel increased as loading continued but were not excessive even at 2400 pounds. The next increment of load produced the first noticeable signs of web bulging in web panels 4S and 4N, simultaneously. At 2530 pounds, flaking of the whitewash occurred along the tension diagonals of web panels 4S, 4N, 5S and 5N. Additional loading caused the web deformation on both sides of panels 4 and 5 to grow excessively. This was accompanied by vertical deformations of the flanges over the length of these panels. The maximum load that could be reached was 2650 pounds. Final deformation patterns are indicated in Fig. 8.

The overall behavior of the specimen can best be described by referring to the load-deflection curve in Fig. 11. The response was essentially linear up to 2500 pounds. In the previous section it was noted that excessive web bulging and flaking of the whitewash occurred along the tension diagonals of web panels 4S and 4N at 2530 pounds. Strain readings indicated that yielding initiated in both webs of panel 5 at 2550 pounds. With the webs yielding and able to carry little or no additional shear, the load-deflection curve became almost flat. A small amount of additional load was realized through the transverse shear strength of the flanges after the webs had failed. Evidence of this was obtained through the recording of large

In conclusion, it is clear that the mode of failure of symmetrically loaded box girders is yielding along the web tension diagonals accompanied

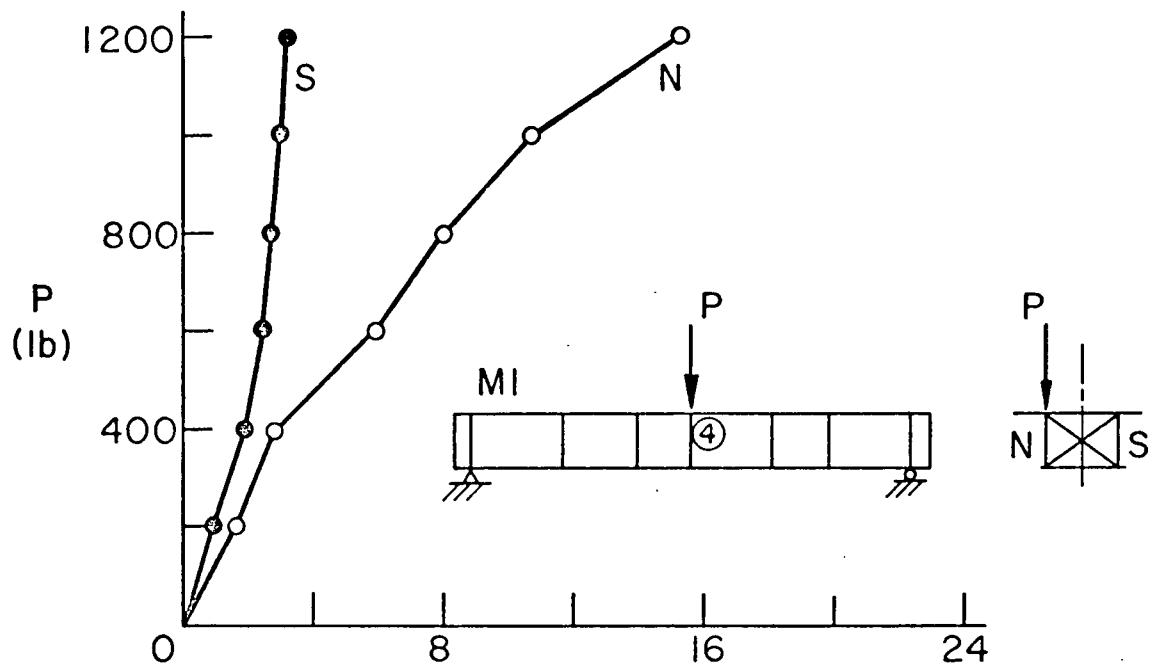
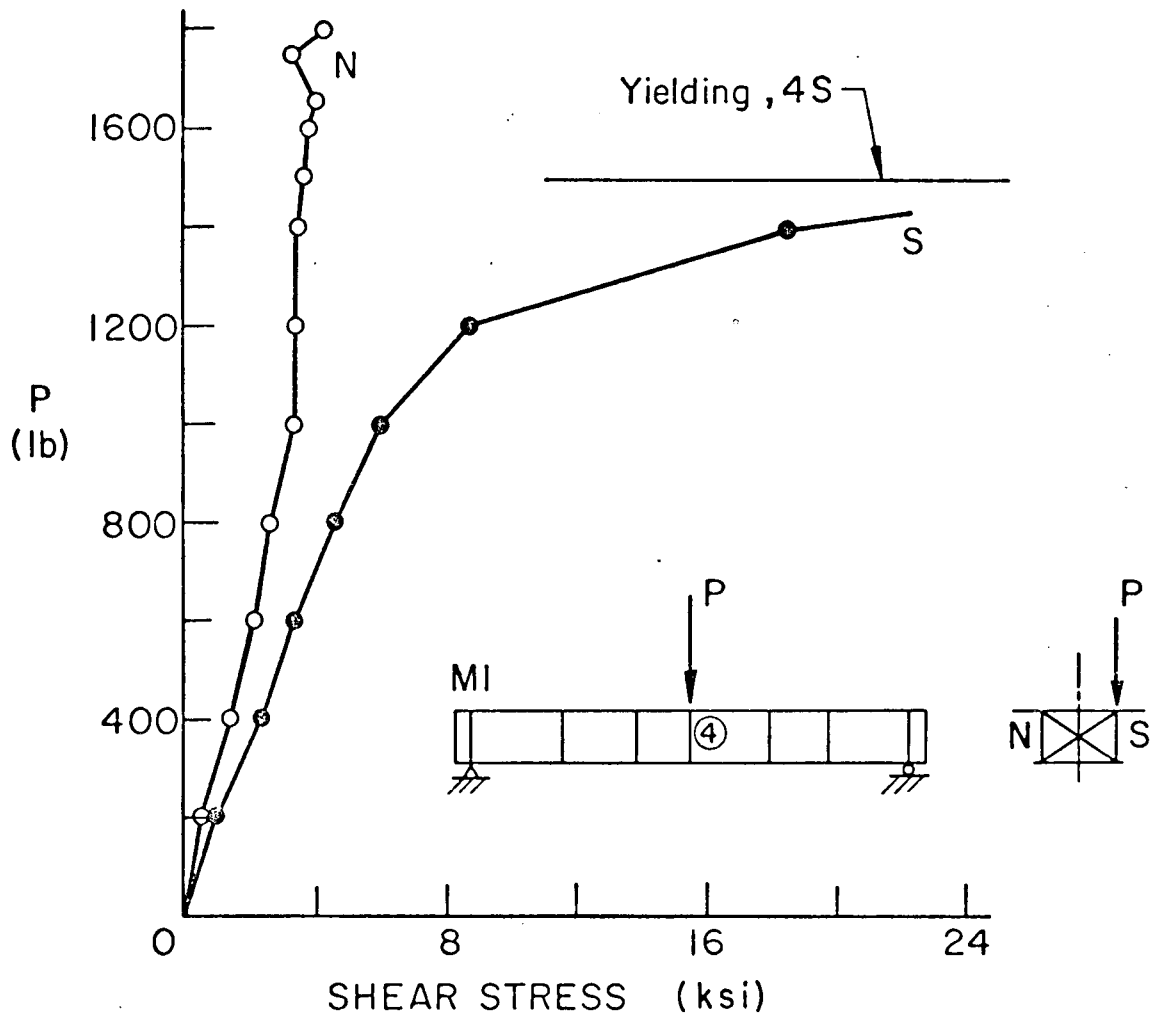
Fig. 16 Shear Stress at Centerline of Panel 4 - Specimen M1 (Unsymmetrical Load)

conditions web panels on the south side were subjected to larger shear stresses than those on the north side, and therefore web failure would be expected to initiate on the south side of the cross section. This actually occurred. The lower part of Fig. 16 clearly points out the difference in magnitude of the shear stresses on the north and south sides. The upper part of this figure shows that the relative magnitude of these stresses is reversed when the eccentricity is reversed. The distribution of shear stresses prior to any web failure is quite similar to that obtained for specimen M2 (Fig. 12).

When web failures initiated on the south side, a redistribution of the flexural shear to the north side was expected to occur. Referring again to the lower part of Fig. 16 it is seen that this was not the case. As web panel 4S began to fail through yielding along the tension diagonal, the shear stress in the corresponding web on the north side remained relatively constant. Behavior of this type was also exhibited in panels 1 and 6. This is unlike the behavior of specimen M2 which demonstrated significant redistribution capability (Fig. 12).
