RETROFITTING FATIGUE DAMAGED

COVER-PLATED BRIDGE MEMBERS

Fritz Engineering Laboratory Report No. 417.1(77)

FOR PRESENTATION AT THE 1978 MEETING

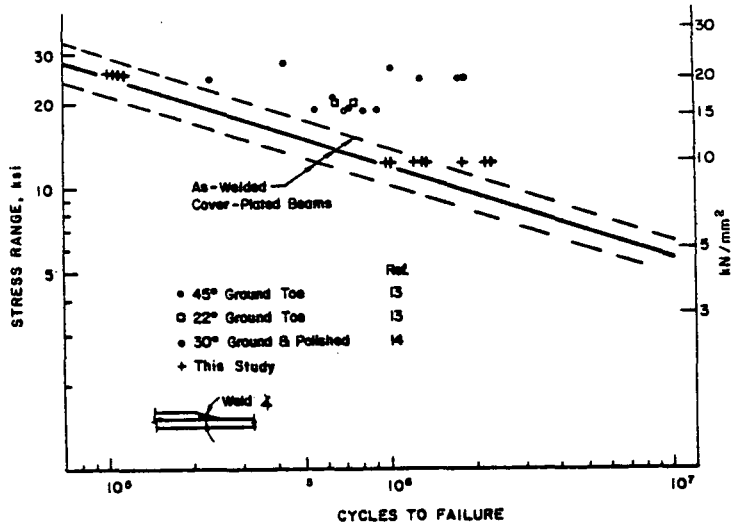
Grinding the weld toe with a burr to provide a smooth transition and minimize the size of the initial discontinuities was the least reliable method. Some improvement was noted at the lower stress range levels as illustrated in Fig. 1, but none at all at the highest level of stress range. Similar results were obtained in earlier studies on as-welded details which indicated that erratic results could be expected.

The results of earlier tests on ground cover-plated beams are also summarized in Fig. 1 and compared with the results of this study and the as-welded beams. It is apparent from the comparison that grinding accompanied by fine finishes decreased the stress concentration condition and resulted in substantial improvements in the fatigue strength. The results also indicate that substantial scatter can be expected from the ground details.

Fig. 1 Effect of Grinding Weld Toe on Fatigue Strength

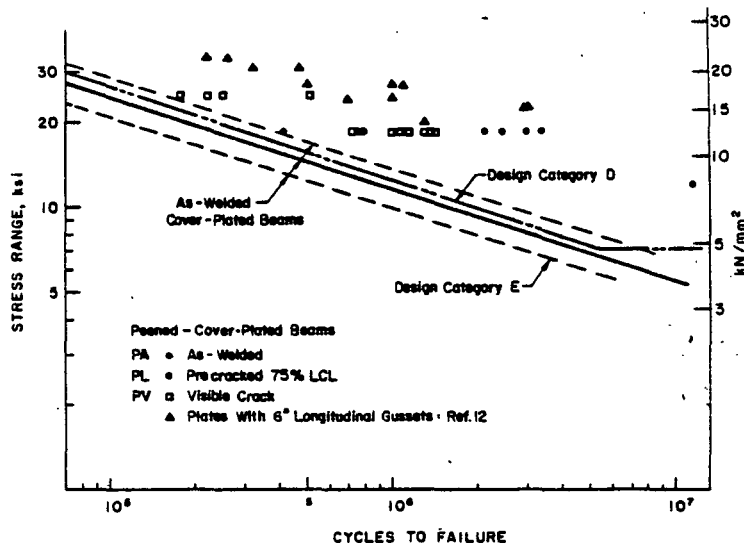
The results of all beams with peened details that were tested under a low minimum stress level (2 ksi) or that were peened under their minimum load, are summarized in Fig. 2. Those details that were peened in the absence of dead load are not plotted in Fig. 2. When the 10 ksi minimum stress was applied to these beams it eliminated most of the beneficial effects of the peening treatment.

Also shown in Fig. 2 are test results on small plate specimens with 152 mm (6 in.) longitudinal gussets welded to their surface. These tests were reported by Gurney and were made on as-welded specimens⁵. The studies on welded attachments reported in NCHRP Report 147 have demonstrated that the attachment length has a significant effect upon fatigue strength. Hence, these 152 mm (6 in.) longitudinal gusset plates were expected to exhibit slightly more life than those provided by cover-plated beams. This was confirmed by the test data. All of the peened plate specimens fell near the upper limit provided by peened cover-plated beams. This suggests that other details can be expected to exhibit a similar increase in fatigue strength when subjected to peening at the weld toe.

Fig. 2 Effect of Peening on Fatigue Strength

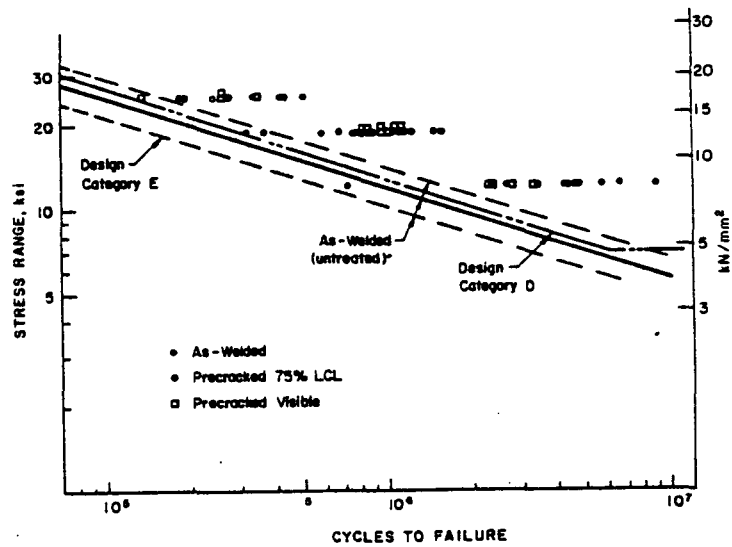
The results of all three test series are summarized in Fig. 4. The test points indicated as as-welded were treated prior to applying any cyclic load. The test points identified as precracked 75% LCL were pre-cycled to 75% of the life provided by Design Category E. At that time the detail was treated. It may or may not have had a detectable fatigue crack. Those points indicated as visible precracked had clearly detectable cracks. Except for those failures in precracked beams that occurred because of failure to incorporate the complete crack into the gas tungsten arc remelt (see Fig. 4), approximately the same increases in life were achieved by all specimens. None of the test series exhibited an influence of minimum stress. Stress range was observed to account for nearly all of the variation in fatigue strength.

Fig. 4 Effect of Gas Tungsten Arc Remelt on Fatigue Strength

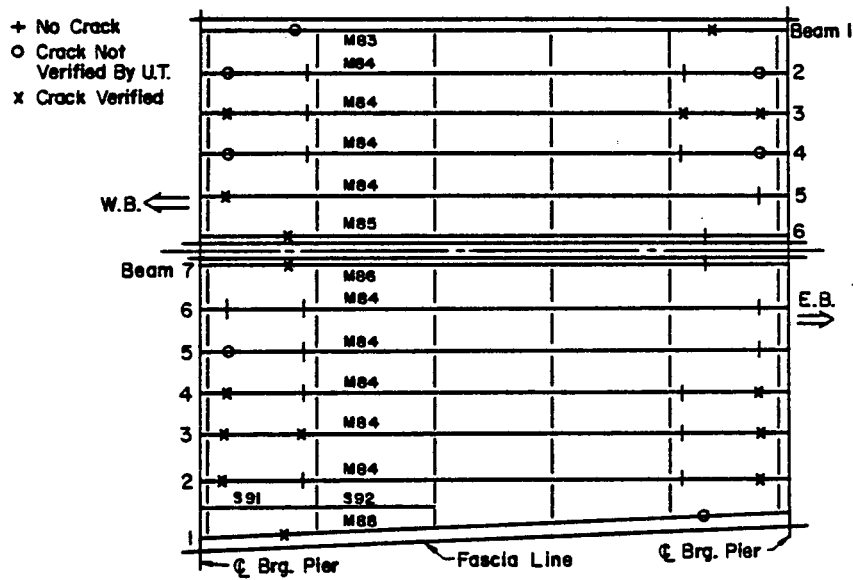
Figure 6 shows the approximate location of the details which were inspected in span 10 and summarizes the findings. Nine details in span 11 were also visually inspected. Indications of cracking were found at seven details. Very large cracks were observed at the east end of Beam 5 of the eastbound bridge and Beam 4 of the westbound bridge - span 11.

Fig. 6 Plan of Inspected Details in Span 10, Yellow Mill Pond Bridge

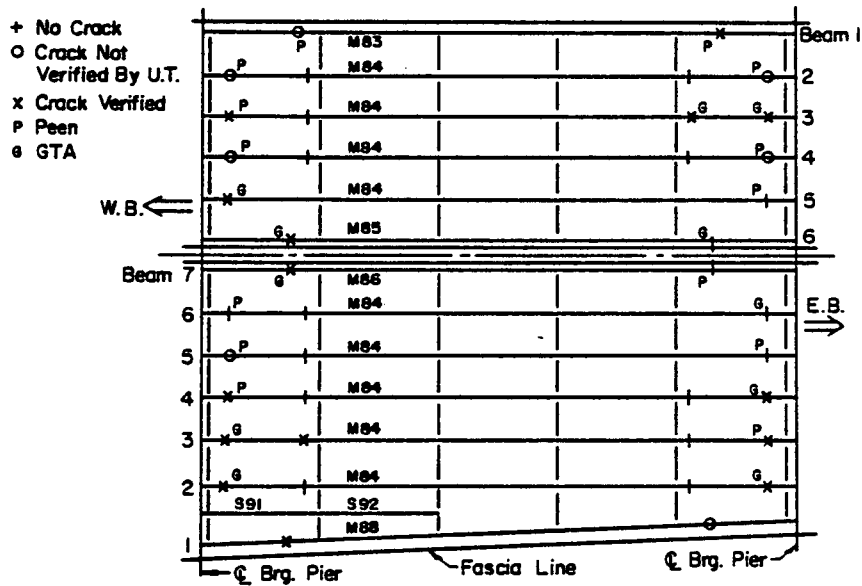
Fig. 10 Repair Methods on Span 10, Yellow Mill Pond Bridge

Twenty-five of the cover plate details in span 10 were repaired after being inspected. Fourteen were peened and eleven were gas tungsten arc remelted. Figure 10 summarizes the type of repair which was made at each cover plate weld toe.

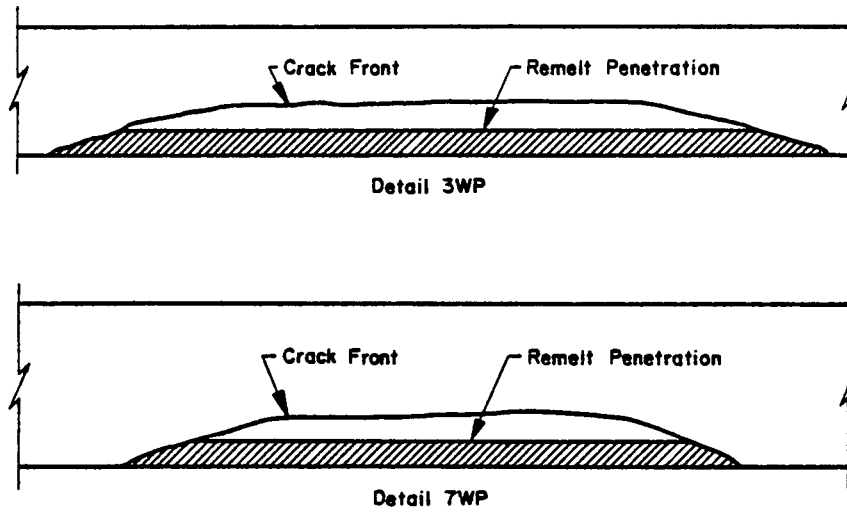
The shape of the large embedded cracks at the west primary detail of Beam 3 (eastbound bridge) and at the west detail of Beam 7 (eastbound bridge) are shown in Fig. 11. The stress intensity model for these embedded cracks is shown in Fig. 12. This approximate model combines the solution for an eccentric crack⁸ with the stress gradient correction factor, F_G , defined in Ref. 9. Utilizing this model and the crack growth

Fig. 11 Crack Shape for Beams 3 and 7 (1976)

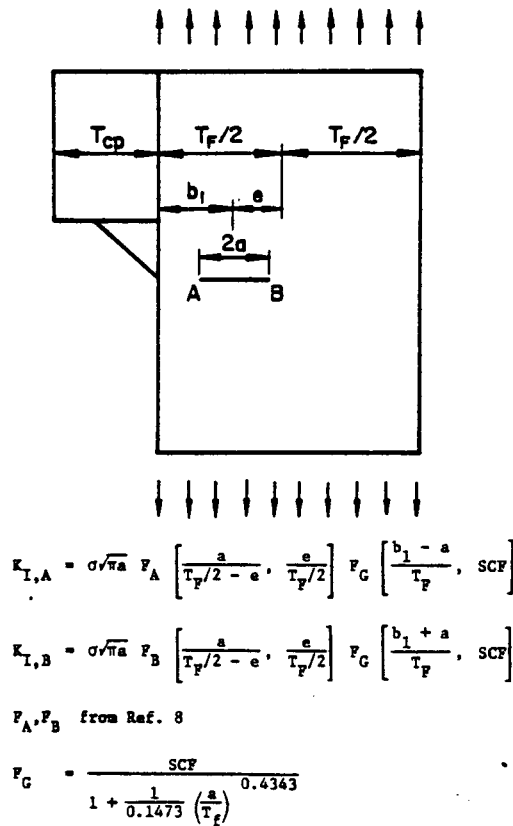
Fig. 12 Stress Intensity Model for Embedded Cracks
