Analysis of stresses in superstructure of glenfield bridge over back channel, October 1977

Project 77-5: Evaluation of the Fracture of the Glenfield Bridge Girder

ANALYSIS OF STRESSES IN SUPERSTRUCTURE
OF GLENFIELD BRIDGE OVER BACK CHANNEL

Fritz Engineering Laboratory Report No. 425/1/77

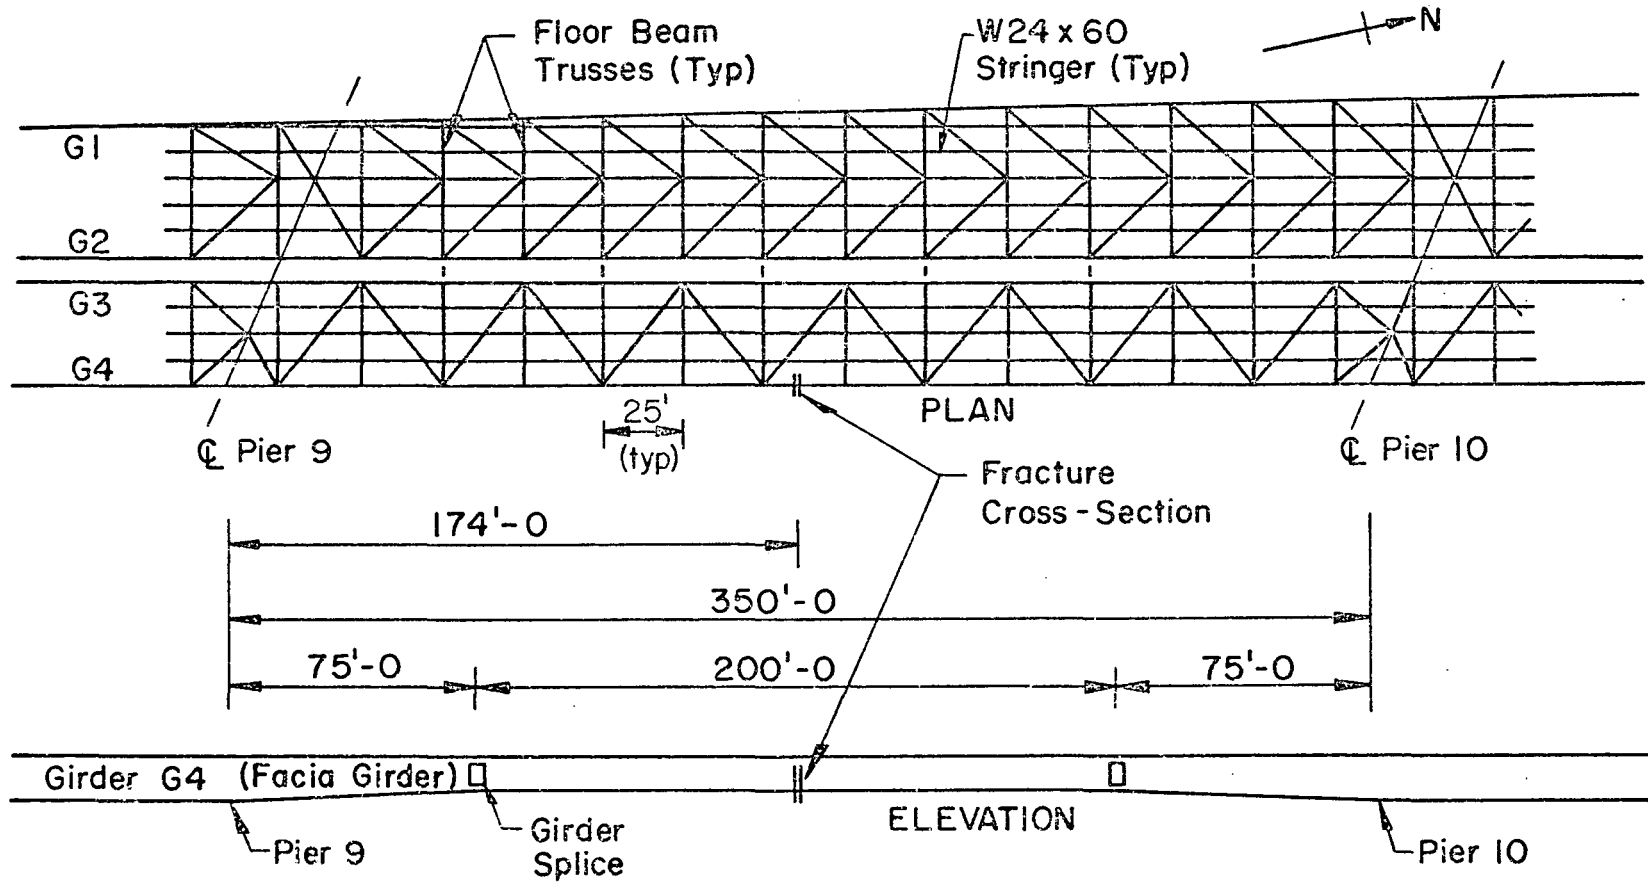
Fig. 1 Plan and Elevation of 350 ft Center Span

The fracture occurred at midpoint of the 350 ft center span (span 9) of the fascia girder (girder G4) as shown in Fig. 1. The superstructure consists of two main girders, G3 and G4, with transverse floor beam trusses spaced at 25 ft which support W24x68 stringers. The girders and stringers support an 8-1/2 in. noncomposite reinforced concrete slab. The adjacent superstructure carrying the southbound lanes also has two main girders, G1 and G2. The two superstructures are connected by trussed diaphragms which are designed to transmit live load between the structures.

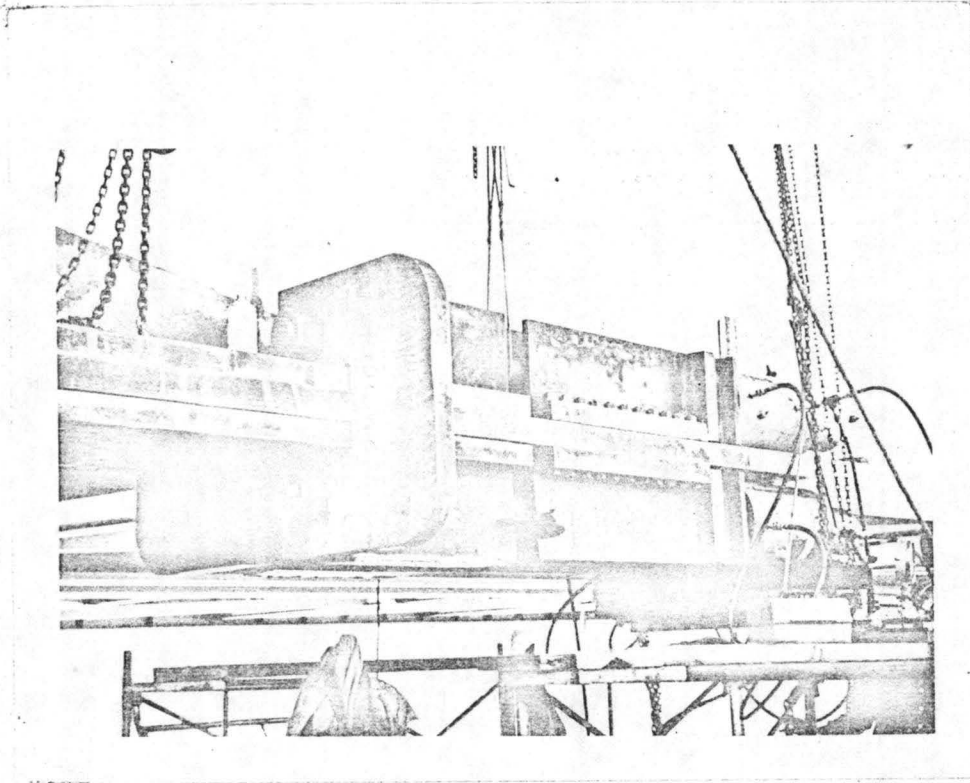
Fig. 2 Horizontal Hydraulic Jacking Arrangement Mounted on Tension Flange of Girder G4

Figure 2 shows the horizontal hydraulic jacking arrangement mounted to the tension flange of girder G4. The hydraulic jacks are shown to the right (north) of the figure. They react against an anchor block which is shown bolted to the tension flange several feet north of the fracture cross section. Large pullrods run from the jacks to the vertical pull plates just left of center of the figure. The pull plates are welded to the unbolted ends of the tension flange splice plates. The large nuts are on the south ends of the pull rods. The fracture cross section is out of view to the left. The "C" shaped plates joining the pullrods prevent the unbolted ends of the tension flange splice plates from deflecting away from the tension flange under the eccentrically applied jack loads.

1. The pull rods are eccentric to the splice plates as shown in Fig.
2. The large "C" shaped plates, connecting pairs of pull rods top and bottom, are designed to minimize separation between the splice plates and the tension flange under the "C" plate. It was observed during jacking, however, that both "C" plates distorted and opened up. It was apparent that the splice plates were bending and that a compressive force was being developed between the ends of the splice plates (just left of the anchor block bolted to the tension flange as shown in Fig. 2) and the tension flange. A lubricant placed on the surfaces of the splice plates to relieve the resulting friction forces was ground off prior to jacking.

- (1) The web and tension flange splice plates were bolted to the south side (Fig. 1) of the fracture cross section,
- (2) four 300-ton capacity horizontal hydraulic jacks anchored to the tension flange north of the fracture cross section (two on top, two below) near the unbolted ends of the tension flange splice plates, pulled on the flange splice plates with sufficient force to bring the bridge deck back to near original alignment and essentially restore the deadload bending moment distributions in girder G4, and
- (3) the remaining bolts in the web and tension flange splice plates were installed to complete the repair. (2)

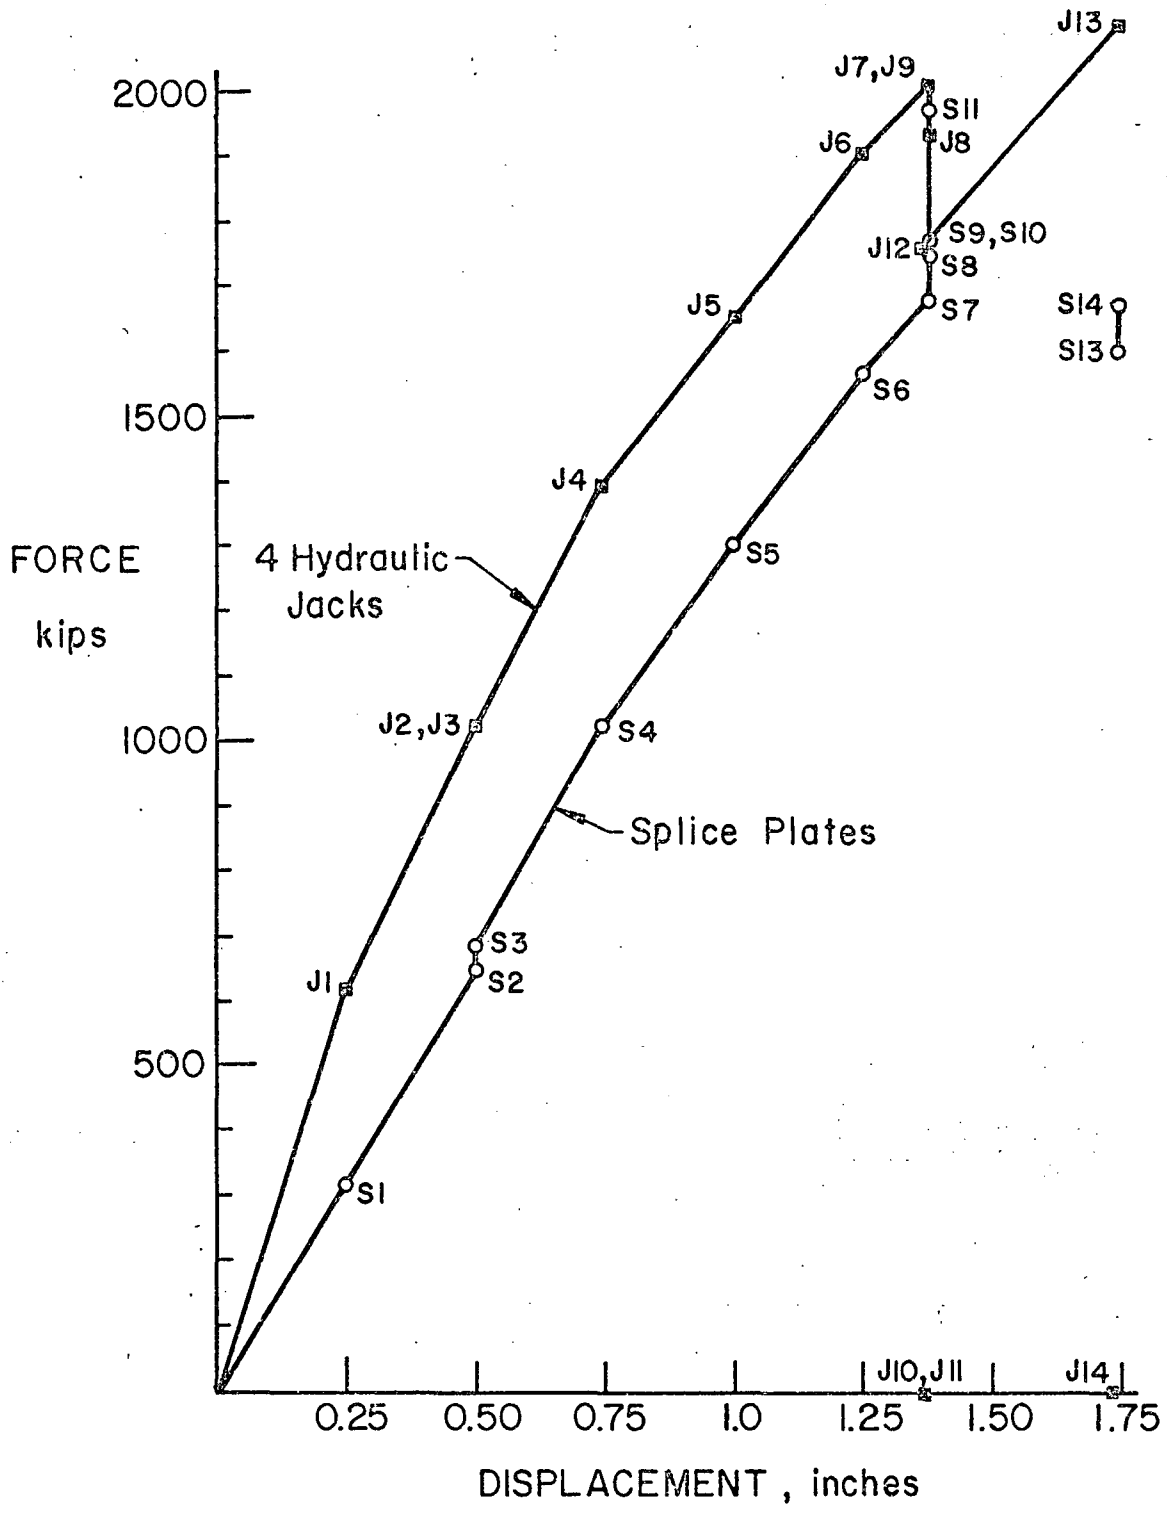
Fig. 7 Relationship between Measured Force in Splice Plates and Force in Hydraulic Jacks versus the Relative Closing Displacement of the Tension Flange

The relationship between the computed force in the splice plates in kips (from measured strains) versus the closing displacement of the tension flange in inches, at the fracture cross section is shown in Fig. 7. The relationship between the total jack force as determined from calibrated pressure gages, versus the closing displacement of the flange is also shown in Fig. 7 for comparison. The flange was closed in increments of 1/4 in. until 1-1/4 in. relative closing displacement was reached. Then two additional increments were added until the total relative displacement reached 1-23/32 in.

It is evident from an examination of Fig. 7 that the splice plate force, as determined by strain gages (Fig. 4), does not completely agree with the total jack force as determined by calibrated pressure gages. The force in the splice plates is consistently lower whenever the jacks are under pressure and closing the tension flange.

jack forces. This conclusion is supported by the behavior at 1/2 in. displacement shown in Fig. 7. When bolts were loosened in the floor beam truss, the force in the splice plates increased slightly as shown by points S2 and S3. An increase in splice plate force would be expected due to a reduction in torsional restraint to girder G4 upon loosening the bolts. The jack force did not change (J2 and J3). This would be expected if frictional forces developed between the splice plate gages and the hydraulic jacks.

In addition, at 1-3/8 in. displacement (Fig. 7), when the jack force was increased from J8 to J9 to bring the jack force to the same level as J7, the force in the splice plates increased only about one-third as much, which would be consistent with an assumption of friction forces developing.

Referring to Fig. 7, it is unlikely that relative tension flange displacement began with nearly zero jack loads as shown. Although no confirming data exists, it is more likely that, due to friction, the jack loads reached 100 to 200 kips before flange displacement was observed. Thus the vertical difference between the two curves in Fig. 7 varies from about 200 kips at low displacement to about 400 kips at the higher displacements. This difference can be explained by the presence of friction forces at the ends of the splice plates which increase as the jack loads and bending of the splice plates increase.

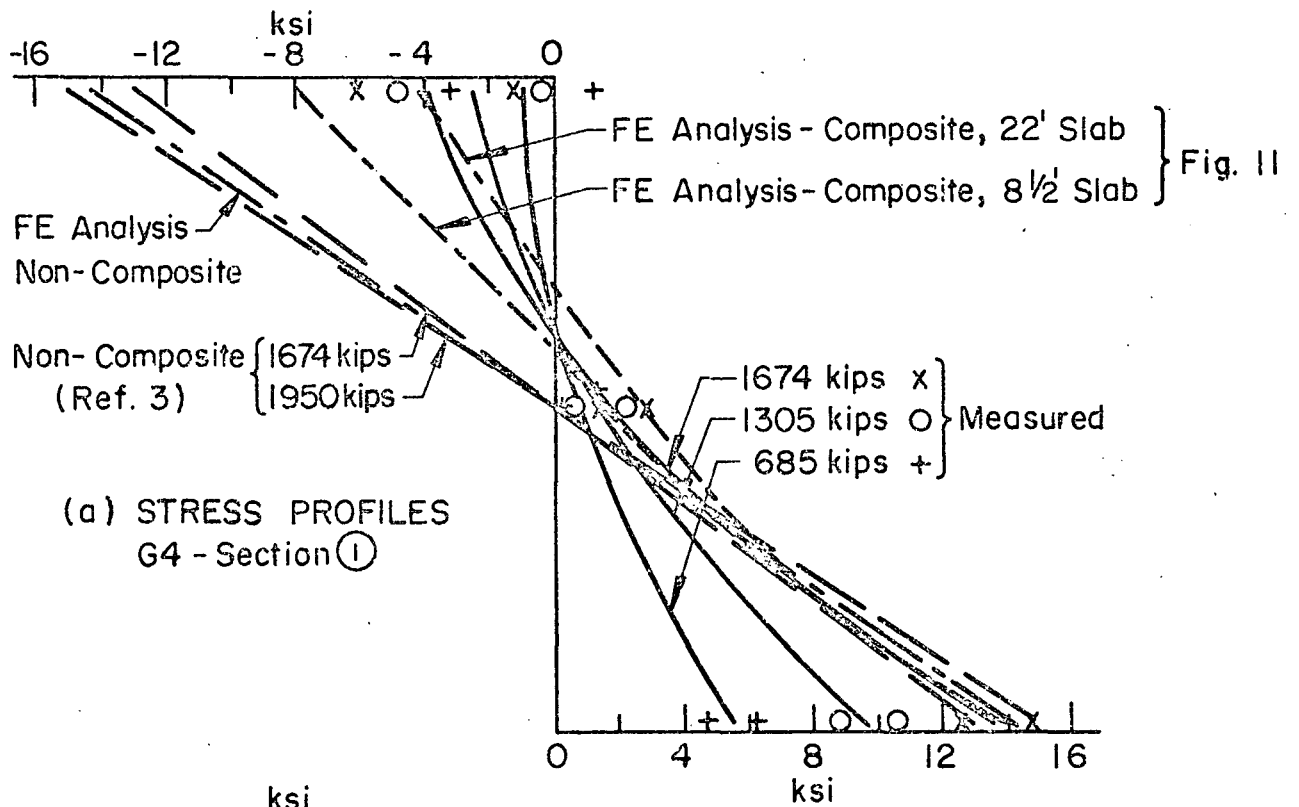
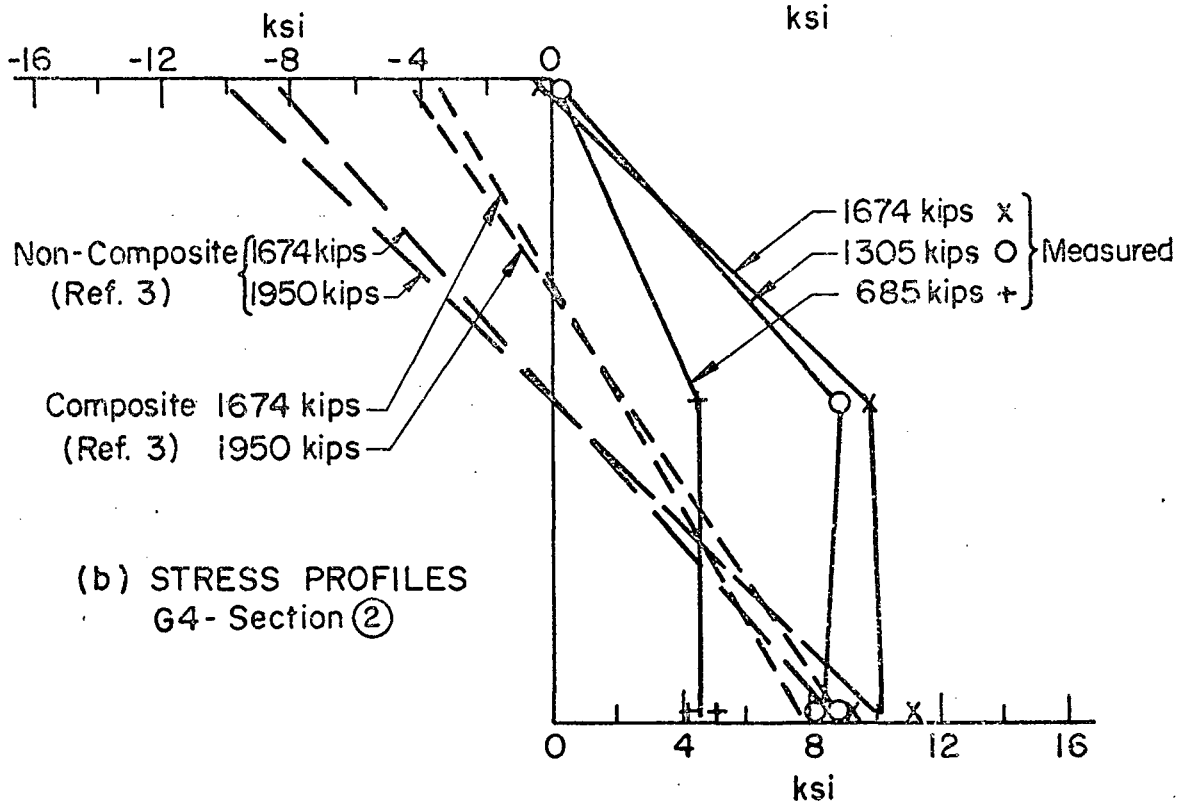
Fig. 8 Stress Distribution in Girder G4

The measured stress distributions in girder G4 are shown in Fig. 8. Figure 8a shows the stress distributions on section 1 (Fig. 3) near the fracture cross section. The measured stress on each side of the girder at section 1 are plotted, and averaged to show the stress distribution in the girder (Solid Curves). Stress profiles are shown corresponding to splice plate forces of 685 (S3), 1305 (S5), and 1674 (S14) kips. The difference in the measured stress in the tension flange and at mid-depth is relatively small. However the difference is particularly apparent in the top flange where a transverse jack force was applied to align the girder as mentioned in Arts. 1.1 and 3.1. Figure 8b shows the stress distributions on section 2 (Fig. 3) at the same levels of splice plate forces. Note that two plotted points were available on the bottom flange, but only one each at mid-depth and on the compression flange.

The three stress profiles obtained from the FE analysis for section 1 of girder G4 are plotted in Fig. 8a. Good agreement is obtained between the FE analysis using the 22 ft wide slab and the measured stress distribution under the 1674 kip force in the splice plates. The FE analyses using the 8 ft-6 in. slab width and for the steel girder alone differ greatly from the measured stress profile above the neutral axis. Although the bridge superstructure is noncomposite, the response of girder G4 during the jacking operation indicates that nearly full composite action existed between the steel girder and concrete slab throughout the jacking operation.

The measured stress profiles in Fig. 8a are fitted to the average stresses recorded by the three pairs of strain gages on section 1 of G4 as discussed in Art. 3.2.1. Under ideal plane bending conditions the flexural stresses obtained from the individual strain gages in a pair of gages would be equal. The stresses plotted in Fig. 8a show a spread of up to 5 ksi for the pair of gages on the top flange. A smaller difference exists in the bottom flange. The difference can be attributed mainly to lateral bending of the top flange during the jacking operation. As mentioned earlier lateral bending was introduced while pulling the compression flange of girder G4 west to bring it to its original position relative to the concrete slab in the vicinity of the fracture cross section. In addition the tension flange would move laterally as it realigned under the applied jack loads.

The pair of strain gages on the bottom flange at section 2 of girder G4 also exhibit a smaller stress differential which also can be attributed to lateral bending. The single strain gages on the web and top flange at section 2 do not permit an averaging of the measured stresses. Thus, the measured stress profiles shown in Fig. 8b are unable to completely account for the lateral bending of girder G4. No FE analysis was performed for section 2.

Figures 8a and 8b also include predicted stress profiles from Ref. 3 based upon an expected total jacking force of 1950 kips. The values given in Ref. 3 were also modified to show predicted stress profiles at the 1674 kip level. The composite section used in Ref. 3 included a slab width of 8-1/2 ft (Fig. 11).

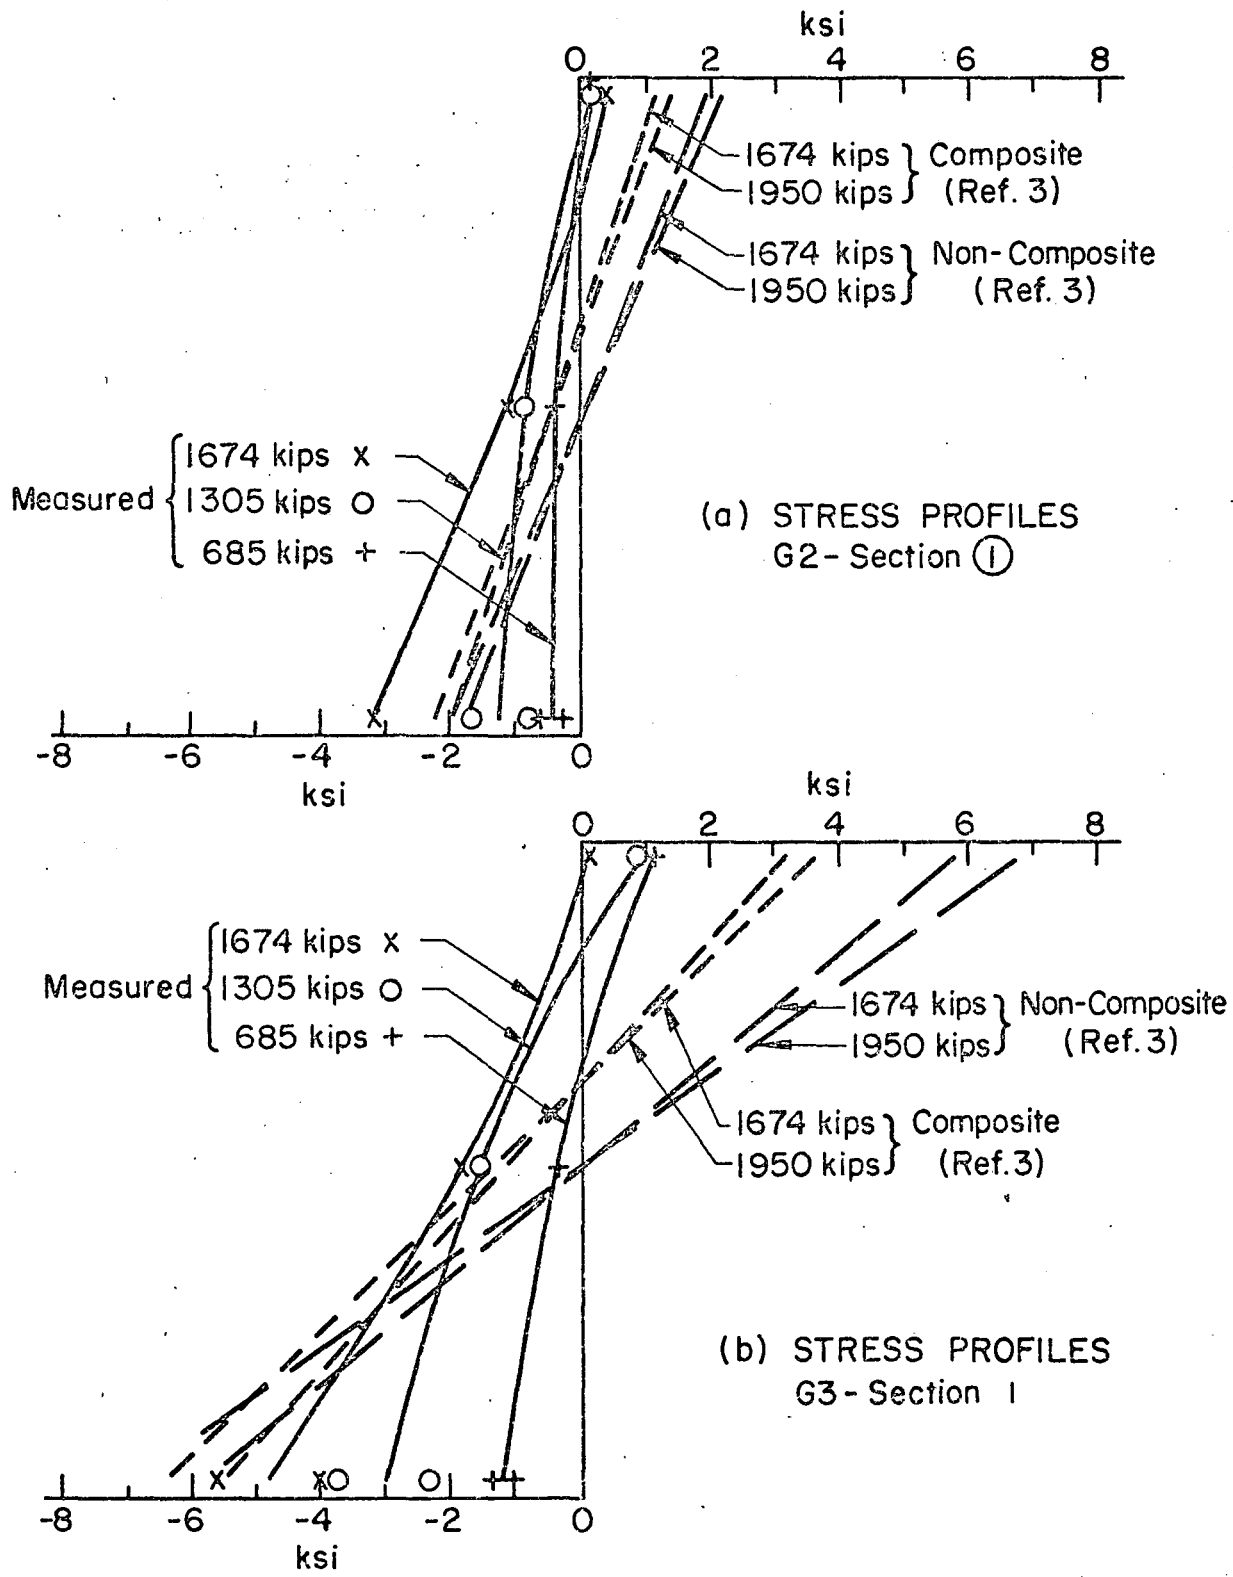
Fig. 9 Stress Distributions in Girders G2 and G3

The measured stress distributions in girders G2 and G3 are shown in Fig. 9. Figure 9a shows the stress distributions on section 1 (Fig. 3)

of girder G2 corresponding to splice plate forces of 685, 1305, and 1674 kips. Only one bottom flange stress level was recorded at 1674 kips because one of the two G2 bottom flange strain gages (Fig. 3) was out of commission at the completion of the jacking operation. Figure 9b shows the stress distributions on section 1 (Fig. 3) of girder G3 at the same levels of splice plate forces.

The measured stress profiles at section 1 of girders G2 and G3 are presented in Figs. 9a and 9b. The stress differential across the bottom flange of each girder is believed due to lateral bending caused by alignment of girder G4 during the jacking operation. Since single gages were placed on the webs and top flange the average flexural stress at these locations cannot be obtained. Only one bottom flange strain gage on girder G2 was operational at the 1674 kip load level.

The measured top flange stresses shown in Fig. 9a and 9b are less than stresses predicted on the basis of composite action using the 8-1/2 ft slab width. Thus, the amount of concrete contributing to the composite action of girders G2 and G3 was obviously greater than the 8-1/2 ft width assumed in Ref. 3, appears closer to the 22 ft slab (half-width) assumed in the FE analysis of girder G4.

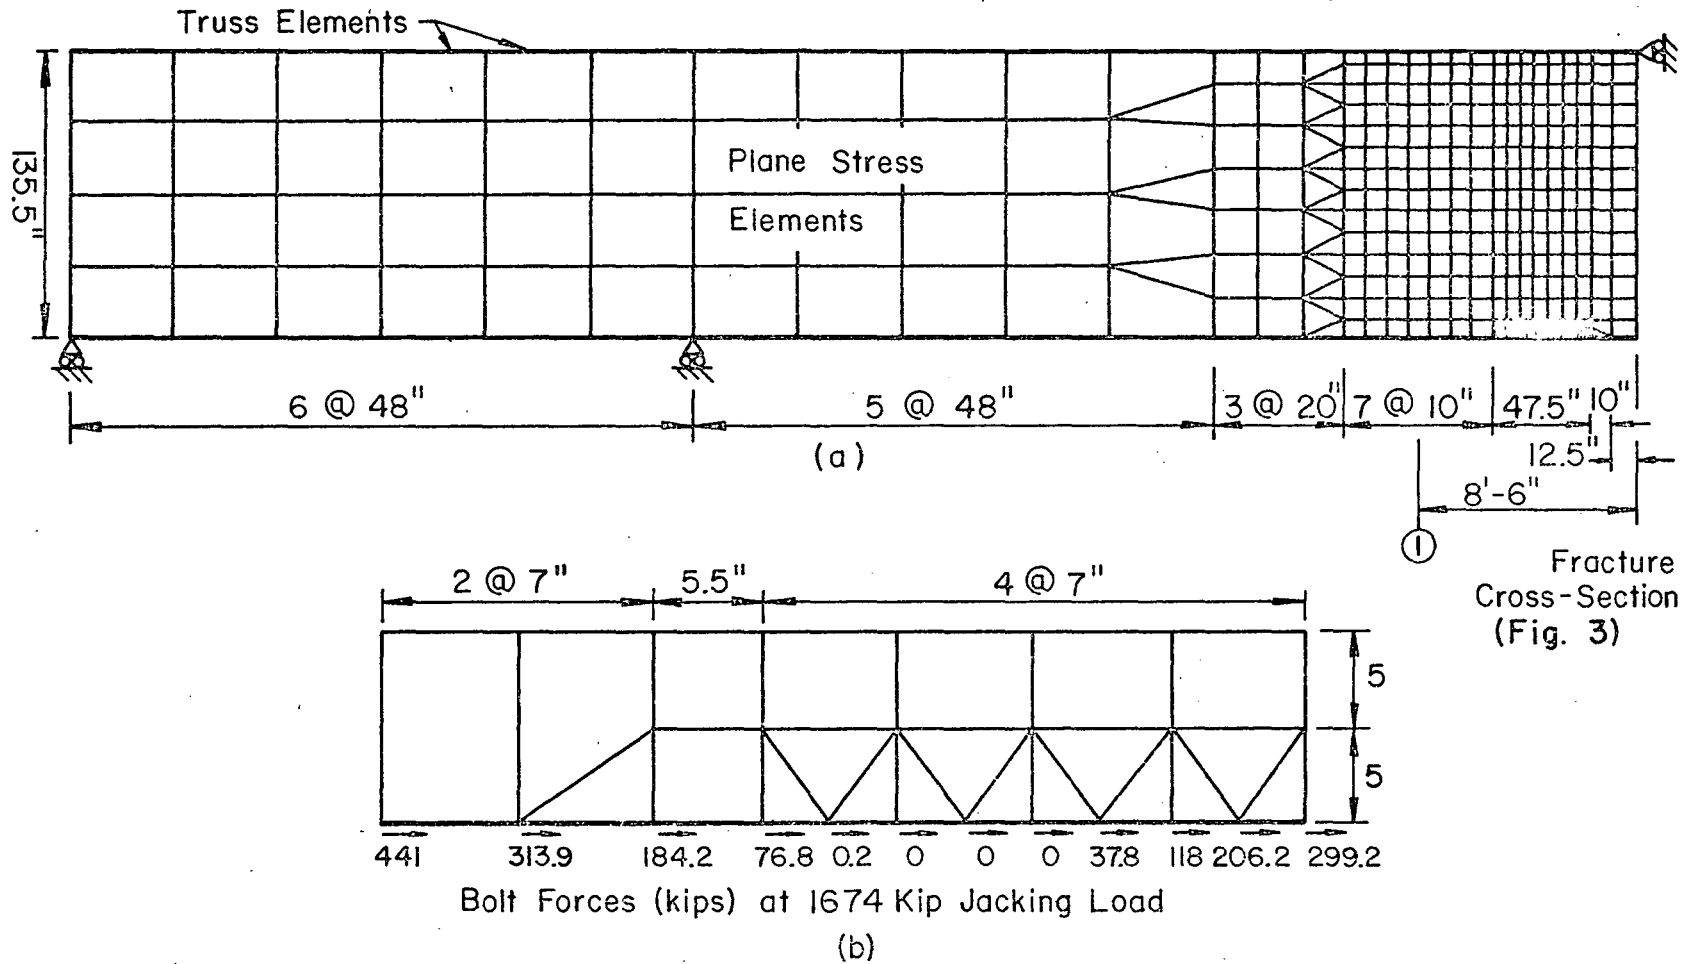
Fig. 10 Finite Element Model of Girder G4 South of Fracture Cross Section

Figure 10 shows the finite element (FE) model used to determine the stress distribution on section 1 of girder G4. A portion of girder G4, south of the fracture cross section, was selected for modeling. The web of girder G4 is modeled by 320 plane stress elements while 64 truss or bar elements model the top and bottom flanges. The horizontal roller support at the fracture cross section accounts for the continuity of the steel top flange and concrete slab above the fracture location. The two vertical roller supports are arbitrarily located sufficiently distant from section 1 so as to have a negligible effect on the stress

Figure 10b is an enlargement of the shaded area in Fig. 10a and shows the distribution of bolt forces applied to the girder. The bolt forces were applied by the flange splice plates during jacking. They are consistent with the final measured 1674 kip force in the splice plates rather than the assumed 1950 kip jacking force which was used in the splice plate analysis of Ref. 2.
