# Fatigue tests of curved plate girder assemblies, April 1980 (Herbein's M.S. thesis) (DOT-FH-11.8198.3) 161p

Report No. FHWA-RD-79-133

# FATIGUE OF CURVED STEEL BRIDGE ELEMENTS

# **Fatigue Tests of Curved Plate Girder Assemblies**

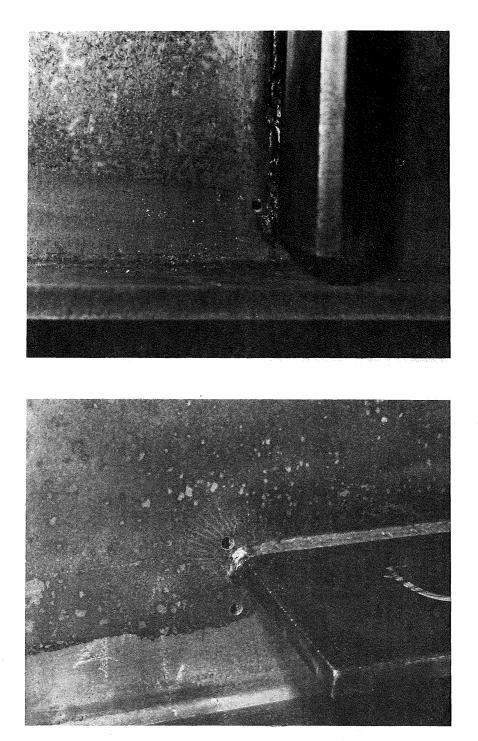
Fig. 51 Typical Web Crack Repairs - Drilled Holes at Type II and III Details

When a visible crack is discovered its location is recorded along with the present number of load cycles on the assembly. If the crack is not through the thickness of a web or flange no repairs are done immediately, but the crack's growth is monitored. When a crack has grown through the web or flange thickness or is initially discovered as a through crack then repairs are made to prevent premature failure of the assembly. The crack repair could consist of drilling a hole to blunt the crack tip as in Figs. 51 and 52, or clamping a splice plate over the cracked section as in Fig. 52, or a combination. The extent of the repair and the sizes of drilled hole and/or splice plate depend upon the location and size of the fatigue crack. The objective is to maintain the integrity of the assembly until at least two million load cycles have been applied.

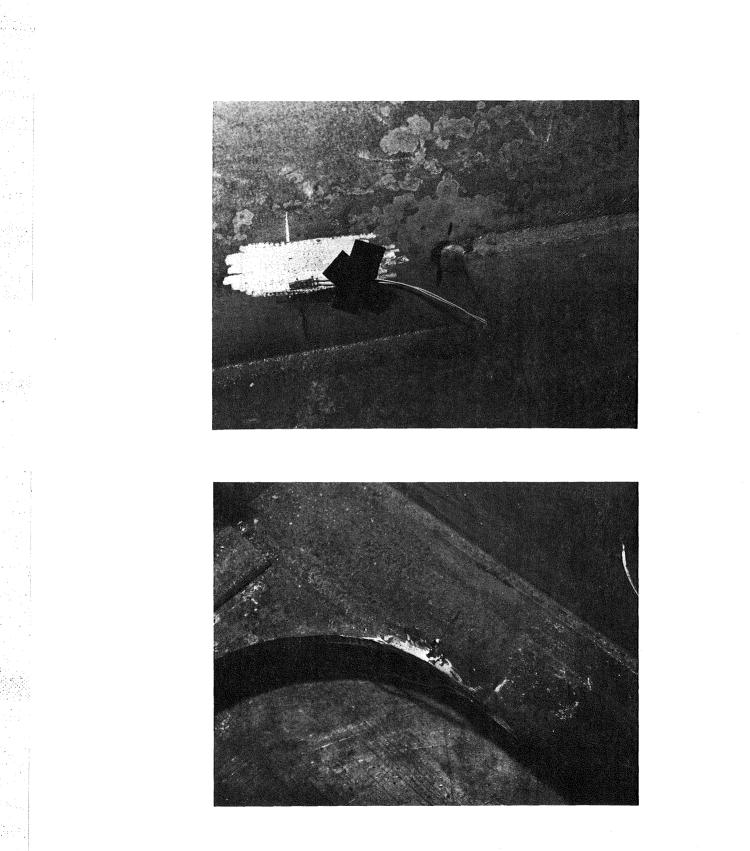
Fig. 58 Typical Fatigue Cracks -Details III and IV ob o

Several fatigue cracks are shown in Figs. 58 and 59. Figure 58 shows cleaner fluid evaporating from the web surface and leaving outlines of cracks growing from the weld termination on a type  $III_{ob}$ detail. The flange crack in Fig. 58 has grown from the circular transition detail IV<sub>o</sub> and propagated through the hole drilled to halt its growth. The flange cracks shown in Fig. 59 developed at type V<sub>oa</sub> and V<sub>ob</sub> details. The drilled hole has halted the small crack at the type V<sub>oa</sub> detail. The crack initiating at the V<sub>ob</sub> fillet weld has propagated across half the flange width.

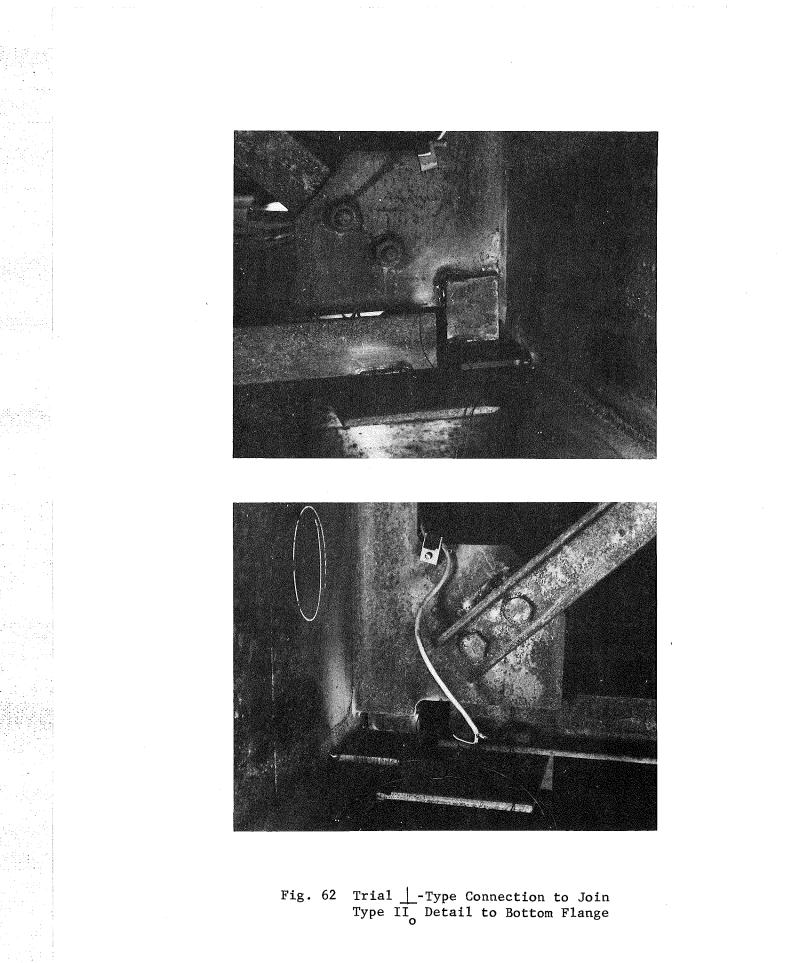
used on the type II<sub>0</sub> details at joints 3, 4, 7, and 8 on Assembly 2. In Fig. 62 the horizontal and diagonal diaphragm members are not connected at the joint thus allowing lateral out-of-plane motion of the type II<sub>0</sub> stiffener before installation of the  $\perp$ -type connection. The horizontal leg of the  $\perp$  is welded to the web-to-flange junction. The vertical leg is then welded to the stiffener. Such a connection may be practical only when the flange tip stress range is too large to consider extending the web stiffener and welding it directly to the flange, as is done for type I<sub>0</sub> details. The  $\perp$ -type details used at joints 4 and 8 on Assembly 2 (ee and ff in Table 7) have approximately 4 inch long horizontal plates, placing them into a Category D detail. Although  $\sigma_r$  varied from 13.7 to 13.9 ksi at these details no visible cracks were observed at the end of the test (2.03 X 10<sup>6</sup> cycles).
