Fatigue tests of curved box girder assemblies, April 1980 (DOT-FH-11.8198.4) (80-20)

FATIGUE OF CURVED STEEL BRIDGE ELEMENTS

Fatigue Tests of Curved Box Girders

Interim Report

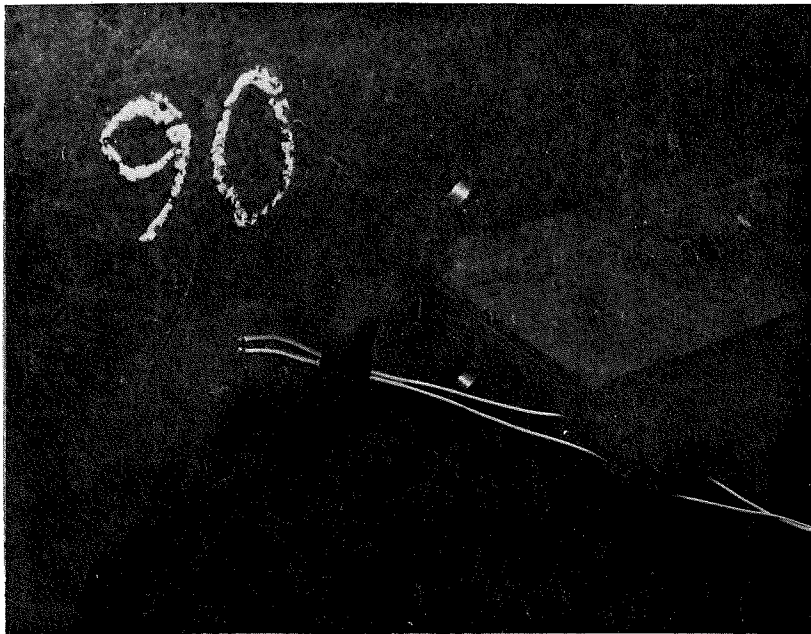
Fig. 41 Holes Drilled through the Web to
Blunt Tip of a Through Crack at
a Type V_c Detail

When a visible crack is discovered its location is recorded along with the present number of load cycles on the girder. If the crack is not through the thickness of a web or flange no repairs are made immediately, but the growth of the crack is monitored. When a crack has grown through the web or flange thickness, or is initially discovered as a through crack, then repairs are made to prevent premature failure of the girder. The crack repair could consist of drilling a hole to blunt the crack tip as shown in Fig. 41, or bolting splice plates over the cracked section as in Fig. 42 or both. The extent of the repairs and the sizes of drilled holes and/or splice plates depends upon the location and size of the fatigue crack. Examples of two other types of crack repair used extensively on the box girders are shown in Fig. 43. The one repair consists of a 1-1/16" diameter hole drilled near the leading tip of a fatigue crack. A 1" diameter A325 high-strength bolt is then installed in the hole and tightened $\frac{1}{2}$ turn beyond the snug position. This simple repair proved very effective in arresting fatigue crack growth. The second repair used splice plates clamped to the projecting edge of the bottom flange when an

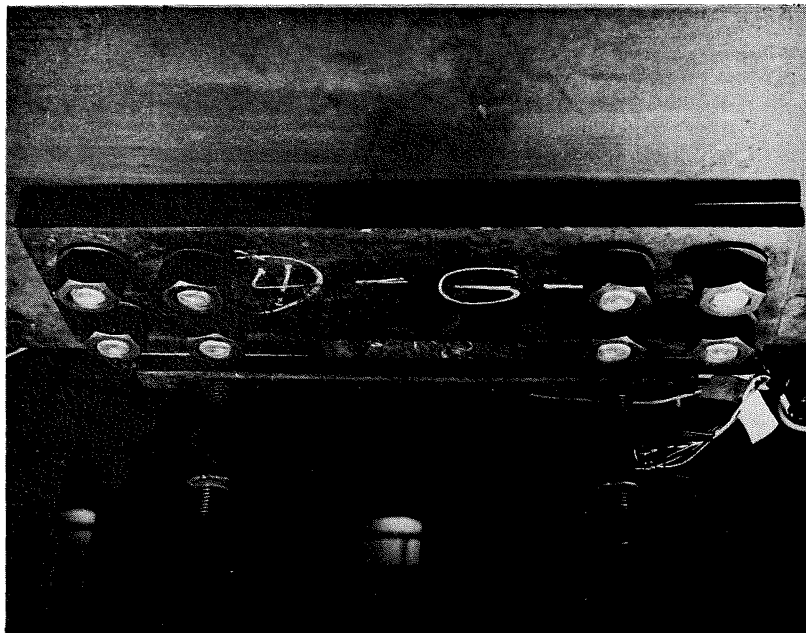
Fig. 42 High-Strength Bolted Splice across
a Through Crack Originating at a
Type VII_{ca} Detail
(Viewed from Beneath Girder 3)

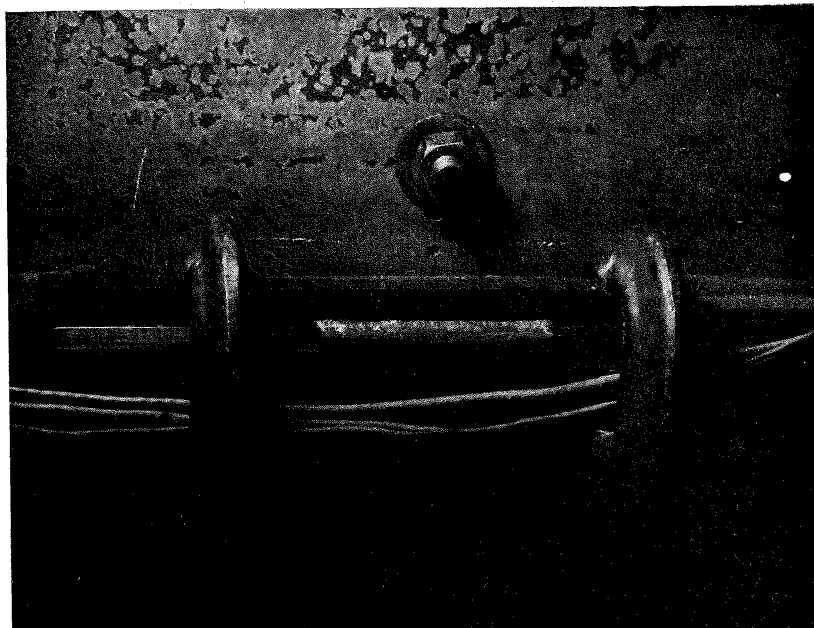
Fig. 43 High-Strength Bolt Installed in a Hole Drilled at the Tip of a Through Crack

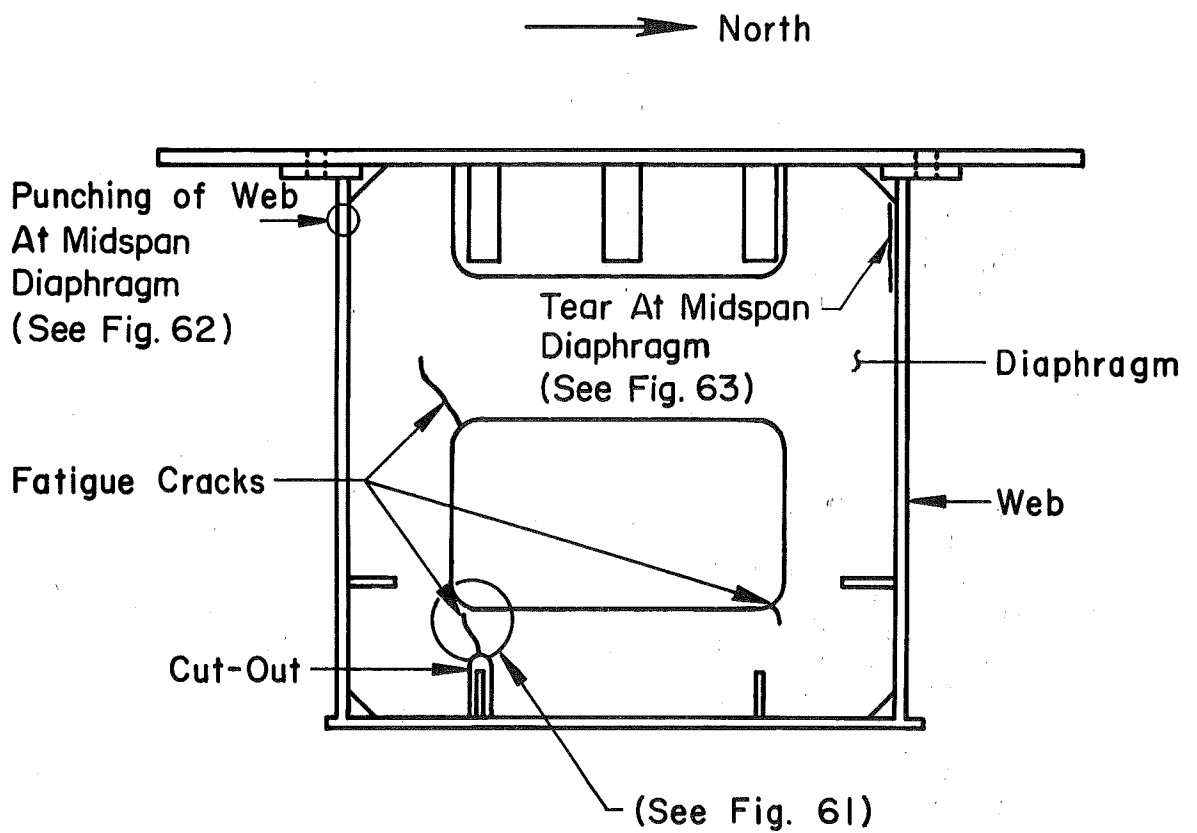
Fig. 60 Girder 3 - Interior Diaphragms from the East at 0.084 Million Cycles

The severity of the secondary fatigue crack growth observed in the fatigue tests of Girder 3 can be attributed to three major factors: 1) the stiffness of the plate-type diaphragms relative to the distortional stiffness of the box girder, 2) the absence of welds connecting the diaphragms to the bottom flange at the load points and 3) inadequate provisions for developing the in-plane diaphragm forces so that these forces are not developed by web bending. With regard to cross-sectional distortion, the plate-type diaphragms are extremely stiff relative to the box girder cross section. Therefore, sizeable forces are generated in the diaphragms as the loads are distributed from the inner to the outer web. The magnitude of the forces in the diaphragms contributes to the formation of cracks in the diaphragm as well as in the web at the web-diaphragm connection. The absence of welds across the bottom of the diaphragms at the load points

Secondary fatigue crack growth was arrested by (1) bolting heavy angles across the plate diaphragms as shown in Fig. 65 to reduce the stress in the diaphragms, (2) welding the top of the diaphragms directly to the flanges at the top of each web by means of gusset plates as shown in Fig. 66 and, (3) welding the plate diaphragms at the quarter points (Joints 3 and 4 and Joints 7 and 8) to the bottom flange. The latter two ensured that the diaphragm forces would not be carried by the web by web bending. Of course, the analyses of Girder 3 were examined closely to determine if the calculated stress ranges in the bottom flange and the small flanges at the top of each web were compatible with the weld details to be introduced, so that the fatigue strength of the girder would not be substantially reduced below 2 million cycles.

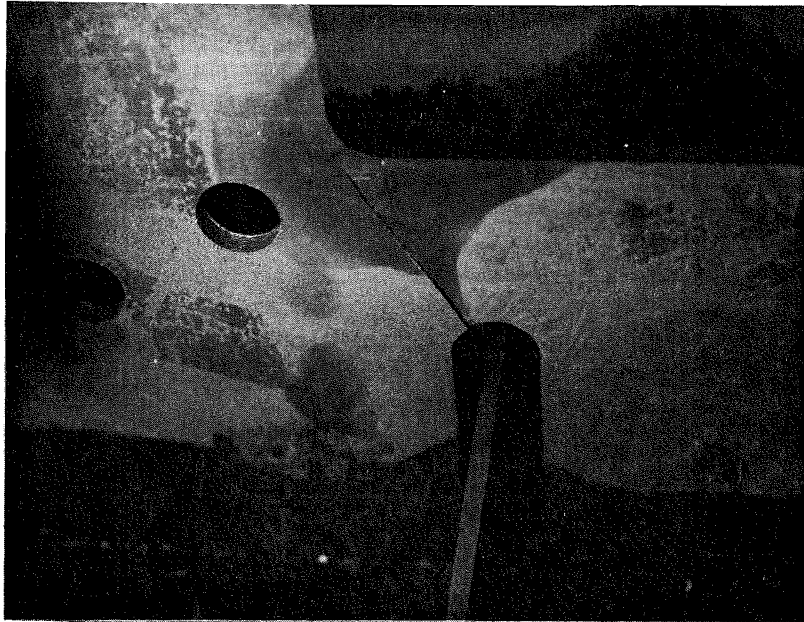
Fig. 61 Girder 3 - Diaphragm at Joints 7 and 8 Viewed from East after 0.084 Million Cycles Showing Crack at Top of Cutout

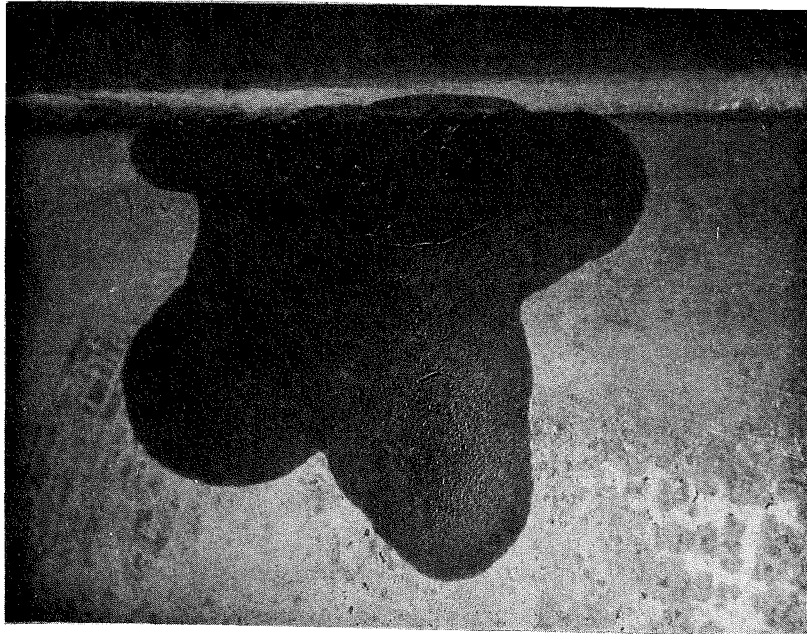
Fig. 62 Girder 3 - Punching in Web at Joint 5 at Top of Diaphragm as Viewed from the South after 0.084 Million Cycles

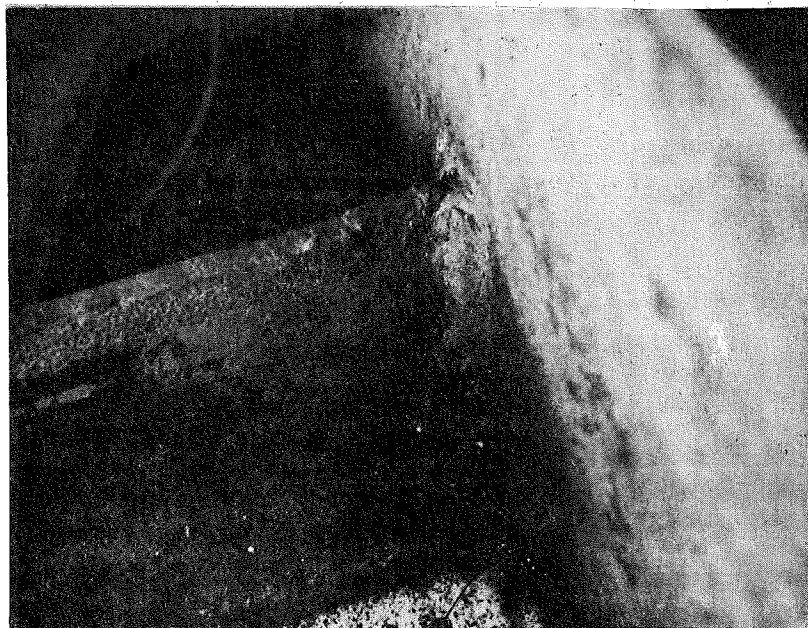
Fig. 64 Girder 3 - Type III at Location e
after 0.084 Million^{ca} Cycles

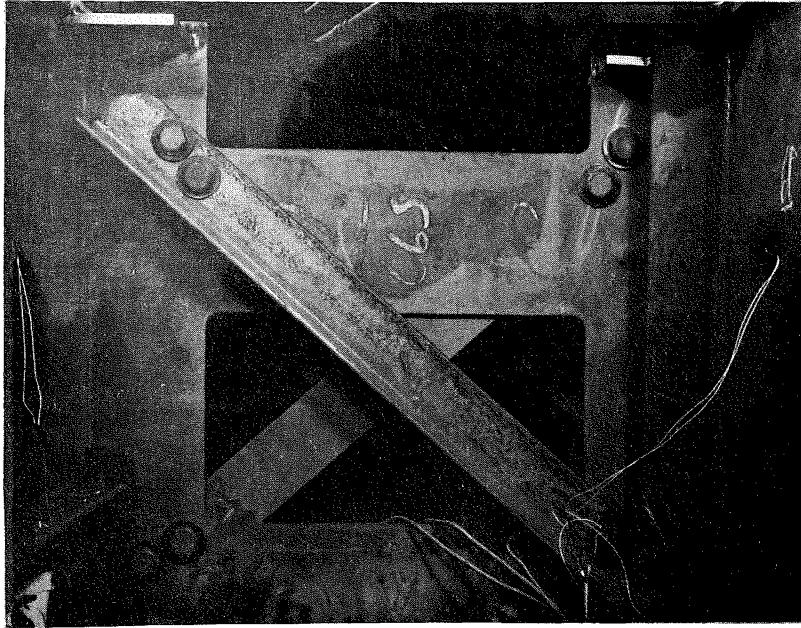
Fig. 65 Girder 3 - Cross Bracing Used to Reinforce Interior Diaphragms

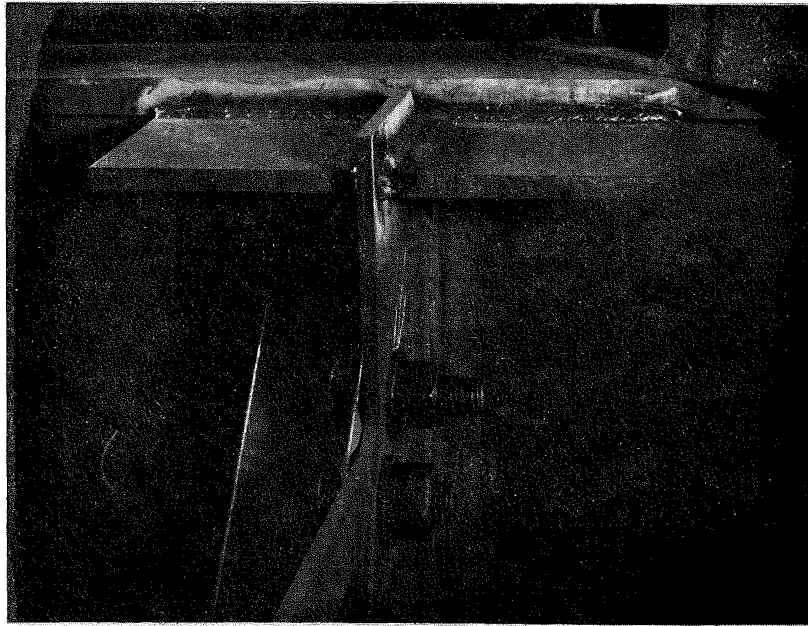
Fig. 66 Girder 3 - Plates Used to Connect Interior Diaphragms to Top Flange (Plates can also be seen in Fig. 65)

Based on the experience with severe secondary fatigue crack growth in Girder 3, Girders 1 and 2 were modified prior to fatigue testing. Gusset plates were welded to the tops of all interior diaphragms to transfer out-of-plane forces directly into the flanges at the tops of the webs (Fig. 66). In addition, any interior diaphragms that were intentionally not welded to the bottom flange during fabrication were welded to transfer diaphragm forces directly to the bottom flange instead of to the webs. With these modifications, the fatigue testing of Girder 1 began.

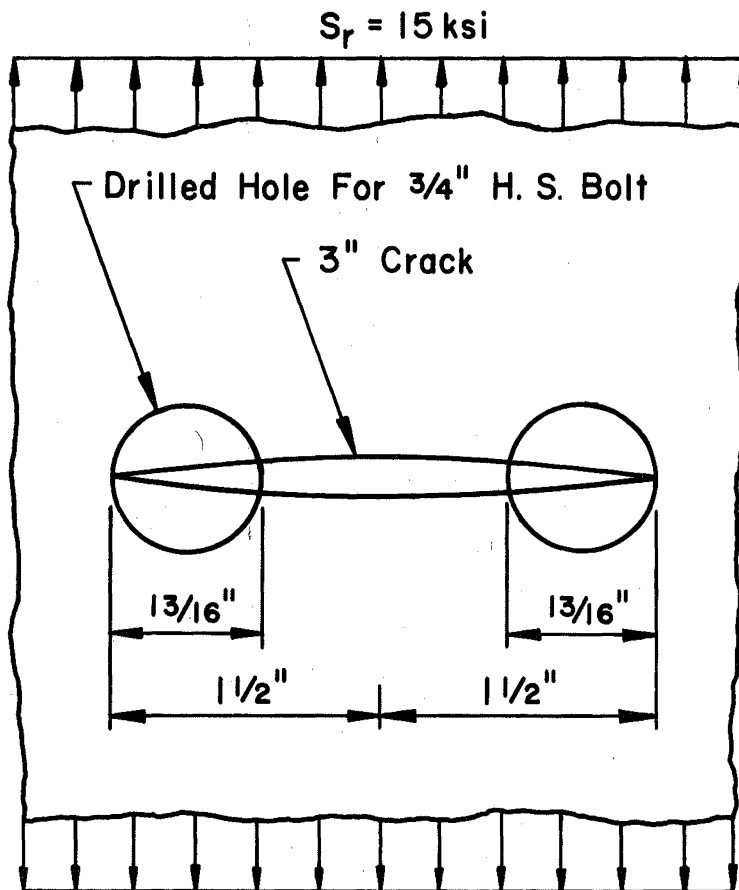
Fig. C2 Fatigue Crack Repair by Drilling Holes at Ends of Fatigue Crack and Bolting
