Characterization of corrosion fatigue damage in the fastener holes of a Boeing 707

**CHARACTERIZATION OF CORROSION FATIGUE DAMAGE IN
THE FASTENER HOLES OF A BOEING 707**

A Thesis
—Presented to the Graduate and Research Committee
of Lehigh University
in Candidacy for the Degree of
Master of Science

Lehigh University
April 2001

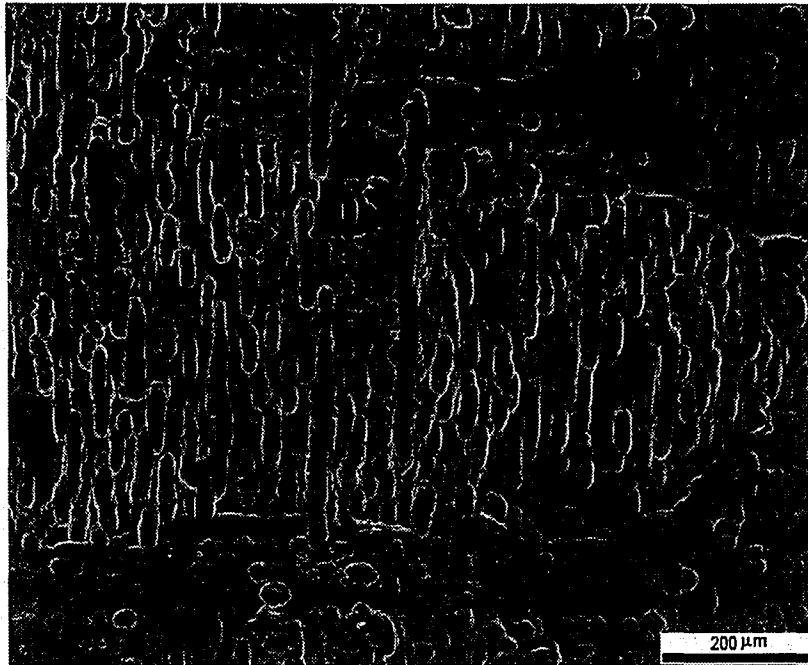
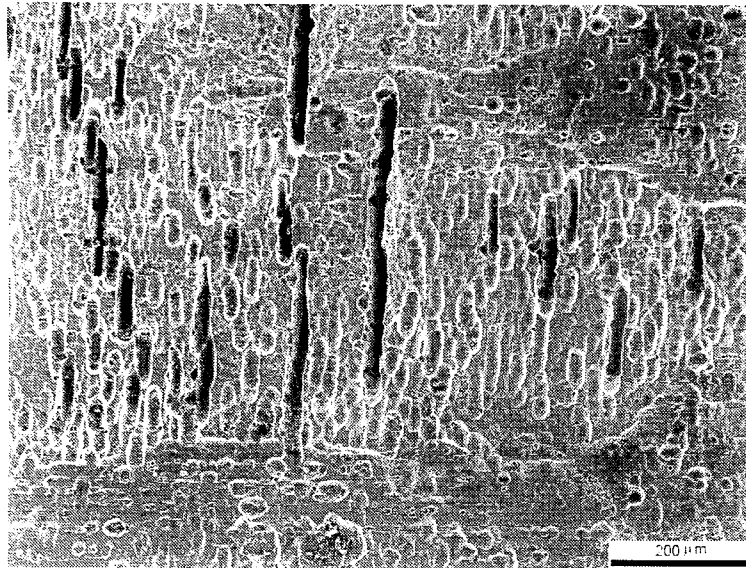
Figure 2.8: SEM micrograph of corrosion-related distributed damage at hole #54 in panel B2-2-2 of the CZ-184 aircraft [18].

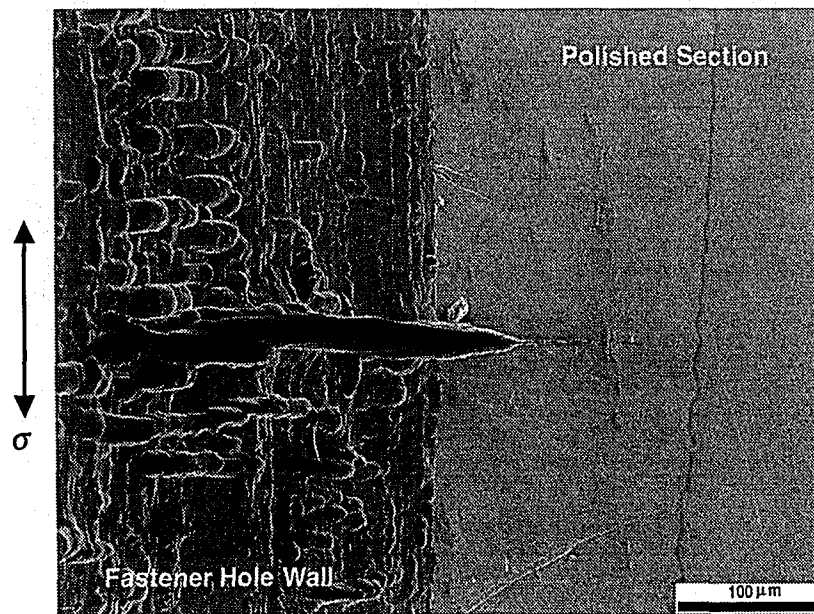
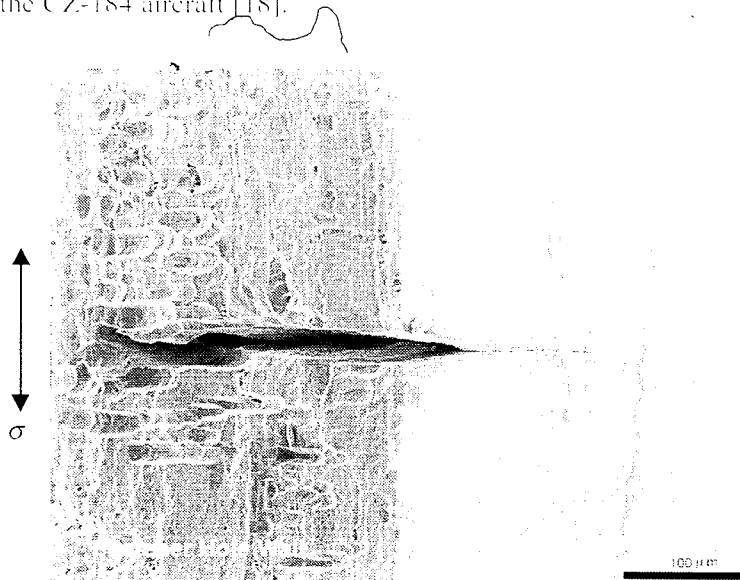
Figure 2.9: SEM micrograph of a section through an elongated damage at hole #77 in wing panel B3-2-5 of the CZ-184 aircraft showing corrosion attack of the fatigue crack [18].

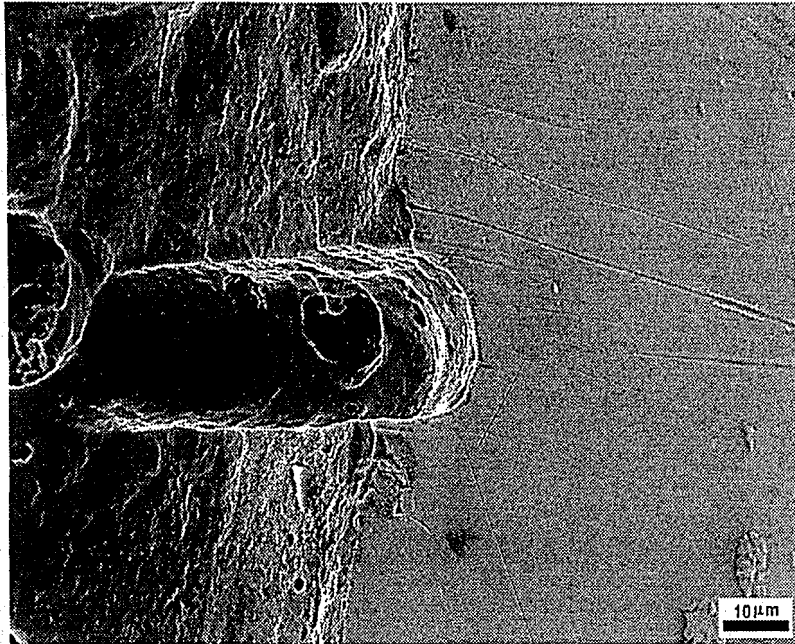
Figure 2.10: SEM micrograph of a through section of a shallow damage at hole #77 in wing panel B3-2-5 of the CZ-184 aircraft suggesting that the crack was dissolved by corrosion [18].

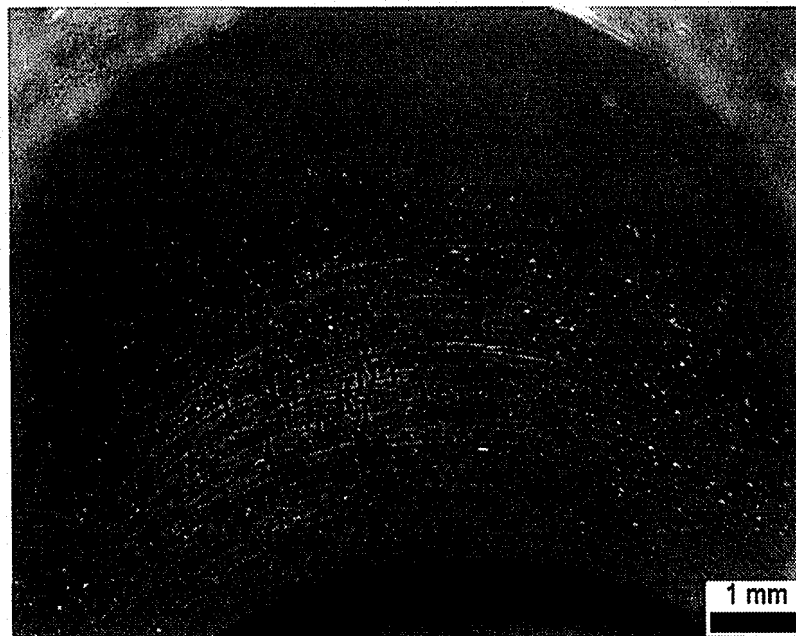
Figure 2.11: Optical micrograph of a highly stressed region of hole #107 in wing panel B3-2-2 of the CZ-184 aircraft showing extensive corrosion fatigue cracking [18].

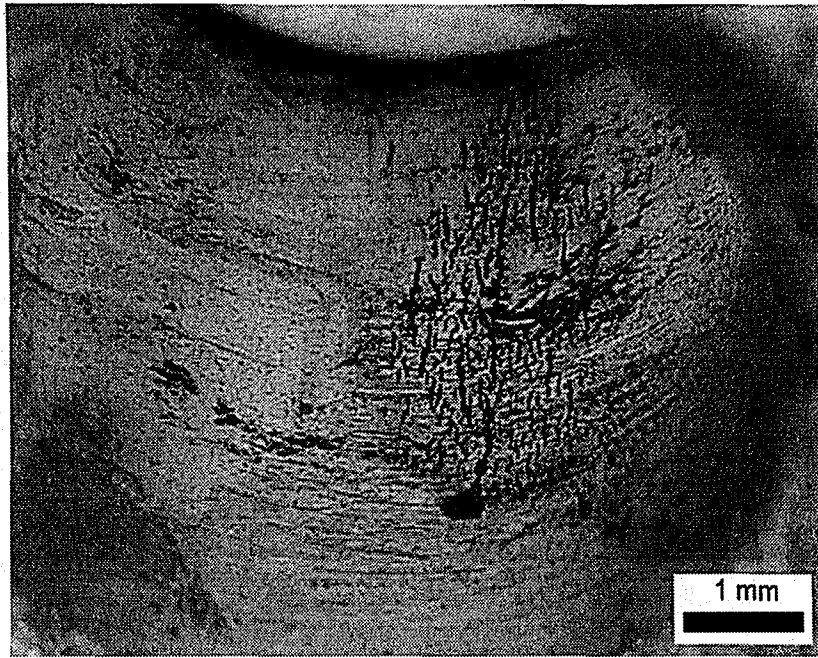
Figure 2.12: Optical micrograph of a highly stressed region of hole #103 in wing panel B3-2-2 of the CZ-184 aircraft showing extensive corrosion fatigue cracking [18].

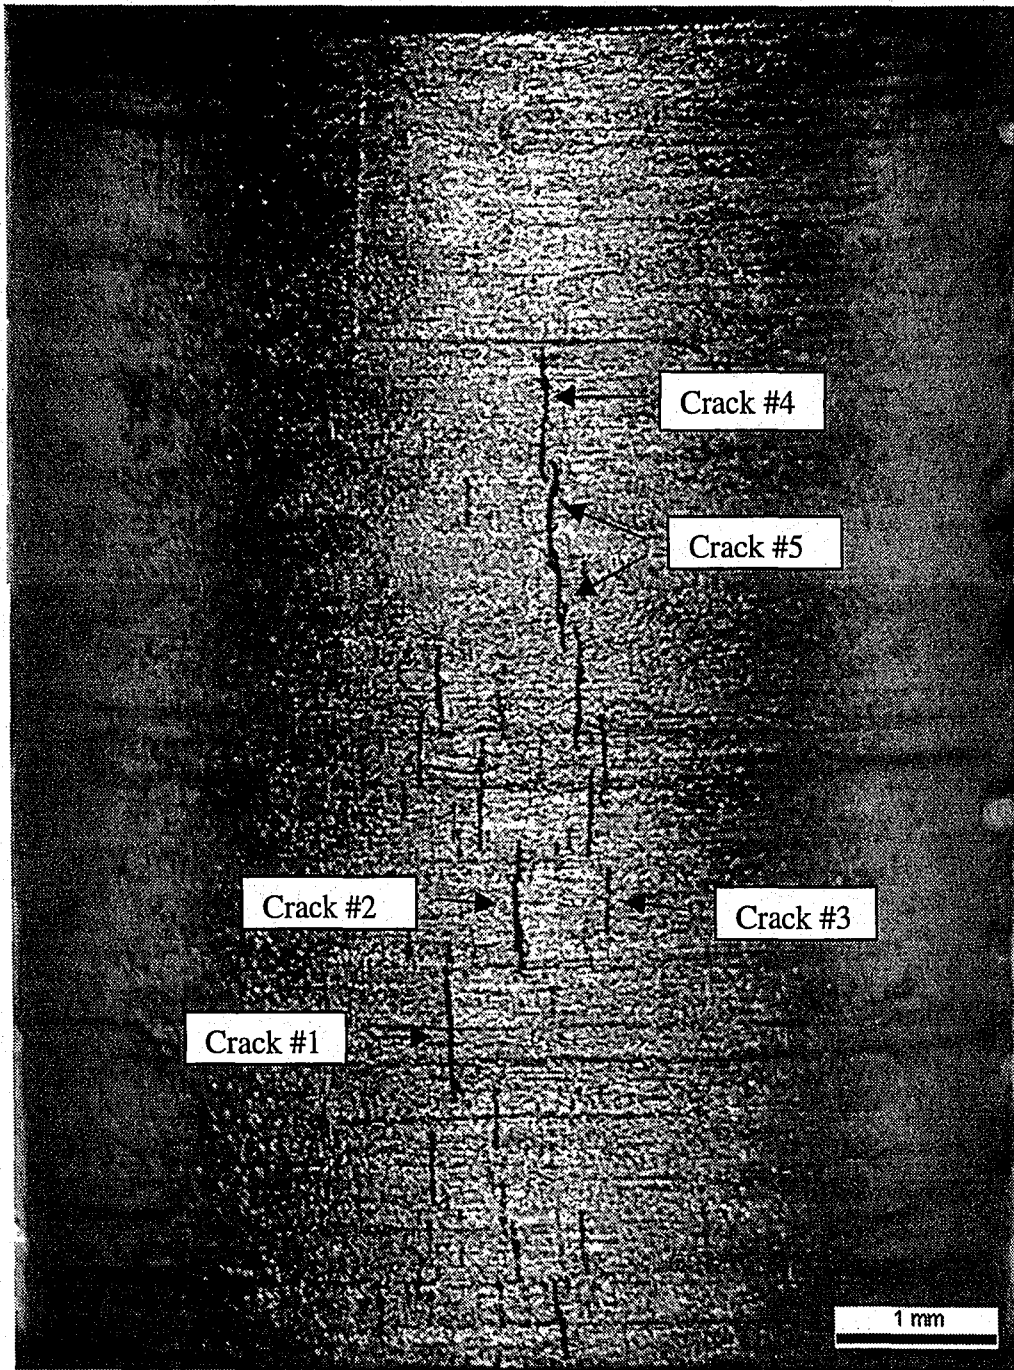
Figure 4.1: 50X Optical micrograph of hole #32 on panel B3-2-6 prior to serial sectioning.

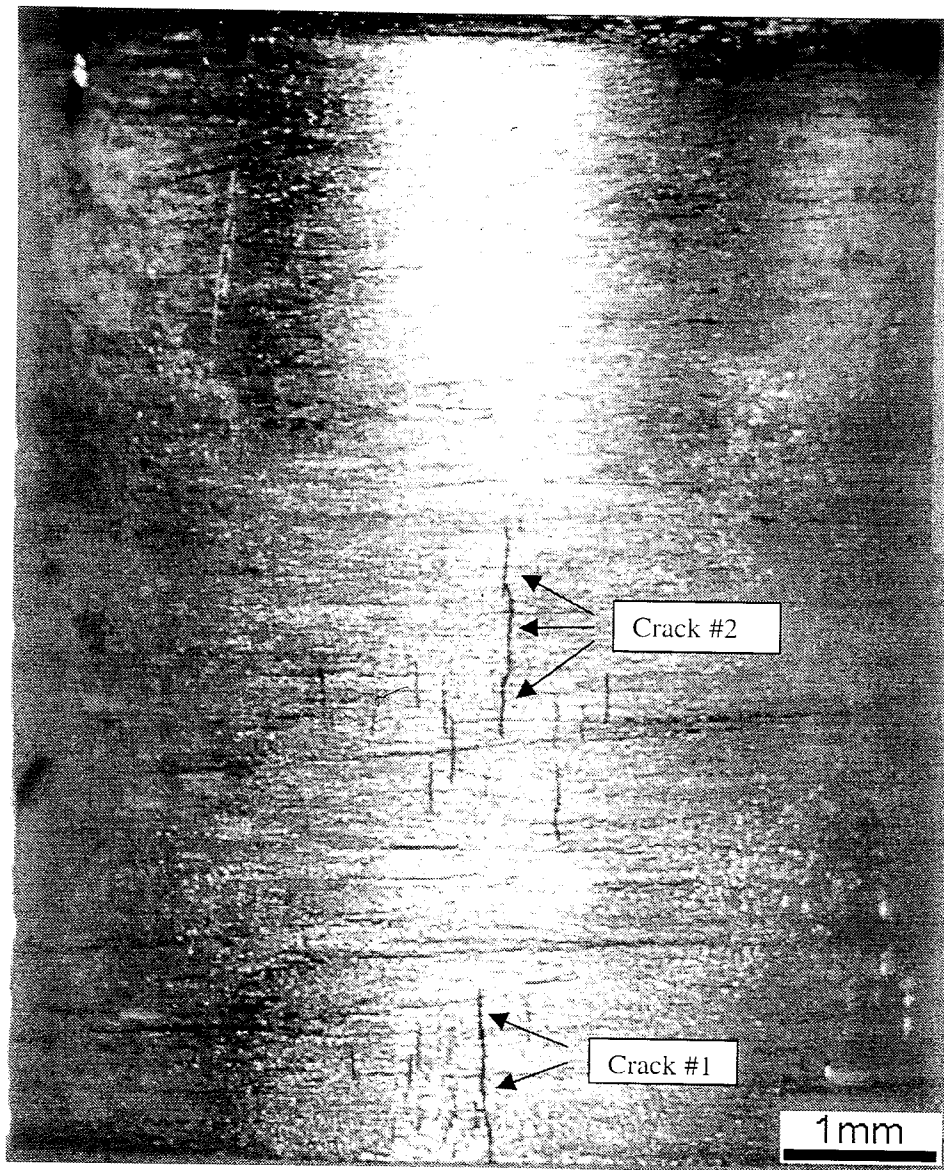
Figure 4.2: 50X Optical micrograph of hole #107 on panel B3-2-2 prior to serial sectioning.

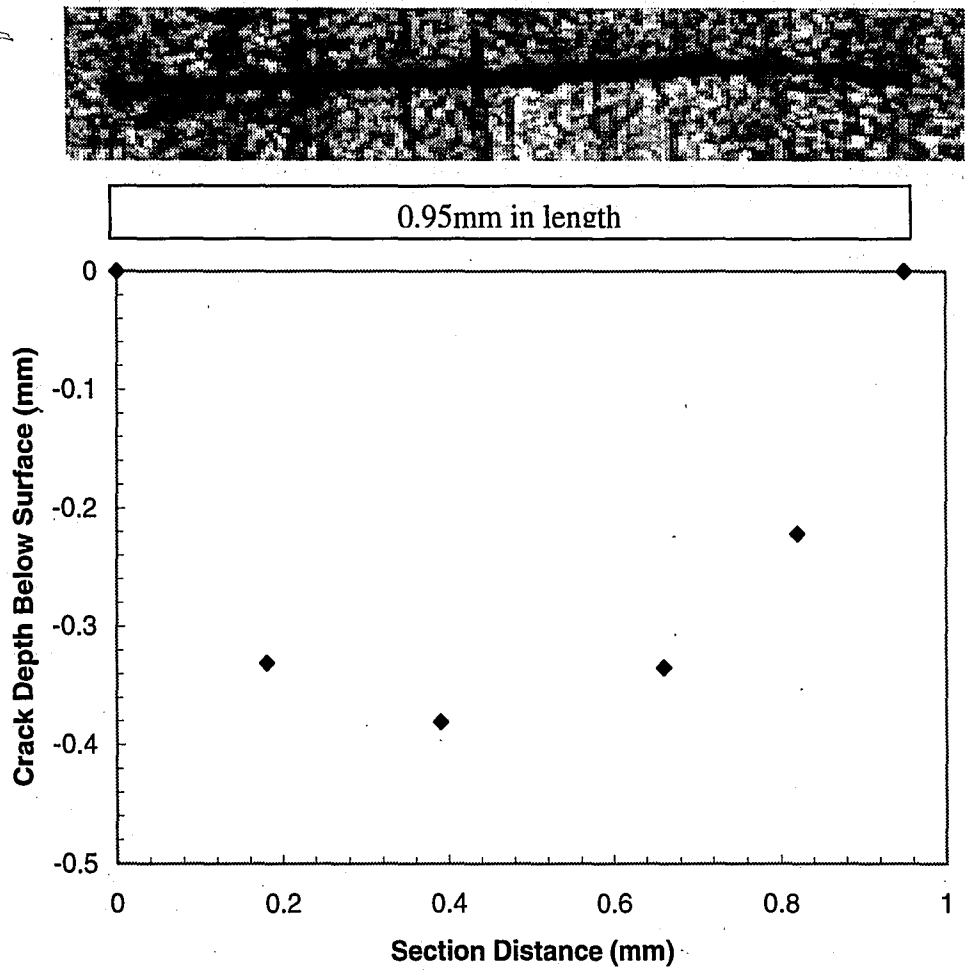
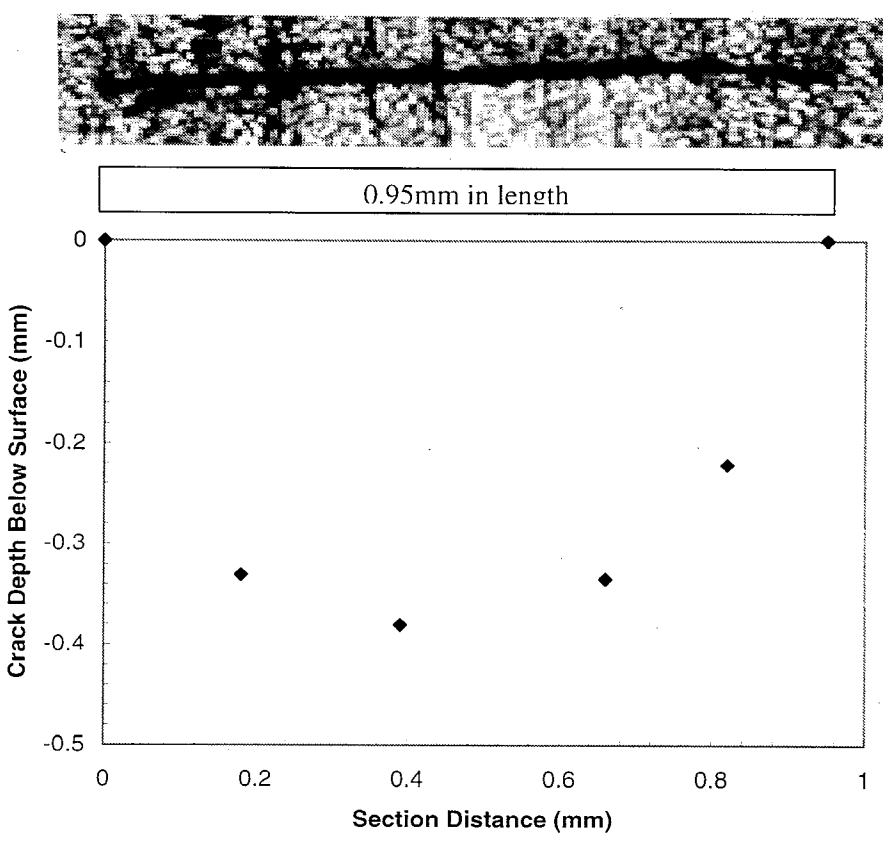
Two cracks on panel B3-2-6 in hole #32 were examined and found to be single, isolated damage sites where the cracks did not link-up. Crack #1 has a length of 0.95mm and a maximum depth of 0.38mm, and the crack measurements are given in Table A.1. From the profile given in Figure 4.3, it can be seen that this crack tends to be semi-elliptical in shape, rather than semi-circular. Crack #3 was the shortest and least deep single crack that was sectioned, and the measurements are seen in Table A.3. It was 0.45mm long with a maximum depth of 0.16mm, as seen from the profile in Figure 4.4. This crack is also semi-elliptical in shape, like the other single crack that was sectioned. These geometrical variations suggest that the mechanistically based probability model for a single dominant crack must be refined to include a semi-elliptical crack geometry. Measurements of crack depth for these two cracks were made using optical microscopy and a digitizing pad. The quality of the optical photos for these cracks was inadequate because scratches easily showed, and therefore they are not presented in this thesis. SEM was not used for the single cracks, but the later use of SEM proved to be useful in photographing interesting features associated with multiple cracks.

Figure 4.3: Optical micrograph for Crack #1 in hole #32 on panel B3-2-6 and its profile.

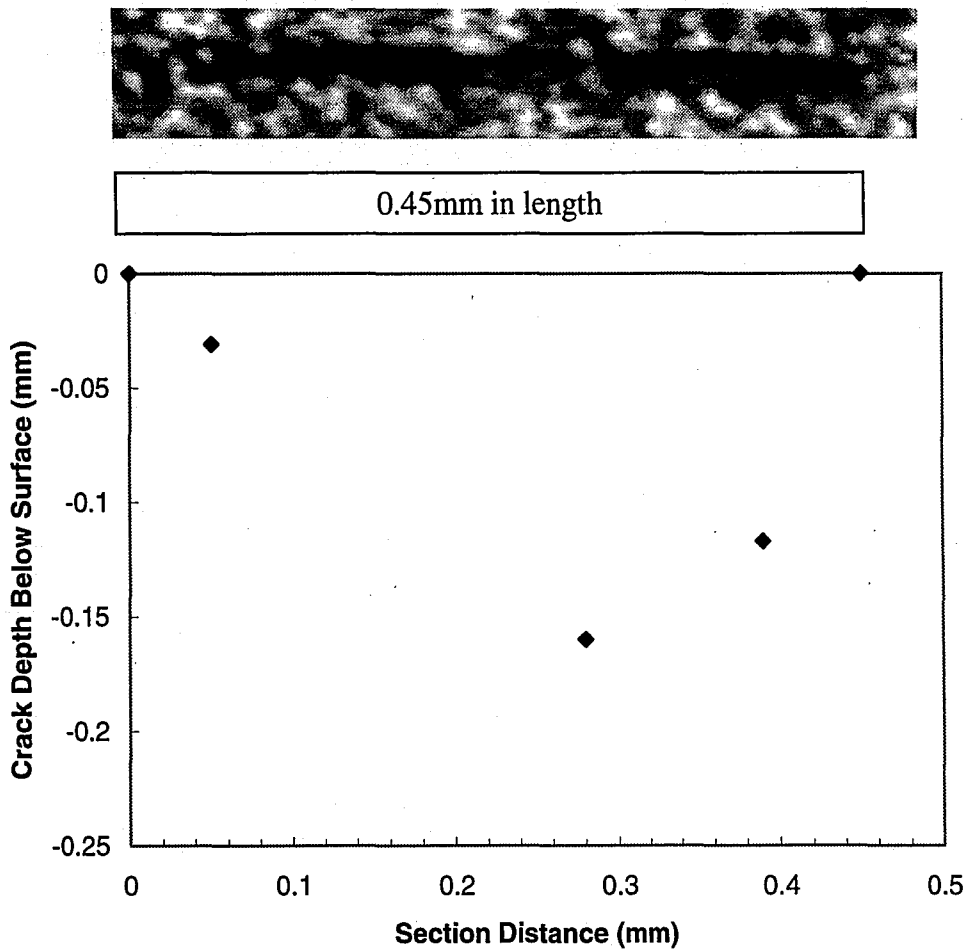
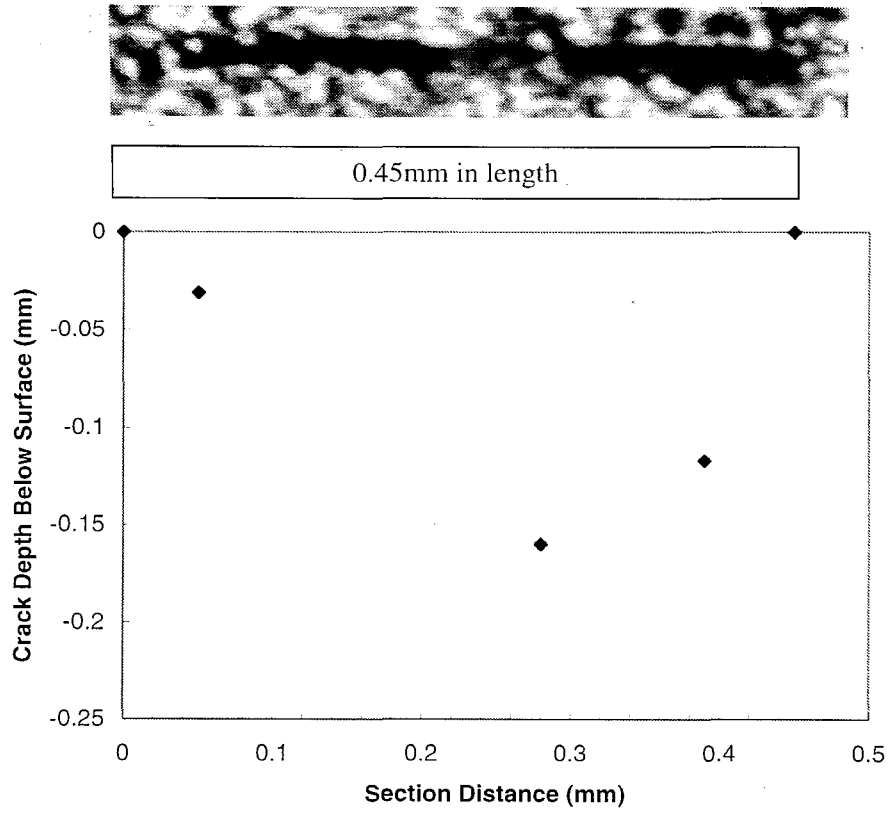
Figure 4.4: Optical micrograph for Crack #3 in hole #32 on panel B3-2-6 and its profile.

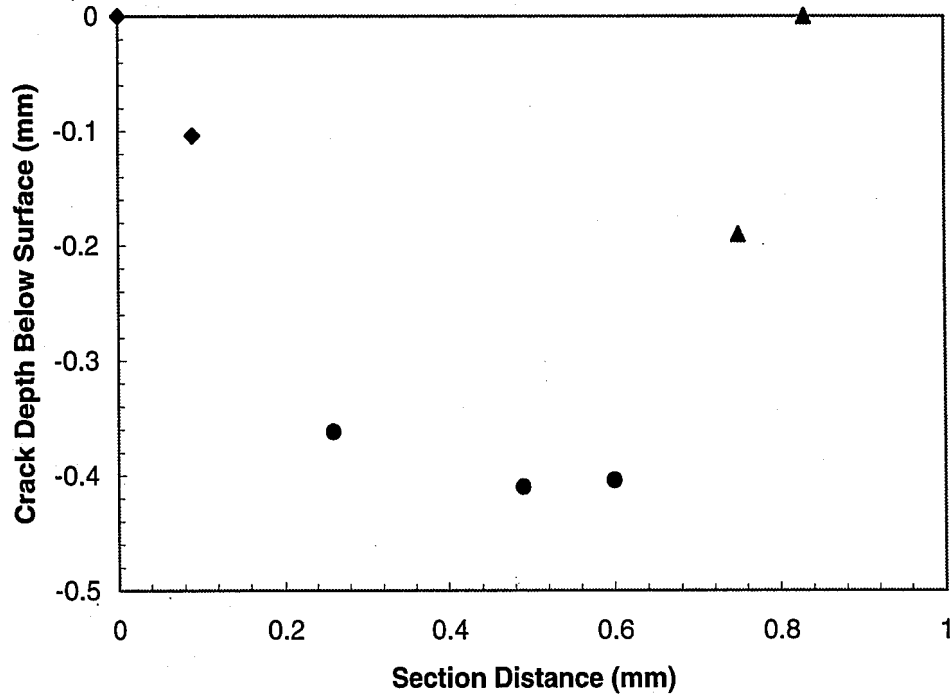
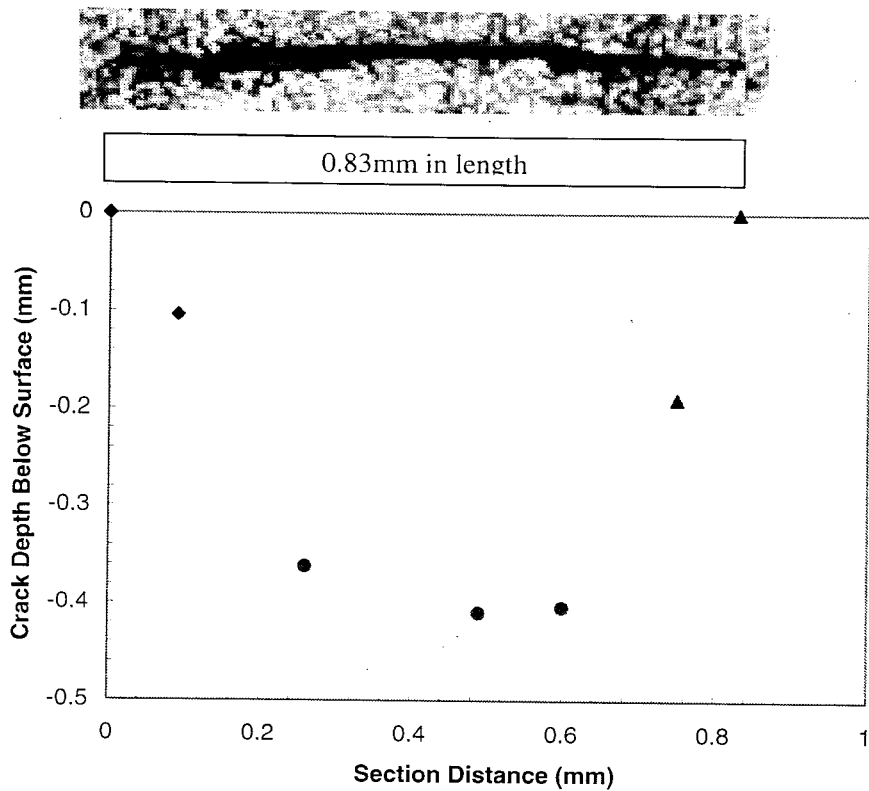
Figure 4.5: Optical micrograph for Crack #2 in hole #32 on panel B3-2-6 and its profile.

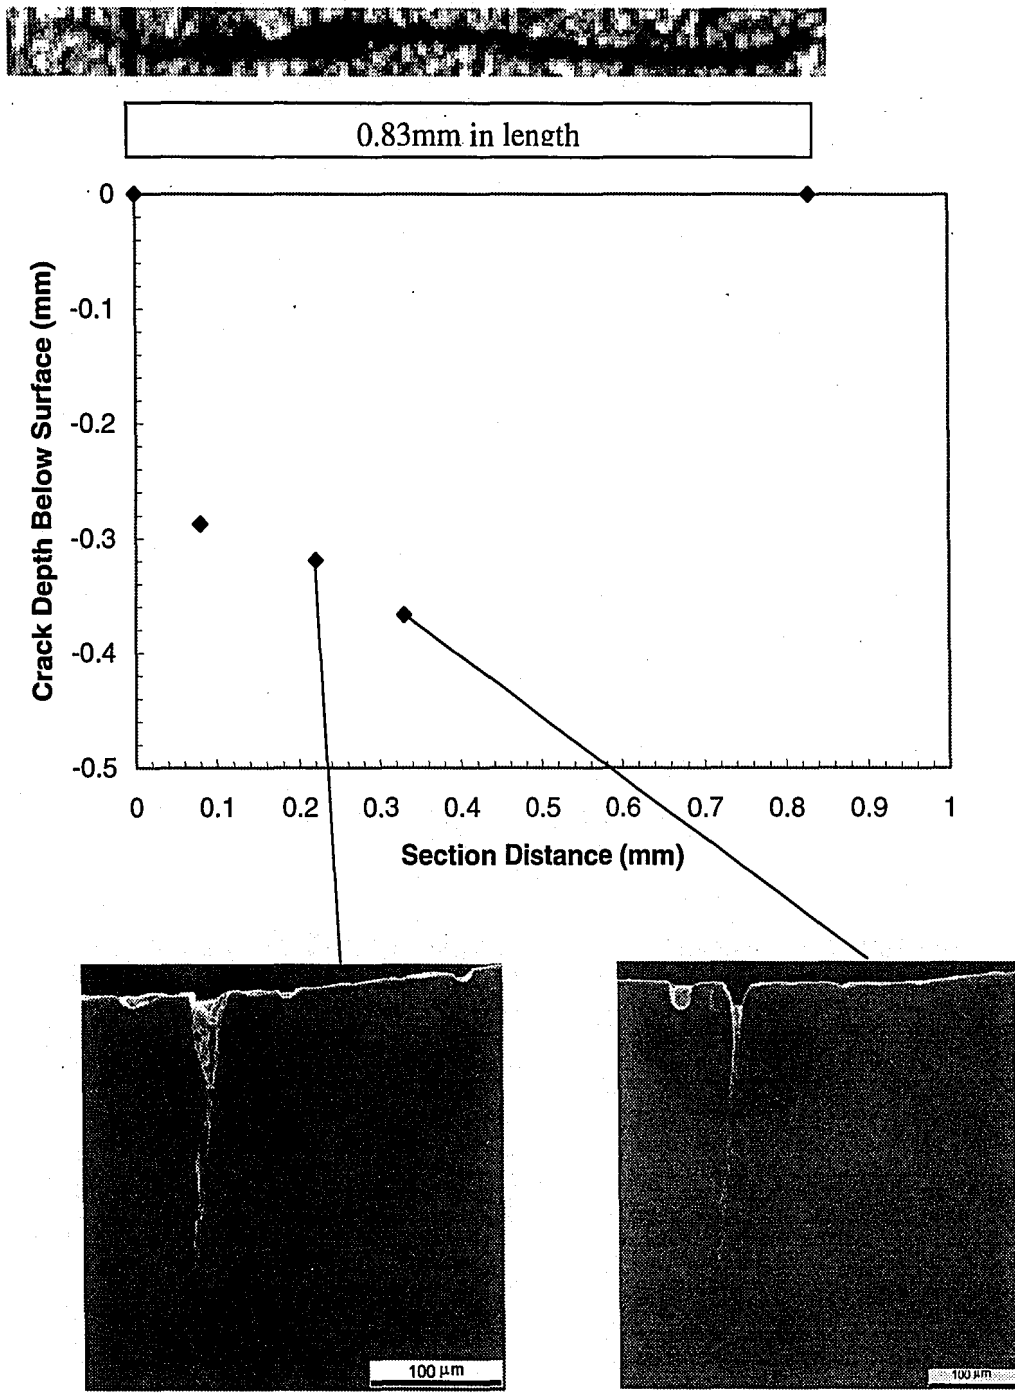
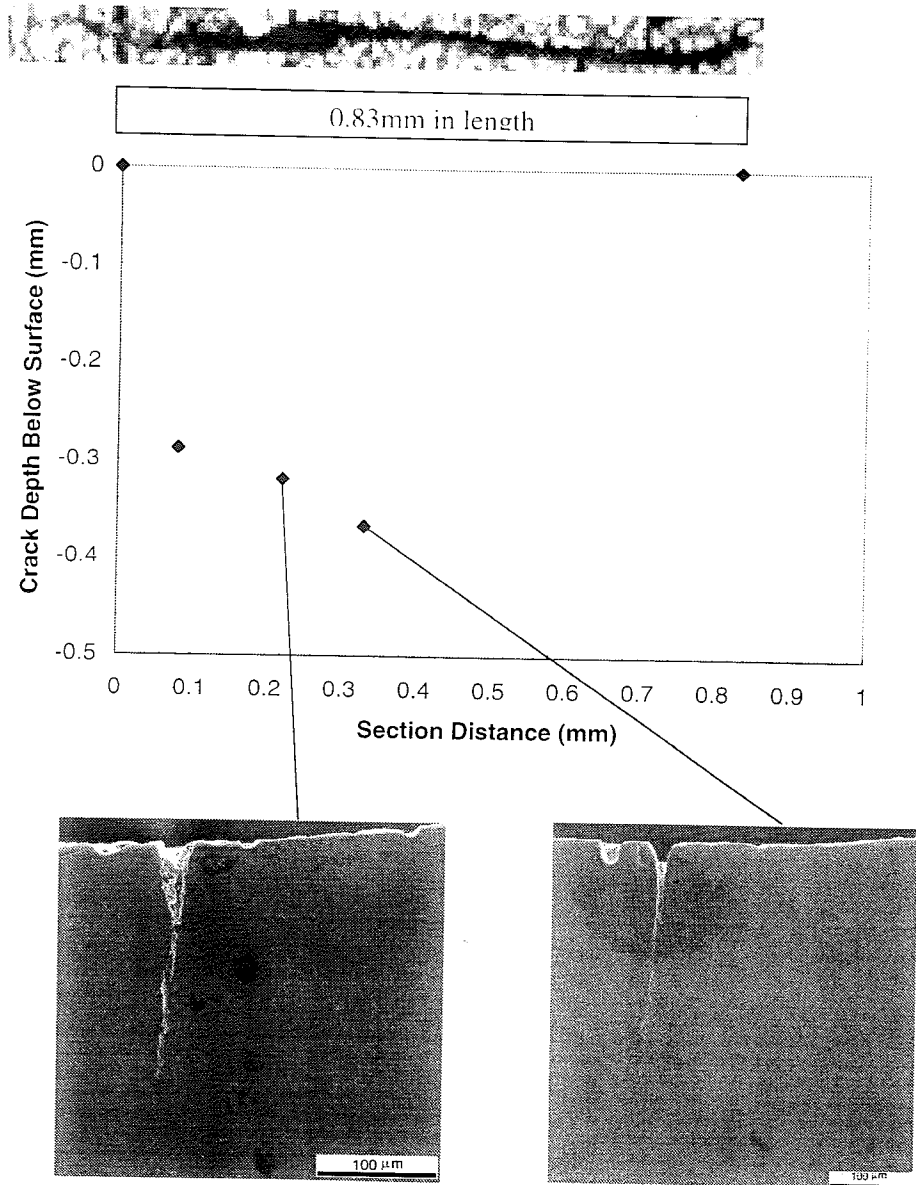
Figure 4.6: Profile with SEM micrographs for Crack #4 on panel B3-2-6.

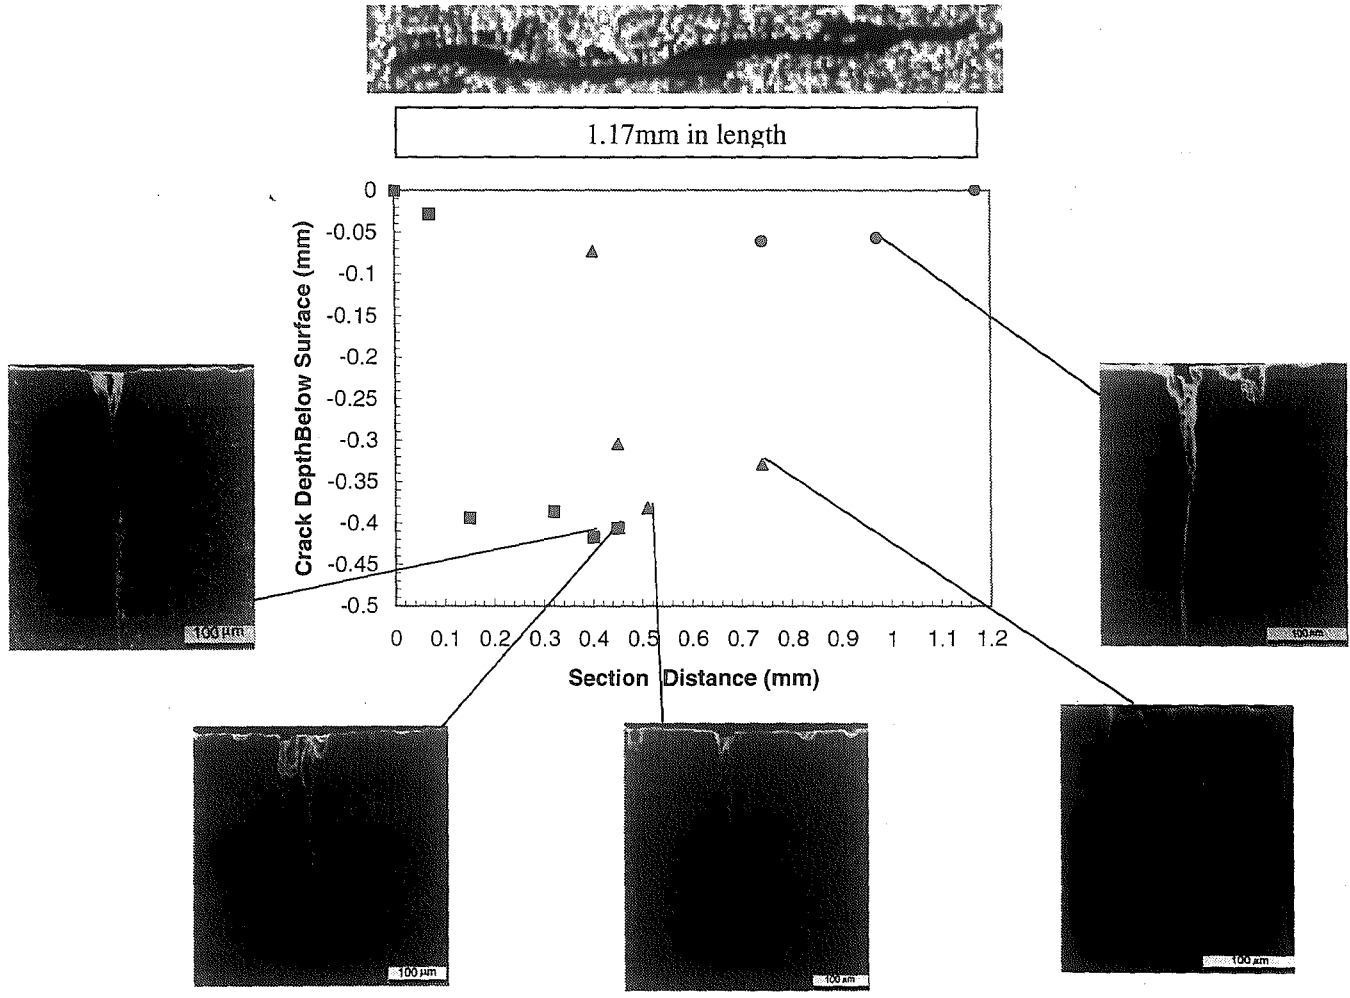
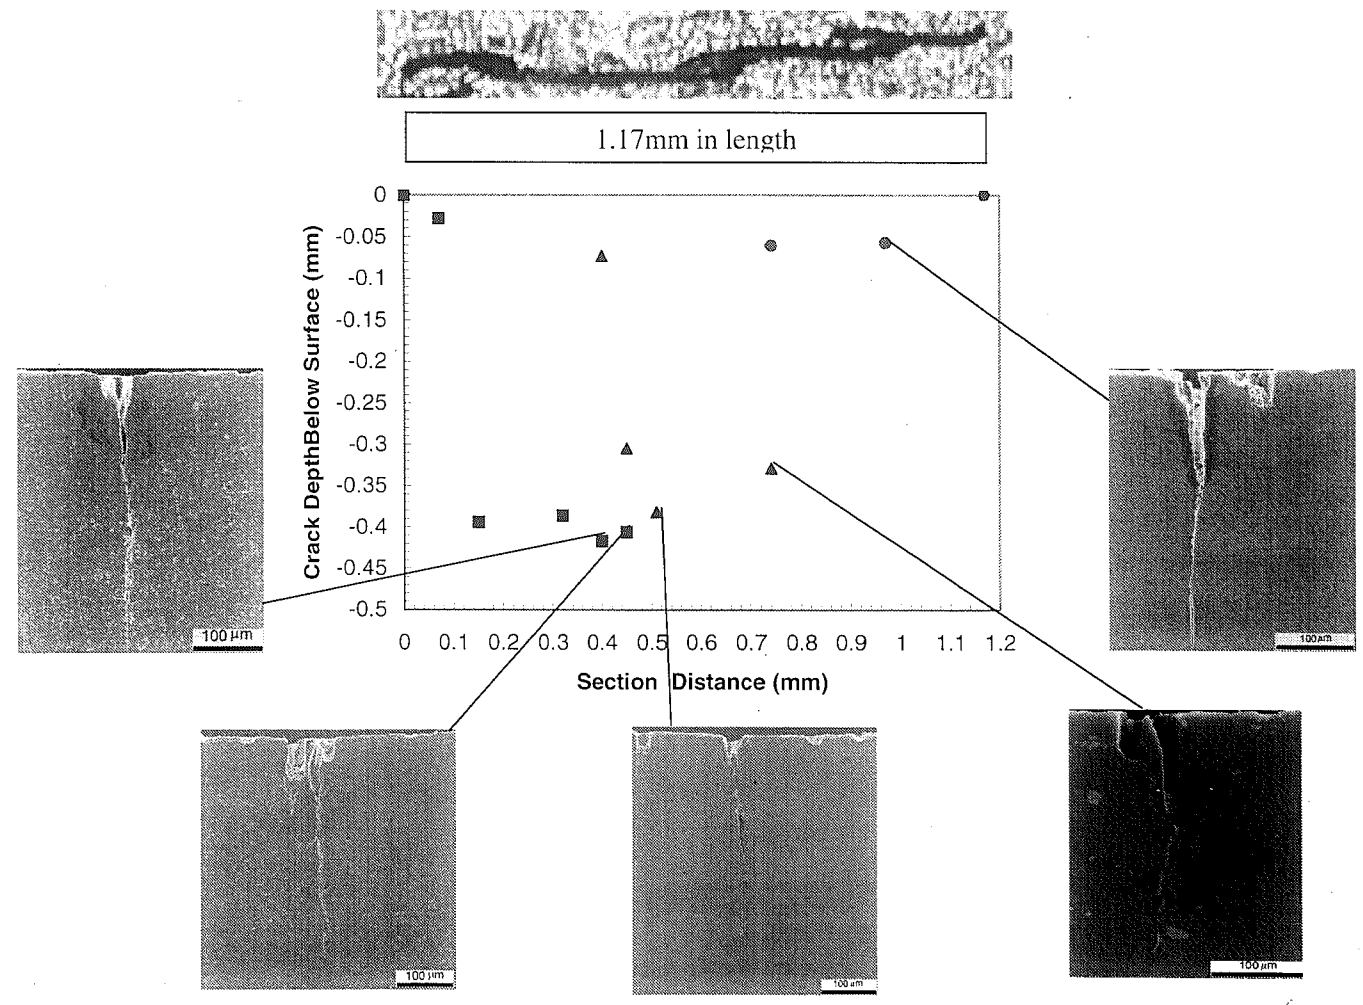
Figure 4.7: Profile with SEM micrographs for Crack #5 on panel B3-2-6.

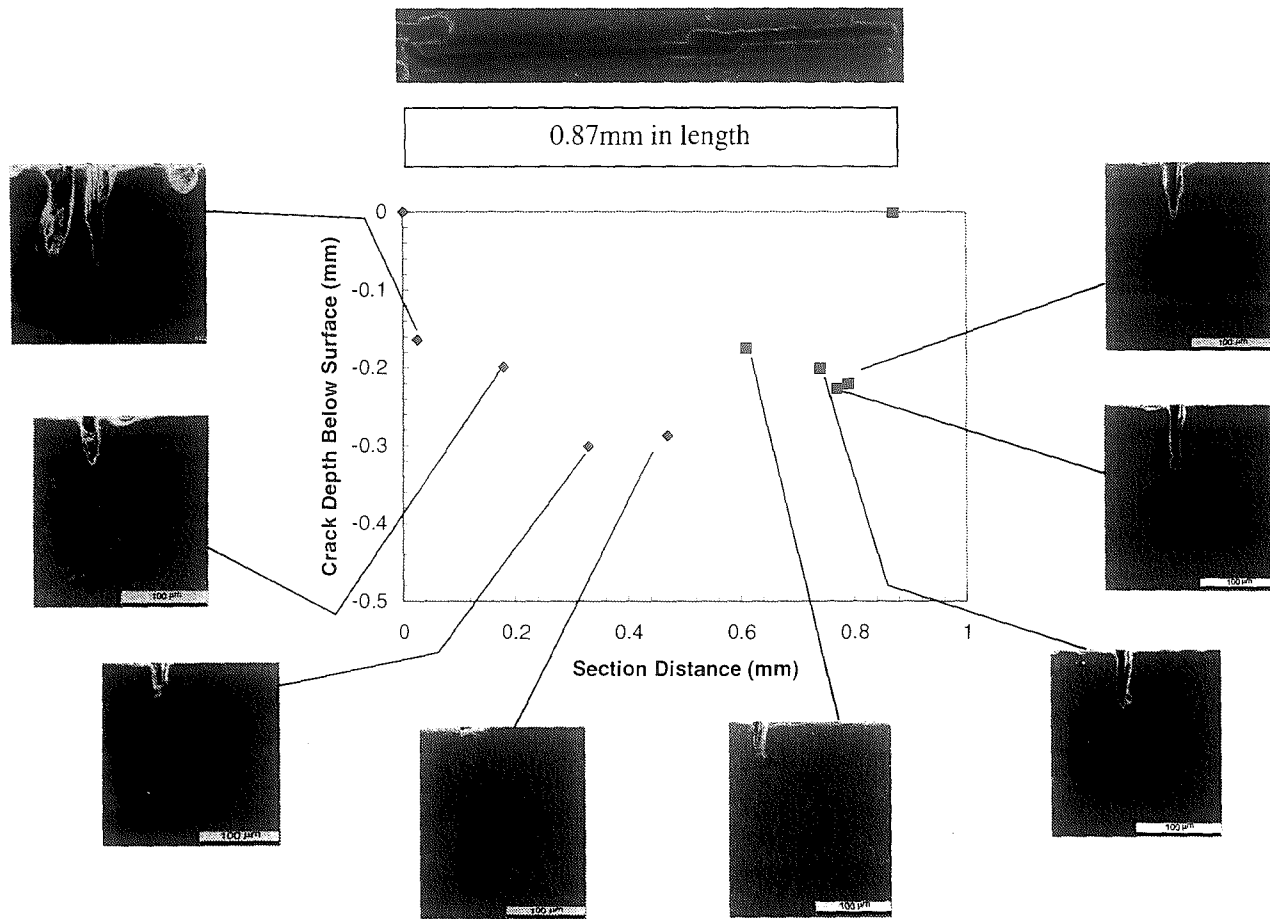
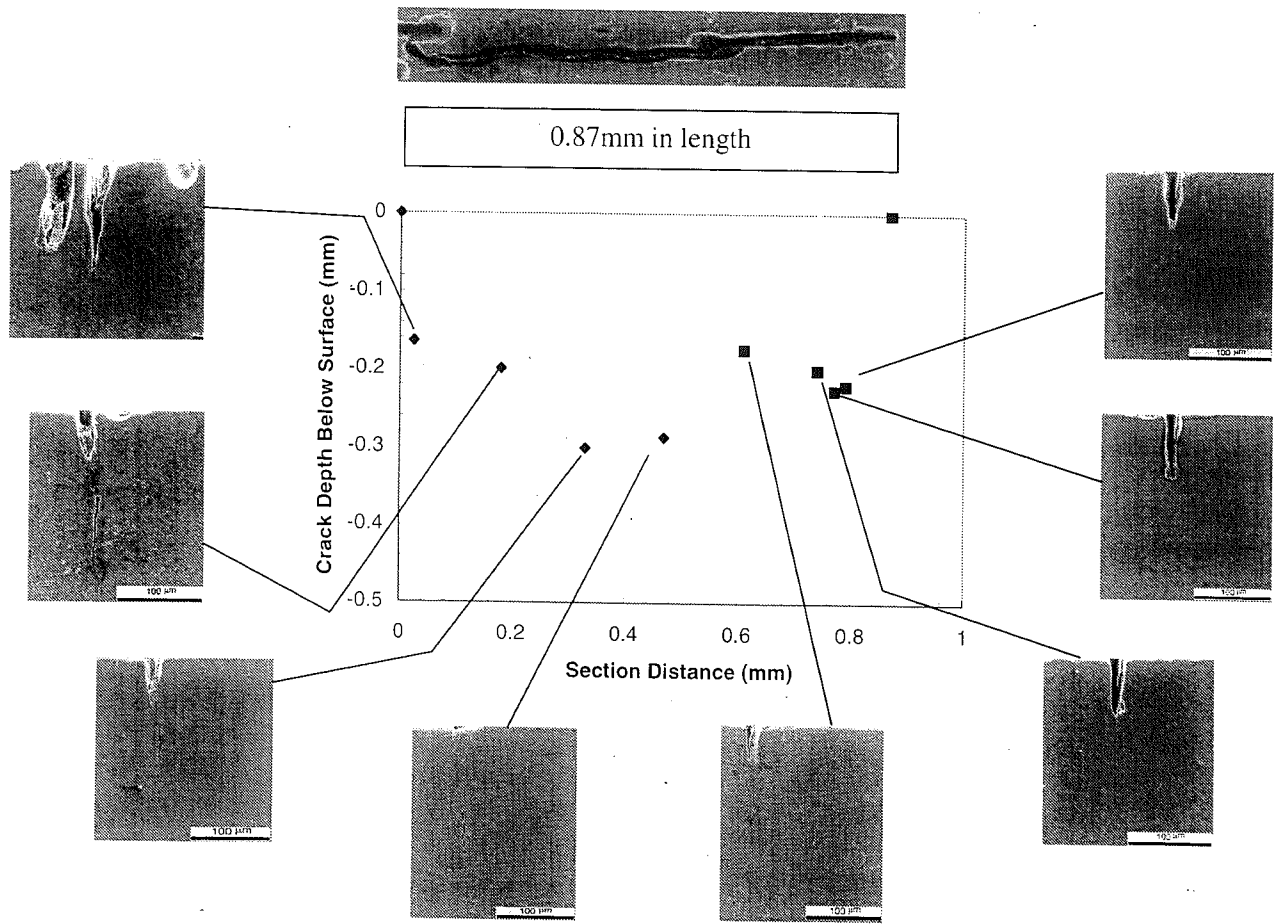
Figure 4.8: Profile with SEM micrographs for Crack #1 in hole #107 on panel B3-2-2.

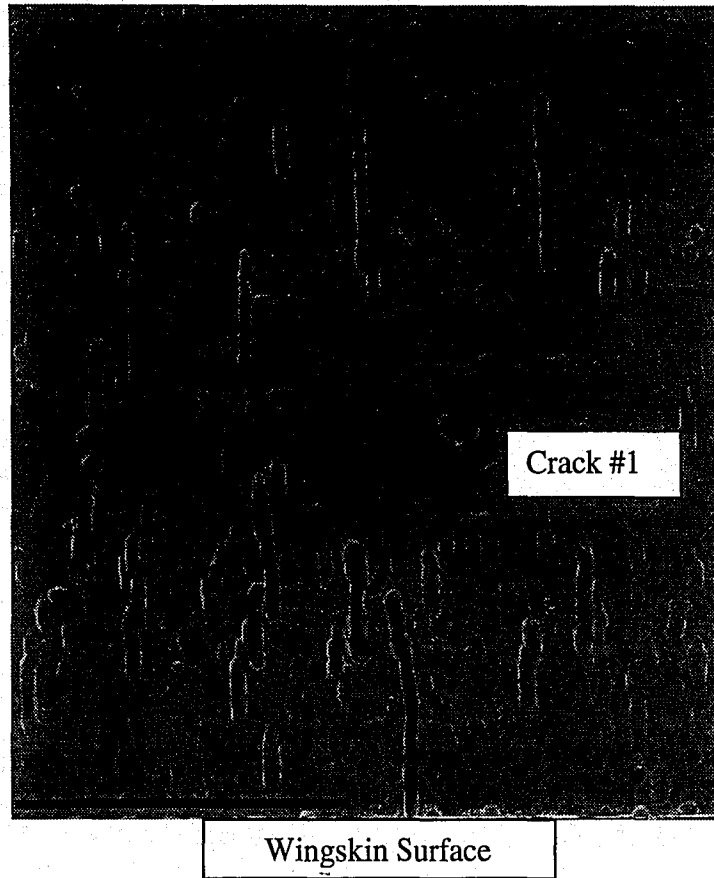
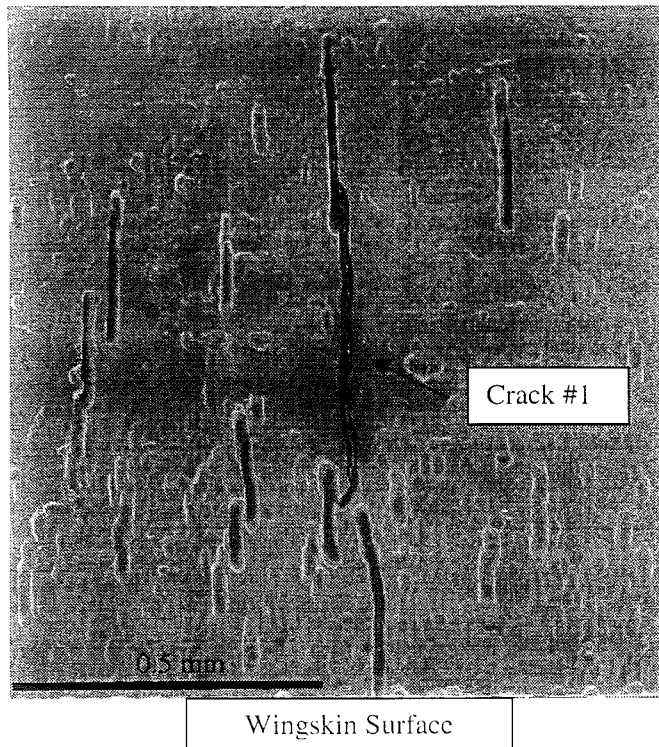
Figure 4.9: 50X SEM micrograph of the lower cracked region of hole #107 on panel B3-2-2. Notice how Crack #1 will link-up with damage near the wingskin surface if the crack continues to grow.

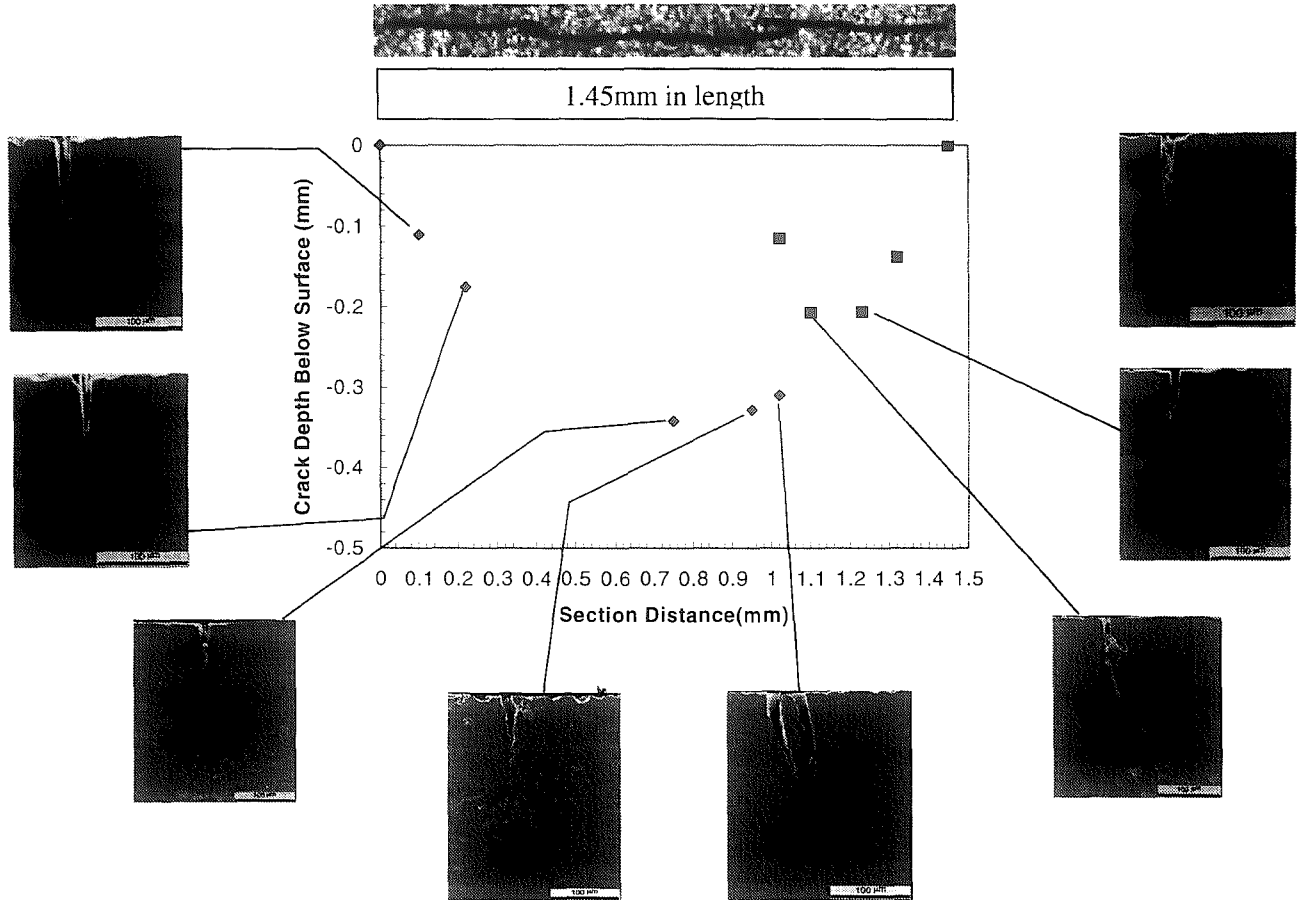
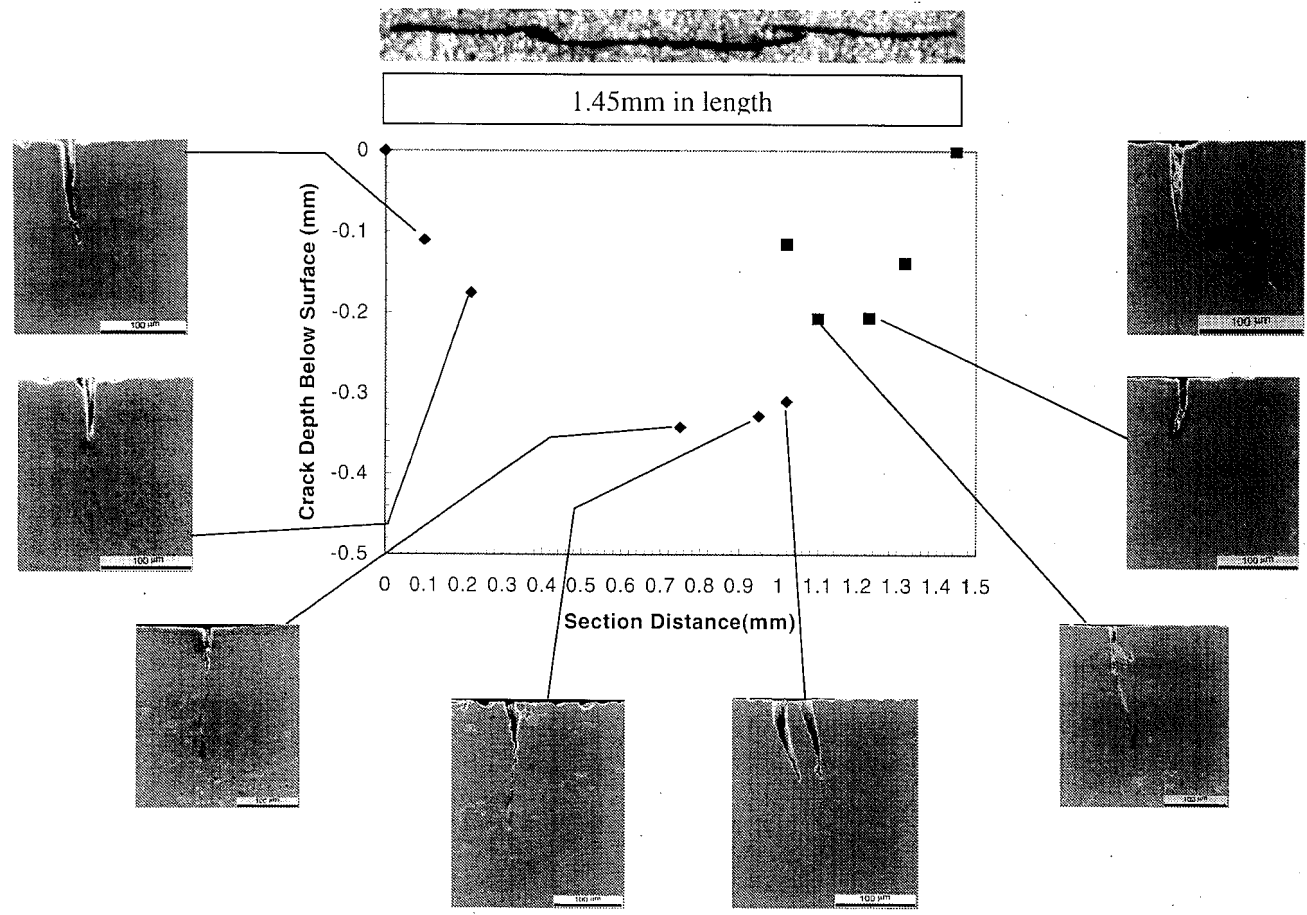
Figure 4.10: Profile with SEM micrographs for Crack #2 on panel B3-2-2.
