Characterization of corrosion fatigue damage in the fastener holes of a Boeing 707

**CHARACTERIZATION OF CORROSION FATIGUE DAMAGE IN
THE FASTENER HOLES OF A BOEING 707**

A Thesis
—Presented to the Graduate and Research Committee
of Lehigh University
in Candidacy for the Degree of
Master of Science

Lehigh University
April 2001

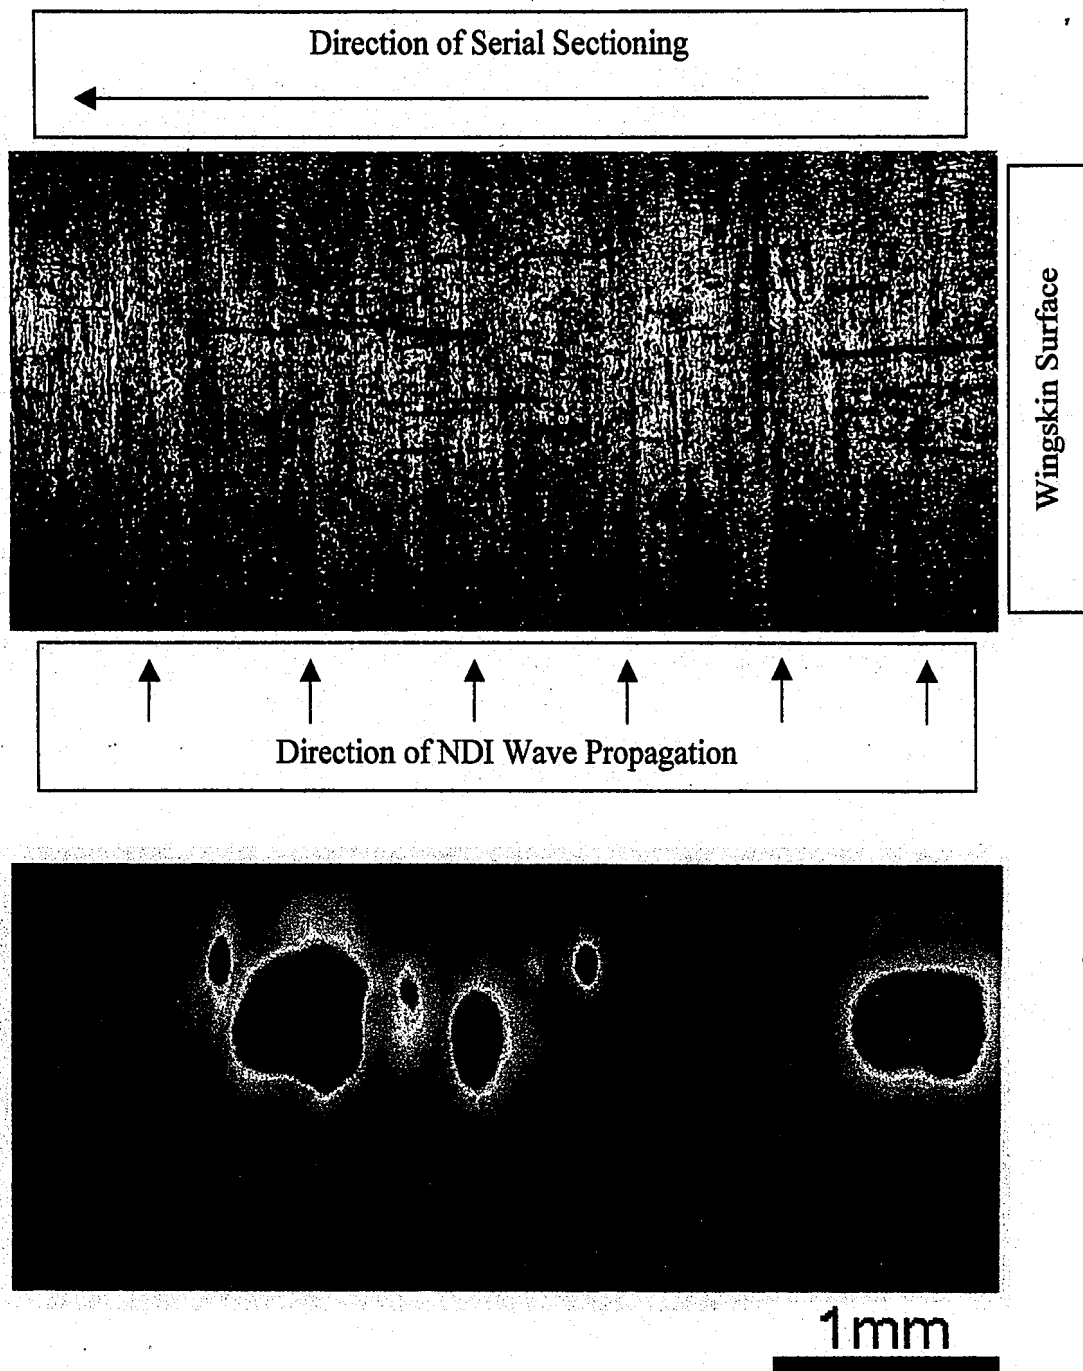
Although NDI acknowledges the presence of damage in the fastener holes, it is not adequate for a fastener hole with multiple cracks along the surface and through the thickness. The actual shape of damage for multiple cracks cannot be resolved from the output, and not all cracks will be detected. Perhaps for a single, isolated crack in a fastener hole NDI would return better results.

Figure 4.20: NDI photo of hole #107 on panel B3-2-2. NDI was performed with assistance from ALCOA.

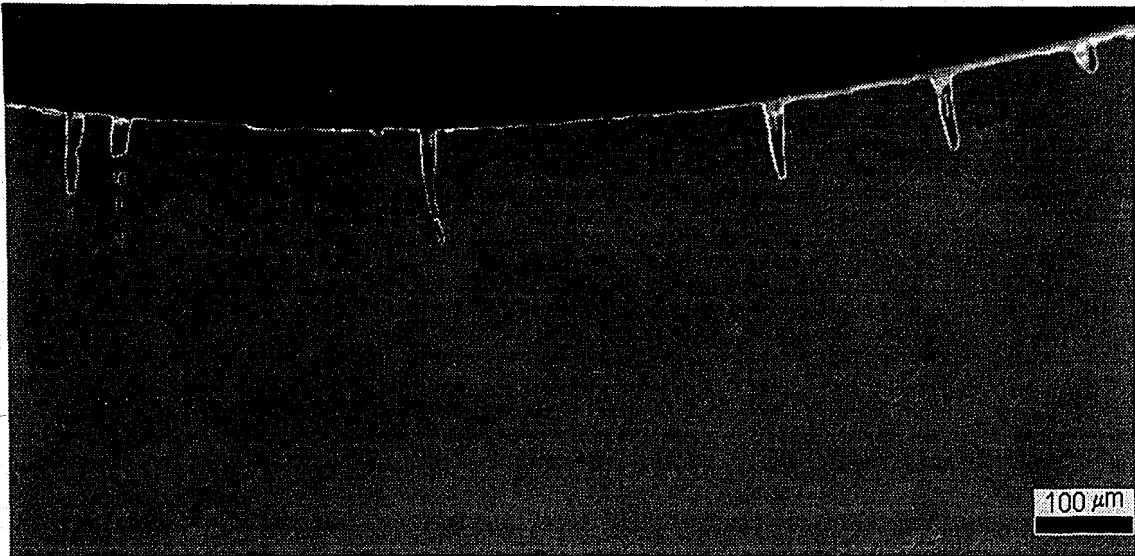
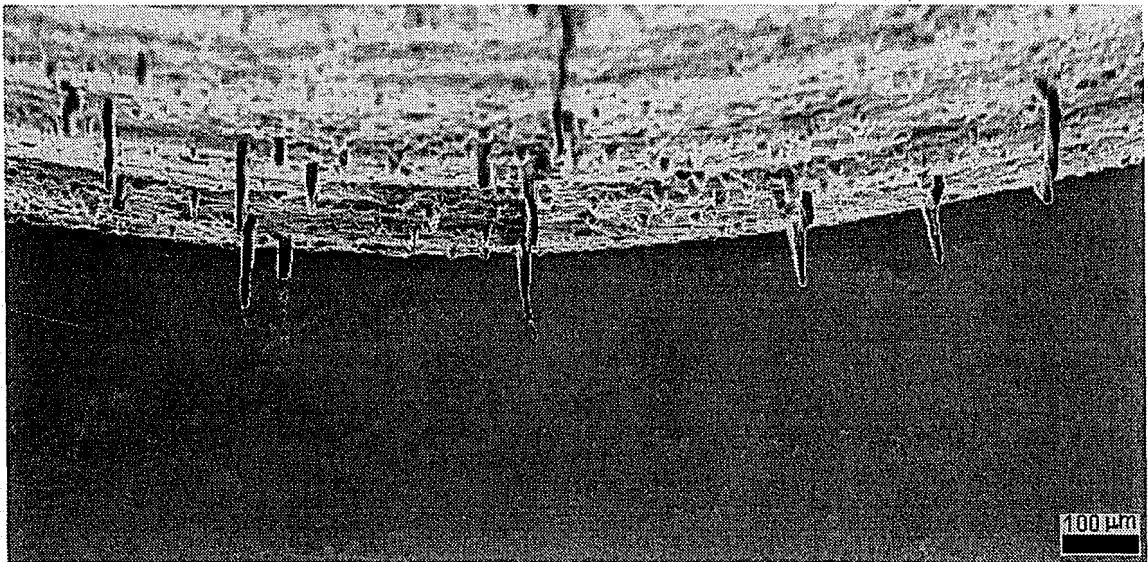
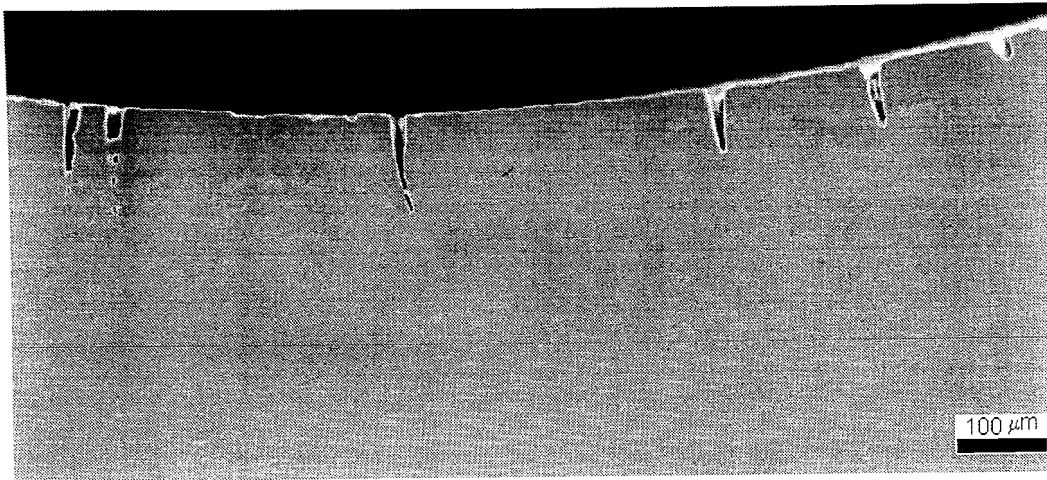
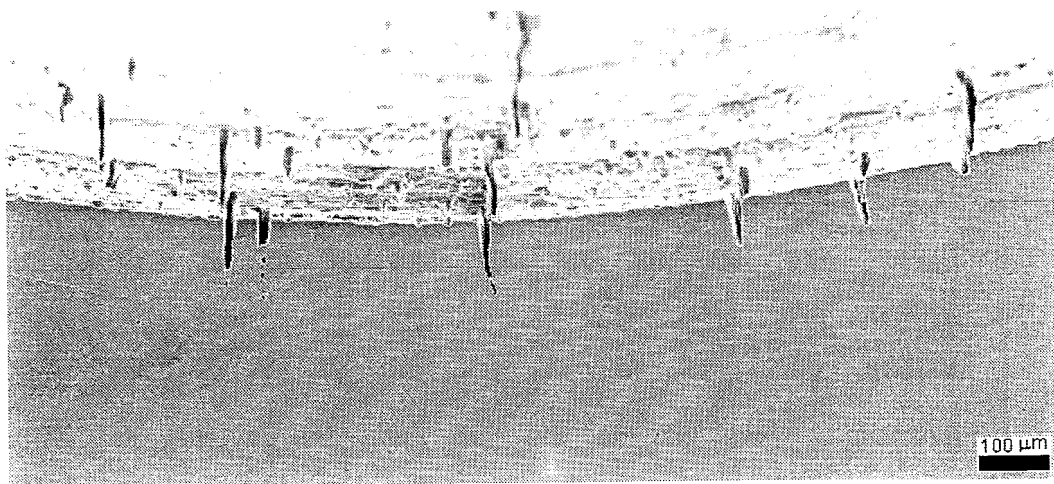
Figure E.1 (cont'd): SEM micrographs of Section 1 that show (c) several cracks are present at the section at 70X and (d) 30° tilted micrograph at 50X which shows the numerous cracks as well as Crack #2 at Section 1.
