Failure Analysis of the US 422 Girder Fracture

Final Report

ATLSS Report No. 04-21

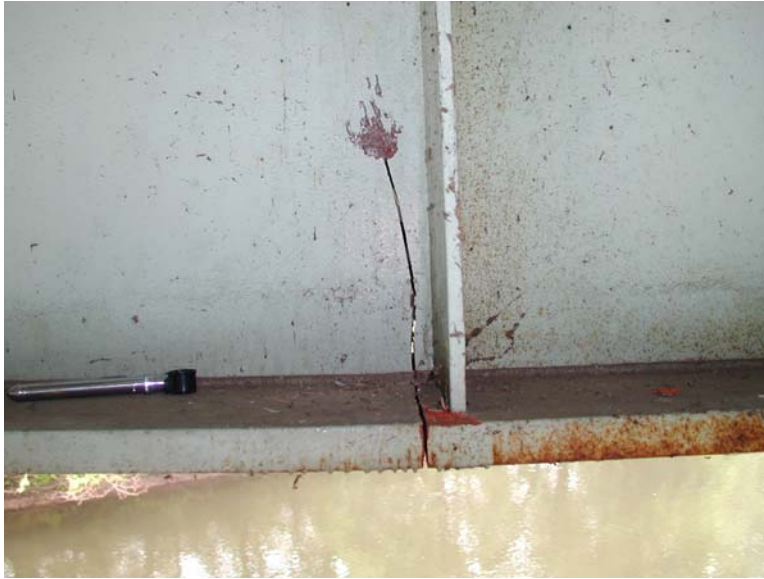
In 2003 a fracture was detected in a steel plate girder in a span of the bridge carrying US 422 over the Schuylkill River in Pottstown, PA. The fracture was found while retrofits to lateral gusset connections were being performed, similar to those that developed fractures in the Hoan Bridge, Milwaukee, Wisconsin in December 2000 [1]. The fracture occurred at one of these lateral gusset plate connections and resulted in a fracture of the girder web that propagated through the entire bottom flange and extended about nine inches into the web before arresting. Views of the fractured girder and lateral gusset plate connection are shown in Figures 1 and 2. The fracture was located at the intersection of the welds joining the lateral gusset plate and vertical stiffener to the web as was also observed in the Hoan Bridge. The lateral gusset plate also developed a fracture along the fillet weld joining the gusset plate to the vertical stiffener that propagated in the gusset plate for another six inches before arresting.

Figure 1 - Fractured Bottom Flange of Girder and Arrested Web Fracture.
(Photo Courtesy of Gannett Fleming)

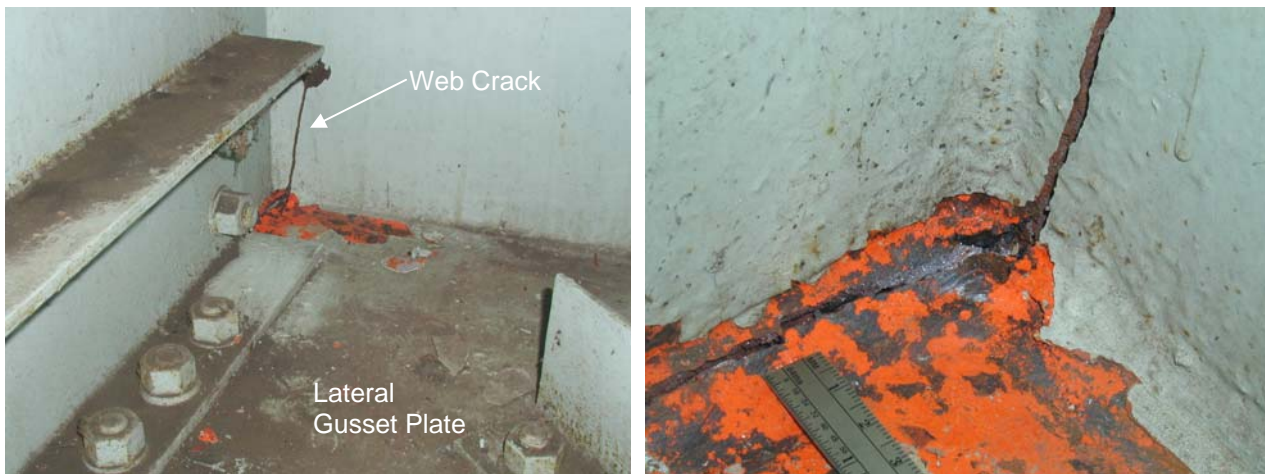
Figure 2 - View of Lateral Gusset Plate Connection and Fracture at the Weld Intersection of the
Gusset and Vertical Stiffener Plates to the Web.
(Photos courtesy of Gannett Fleming)

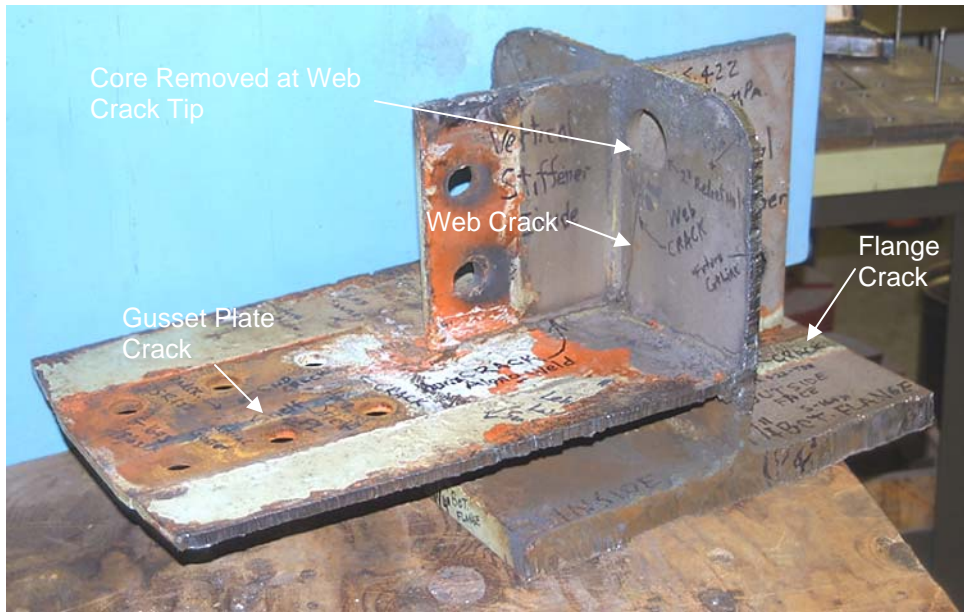
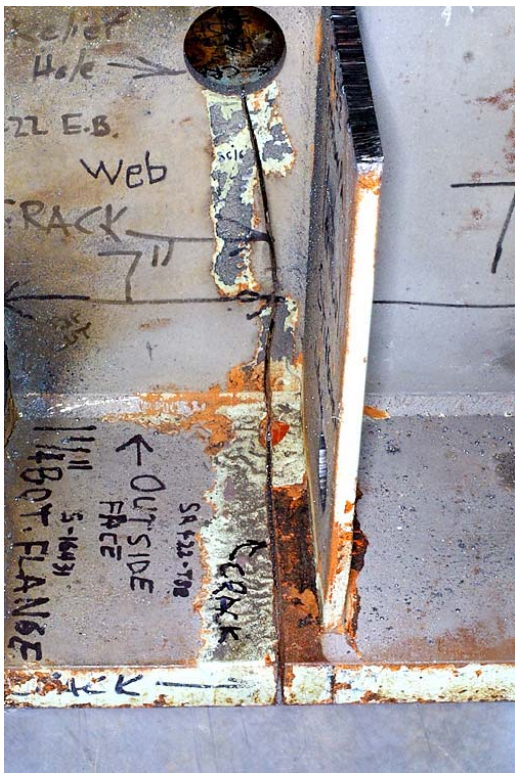
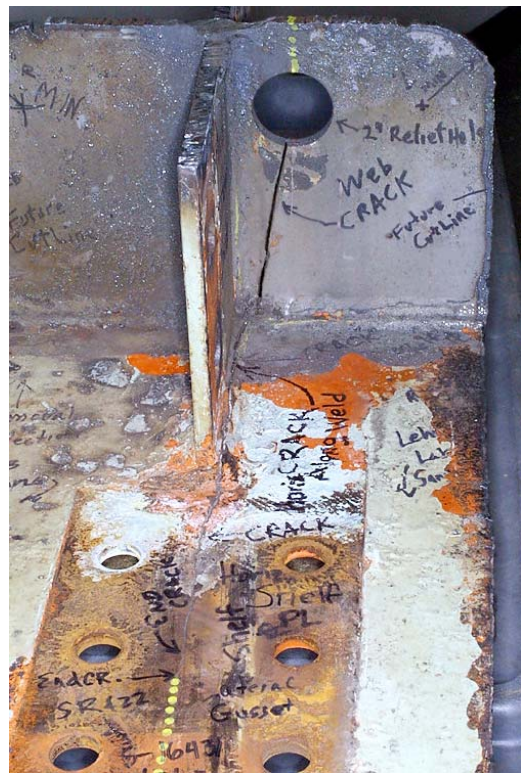
The fracture region removed from the plate girder is shown in Figure 3 and consisted of the entire web and flange fracture including the lateral gusset fracture. Prior to removal from the structure a core was drilled at the arrested web crack tip to prevent possible re-initiation of the crack. The core was also included for examination (see Sec.II.3). Figure 4 shows the general appearance of the crack surface. A light corrosion layer was evident over most of the surface from exposure to the weather prior to removal. No evidence of heavy corrosion resulting from long-term exposure was seen anywhere on the crack surface which precluded the existence of an earlier crack in the gusset-vertical stiffener weld (see Figure 5) or girder web. Chevron marks on the web fracture surface clearly pointed to the weld intersection of the lateral gusset plate and the vertical stiffener as the origin of the girder fracture (see Figure 4). The brittle fracture propagated into the bottom flange via the girder longitudinal fillet welds (see Figure 6) and also propagated upward in the web until it arrested about 9 inches from the bottom flange.

Figure 3 - Fracture Region Removed From the Girder.

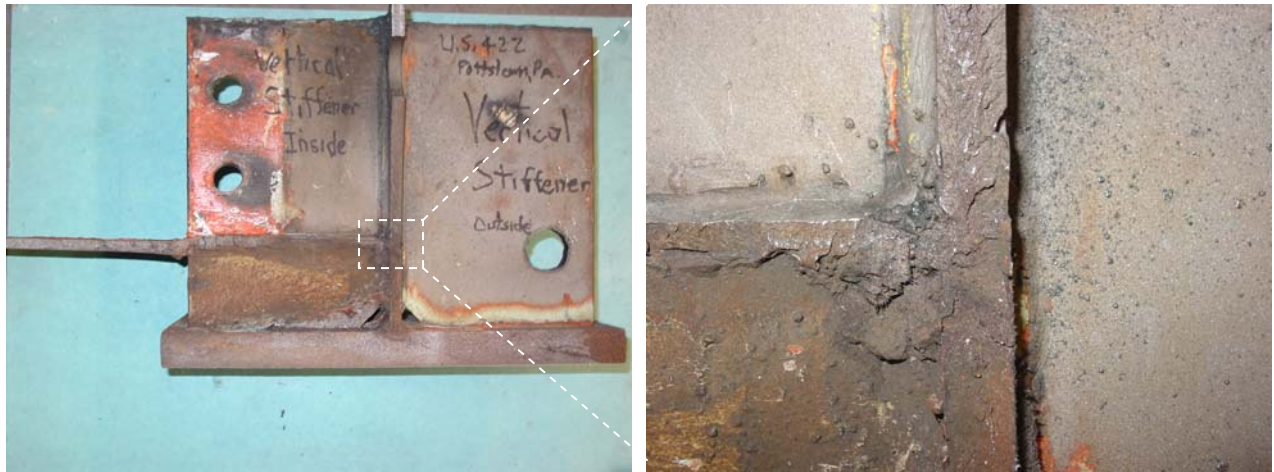
Figure 4 - Brittle Fracture Appearance of Crack Surfaces With Chevrons Pointing Back to Fracture Origin at the Weld Intersection of the Lateral Gusset and Vertical Stiffener.

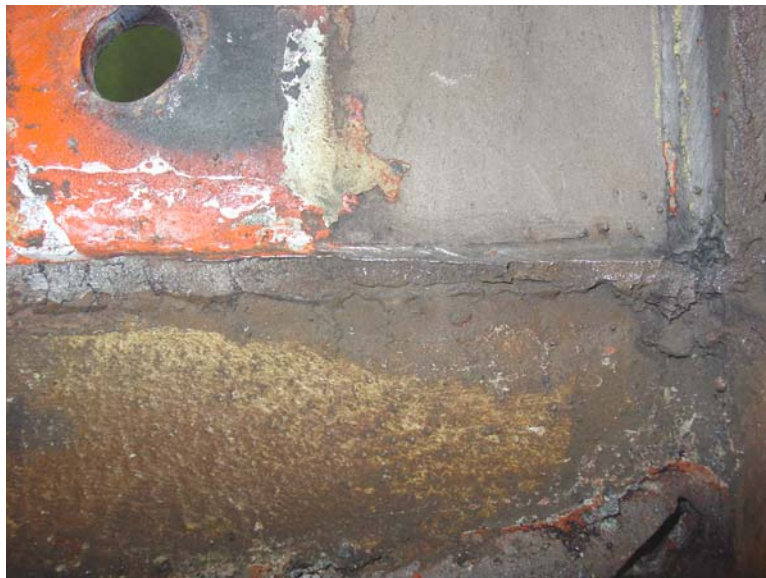
The origin of the brittle fracture in the gusset-vertical stiffener fillet weld appeared to be in the vicinity of the weld intersection (within 1in.), however, its point of origin was less clear since the weld quality was poor and multiple initiations occurred along the weld before arresting in the gusset plate beyond the vertical stiffener. The cause of the poor weld quality appeared to be due to excessive root opening between the gusset and the vertical stiffener from poor fit-up. It is apparent in the detailed view of the web fracture origin shown in Figure 4 that the gusset-vertical stiffener weld crack and web crack were offset about $\frac{1}{4}$ in. and not continuous and hence required a separate but near simultaneous brittle fracture initiation in each element.

Figure 5 - Brittle Fracture Appearance of Gusset Plate-Vertical Stiffener Fillet Weld.

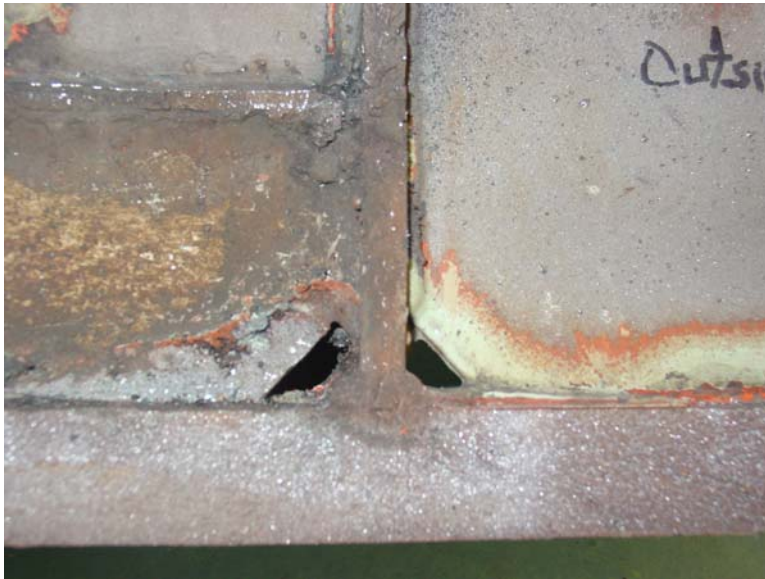
Figure 6 - Propagation of the Brittle Fracture From the Web Into the Bottom Flange Plate Via the Girder Longitudinal Fillet Welds.

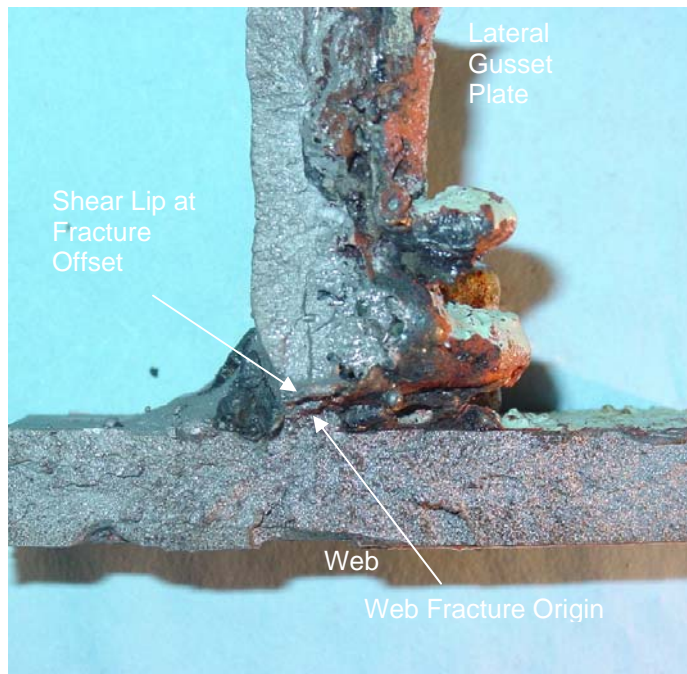
Figure 7 shows a detailed view of the crack surface at the lateral gusset-vertical stiffener weld intersection after cleaning corrosion and debris from the surface. A shear lip at the termination of the gusset-vertical stiffener weld crack is also apparent consistent with two

separate fractures noted above. It is also clear from convergence of chevron marks that the origin of the web fracture was located in the weld metal at the corner intersection of the gusset-web weld and the gusset-vertical stiffener weld. Incomplete fusion and entrapped slag are also evident at the weld root and toe that is not uncommon at welds intersecting at corners. A cross-section of the weld joining the gusset plate to the web near the corner weld intersection is shown in Figure 8 and indicates the weld root condition in this region.

Figure 7 - Fracture Origin of Girder Fracture at the Intersection of the Lateral Gusset and Vertical Stiffener Welds.

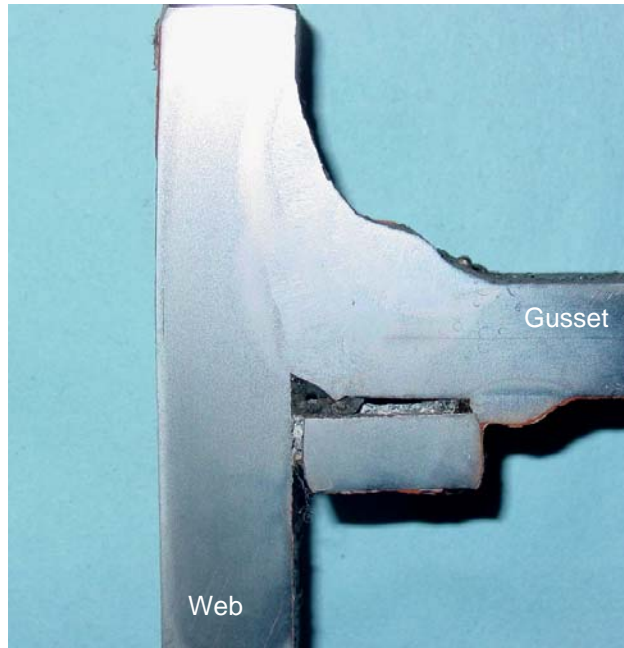
Figure 8 - Cross-section of Weld Joining the Gusset Plate to the Girder Web Showing Incomplete Root Fusion and Attendant Root Discontinuities.

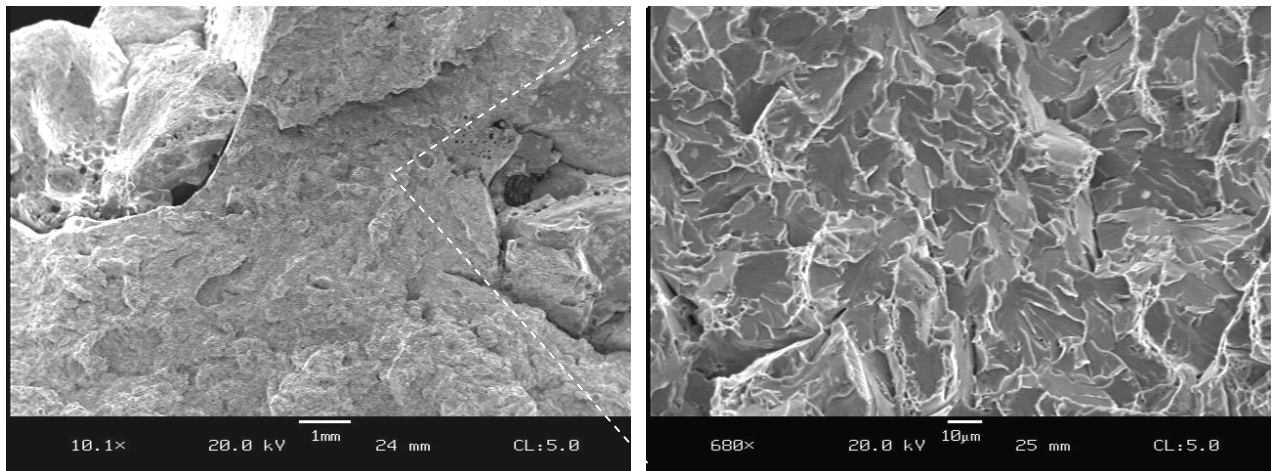
The web fracture origin region was examined microscopically with a scanning electron microscope (SEM) to identify the presence and source of an initiating defect at the onset of crack instability. Figure 9 shows a low magnification SEM image of the origin region (also see Figure 7). Other than several sub-millimeter sized weld porosity defects no evidence of an initial fabrication defect was observed in this region. There was also no evidence of fatigue crack development in this region from surface or internal discontinuities present. The only fracture mechanism observed in this area was cleavage fracture as shown in the higher magnification image in Figure 9.

The absence of evidence of stable crack growth at the fracture origin is similar to the Hoan Bridge girder fractures at similar details [1]. In this case fracture was attributed to constraint induced fracture from high levels of tri-axial constraint at the crack-like geometrical condition at the weld intersection of the gusset plate and vertical stiffener elevating stresses well beyond the yield point in this region and stress intensities exceeding the fracture toughness of the web material. Although direct evidence of defect sharpening by cyclic stresses was also not observed in this case it was concluded that this had likely occurred at the microscopic level prior to the fracture. The similarity of the detail and absence of stable crack extension in the current fracture is suggestive of a similar fracture mechanism.

Figure 9 - SEM Images of the Fracture Origin Region and Cleavage Fracture.
[Mag. 10.1x & 600x]

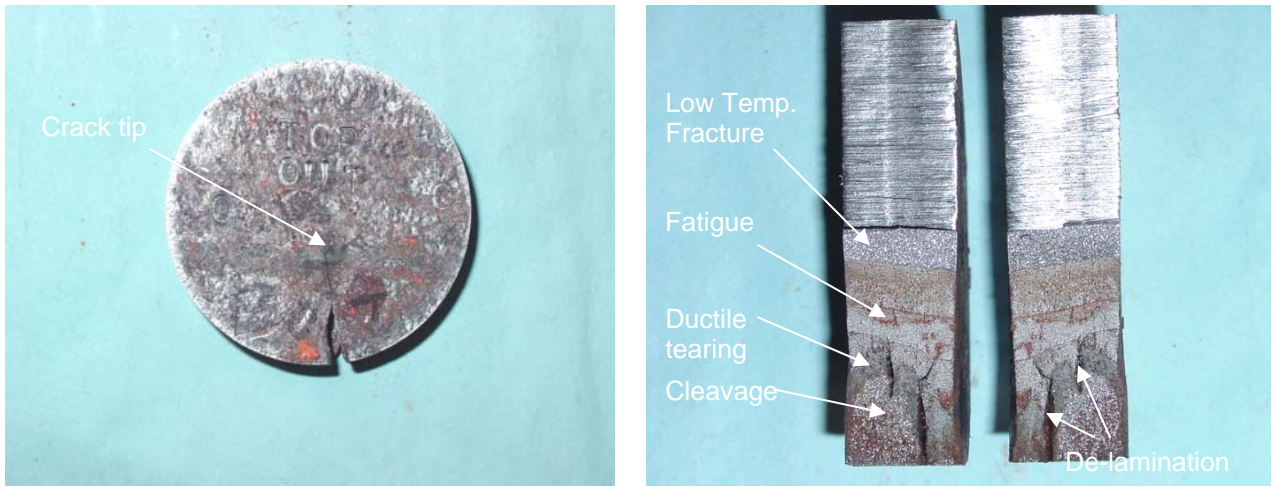
The core drilled at the web crack tip was examined fractographically to characterize the conditions that caused the fracture to arrest. Views of the core containing the crack tip and the exposed crack surfaces after saw-cutting and fracturing the remaining ligament at low temperatures is shown in Figure 10. It is clear that the cleavage fracture arrested due to the presence of two plate de-laminations that relieved the thickness constraint needed for continued propagation of the cleavage fracture. The SEM images seen in Figure 11 show that the cleavage fracture mechanism momentarily reverted to a ductile tearing mechanism just prior to arrest. It is also significant that prior to drilling the core the arrested crack re-initiated by fatigue and propagated about ¼ in. in the short time before the crack tip was removed from the structure. Figures 10 and 11 show the fatigue extension and typical fatigue striations observed in this region. At the observed growth rate a second fracture of the girder was highly probable in a short time interval.

Figure 10 - Crack Tip of Web Fracture Arrested By Plate De-laminations. Note Fatigue Crack Extension Prior To Drilling Core.

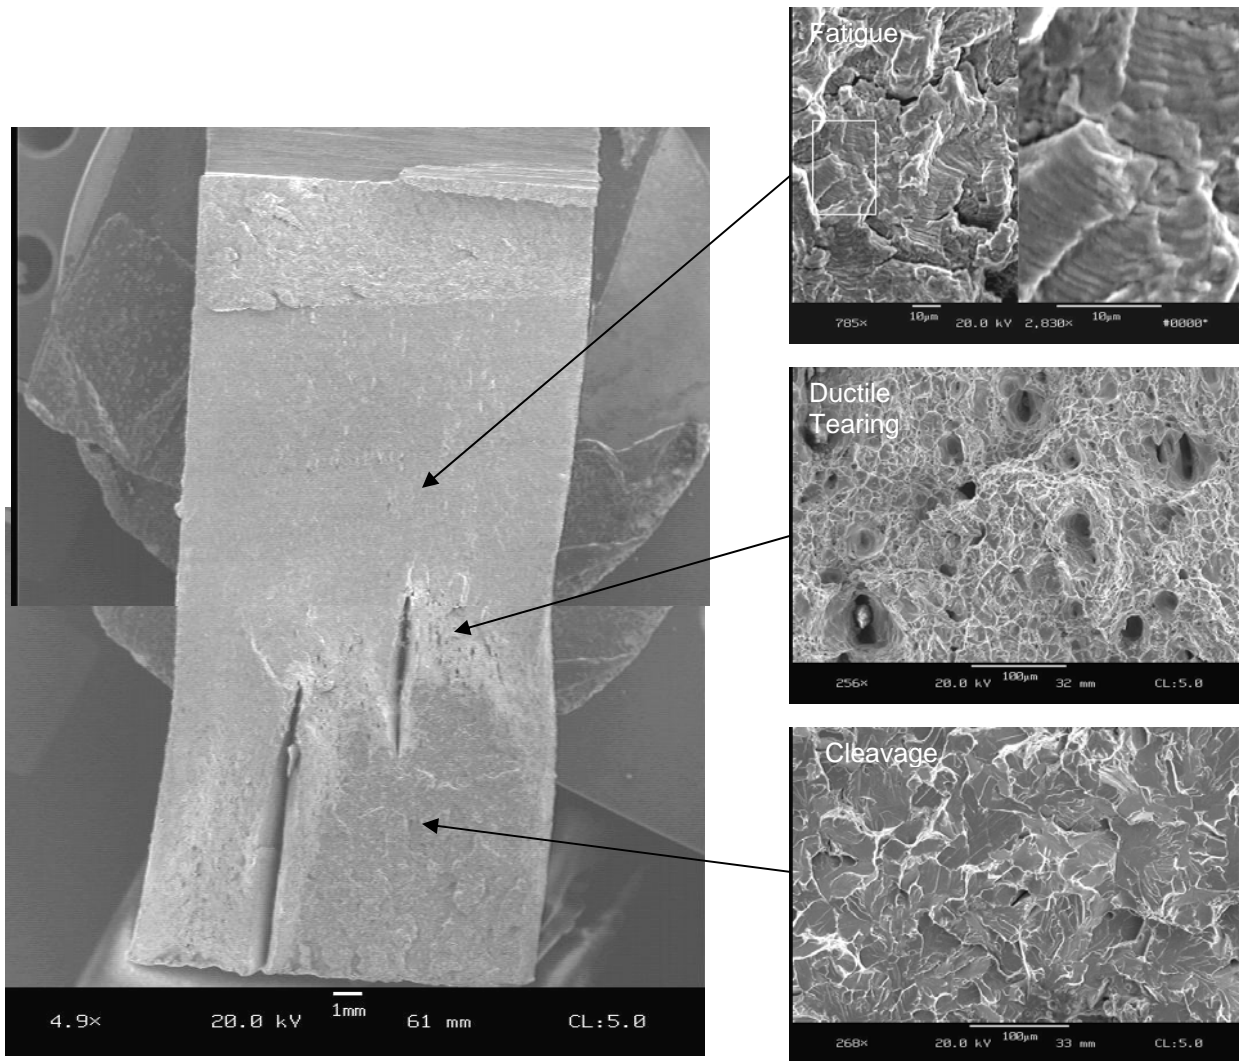
Figure 11 - SEM Images of Web Crack Tip Showing the Arresting De-laminations and Fracture Mechanism Details.

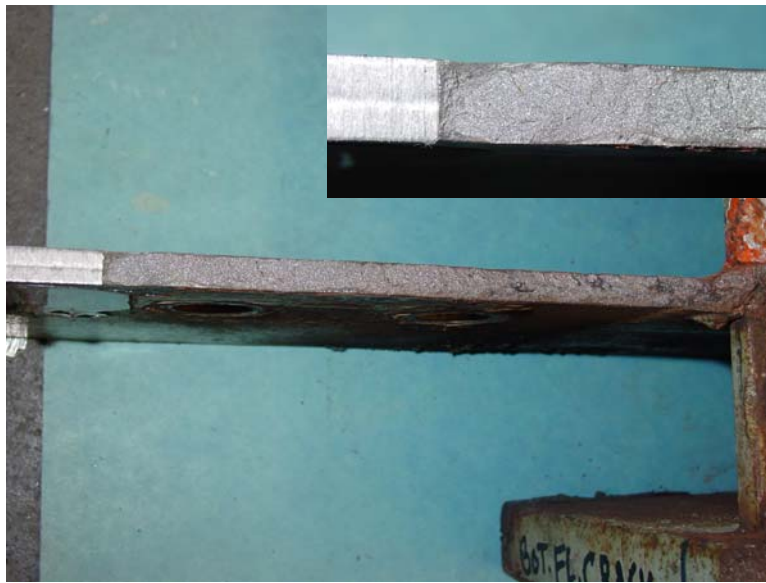
An enlarged view of the crack arrest region of the lateral gusset plate fracture is shown in Figure 12. A low magnification SEM image of the region is shown in Figure 13. As also observed at the web fracture crack tip the fracture mechanism also changed from cleavage to ductile tearing prior to arrest. Since no material discontinuities were observed at the crack tip to

alter the stress field in this region crack arrest occurred because of loss of crack driving force due to reduced stresses in the plate and arrest of the crack in the web.

Figure 12 - Crack Arrest Region in the Lateral Gusset Plate.

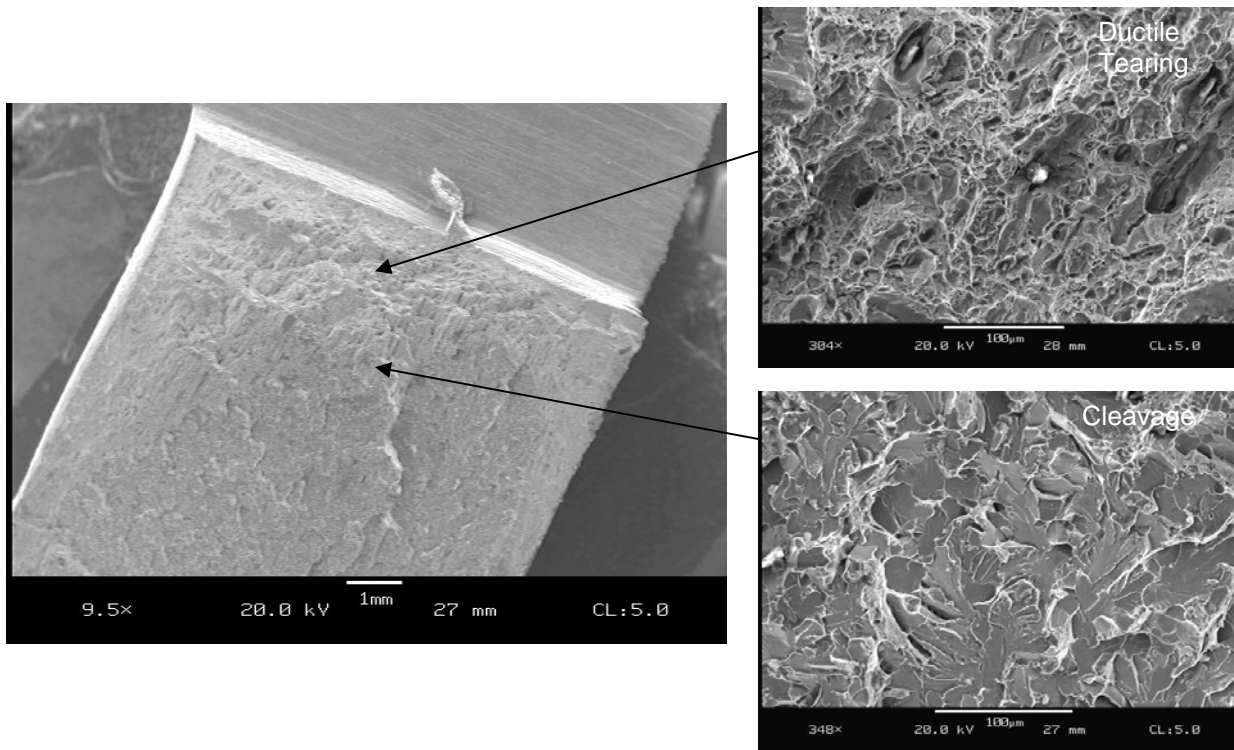
Figure 13 - SEM Images of the Gusset Plate Crack Tip Arrest Region.

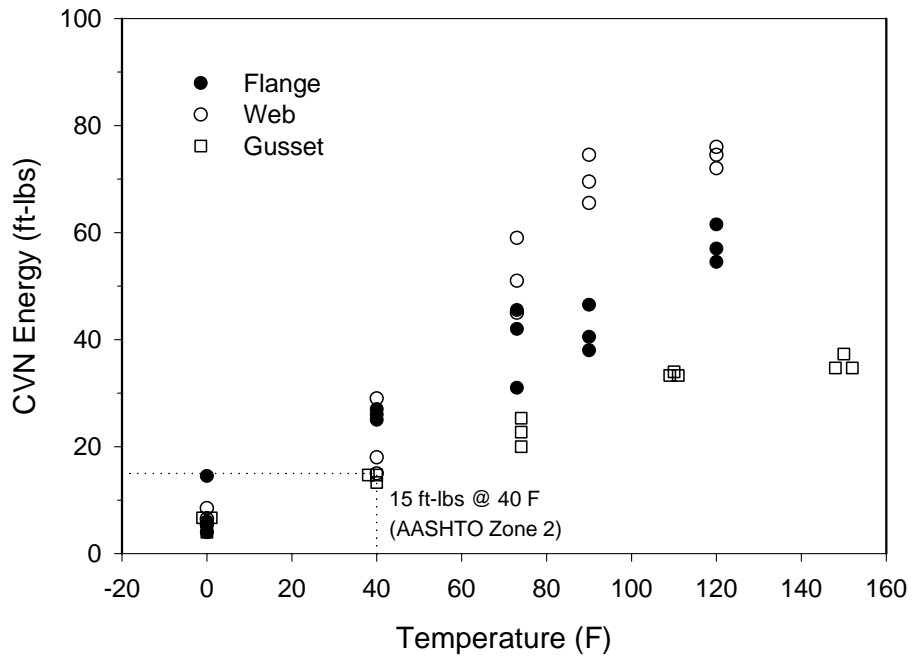
A plot of the CVN test results obtained over a range of temperatures is shown in Figure 14. For all three plates the notch toughness was at or approaching upper shelf at room temperature and hence the static fracture toughness of the steels would be expected to remain high at temperatures as low as the minimum service temperature (0 to-30 F). An estimate of the fracture toughness, K_{IC} (1 sec), corresponding to bridge loading rates can be obtained by applying a K_{Id} –CVN correlation and temperature shift to the CVN test data. For the measured yield strength of about 38 ksi results in a full static temperature shift

Figure 14 - CVN Test Results for the Girder Plate Elements.

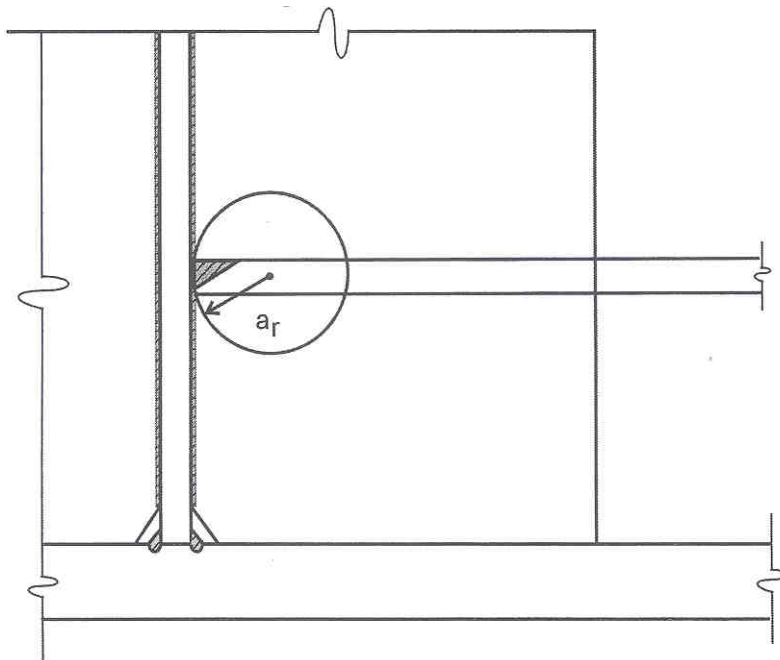
In the Hoan Bridge analysis [1] the extension of the crack-like geometrical condition introduced by the slotted gusset plate at the weld intersection of the gusset and vertical stiffener into the web was modeled as a penny shaped crack with an effective crack width of 3 in. (see Figure 15). The stress intensity factor is defined as

Figure 15 - Idealized Circular 3D Crack Model at Lateral Gusset Plate-Vertical Stiffener Intersection. [1].
