Concrete Deck Cracking Investigation SR309 over Church Road, Montgomery County, PA

Final Report

ATLSS Report No. 09-07

August 2009

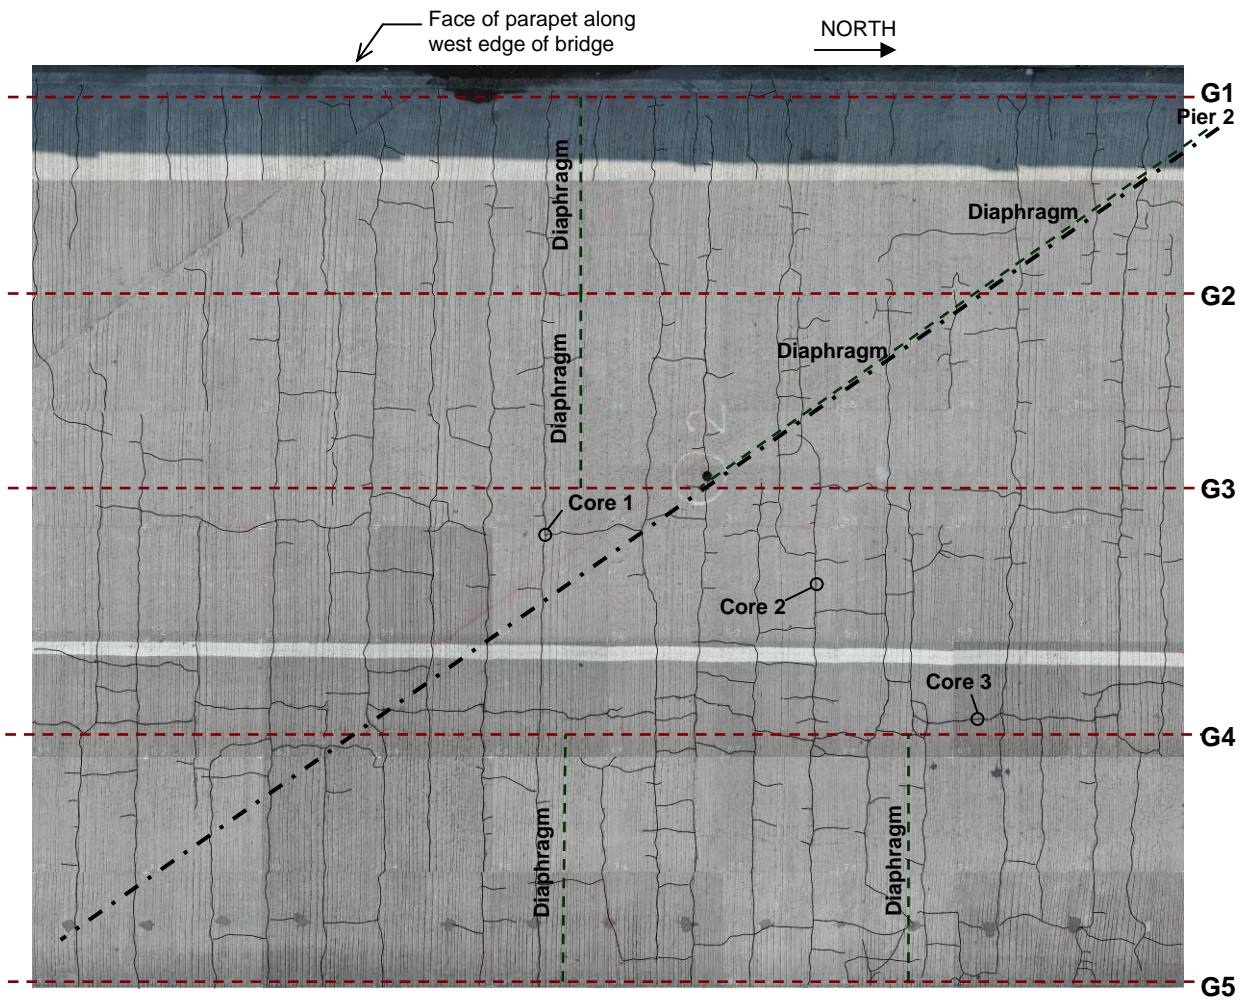
Figure 2.5 – Composite image of cracking in negative moment crack survey grid

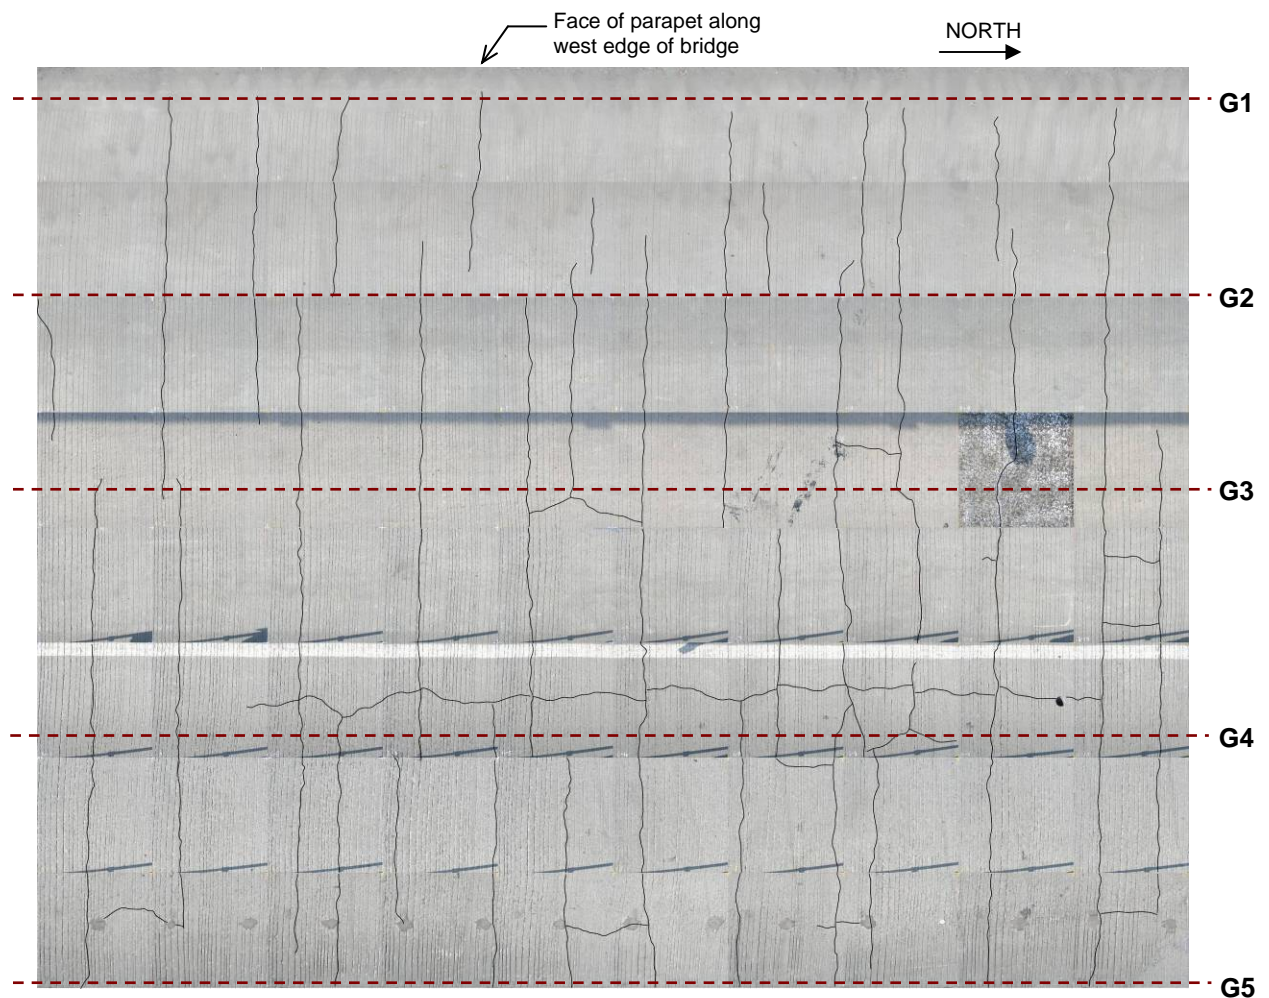
Figure 2.7 – Composite image of cracking in positive moment crack survey grid

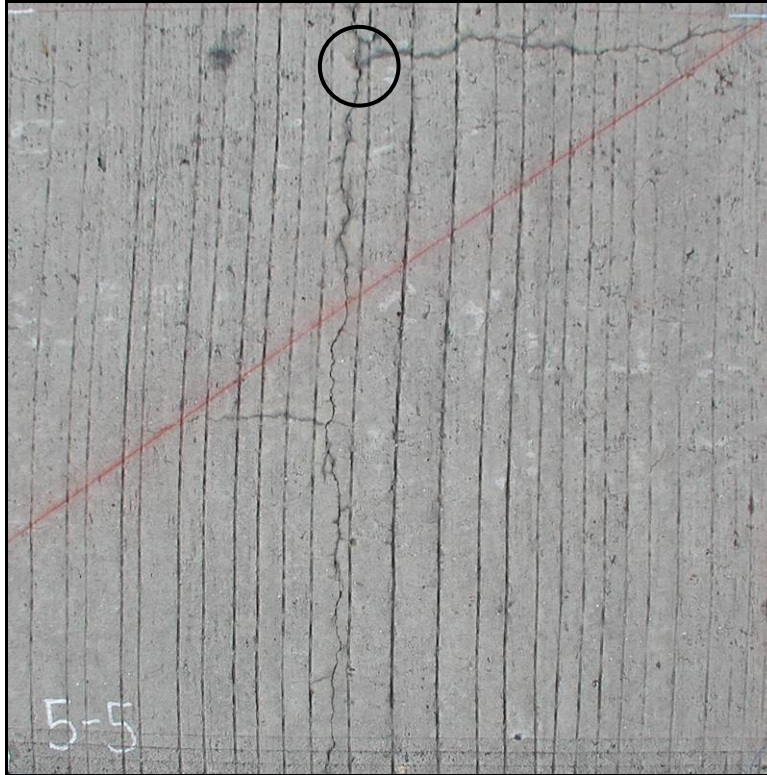
Figure 3.3 – Negative moment crack survey grid area 5-5 showing location of Core #1

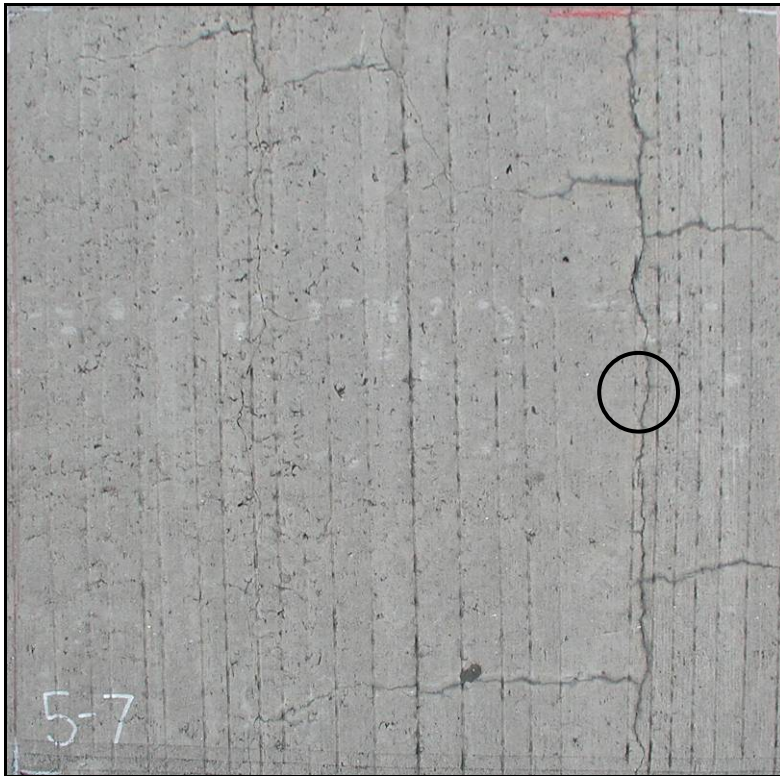
Figure 3.5 – Negative moment crack survey grid area 5-7 showing location of Core #2

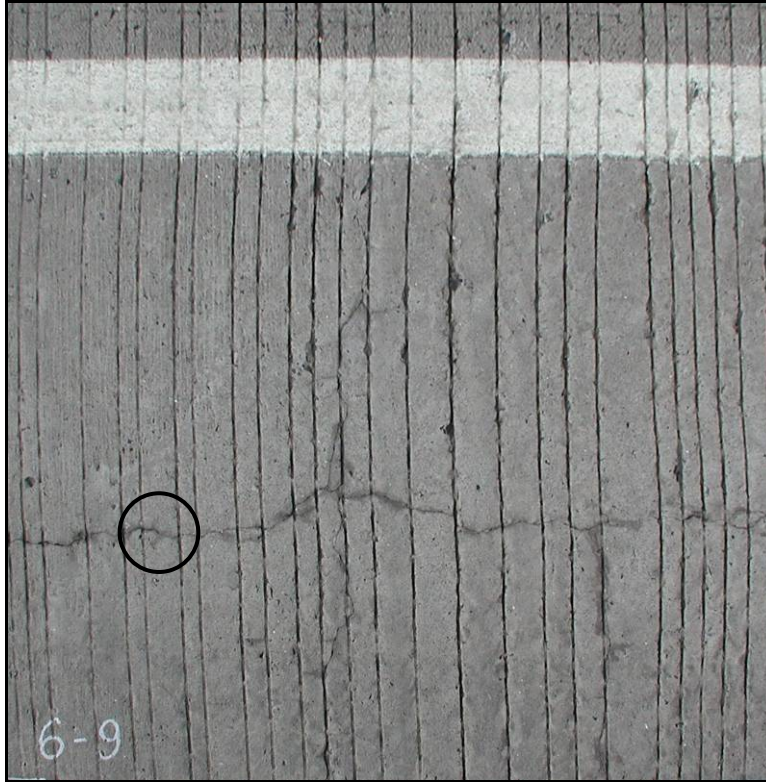
Figure 3.7 – Negative moment crack survey grid area 6-9 showing location of Core #3

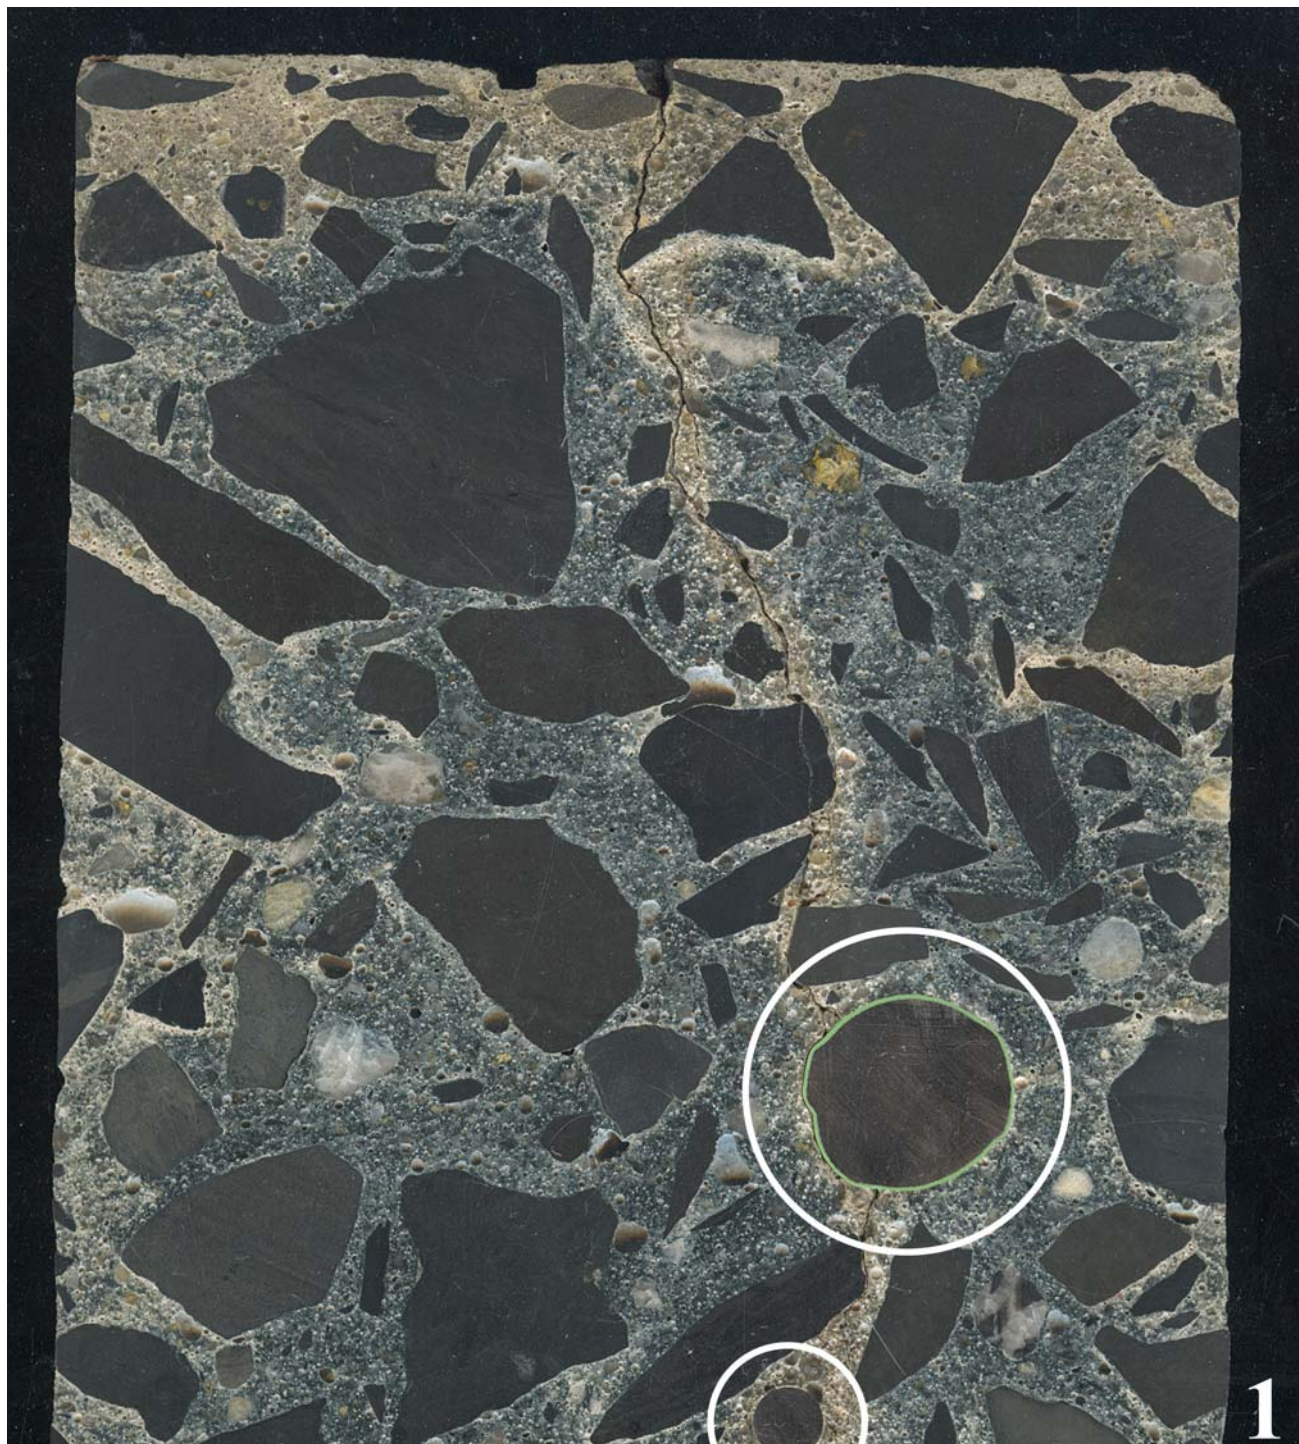
Figure 4A – Boxed Area "a" in Figure 4. A reinforcing bar (large circle) is green epoxy-coated. A mesh section is circled. The vertical crack circumscribes most aggregate particles.

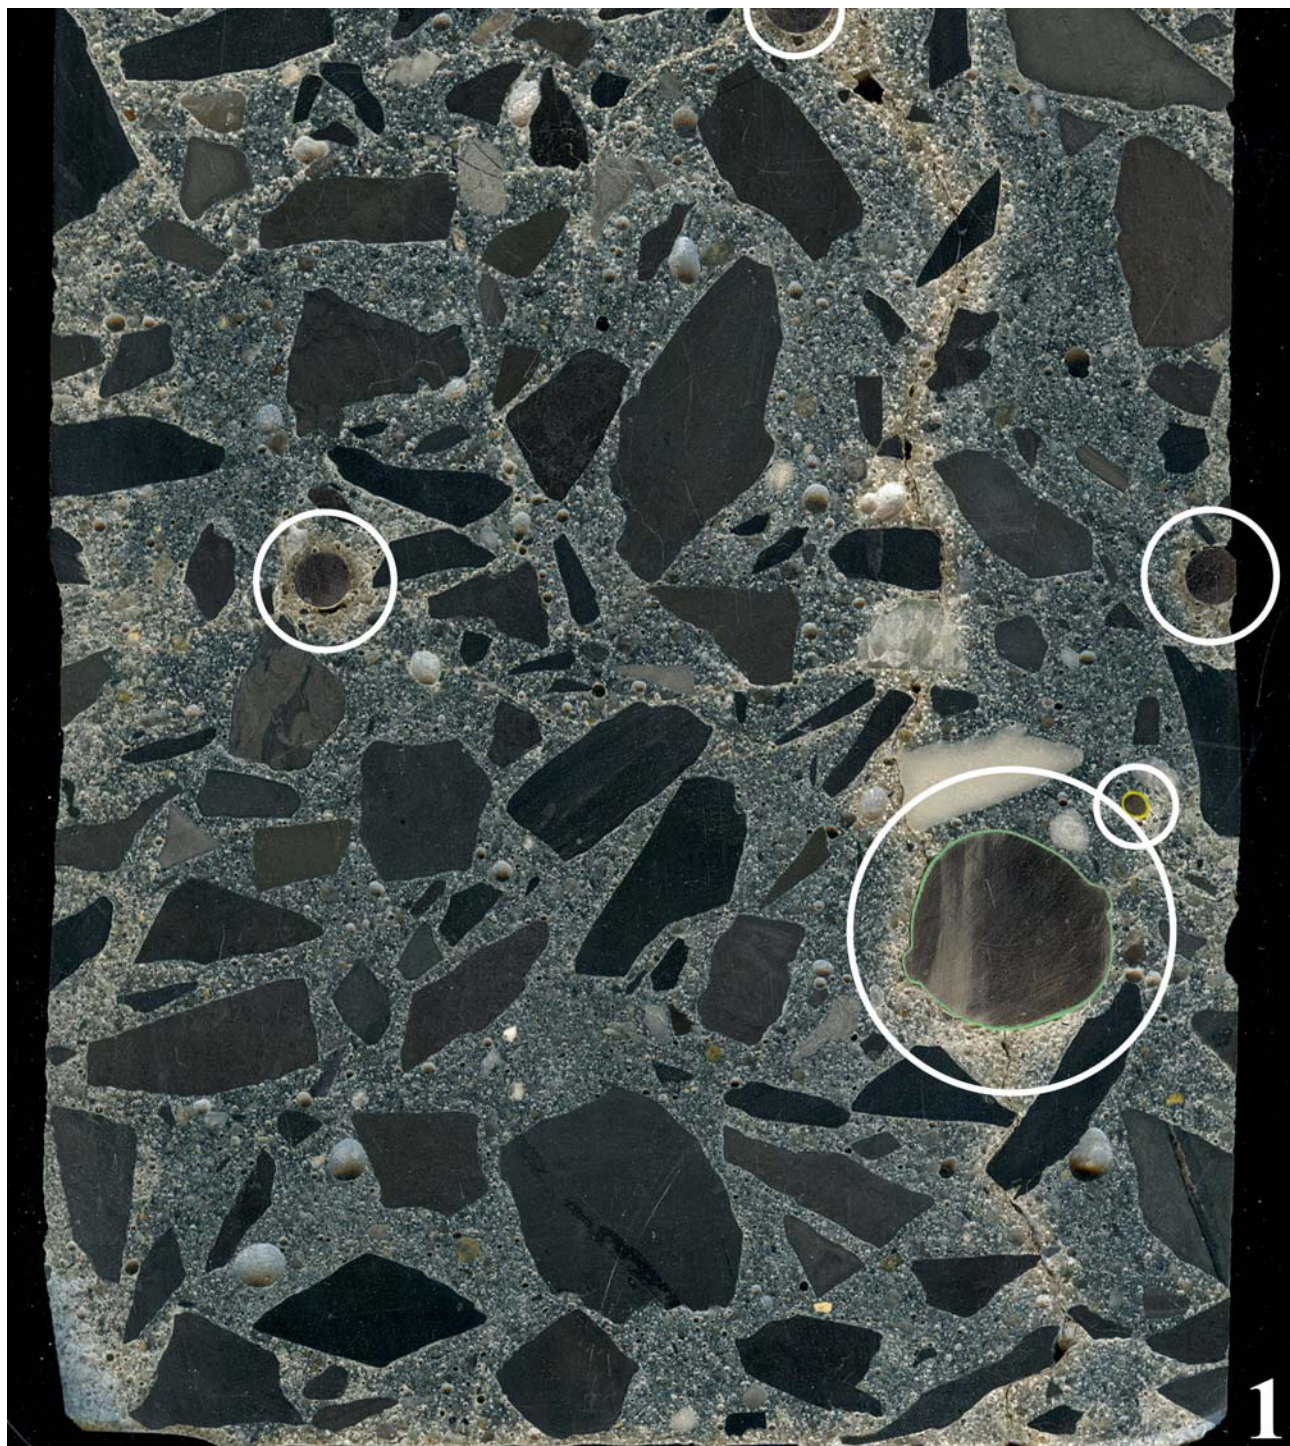
Figure 4B – Boxed Area "b" in Figure 4. The reinforcing bar (large circle) is green-epoxy-coated. A tie-wire (small circle) is yellow-epoxy-coated. Mesh sections are within the intermediate-sized circles. The vertical crack circumscribes most aggregate particles and extends to the core bottom.

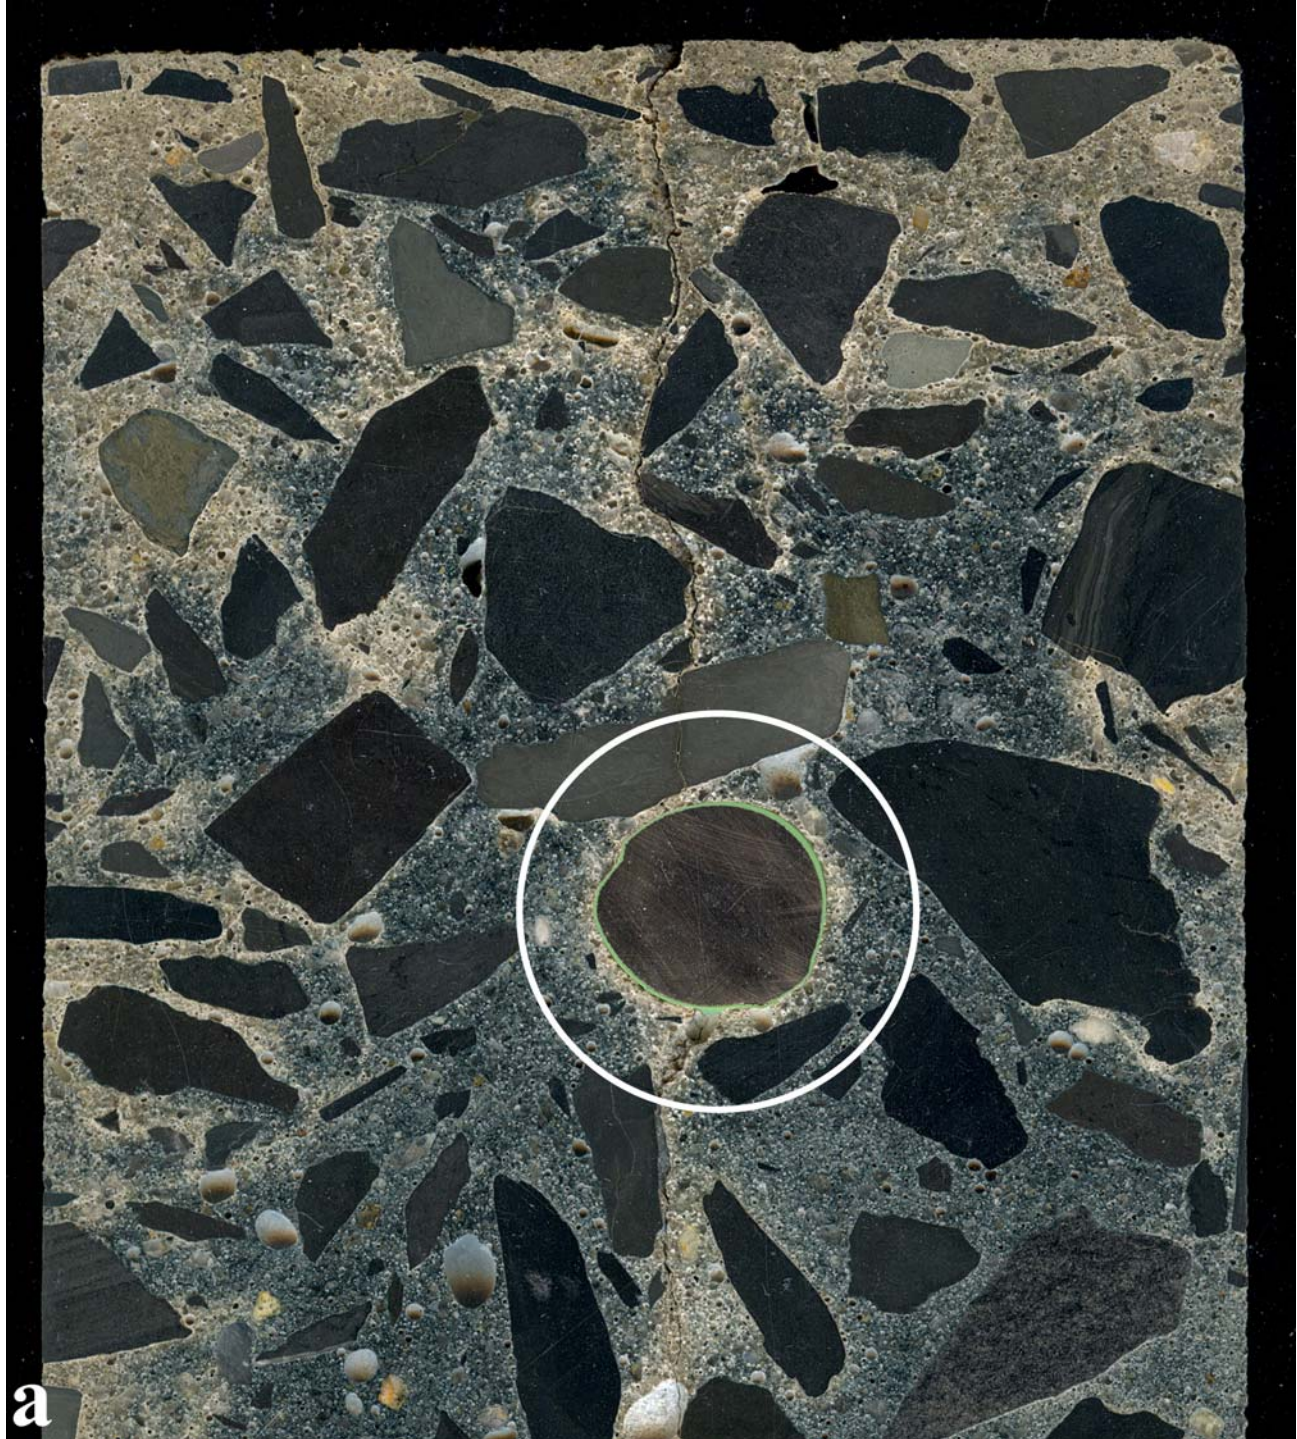
Figure 5A – Boxed Area "a" in Figure 5. The reinforcing bar (circled) is green epoxy-coated. The vertical crack circumscribes most aggregate particles.

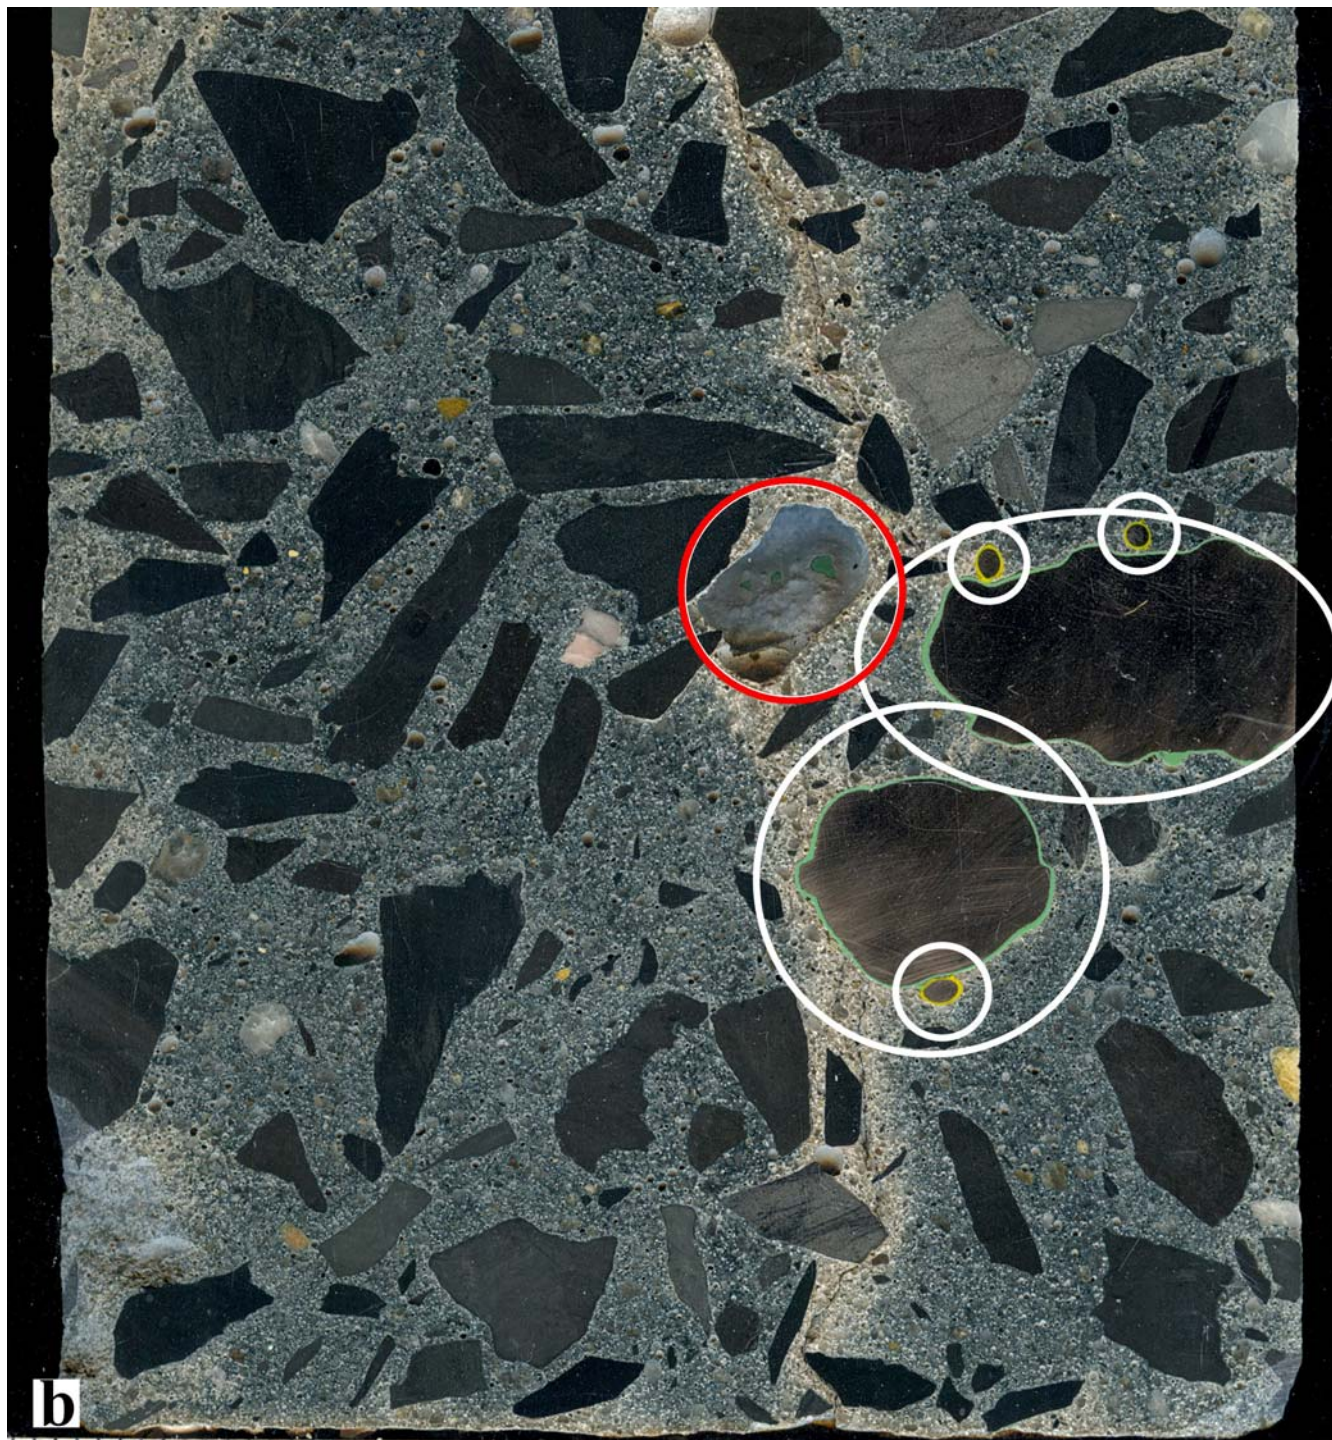
Figure 5B (Core 2) – Boxed Area "b" in Figure 5. No. 5 bars (large circle and ellipse) are green epoxy-coated, and tie-wires (small circles) are yellow epoxy-coated. Within the red circle is a large entrapped air void. The vertical crack circumscribes most aggregate particles and extends to the core bottom.

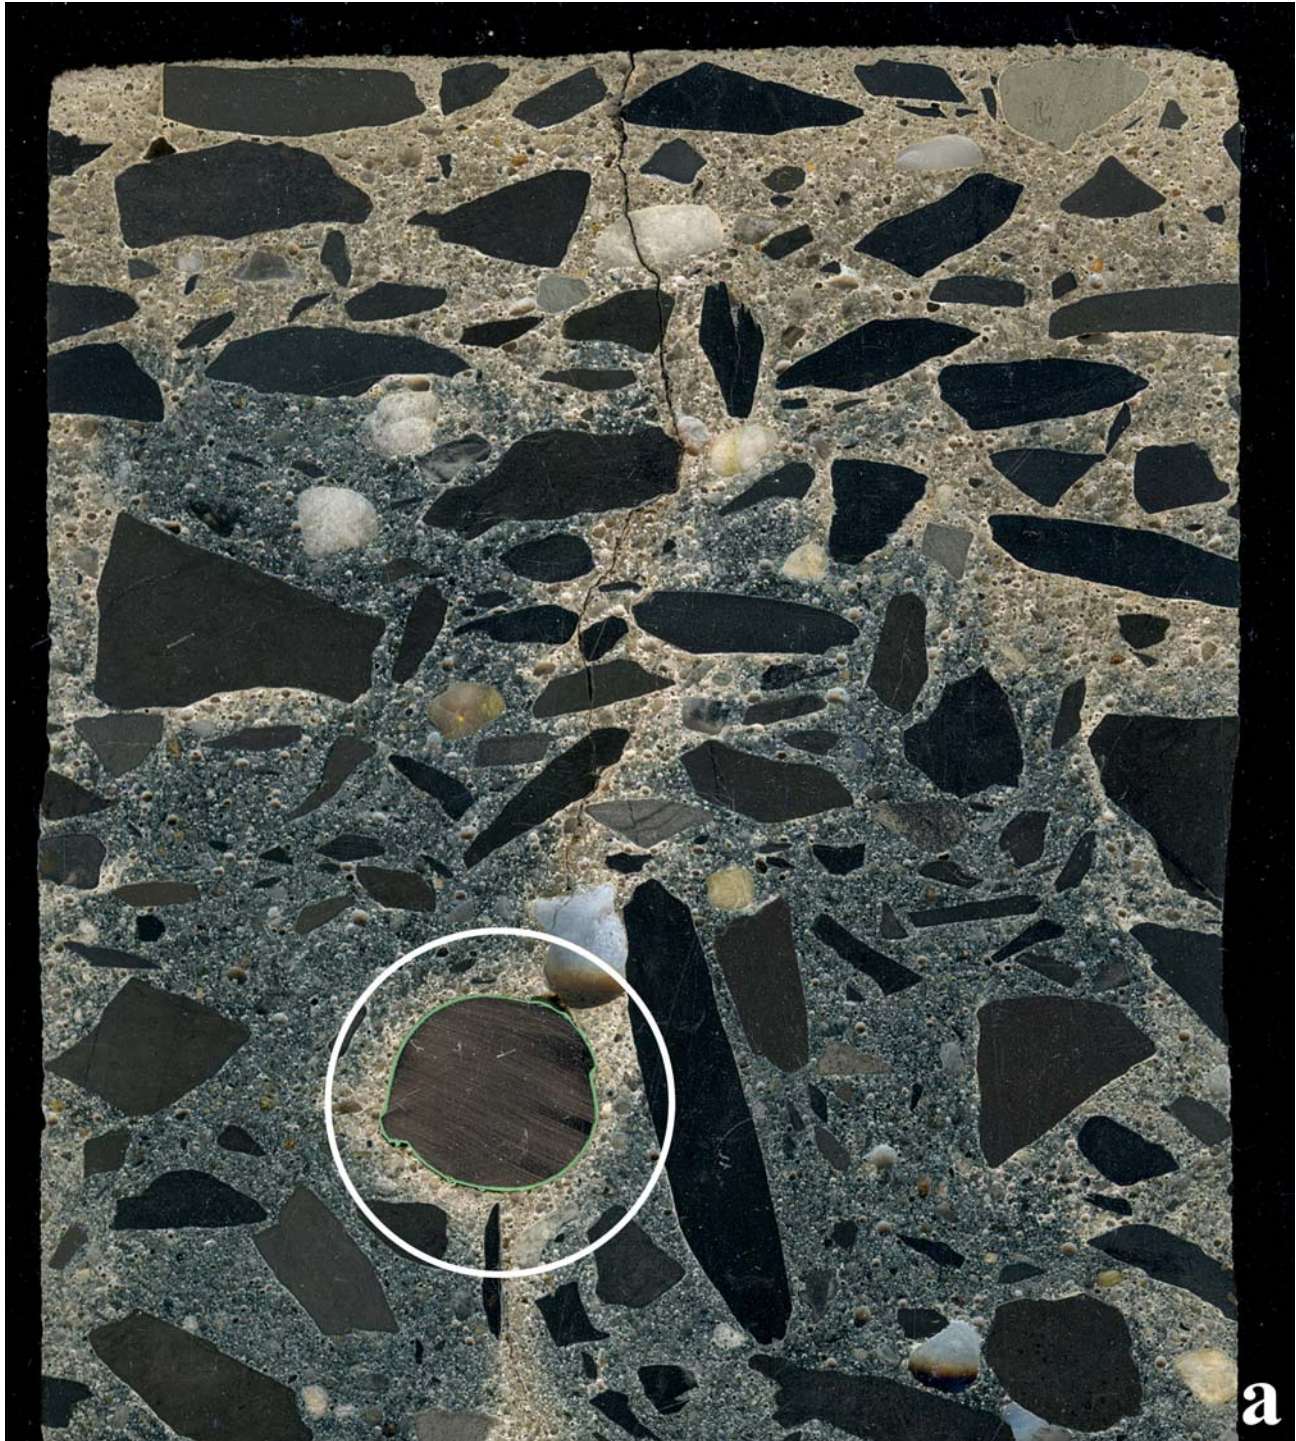
Figure 6A – Boxed Area "a" in Figure 6. The reinforcing bar (circled) is green-epoxy-coated. The vertical crack transects several aggregate particles and mainly circumscribes aggregate particles.

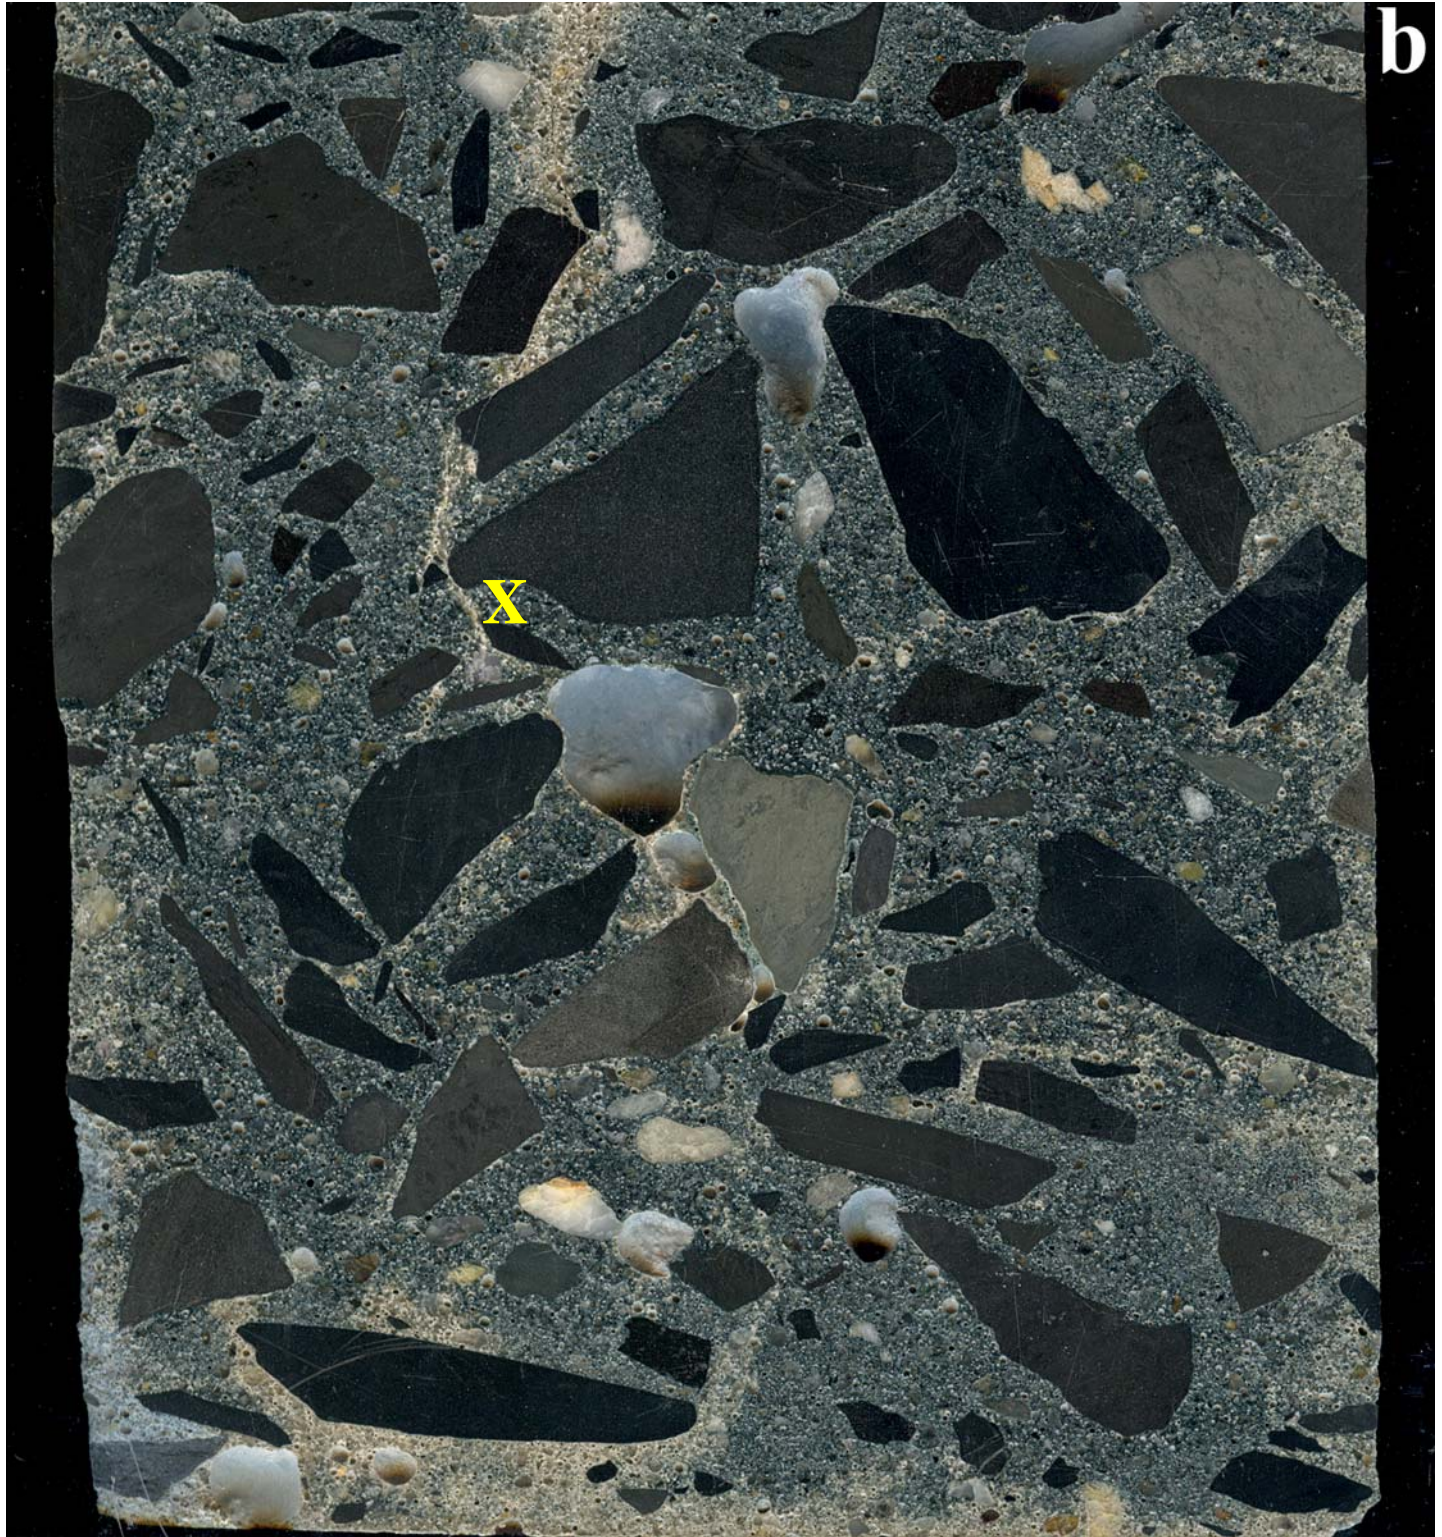
Figure 6B – Boxed Area "b" in Figure 6. The vertical crack transects many aggregate particles and terminates 2¹/₂ inches from the core bottom (denoted by the X).

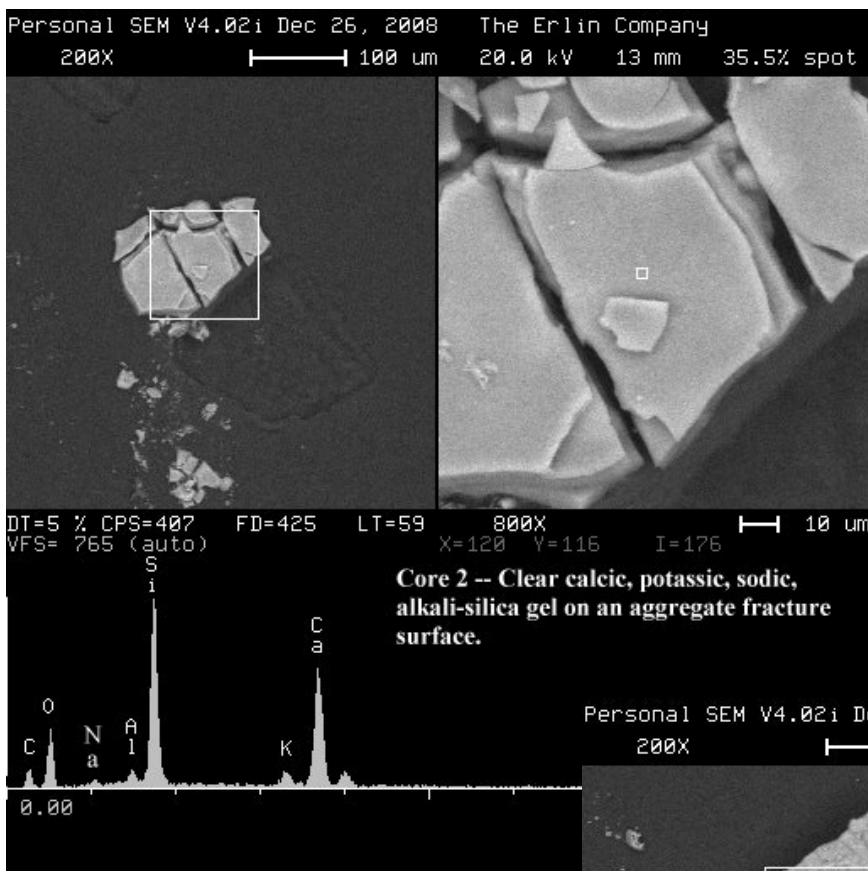
Figure 8a – Clear calcic, potassic, sodic, alkali-silica gel from an aggregate fracture surface. The elemental spectrum is of the small-boxed area at center in the right micrograph. Contiguous white gel is shown in Figure 8b.

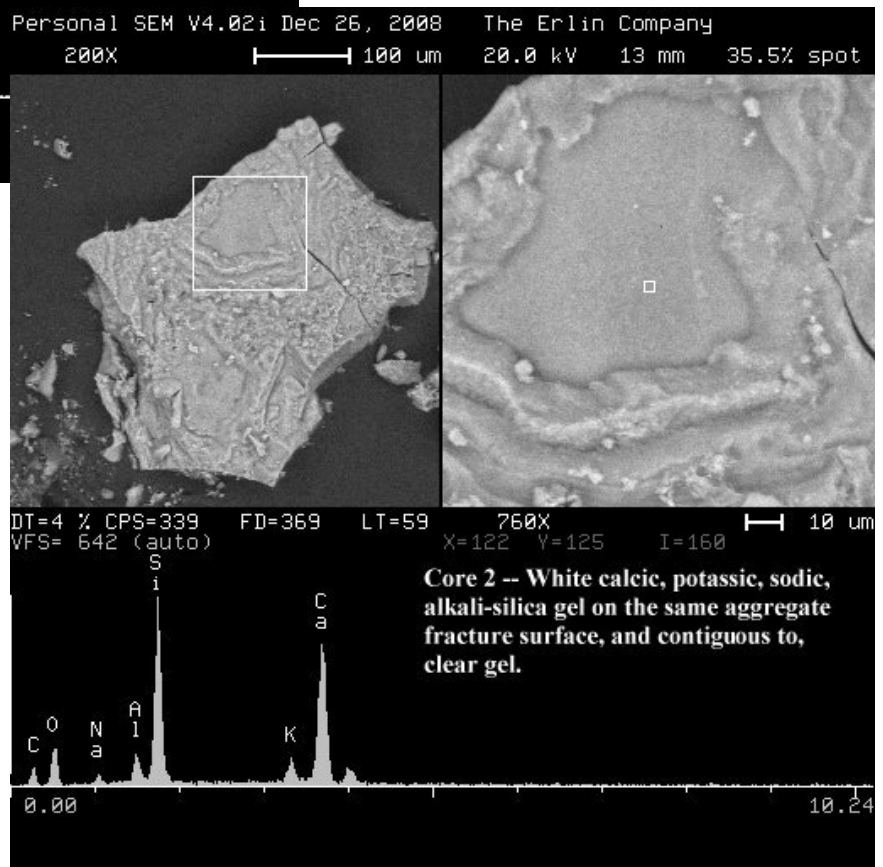
Figure 8 (Core 2) – Electron micrographs of clear (Figure 8a) and white (Figure 8b) calcic (Ca)-potassic (K)-sodic (Na) alkali-silica gel on the fracture surface of an aggregate particle. The right micrographs are the boxed areas in the left micrographs. The elemental spectra are of the small-boxed areas at about center in the right micrographs.

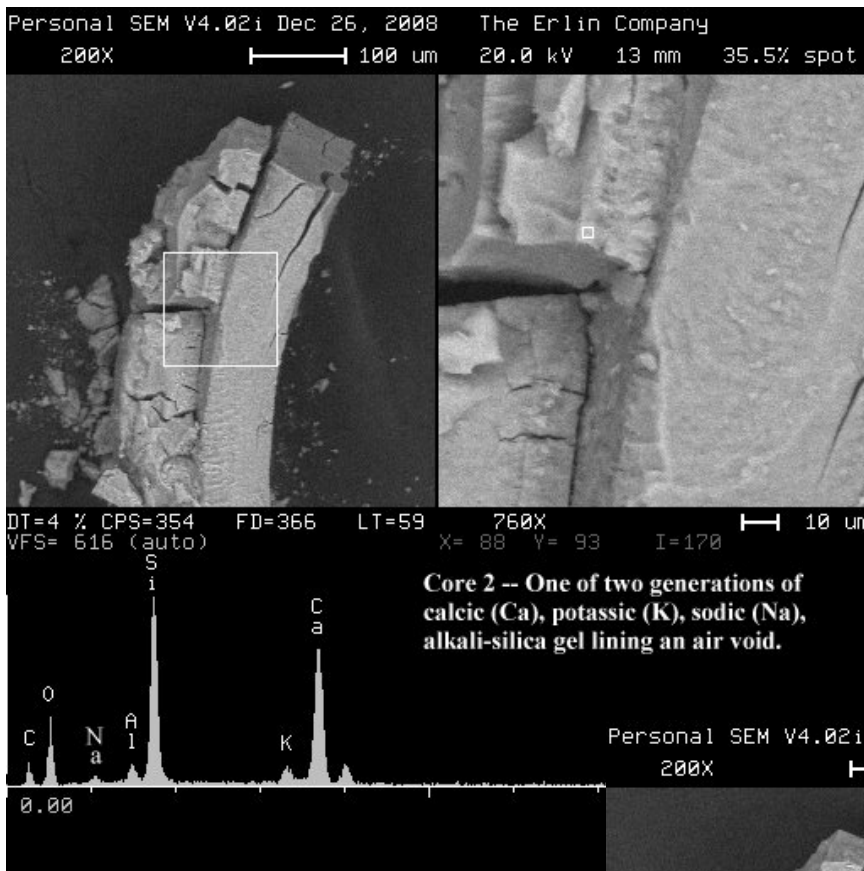
Figure 9a – Base generation of white calcic, potassic, sodic, alkali-silica gel lining an air void. The elemental spectrum is of the small-boxed area left and above center in the right micrograph. The gel is overlain by a second generation of gel (Figure 9b).

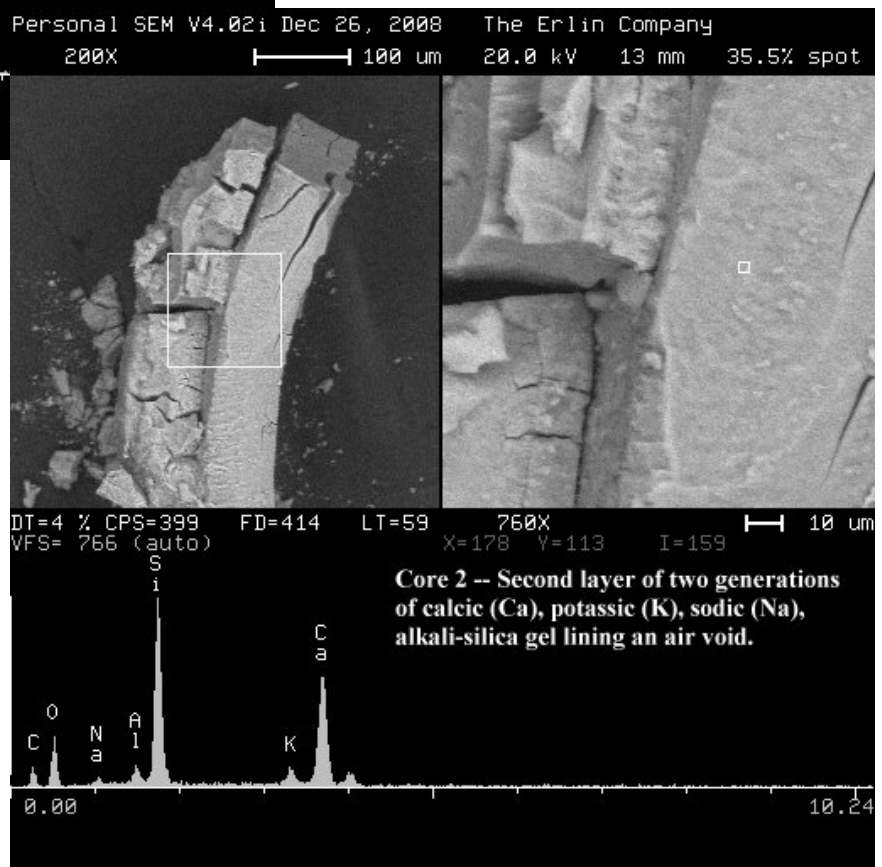
Figure 9 (Core 2) – Electron micrographs of two generations of white, calcic (Ca)-potassic (K)-sodic (Na) alkali-silica gel lining an air void. The right micrograph is the box area in the left micrograph. The elemental spectrum is of the small-boxed area at about center in the right micrograph.

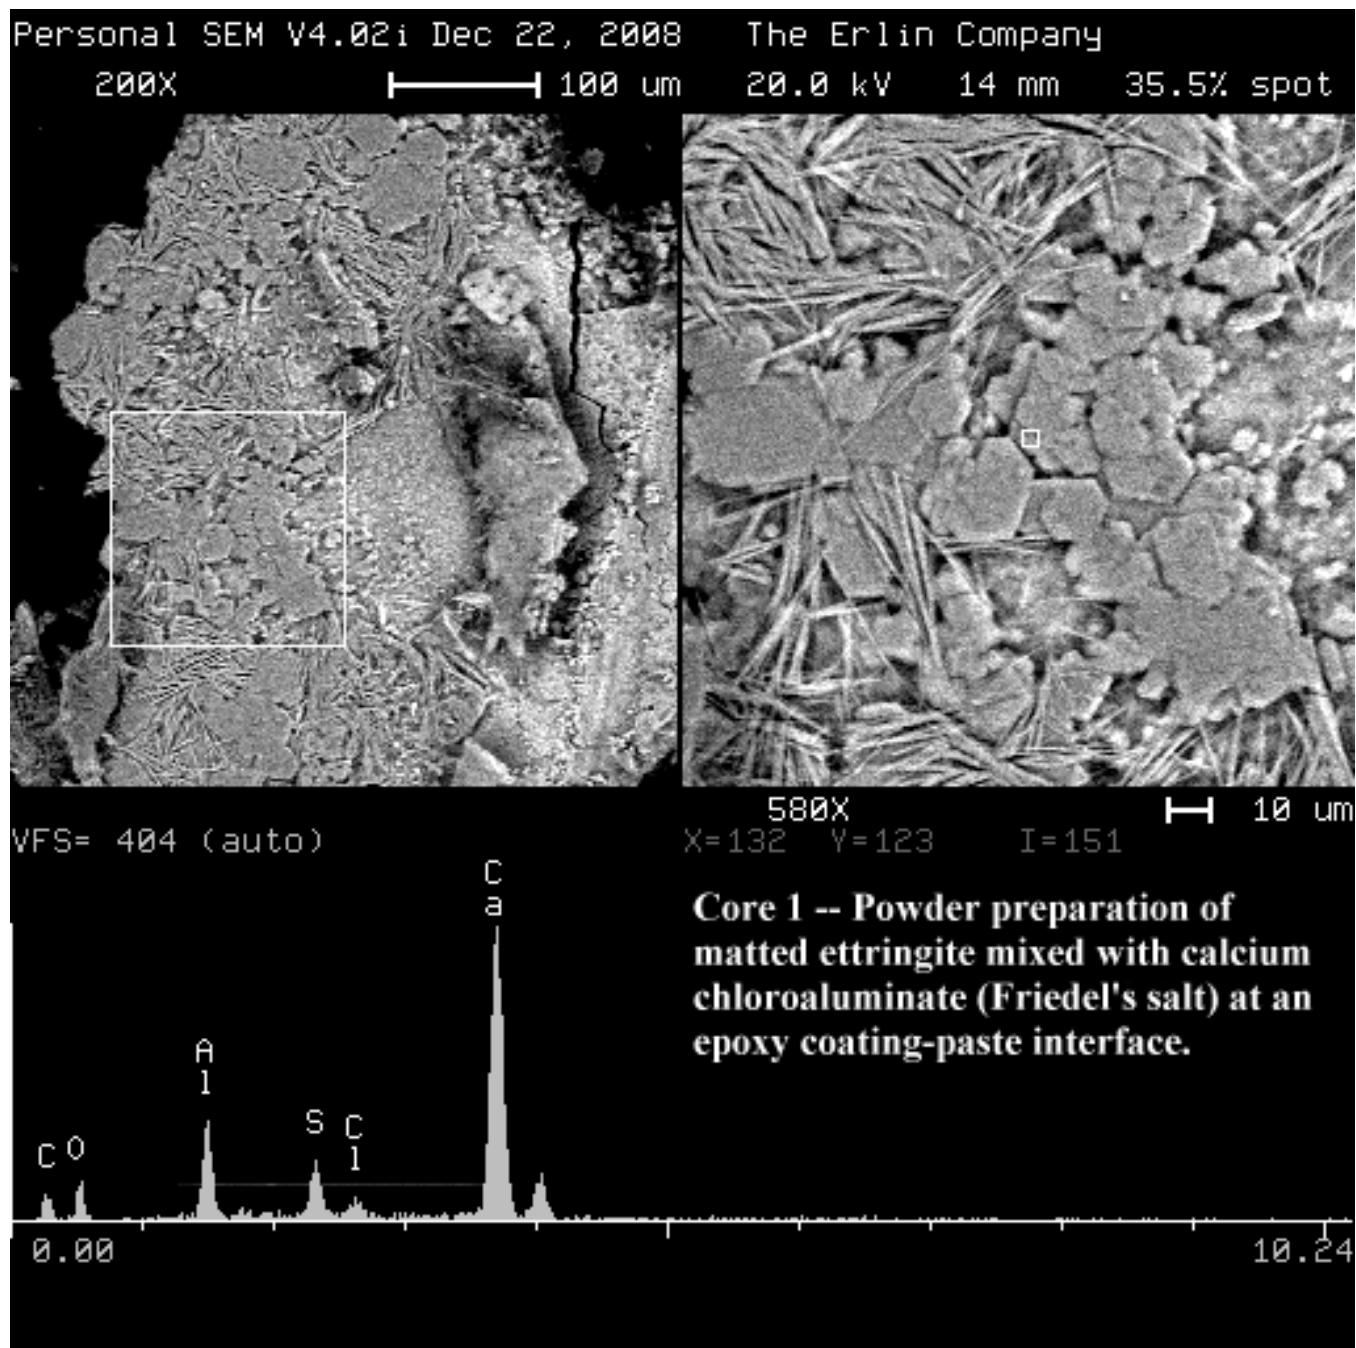
Figure 12 (Core 1) – Electron micrograph of secondary products in the interface surface of a green epoxy-coated reinforcing bar and flanking mortar. The right micrograph is the box area in the left micrograph. The elementary spectrum is of the small-boxed area at about center in the right micrograph. The spectrum corresponds to a mixture of ettringite (possibly mono sulfoaluminate) and calcium chloroaluminate (Friedel's salt).
