Concrete Deck Cracking Investigation SR309 over Church Road, Montgomery County, PA

Final Report

ATLSS Report No. 09-07

August 2009

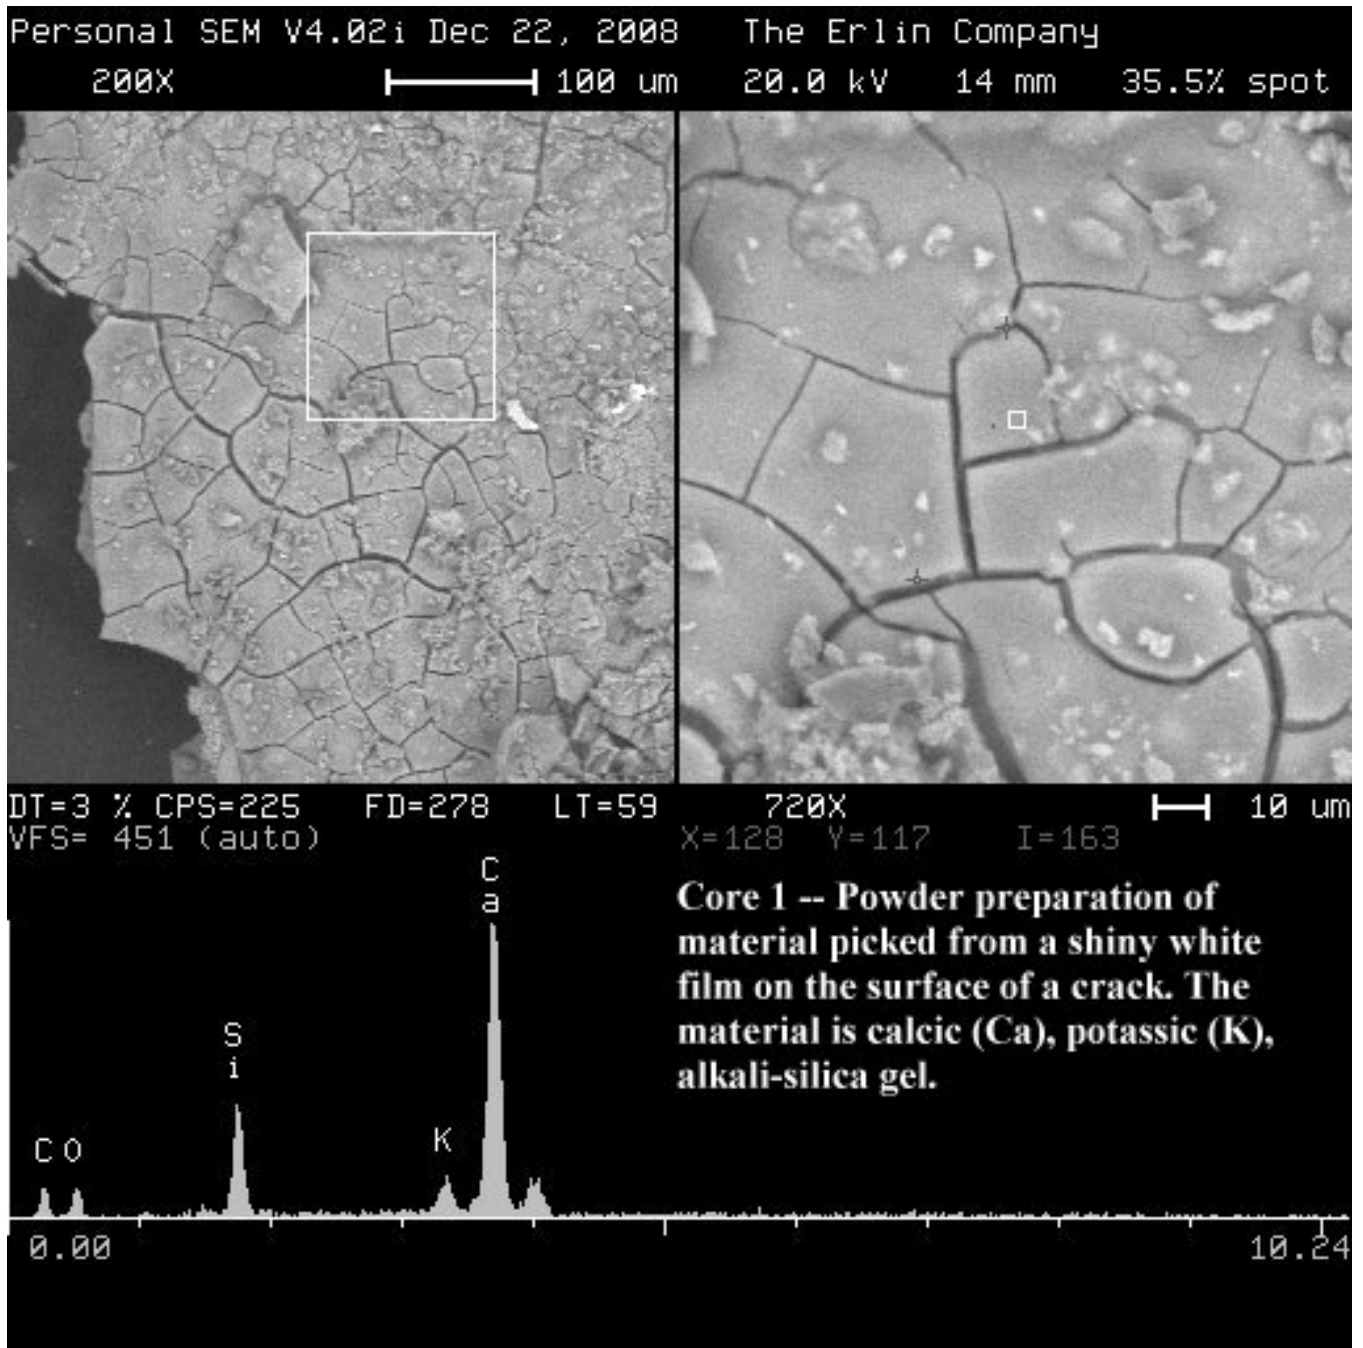
Figure 13 (Core 1) – Electron micrograph of calcic-potassic alkali-silica gel from a crack surface. The right micrograph is the box area in the left micrograph. The elemental spectrum is of the small-boxed area at about center in the right micrograph. The spectrum corresponds to calcic (Ca)-potassic (K), alkali-silica gel.
