DISTORTION INDUCED CRACKING IN STEEL BRIDGE MEMBERS

ATLSS Report No. 90 - 07

August, 1990

FINAL REPORT

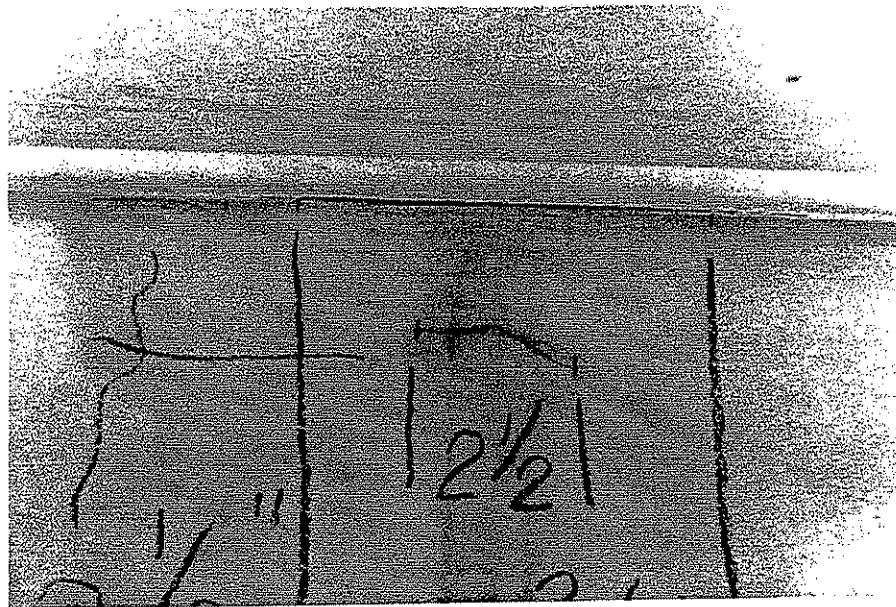
Figure 2: (a) Web gap fatigue cracking at the transverse connection plate for a floorbeam; (b) Web gap cracking on the exterior girder web face

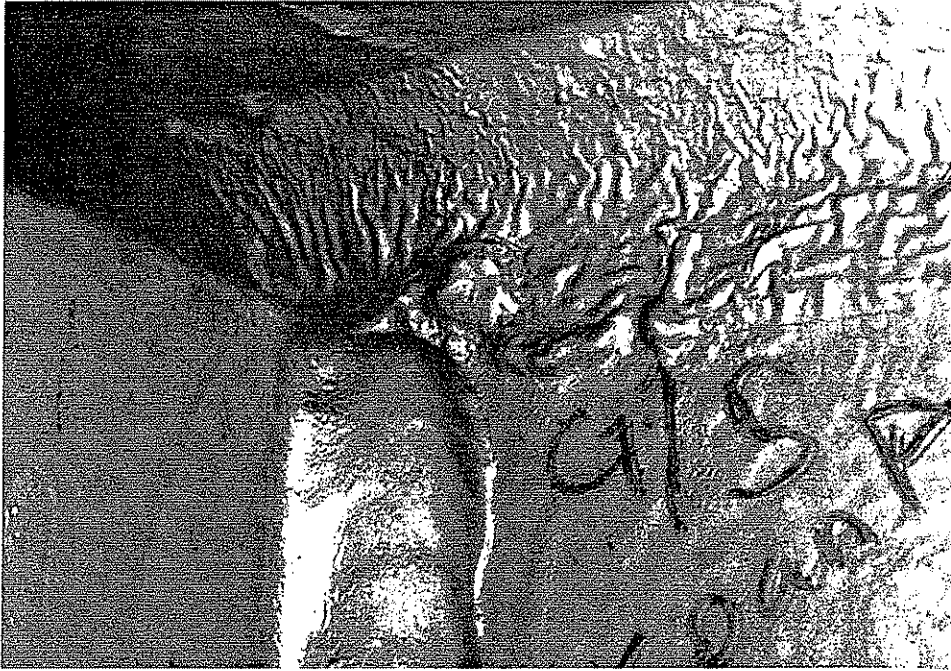
Figure 17: Cracks at connection plates, Beaver Creek Bridge, Reference 18

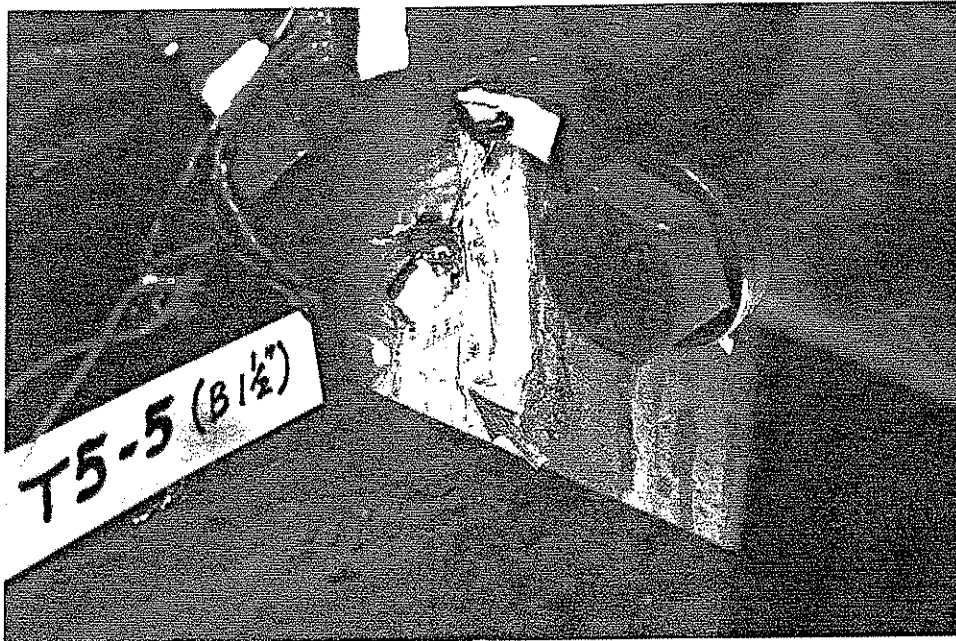
Figure 30: Fatigue cracking at Detail T5-5 (Type B), west web gap

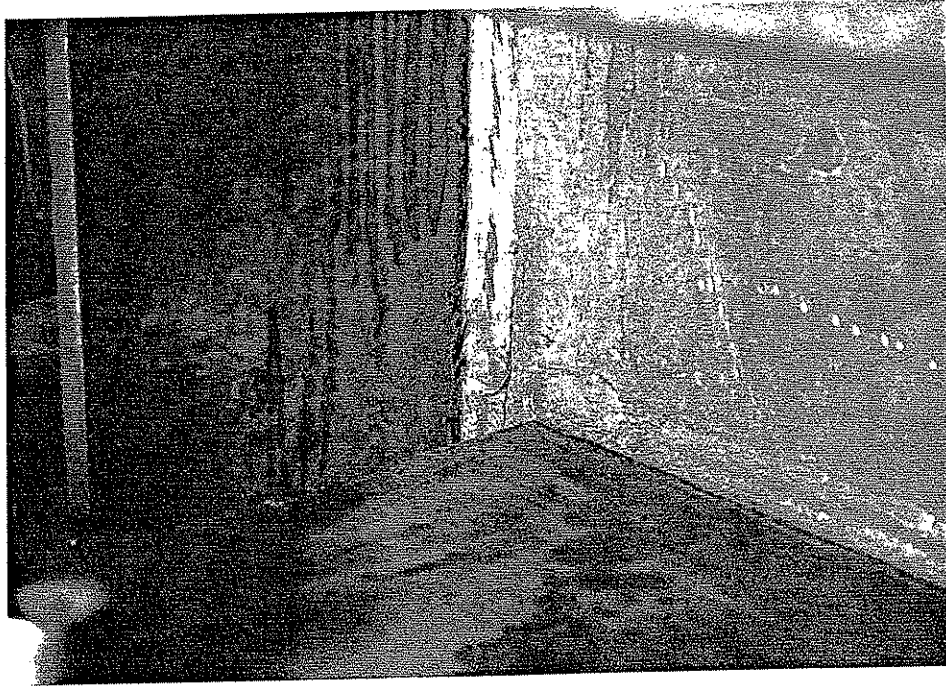
Figure 33: Cracking along vertical weld toe in the horizontal web gap

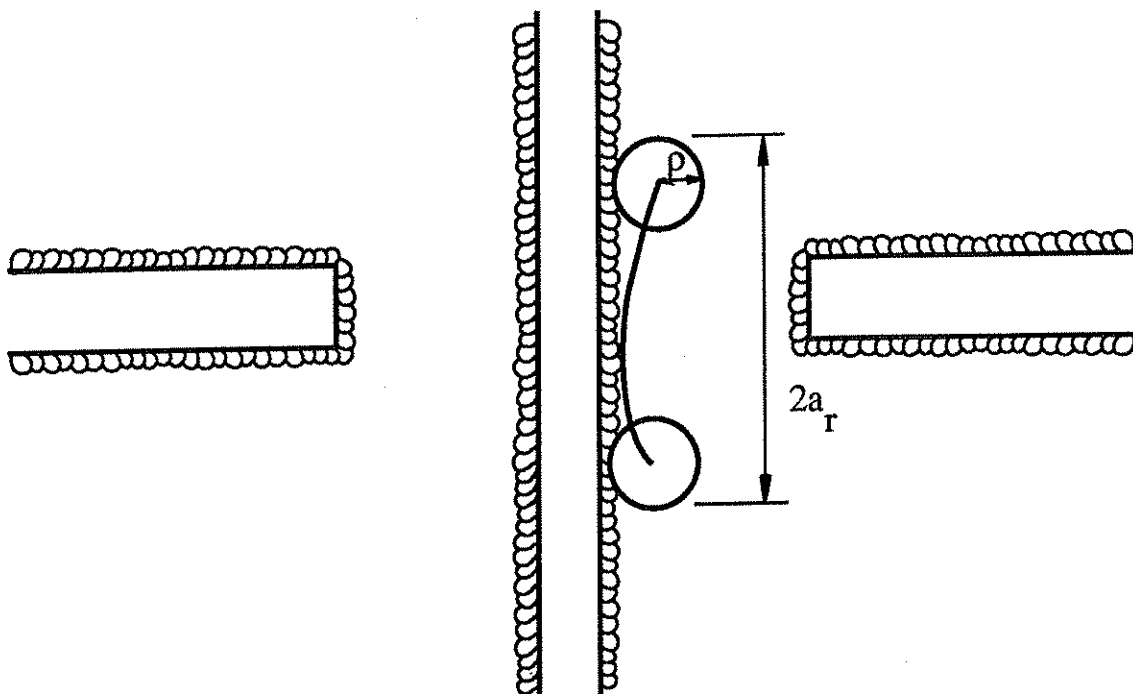
Figure 39: Retrofit holes at lateral gusset plate web gaps

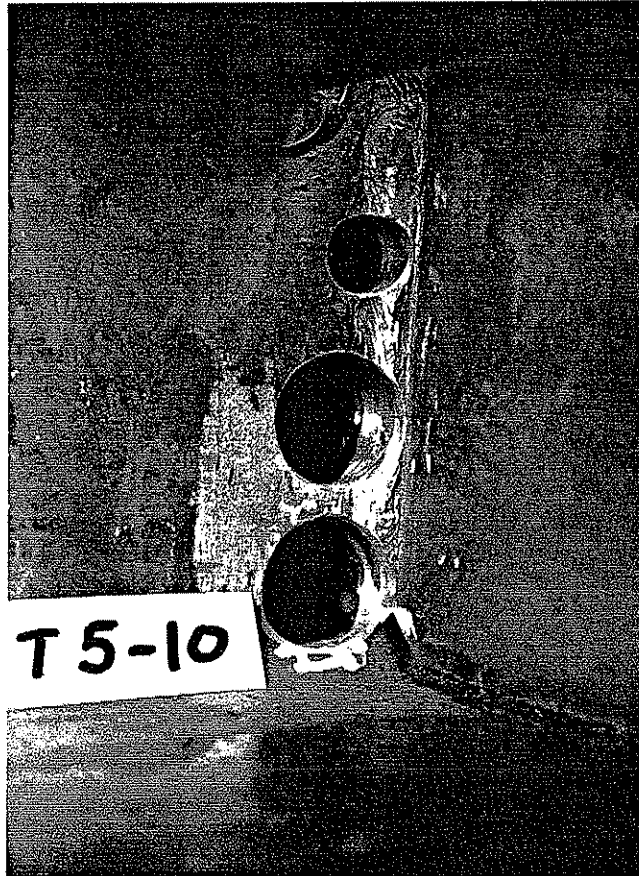
Figure 40: Additional crack arrest holes installed at crack tip

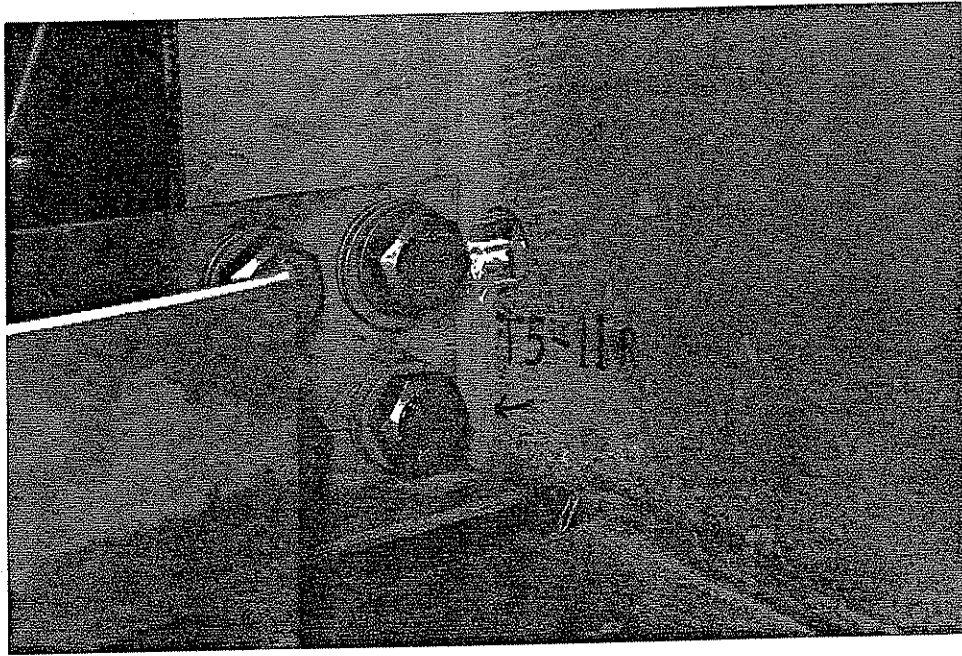
Figure 41: Retrofit hole and bolted attachment provided

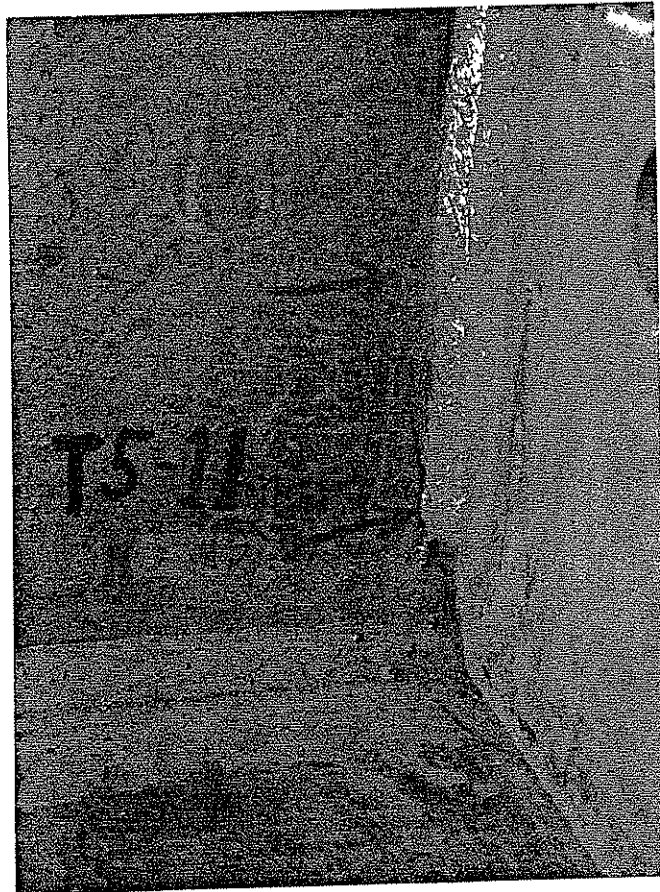
Figure 42: Crack along vertical connection plate weld

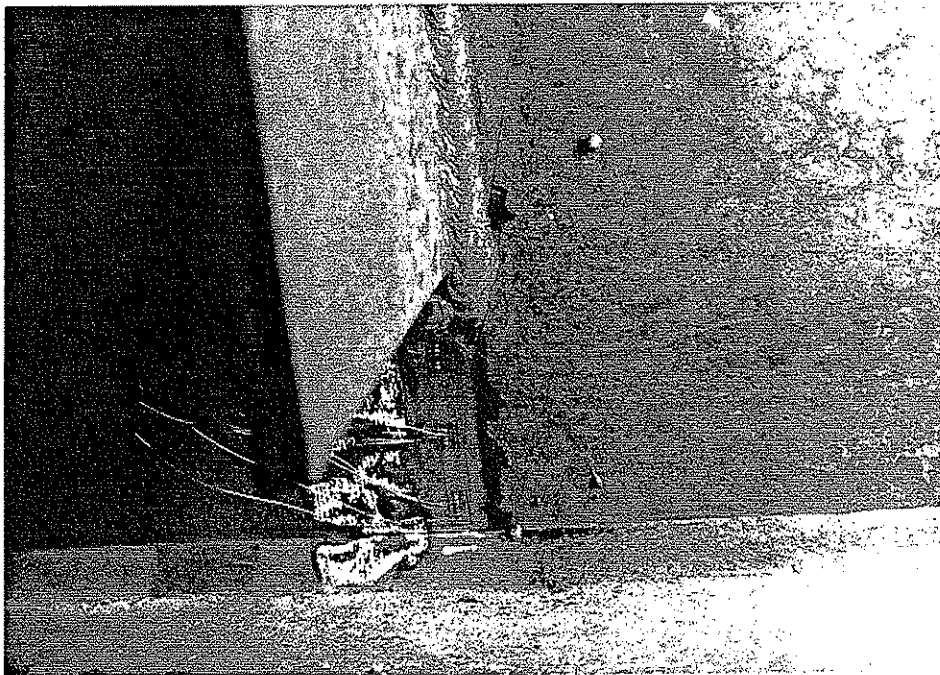
Figure 44: Crack forming at end of connection plate weld and extending up the transverse weld in (T2-L1) 3 in. gap

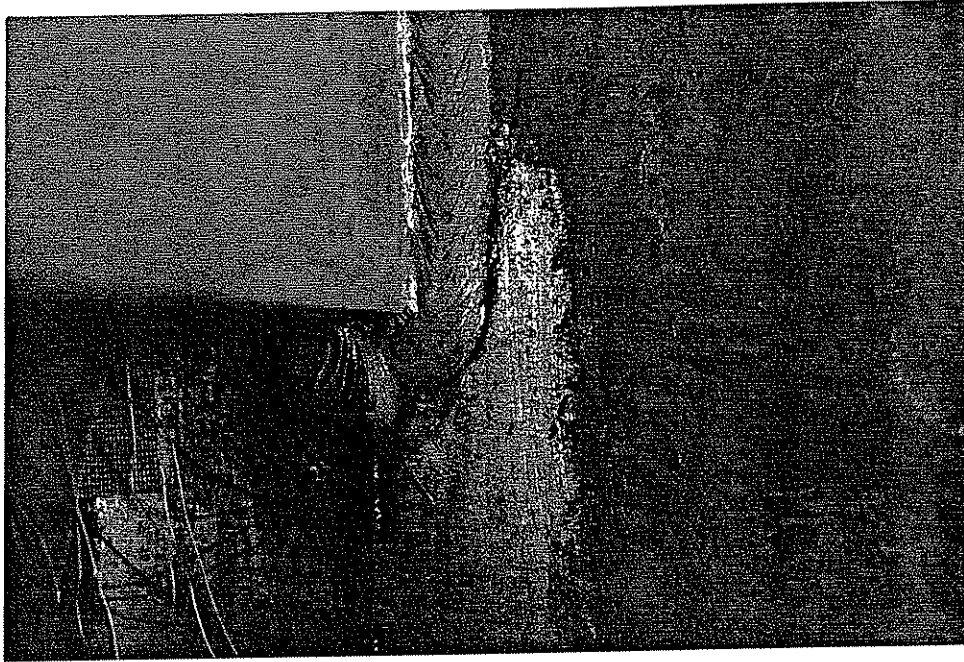
Figure 45: Closeup view of crack at end of transverse connection plate welds (3 in. detail)

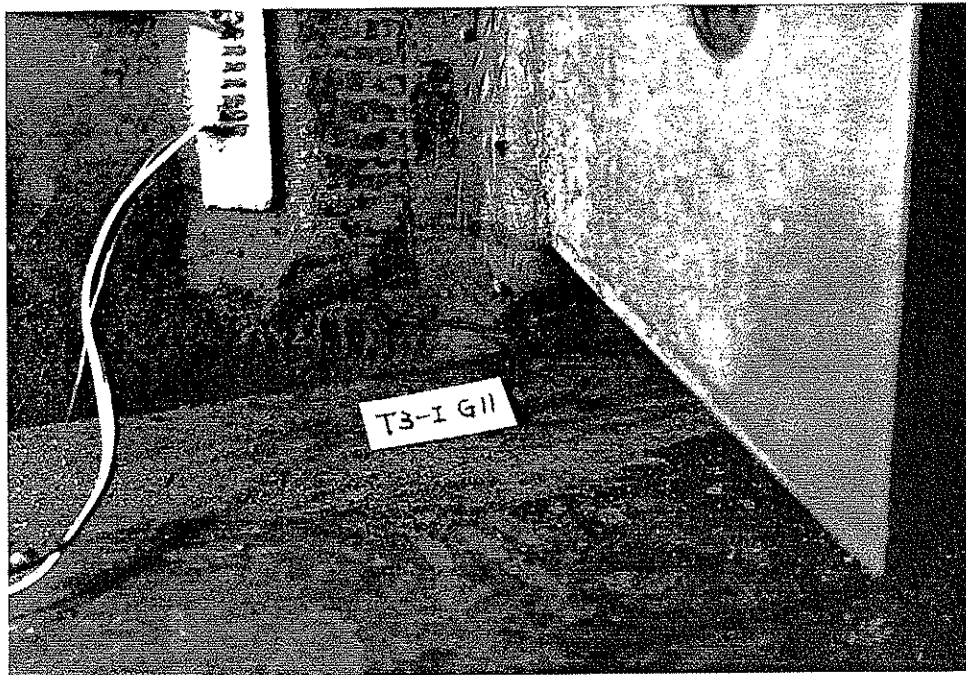
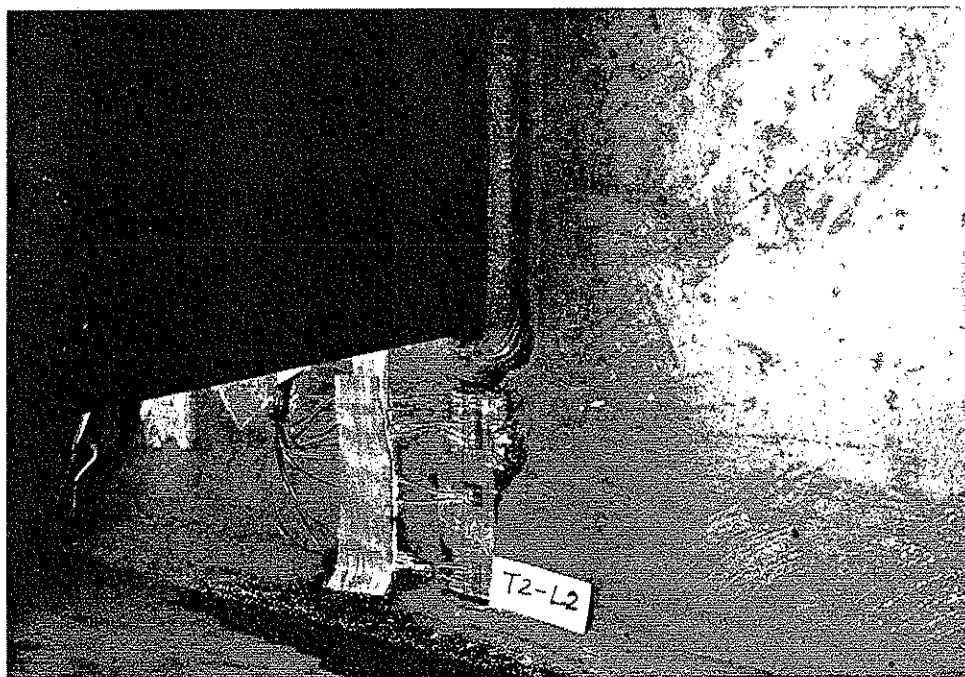
Figure 46: Cracks forming at ends of connection plates: (a) Branching crack at end of connection plate with 1 1/2 in. web gap; (b) Small crack in weld after completion of test at a 3 in. web gap

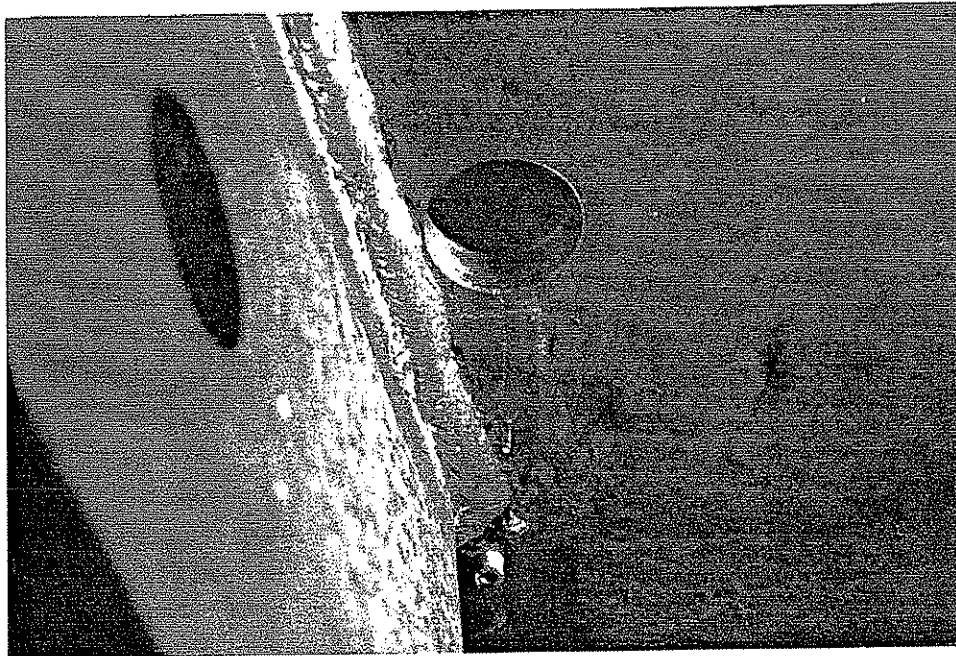
Figure 56: Retrofit hole(7/8 in.) at crack tip T2-H G8

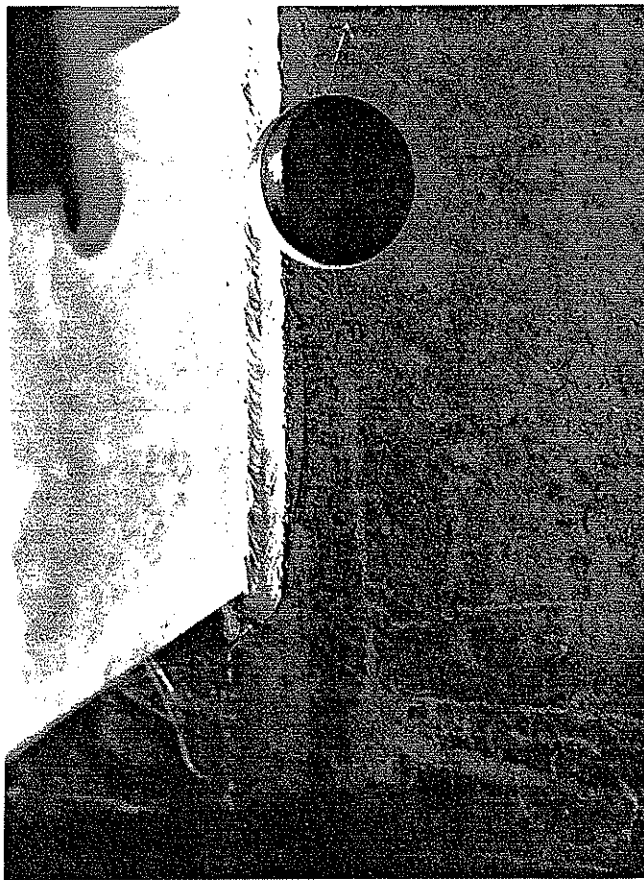
Figure 57: Retrofit hole (1 1/4 in.) at crack tip T4-I G12

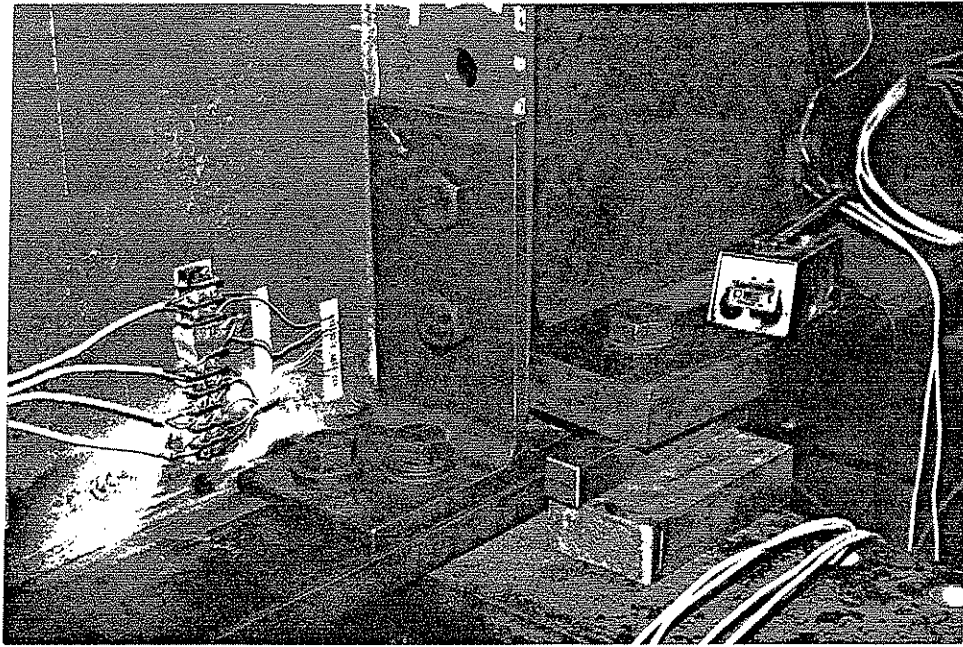
Figure 58: Retrofit Tee bolted to connection plate and flange (T3-I G11)
